**AIRCRAFT ACCIDENT  
PRELIMINARY REPORT**

**A 05/23**

**Air Accident Investigation Bureau (AAIB)  
Ministry of Transport Malaysia**

**Accident Involving Fixed Wing Aircraft Hawker Beechcraft 390 Premier 1,  
Registration N28JV, at Elmina, Shah Alam, Selangor  
on 17 August 2023**

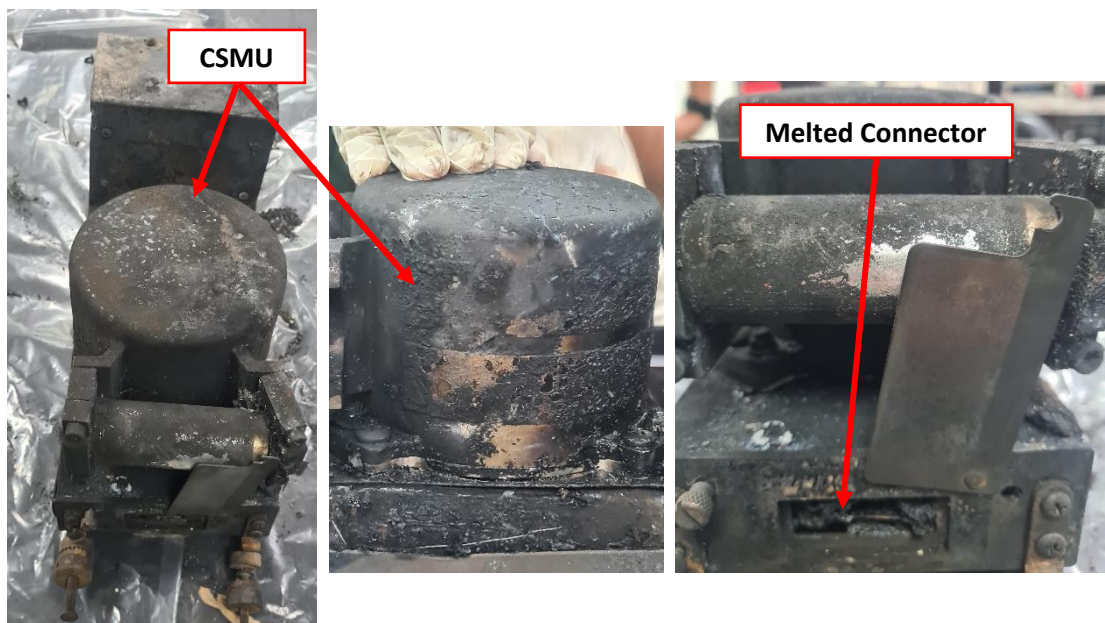
On 19 Aug 23, the damaged CVR was disassembled to be assessed further at the AAIB Flight Recorder Laboratory. Visual inspection (Figure 3) indicated that the CVR was exposed to elevated temperature of the post-crash fire. Parts of the external paint coating had liberated from metal surface of the Crash Survivable Memory Unit (CSMU). The front face connector had also melted.

Figure 3: (Left): Overall view of CVR. (Centre): View of CSMU with bare metal surface visible, absent of paint coating. (Right): Front face connector melted.

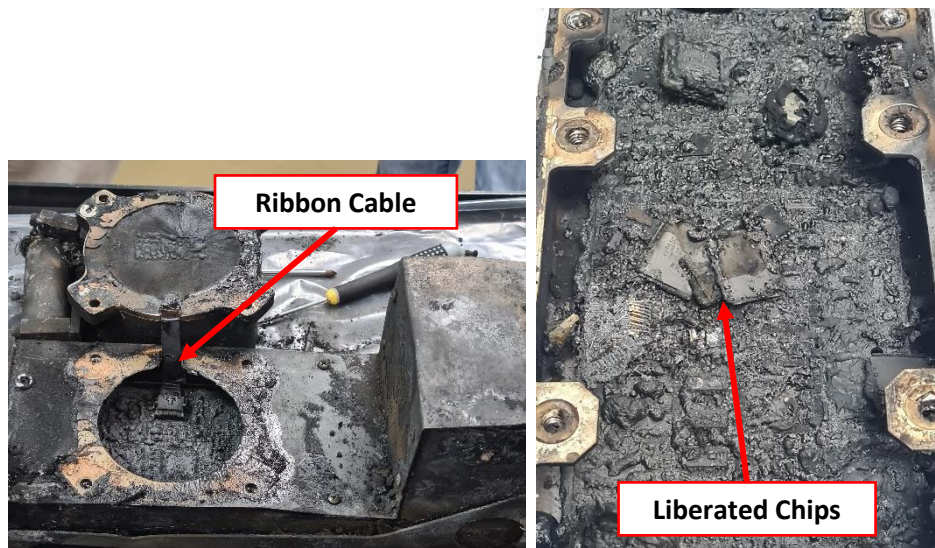
The CSMU was then removed from the CVR chassis. It was observed that the exposed portion of the ribbon cable connecting the memory storage module<sup>4</sup> exhibited signs of thermal stress (Figure 4). Visual examination of the circuit board within the CVR chassis indicated that it was exposed to elevated temperature which was sufficient to cause the solder joints to melt, as several integrated circuit (IC) chips were not in their original position.

Figure 4: (Left) CSMU separated from CVR chassis.  
(Right) Several IC chips liberated from their solder joints.

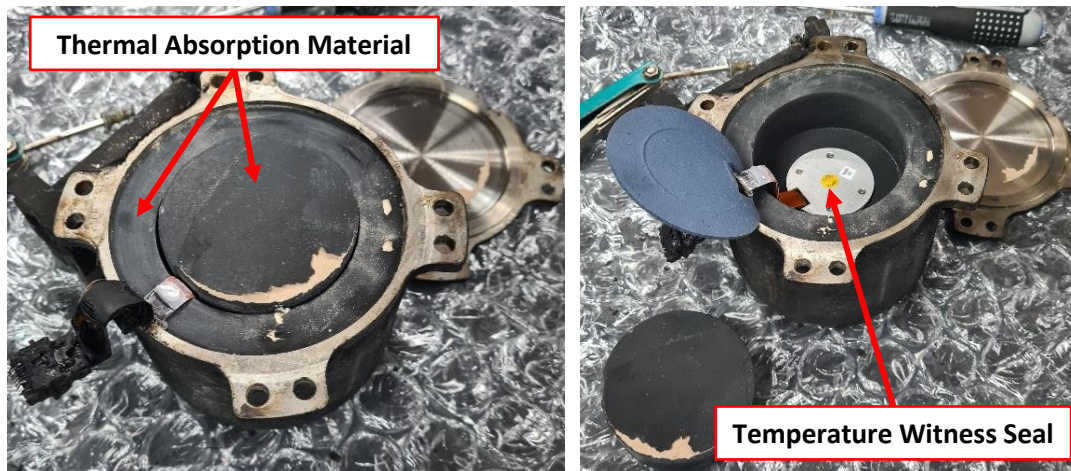
The CSMU base plate was removed and the internal area of the CSMU appeared to be in good condition with the thermal absorption material still in its original state<sup>5</sup> (Figure 5). The portion of the ribbon cable housed within the CSMU appeared to be undamaged.

Figure 5: (Left): Thermal absorption material condition.  
(Right): View of memory storage module exposed.

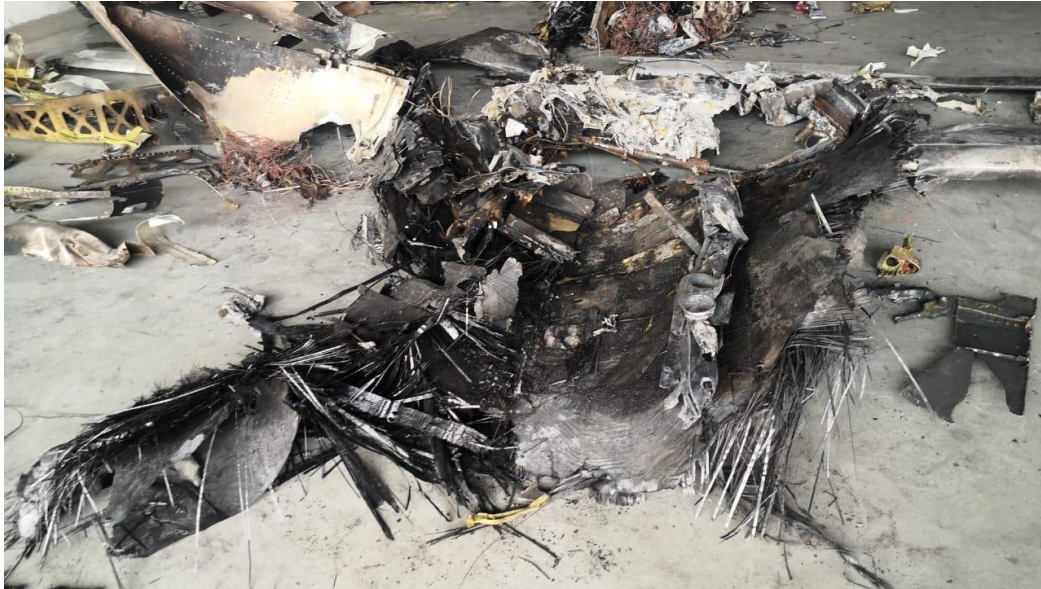
The aircraft container was shattered due to the high energy impact and post-crash fire. This disintegration of the container failed to prevent intrusion of outside objects. Therefore, occupants sustained fatal injuries.

Figure 8: Container was shattered. Survivability was almost impossible.

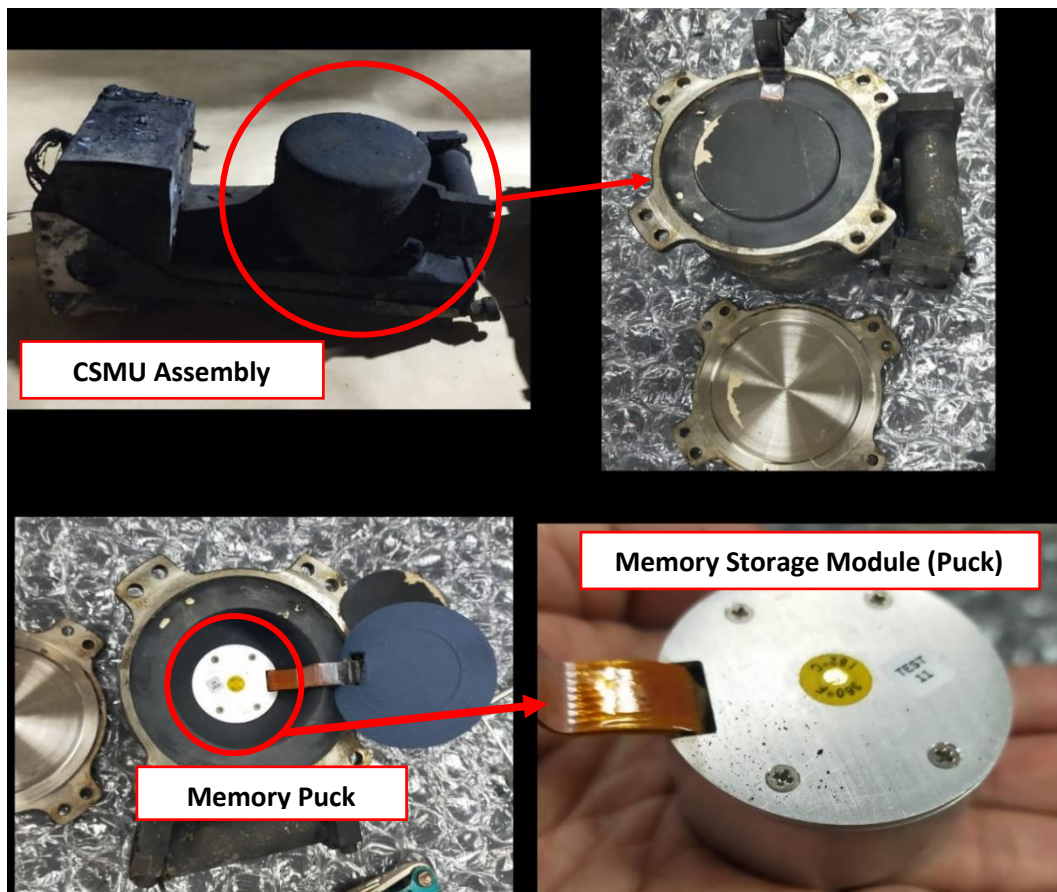
Figure 9: Condition of the Recovered CVR Memory Module (Puck)

Visual inspection found that the Cockpit Voice Recorder (CVR) was exposed to elevated temperature of the post-crash fire. The Crash Survivable Memory Unit (CSMU) was removed from the CVR chassis. The CSMU's memory storage module (memory puck) was extracted and sent initially to the TSIB Singapore flight recorder laboratory before being sent to the L3Harris accident investigation laboratory in the U.S. The CVR audio data was successfully recovered in the L3Harris facility.

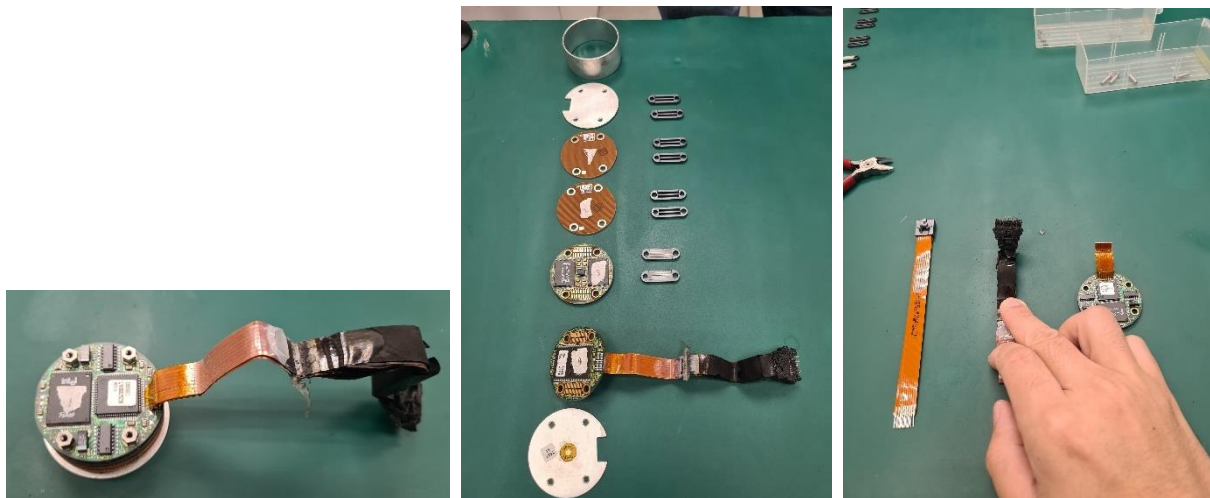
During the disassembly process, the internal and each layer of the memory puck appeared to be in good condition. The part number of the damaged ribbon cable was determined to be 024-E1575-00, which is used for a memory storage module that operates at 5V (Figure 1).

Figure 1: (Left): View of memory puck with base cover removed, showing the memory PCB. (Centre): Each layer of the memory puck removed. (Right): Verification of the replacement cable to be used.

A new ribbon cable was successfully attached. The memory storage module was reassembled and electrical checks were performed. Based on the electrical checks conducted, it was determined that it was safe to apply electrical power to the memory storage module to attempt downloading the stored data.

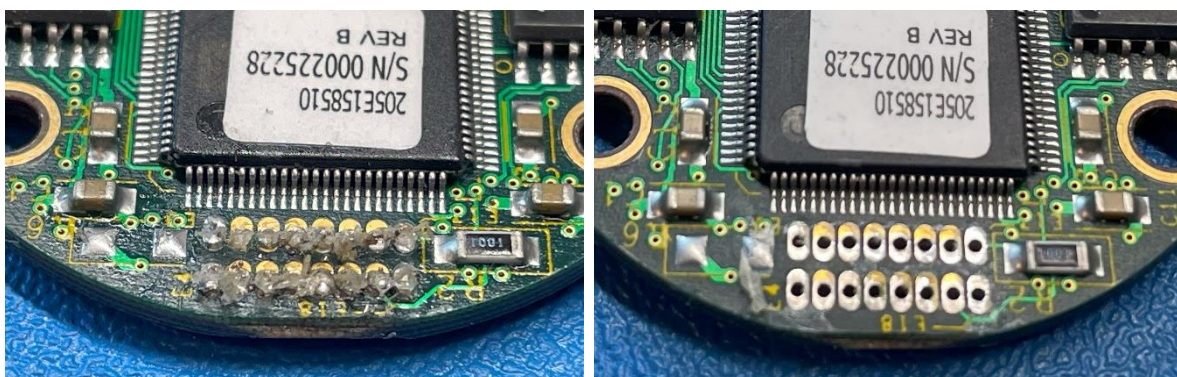
Figure 5: Removal of the remaining cable assembly. (Left): Before. (Right): After.

Disassembly of the memory module (Figure 4), including removal of the remaining cable assembly components (Figure 5) was uneventful. Safe-to-power measurements performed after the cable remnants removal was within specification.

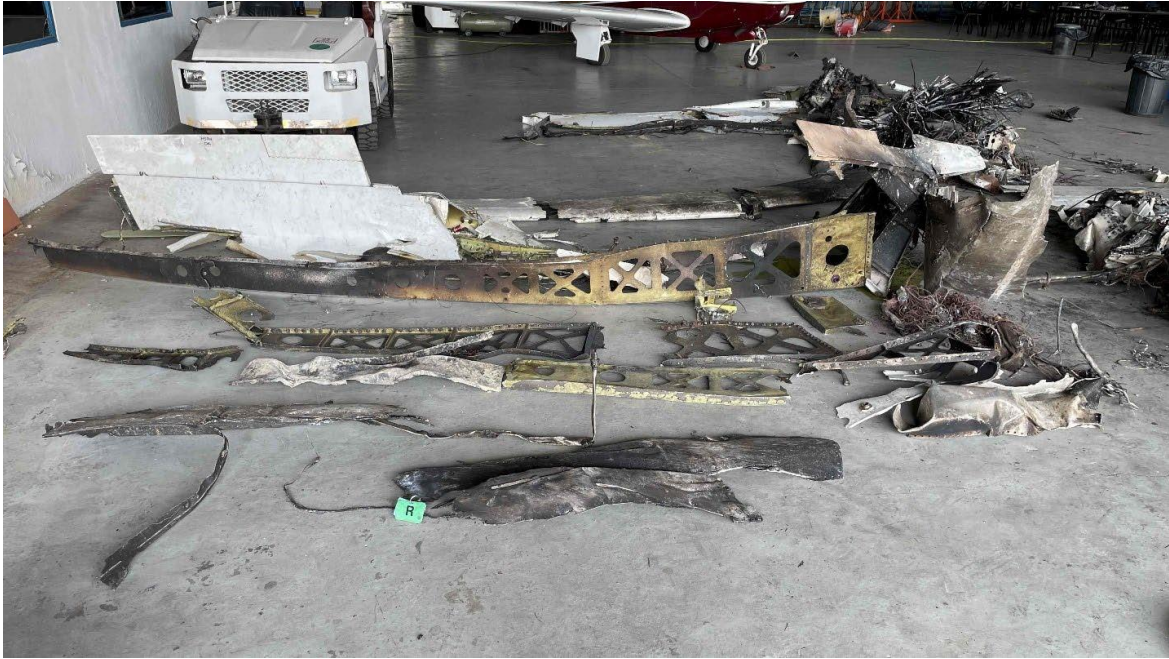
Figure 2. Right Wing.

The right wing (Figure 2) had fragmented, and its skins were distributed through the debris field. One of the wing spars was located principally intact and bent slightly aft, the remaining spars were fragmented with eight distinct sections identified.

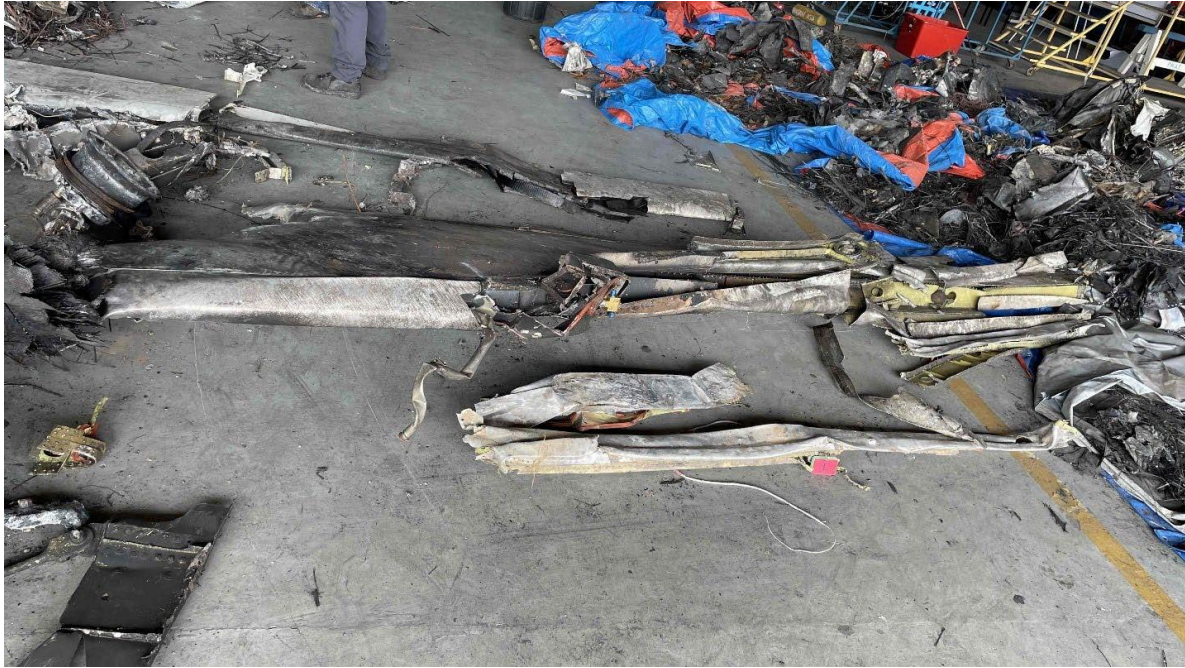
Figure 3. Left Wing.

The left wing exhibited leading edge crush damage starting at the root and progressively moving aft and through the intermediate spars as it continued to the aft

spar at the tip. The wing sustained thermal damage to most of its skin surface, bubbling and darkening the paint. (Figure 3) The inboard section of the leading edge was crushed aft to the wing forward spar and upward to the wing top skin. It also exhibited diagonal scratches in and aft/upward direction.

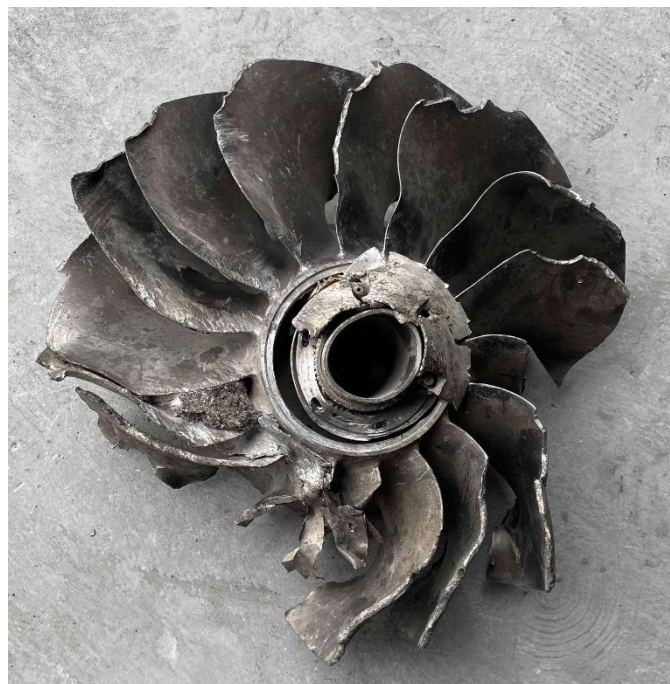
Figure 4. Right Engine Fan.

The Low Pressure (LP) shaft remained partially attached to the fan (Figure 4), which had separated from the engine. Remnants of the spinner were still in place. The LP shaft had separated aft of the 1.5 bearing retainer and exhibited twisting in the opposite direction of rotation and deformation with 45° shear lips at the separation area.

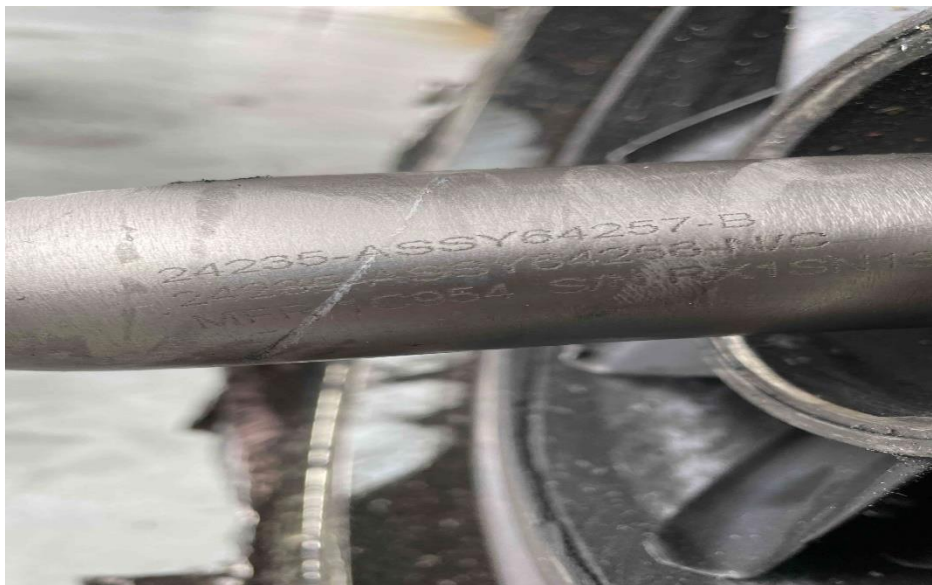
Figure 5. Right Engine LP Shaft.

The LP shaft was protruding about 4 inches, and had twisted and separated, such that the normally straight serial number was beginning to spiral (Figure 5).

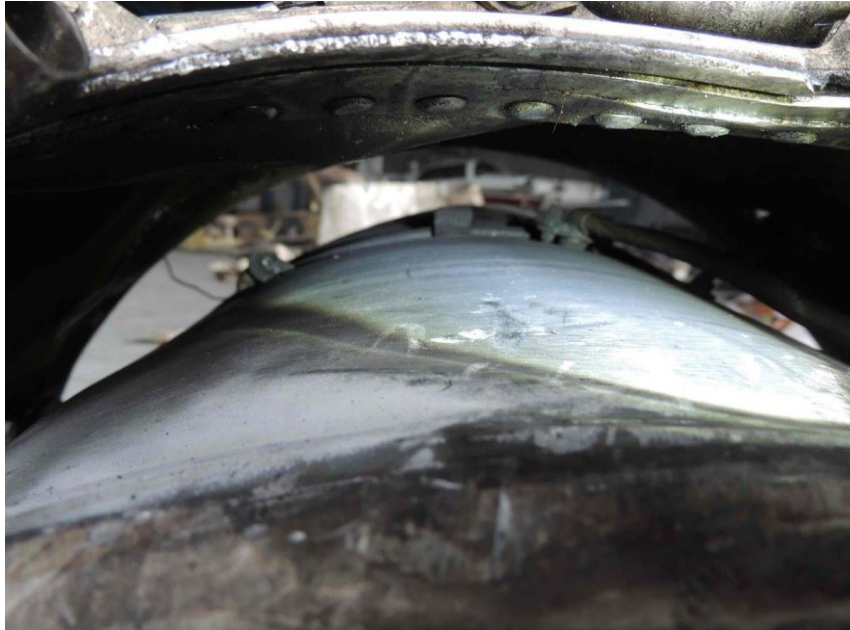
Figure 6. Right Engine Diffuser Case.

blades appeared intact and but appeared to have sustained crush damage. The first stage LP blades could not be observed, and the case could not be removed due to the damage sustained, however there was no damage to the rear housing/mixer that would have indicated 1<sup>st</sup> stage LP blade liberation. The diffuser outer case showed no outward dents or any other signs of High-Pressure Turbine (HPT) damage that would have indicated HPT blade or disk liberation (Figure 6).

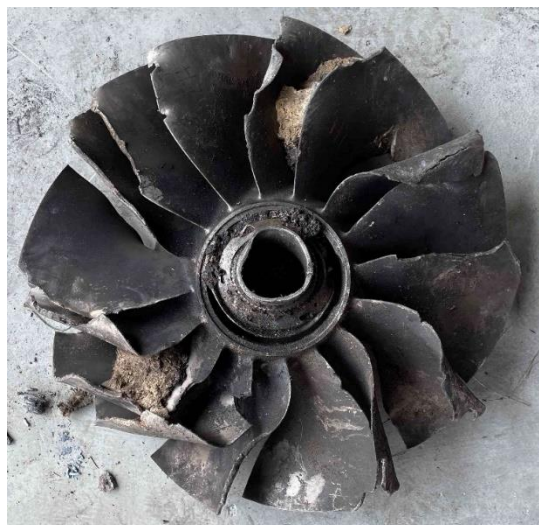
Figure 7. Left Engine Fan.

The fan had detached, but the fan nut and locking plate were in place; none of the blades had been liberated, but all exhibited significant leading edge gouges, and tip separation along with embedment of mud material (Figure 7). The blades were covered in black soot.

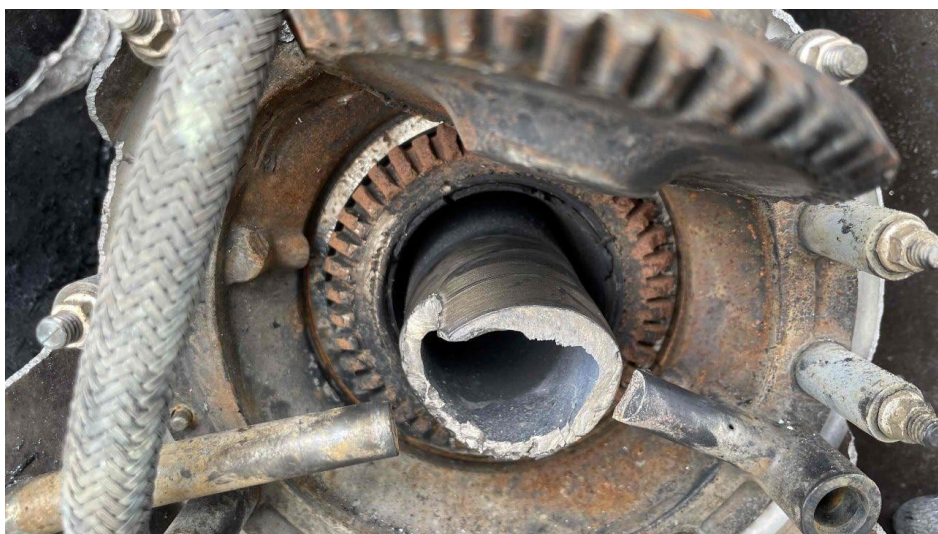
Figure 8. Left Engine LP Shaft.

Number 2 bearing and 1<sup>st</sup> reduction bevel gear assembly remained in position, and the LP shaft remained in position and had twisted and separated, such that the shaft was twisting in the opposite direction of rotation (Figure 8).

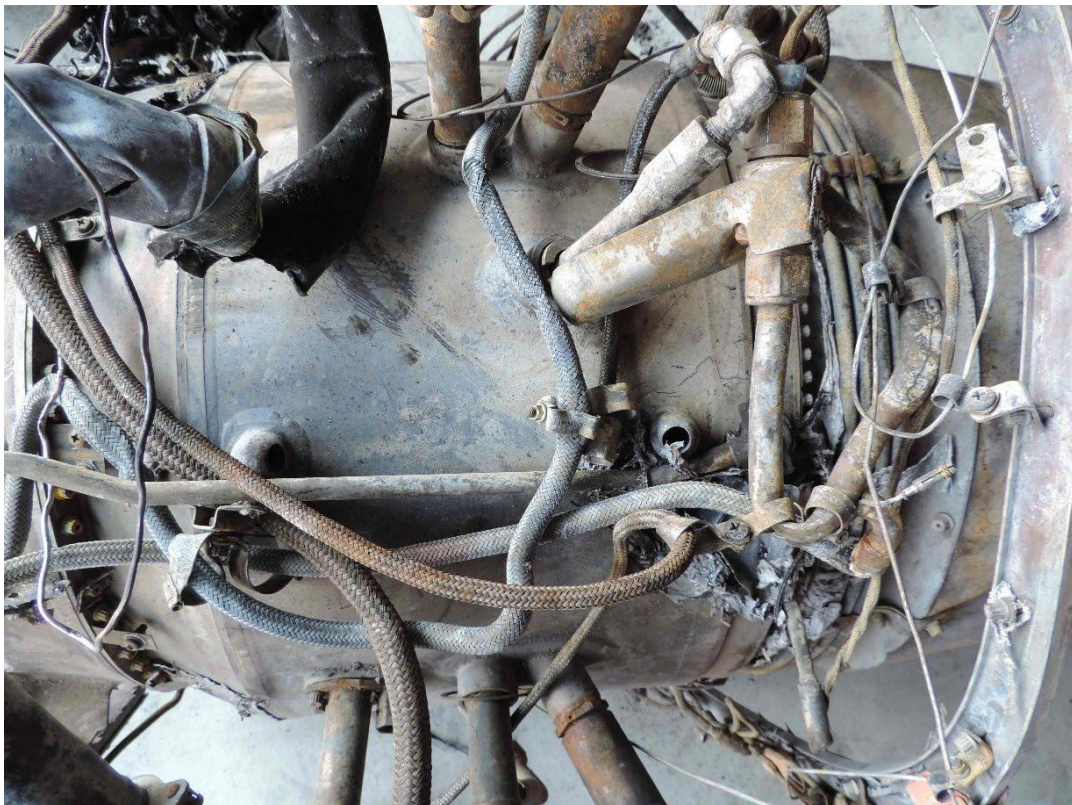
Figure 9. Left engine diffuser case.

From the aft end of the engine, viewed through the mixer, the 2<sup>nd</sup> stage LP turbine blades appeared intact and undamaged. The first stage LP blades could not be observed, and the case could not be removed due to the damage sustained, however there was no damage to the rear housing mixer assembly that would have indicated 1<sup>st</sup> stage LP blade liberation. The diffuser outer case showed no outward dents or any other signs of HPT damage that would have indicated HPT Blade or disk liberation (Figure 9).

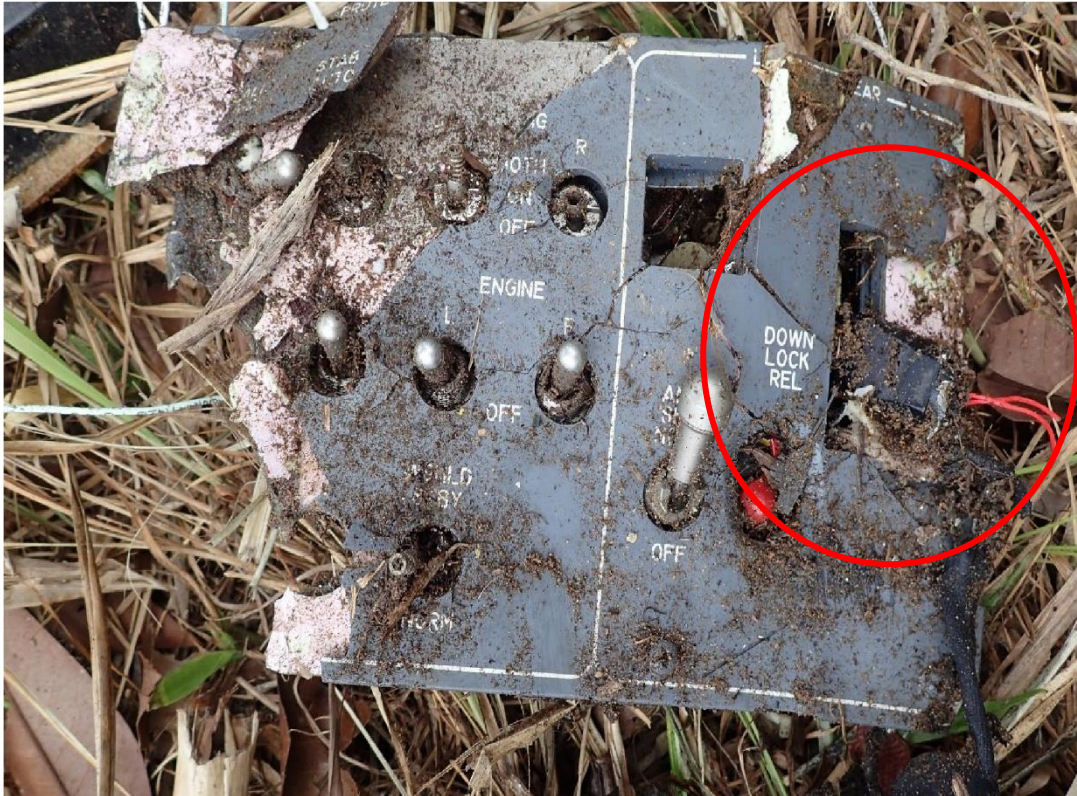
Figure 10. Landing Gear Handle.

The cockpit was highly fragmented. The cockpit controls were examined. The landing gear handle was found in the down position but the handle was damaged. (Figure 10) The lift dump handle was damaged and found in an intermediate position (normal range is retracted or extended) (Figure 11).

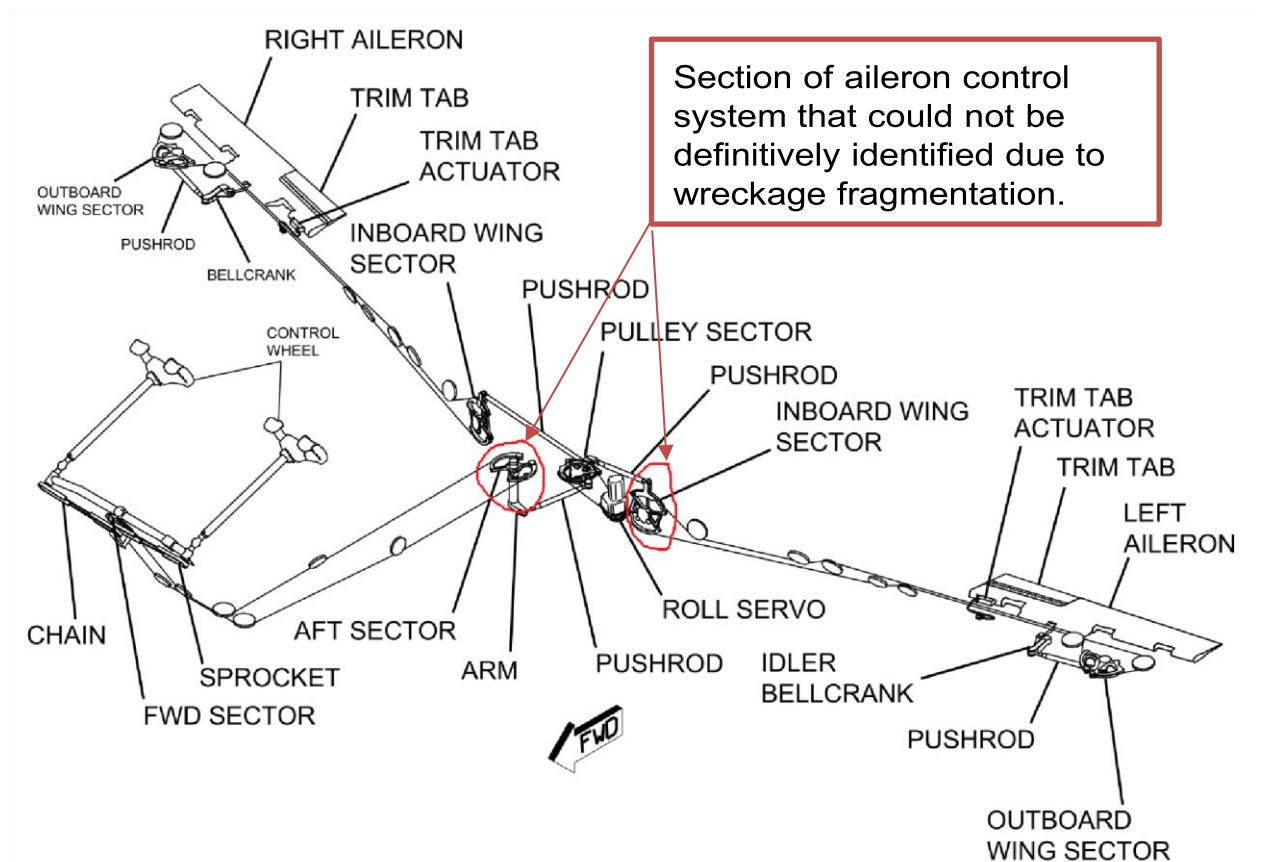
Figure 12. Aileron control system components examined during investigation.

The aileron system was retrieved from the wreckage and examined. The aileron system from the control column to the left and right ailerons were recovered and examined except for the aft sector and the left wing inboard sector (Figure 12). These components could not be definitively identified due to wreckage fragmentation. The breaks in the cables had ends that had a splayed, broom straw appearance consistent with tension overload. All remaining control sectors and their associated fittings were either intact or exhibited damage consistent with overload.

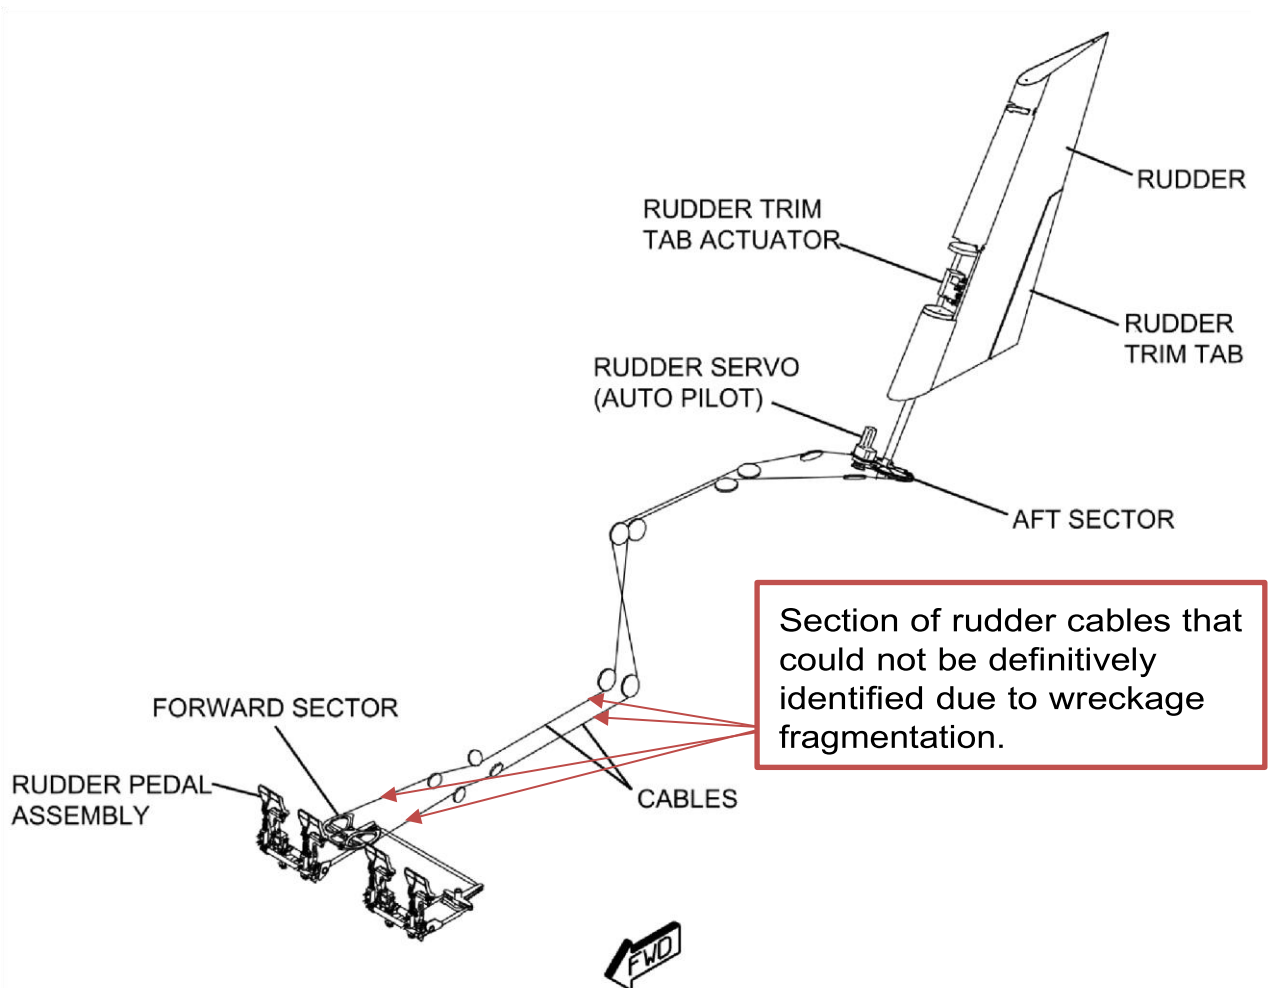
Figure 13. Rudder control system components examined during investigation.

Flight control cables of various lengths were found that exhibited breaks consistent with tension overload but these cables could not be positively identified as rudder or elevator cables.

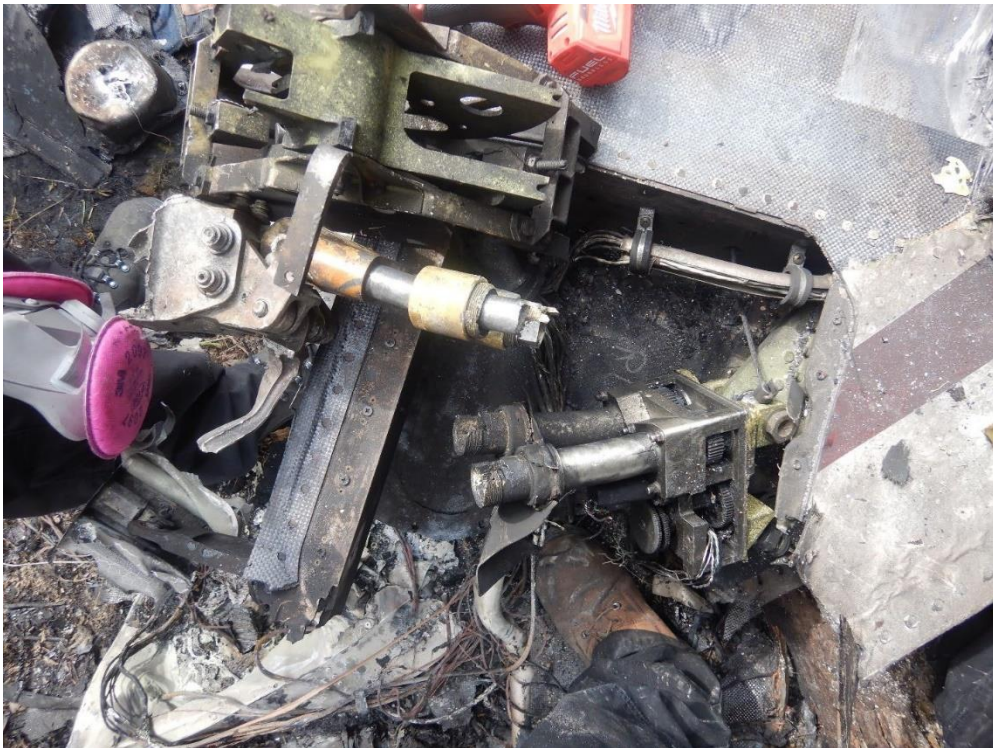
Figure 14. Pitch trim actuator.

The pitch trim actuator was found broken with the severed links exhibiting indications of tensile overload. (Figure 14) The parts of the actuator were placed together and the extension distance was measured at approximately 16.5 inches. This corresponds to -3.6 degrees leading edge down. The take-off range is -3.2 degrees to -4.4 degrees. The pitch trim actuator range is -7.0 degrees to +1.4 degrees.

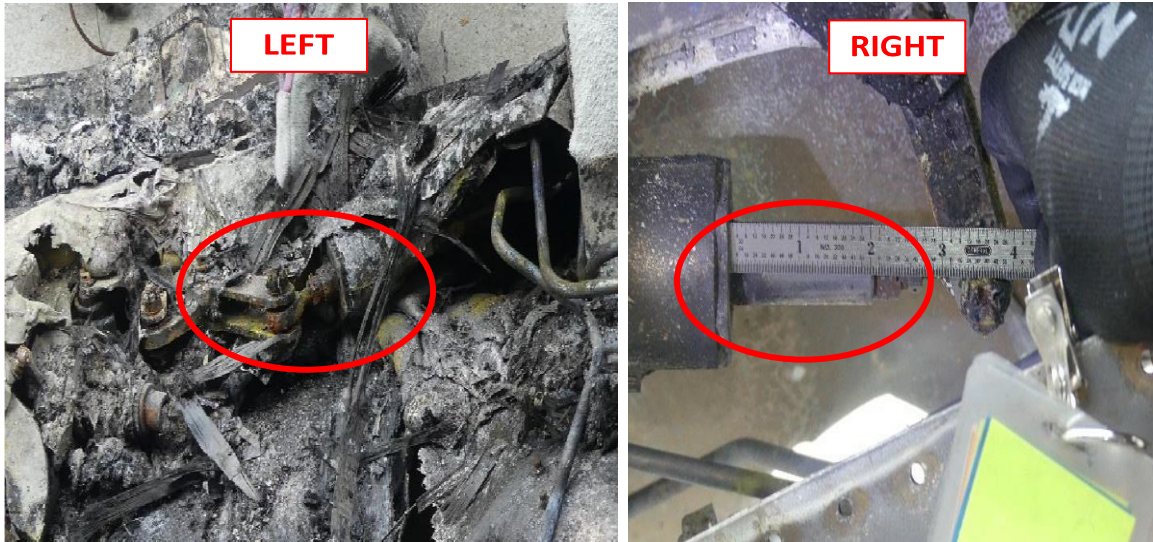
Figure 15. Left and Right Lift dump Actuators.

The right lift dump actuator was found in an extended position while the left lift dump actuator was found in the retracted position (Figure 15). The down-lock striker on the right lift dump panel was bent from impact (Figure 16). Both the left and right middle and outboard spoilers were in the stowed position.
