FINAL REPORT

SI 01/24

Fixed Wing Aircraft Piper PA28-181 Archer III

Registration 9M-ITX

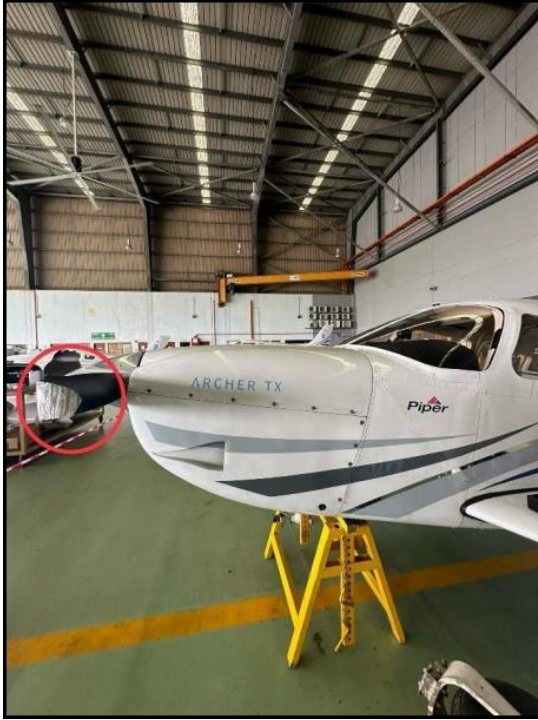
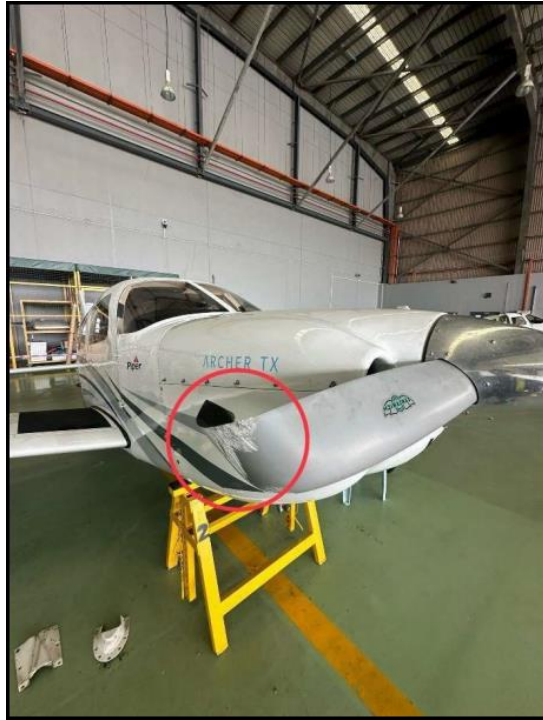
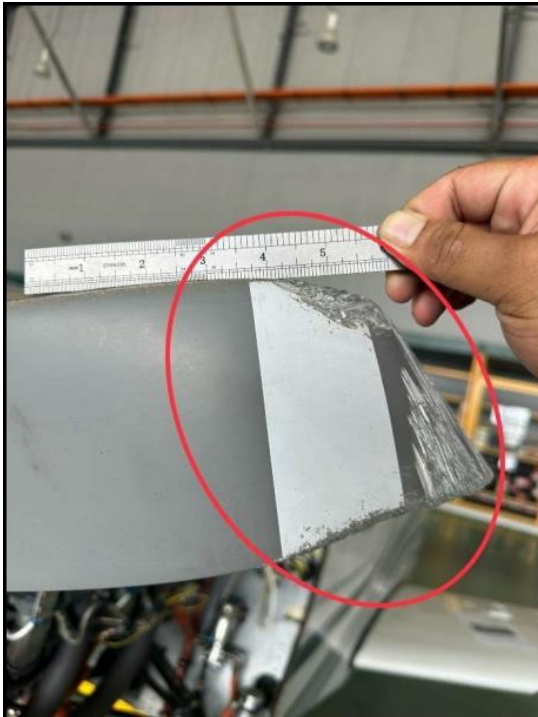
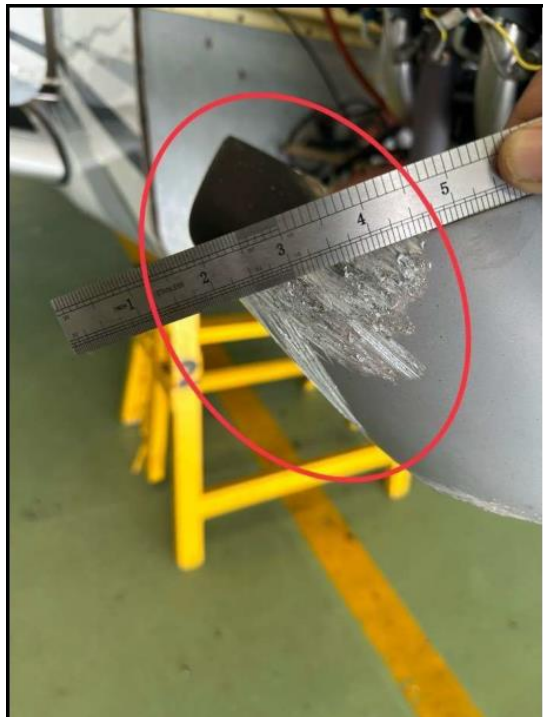
- **Propeller:** Both propeller tips showed significant damage, including scratches and visible bends. The scratches indicate contact with the runway surface, while the bends suggest substantial impact forces.
- **Nose Landing Gear (NLG):** The NLG was severely damaged, with complete collapse observed. This damage resulted from the repeated bouncing of the aircraft upon touchdown, with notable deformation and fractures compromising its structural integrity.

1.3.1 Bent Propellers. The propeller tips were significantly bent, indicating impact with the runway surface. Scratches and deformation on both tips suggest that the propeller absorbed substantial forces during the incident.

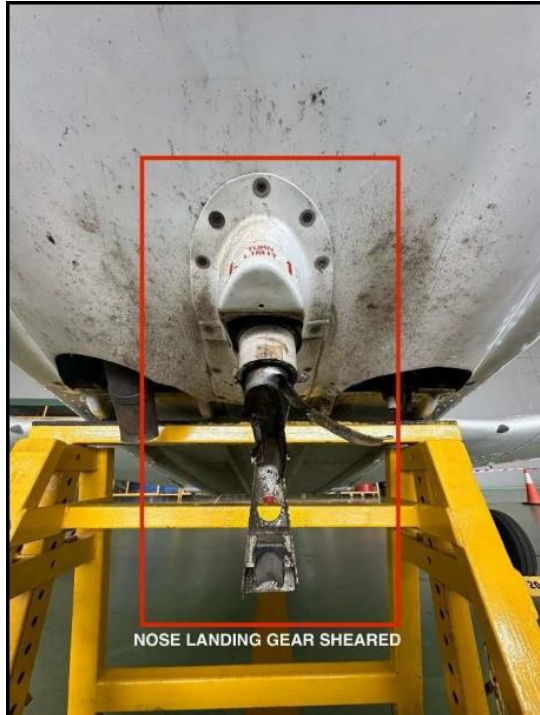
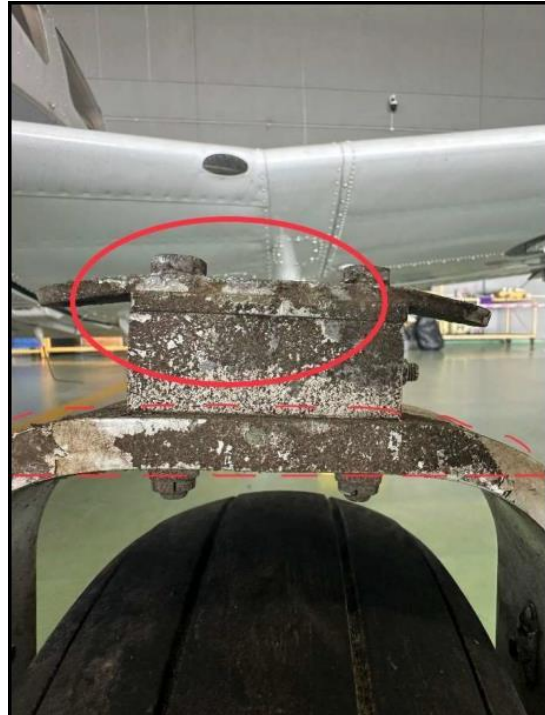
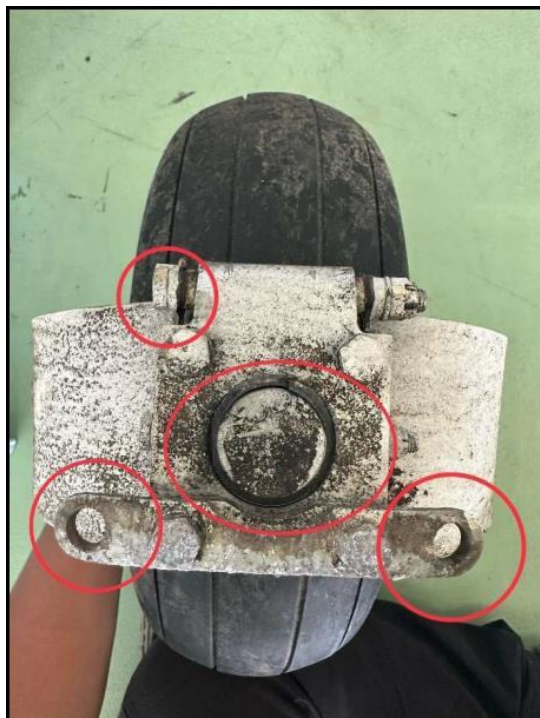
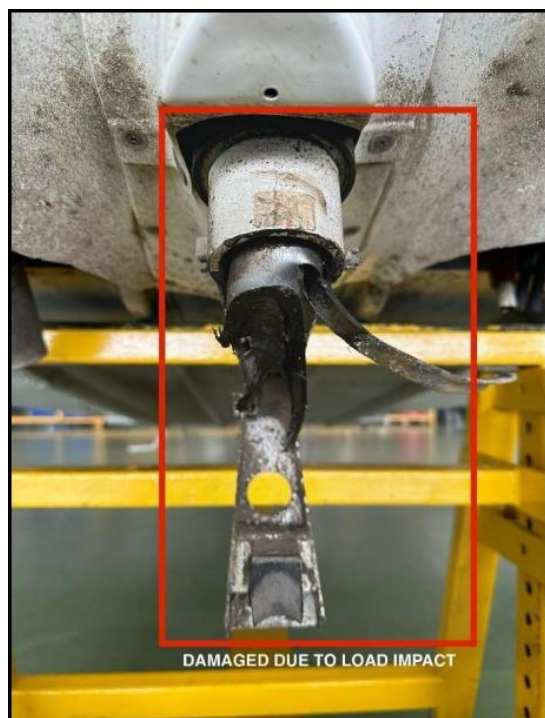
1.3.2 Nose Landing Gear Sheared. The NLG was sheared off, resulting in a complete collapse. This damage resulted from the aircraft's repeated bouncing upon touchdown, causing severe deformation and failure of the gear assembly.

3.1.1 Aircraft Operation and Configuration. The investigation found that the aircraft approached the runway at an excessive speed of 95 knots, approximately 20 knots above the recommended 75 knots. This high speed was primarily due to the failure to extend the flaps before landing, which made it difficult to reduce speed and significantly worsened the impact on the runway, ultimately leading to the collapse of the nose landing gear.

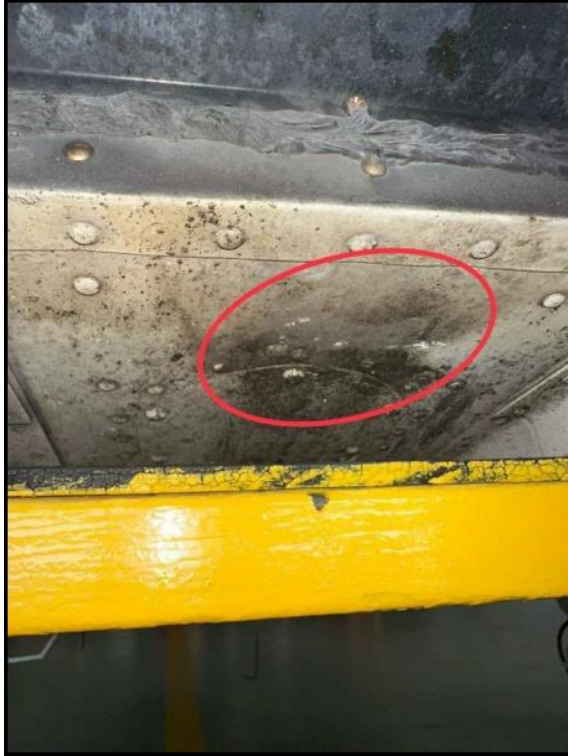
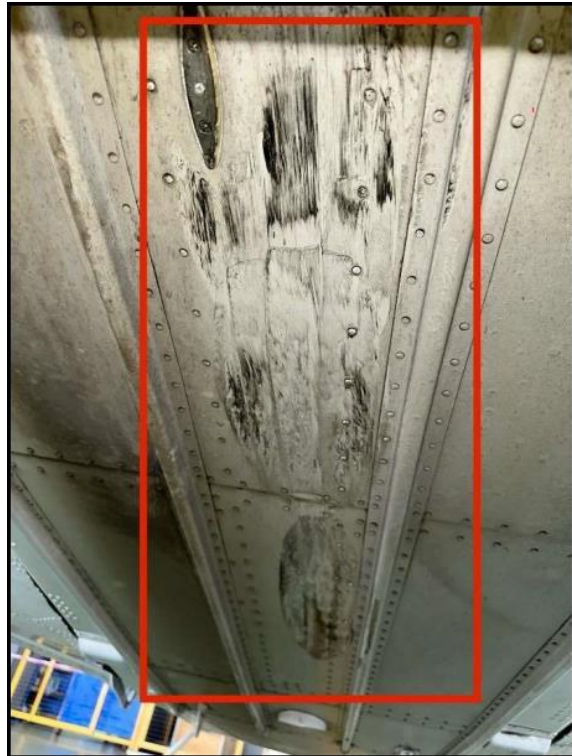
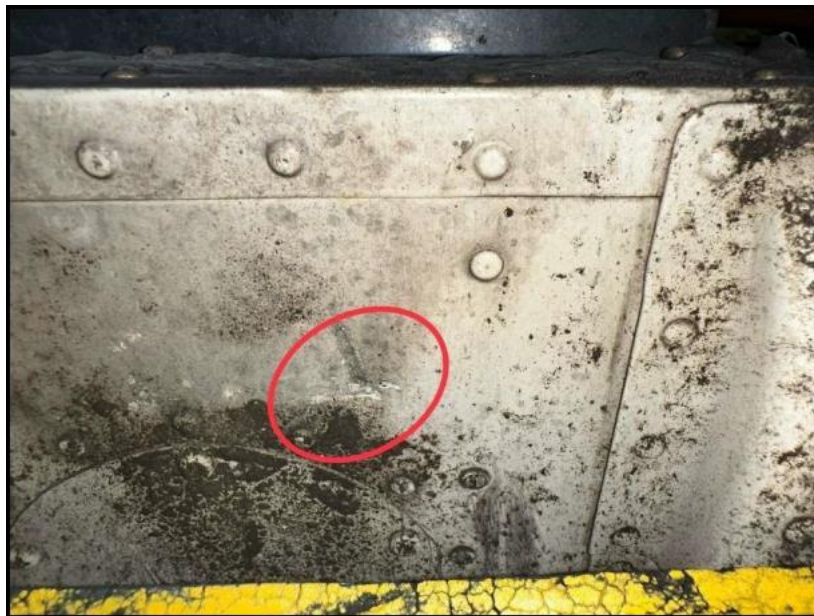
- **Aircraft Belly Skin:** The belly skin exhibited deformation, including dents and abrasions, likely caused by contact with the runway surface. Scraping along the belly was also observed, consistent with the aircraft's movement across the runway after the gear collapse.

1.3.3 Belly Skin Damaged. The belly skin of the aircraft exhibited noticeable damage, including dents and abrasions. This damage was consistent with contact and scraping against the runway surface.

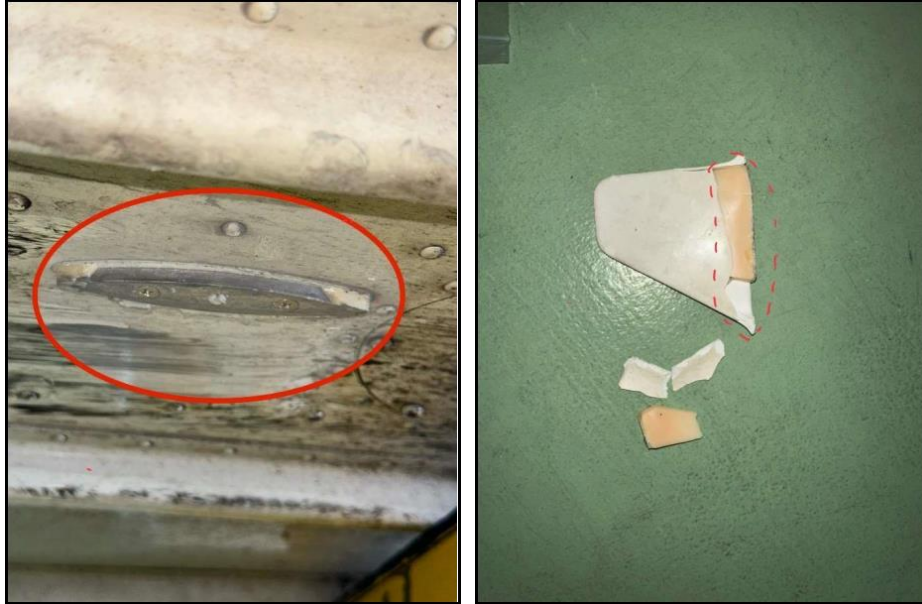
1.3.4 Distance Measuring Equipment (DME) Antenna Broken. The DME antenna was found to be broken. The damage to the antenna suggests it may have been impacted or subjected to forces during the landing.

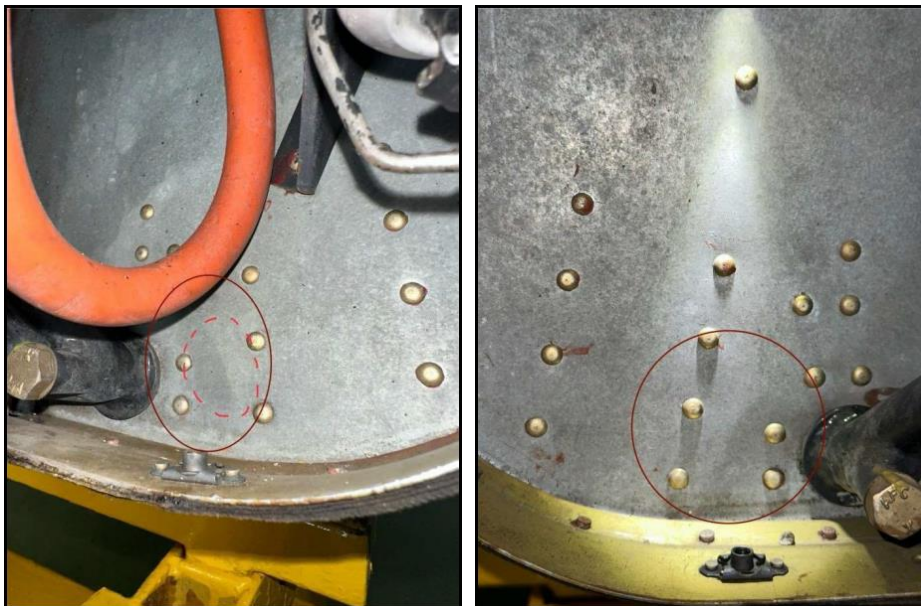
1.3.5 Dented Firewall. The aircraft's firewall showed signs of denting. This damage may have been caused by the impact forces transmitted through the aircraft structure during the incident.

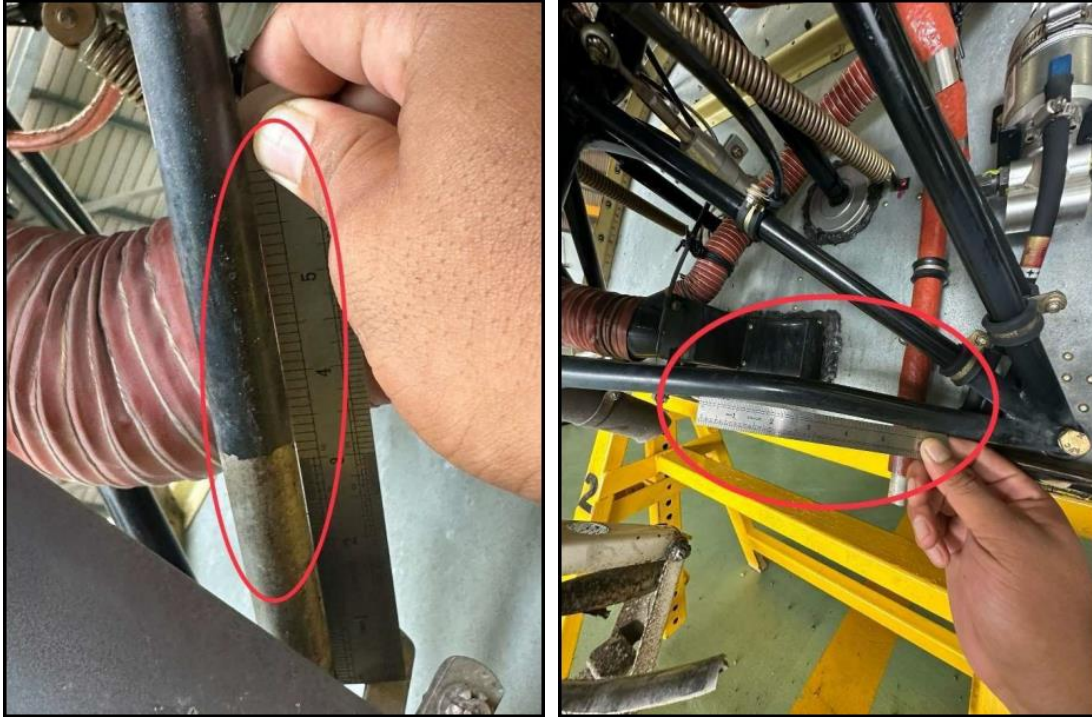
1.3.6 Bent Engine Frame. The engine frame was observed to be bent, indicating that the engine experienced substantial forces during the occurrence. The deformation of the frame could affect engine alignment and operation.
