**AIRCRAFT ACCIDENT
FINAL REPORT
A 05/23P**

**Air Accident Investigation Bureau (AAIB)
Ministry of Transport Malaysia**

**Accident Involving Fixed Wing Aircraft Hawker Beechcraft 390 Premier 1,
Registration N28JV, at Elmina, Shah Alam, Selangor
on 17 August 2023**

Issued on 16 August 2024
MOT.(S).600-5/4/99

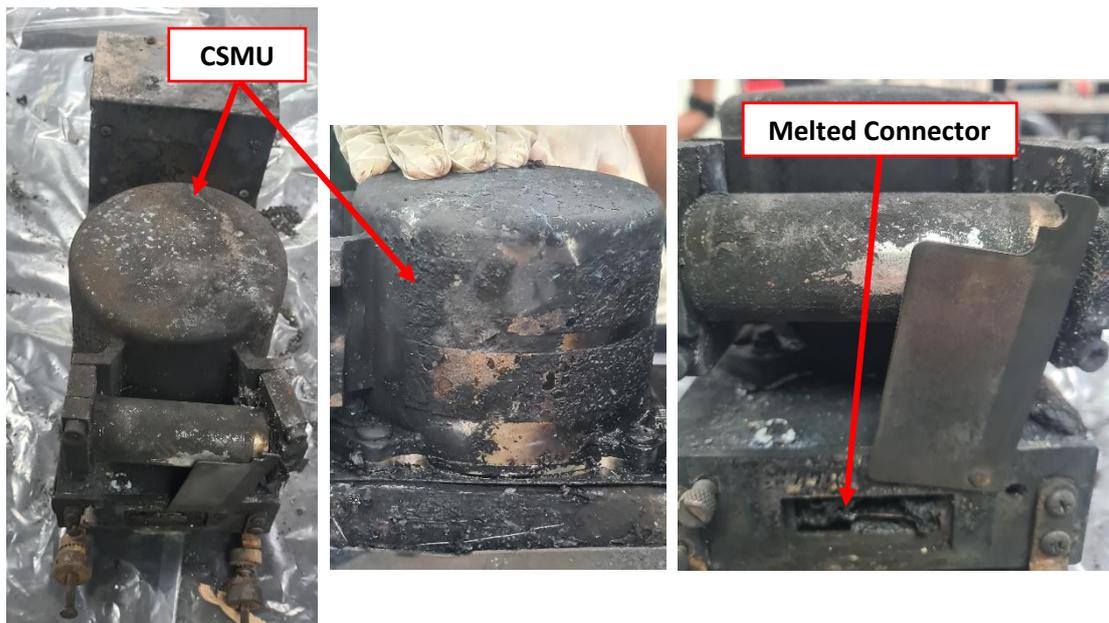
On 19 August 2023, the damaged CVR was disassembled for further assessment at the AAIB Flight Recorder Laboratory. Visual inspection (Figure 3) indicated that the CVR was exposed to high temperatures from the post-crash fire. Parts of the external paint coating had detached from the metal surface of the Crash Survivable Memory Unit (CSMU), and the front face connector had melted

Figure 3. (Left): Overall view of CVR. (Centre): View of CMSU with bare metal surface visible, absent of paint coating. (Right): Front face connector melted.

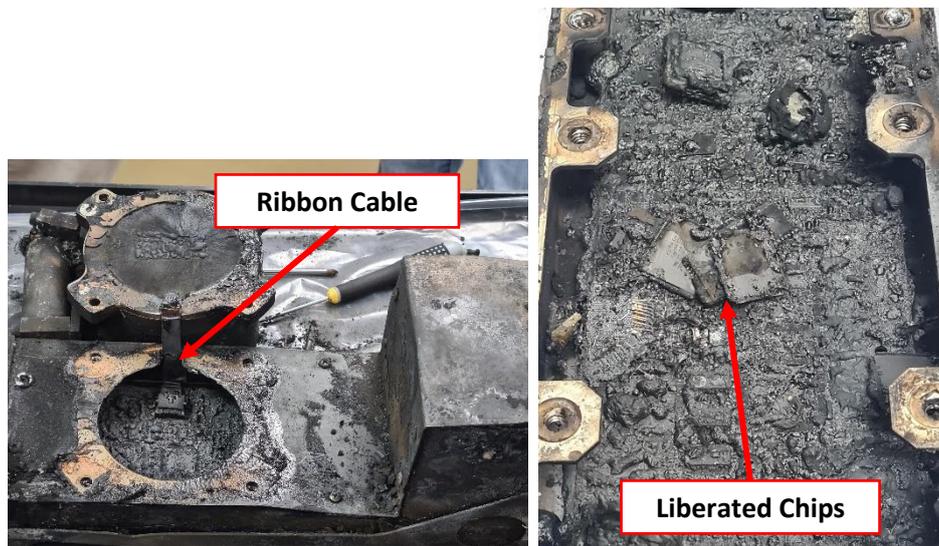
The CSMU was then removed from the CVR chassis. The exposed portion of the ribbon cable connecting the memory storage module showed signs of thermal stress (Figure 4). Visual examination of the circuit board within the CVR chassis indicated exposure to high temperatures, sufficient to cause the solder joints to melt, with several integrated circuit (IC) chips not in their original positions.

Figure 4. (Left) CSMU separated from CVR chassis.
(Right) Several IC chips liberated from their solder joints.

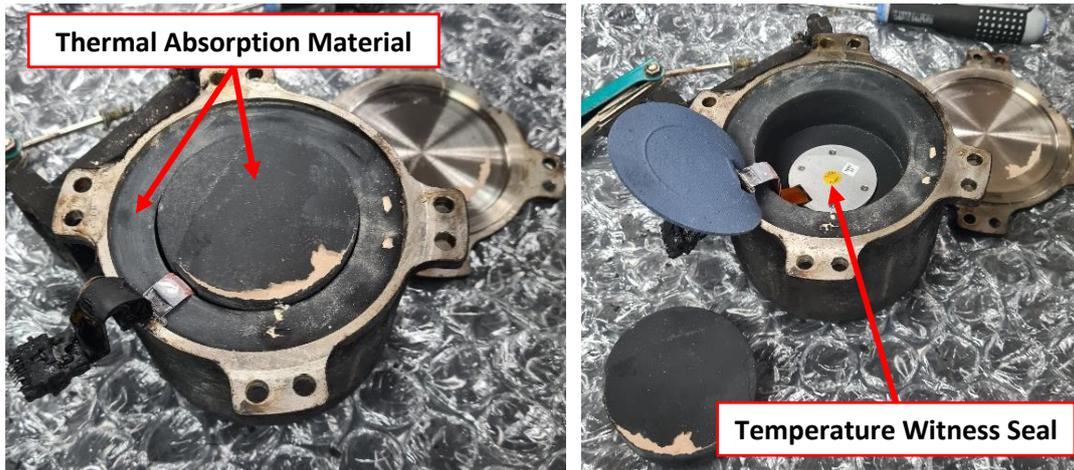
The CSMU base plate was removed, revealing that the internal area of the CSMU was in good condition, with the thermal absorption material still intact⁷ (Figure 5). The portion of the ribbon cable within the CSMU appeared undamaged.

Figure 5. (Left): Thermal absorption material condition.
(Right): View of memory storage module exposed.

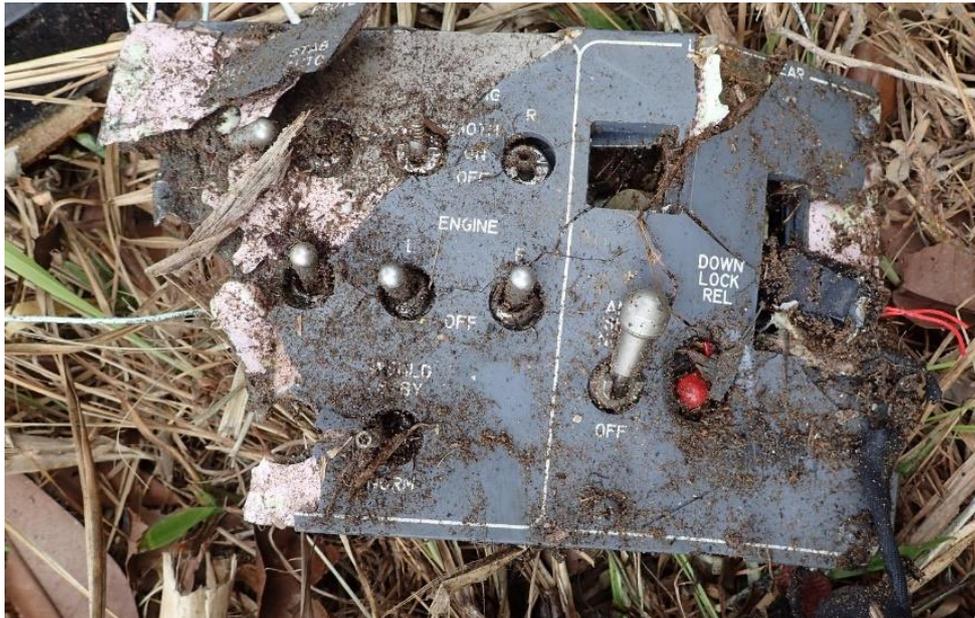
The cockpit was highly fragmented. The landing gear handle was found in the down position but was damaged (Figure 9). The lift dump handle was also damaged and found in an intermediate position, whereas the normal range is either retracted or extended (Figure 10).

Figure 9. Damaged Landing Gear Handle.

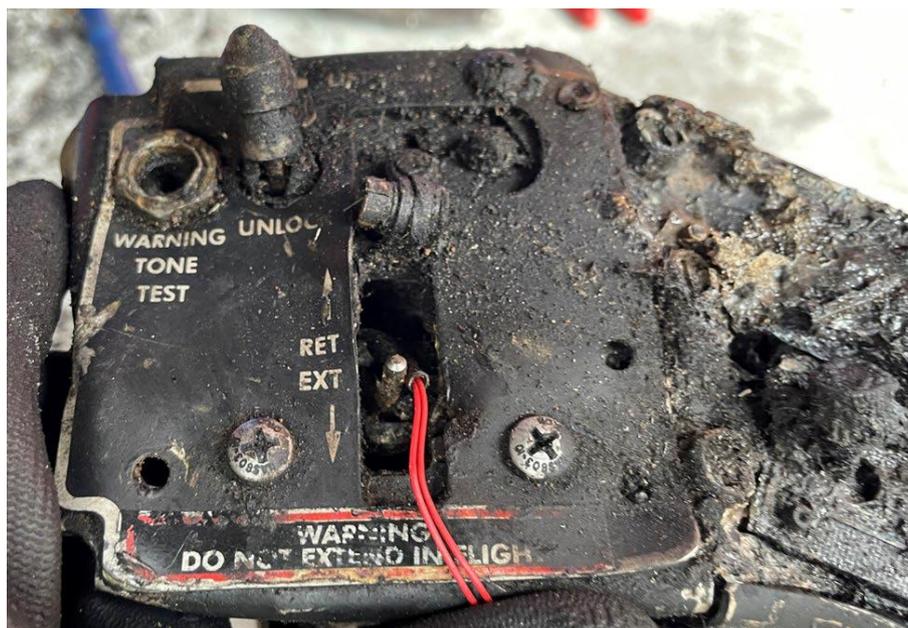
Figure 10. Lift Dump Handle Found in Intermediate Position.

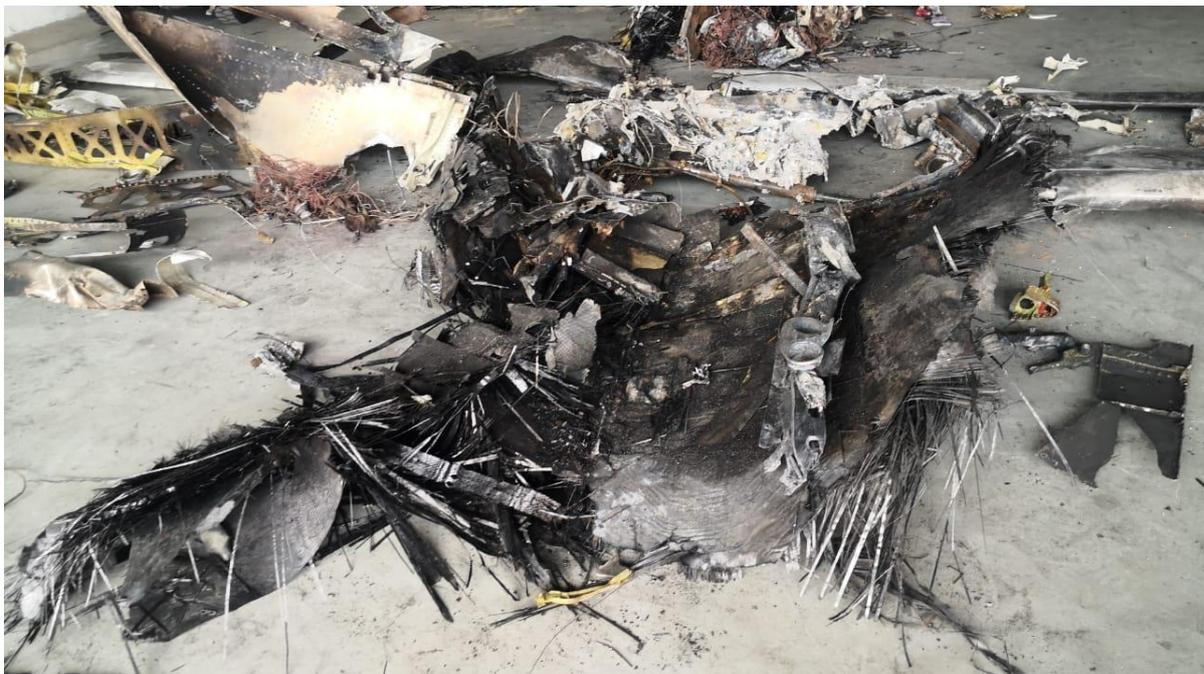
The container, encompassing both the cockpit and cabin spaces, should withstand deformation to prevent injury or death. However, the aircraft container shattered due to the high-energy impact and post-crash fire, leading to fatal injuries for occupants.

Figure 13. Container was shattered. Survivability was almost impossible.

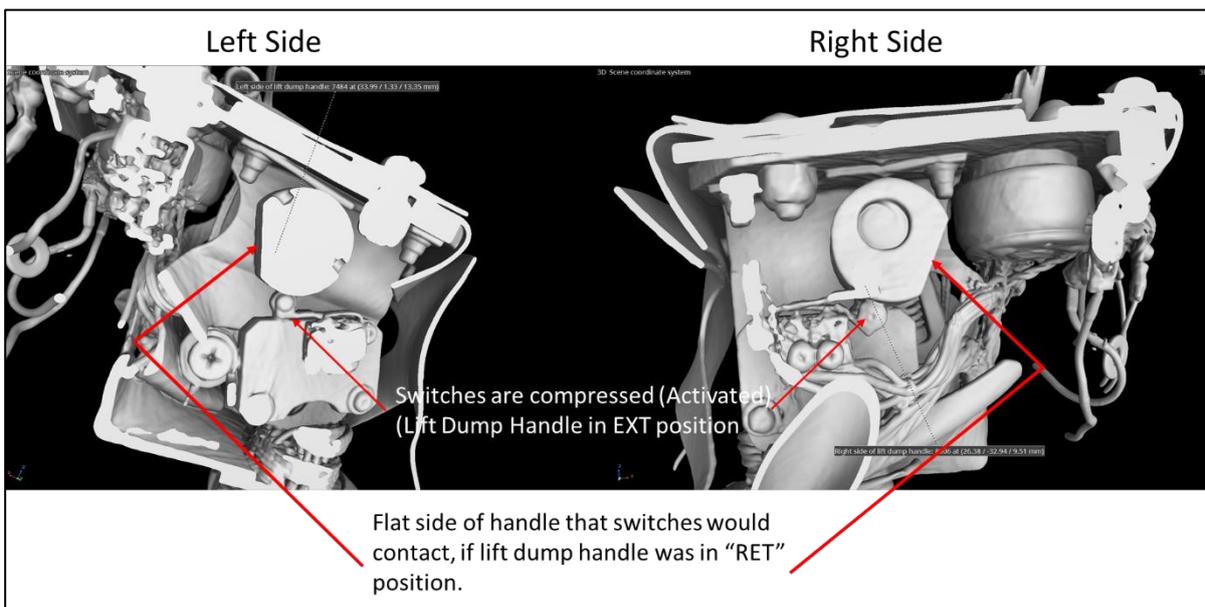
The details of the examination of the N28JV aircraft's lift dump panel using CT imaging confirm that the lift dump handle was in the EXT (extend) at the time of the accident.

Comparison of the exemplar lift dump handle photographs showing the RET (retract) and EXT (extend) positions in Figures 17 and 18 with the CT images in Figure 19 of the N28JV lift dump handle confirms that the lift dump handle was in the EXT (extend) position. Additional photographs, CT images, and detailed information from the CT examination are provided in Appendix F.

Figure 19. CT Image of N28JV Lift Dump Panel

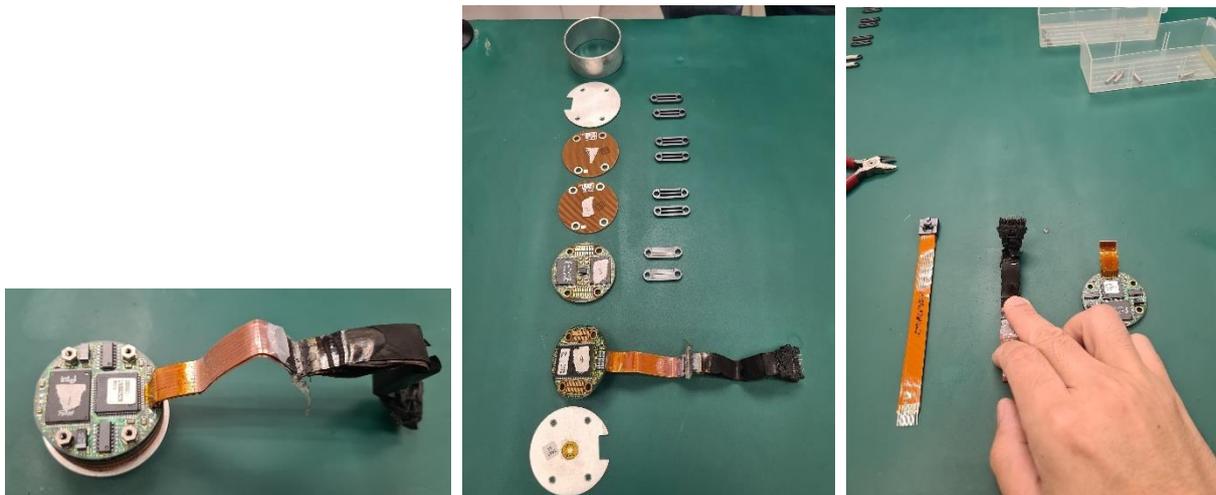
During disassembly, the internal components and each layer of the memory puck appeared to be in good condition. The part number of the damaged ribbon cable was identified as 024-E1575-00, which is used for a memory storage module operating at 5V (Figure 1).

Figure 1: (Left). View of memory puck with base cover removed, showing the memory PCB. (Centre): Each layer of the memory puck is removed. (Right): Verification of the replacement cable to be used.

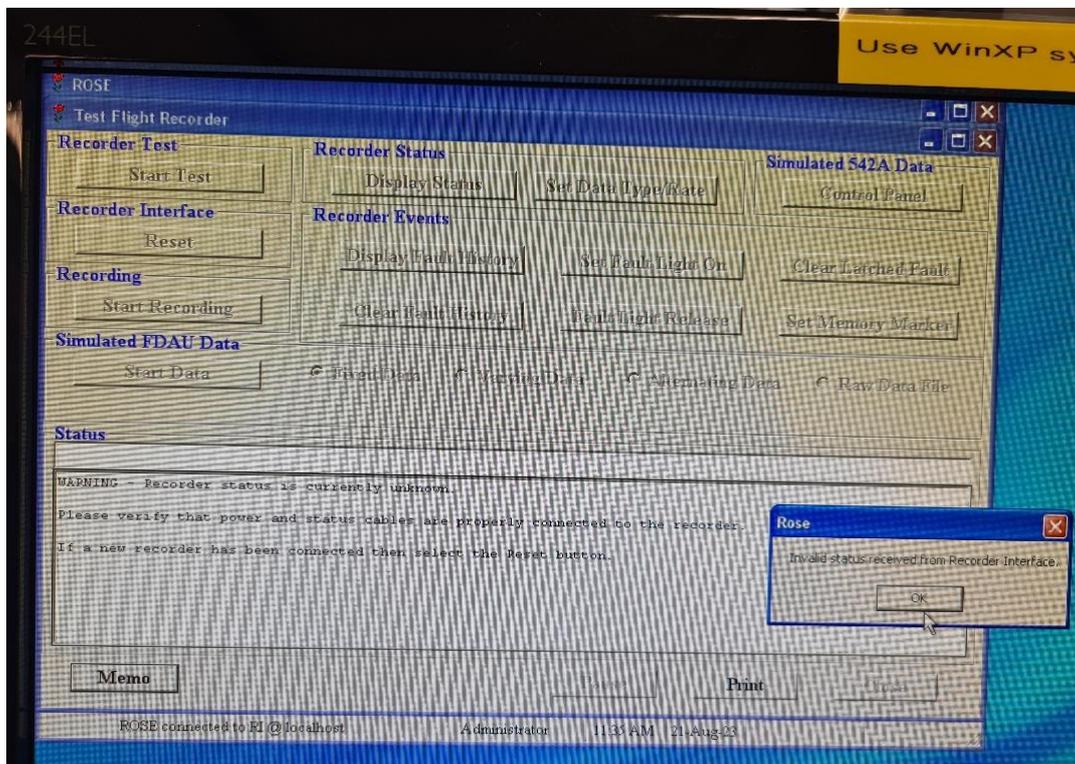
In L3Harris's Readout Support Equipment (ROSE) software, the "Test Flight Recorder" function was selected to determine if ROSE could communicate with the Golden Chassis and the memory storage module. An error was encountered indicating that ROSE could not establish communication with the memory storage module that was connected to the Golden Chassis (Figure 2).

Figure 2. Error encountered in ROSE.

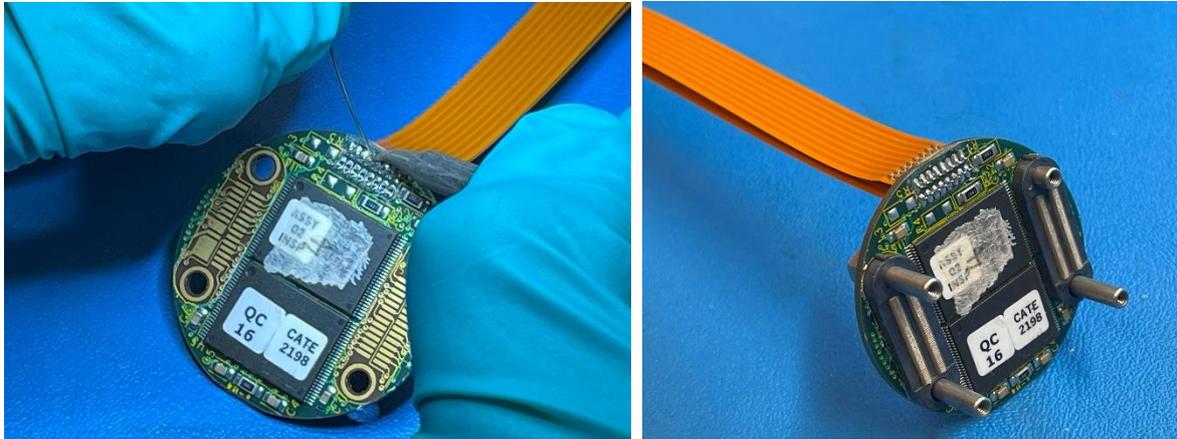
Figure 6. Reinstallation of a new cable assembly.

Reinstallation of a new cable assembly (Figure 6) was similarly uneventful. Post-installation and reassembly safe-to-power testing were successful (Table 1).

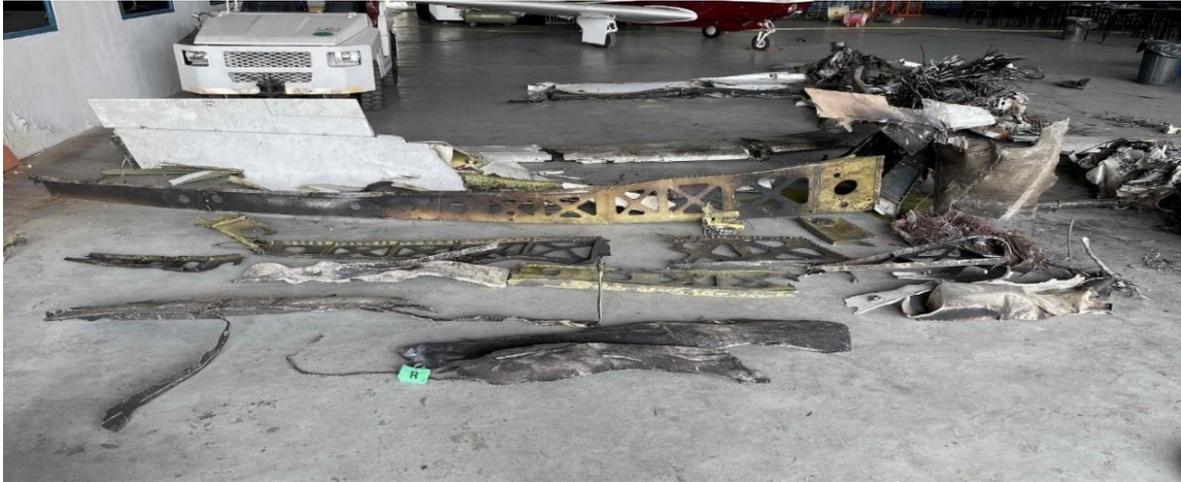
The right wing had fragmented (Figure 2), and its skins were distributed throughout the debris field. One of the wing spars was located principally intact and bent slightly aft, while the remaining spars were fragmented with eight distinct sections identified.

Figure 2. Right Wing.

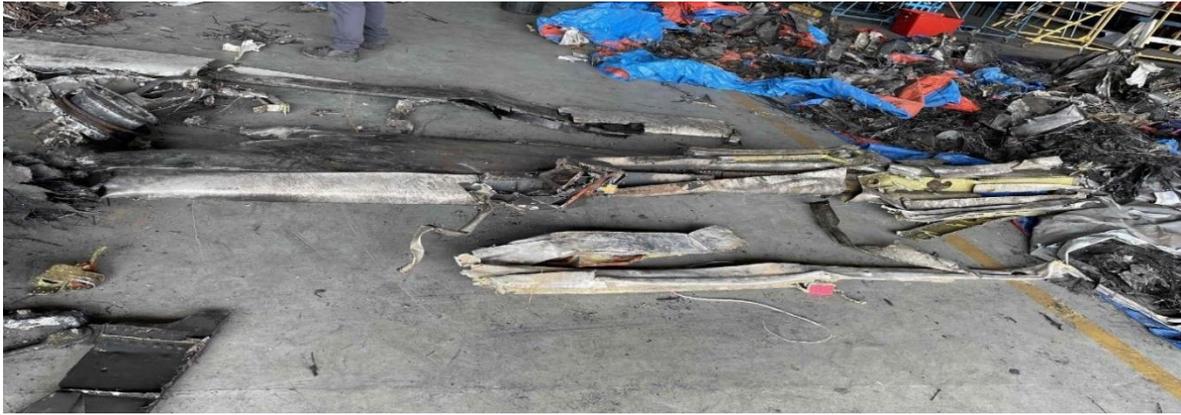
The left wing exhibited leading-edge crush damage starting at the root and progressively moving aft and through the intermediate spars as it continued to the aft spar at the tip (Figure 3). The wing sustained thermal damage to most of its skin surface, bubbling and darkening the paint.

Figure 3. Left Wing.

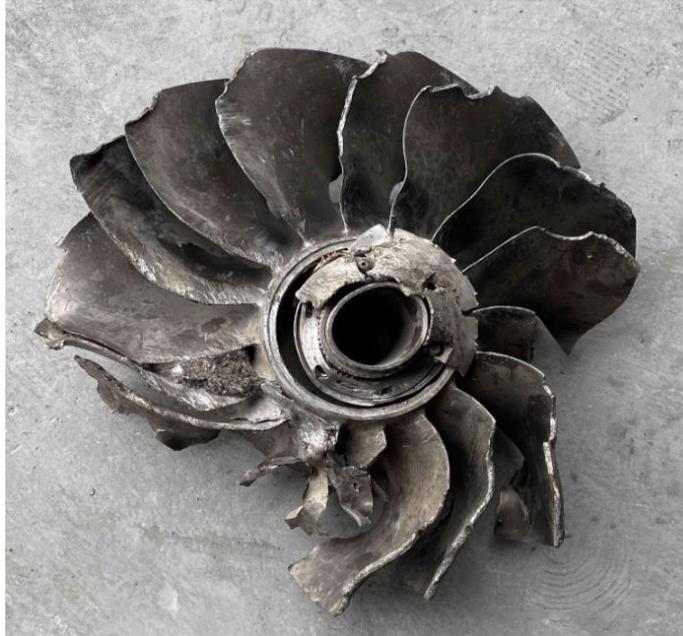
opposite direction of rotation and deformation with 45° shear lips at the separation area.

Figure 4. Right Engine Fan.

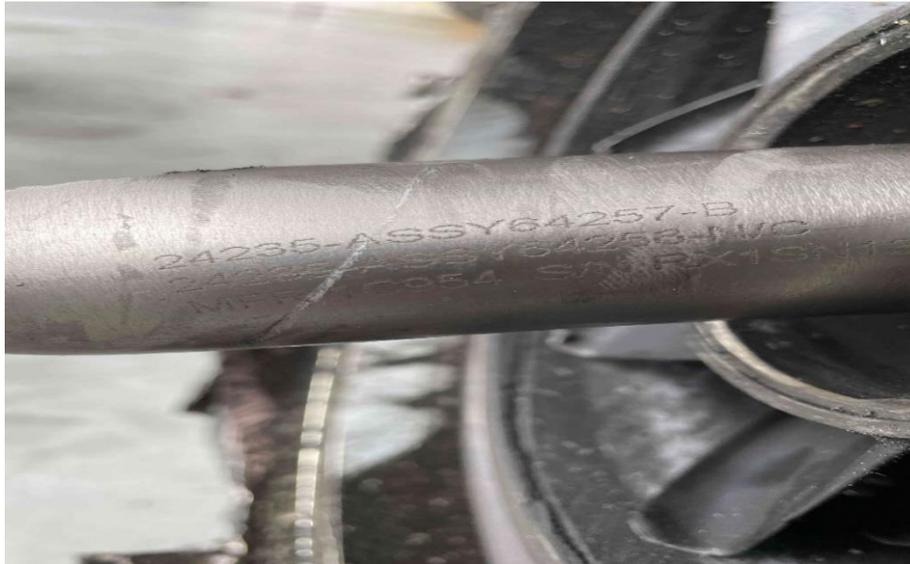
The LP shaft was protruding about 4 inches and had twisted and separated, such that the normally straight serial number was beginning to spiral (Figure 5).

Figure 5. Right Engine LP Shaft.

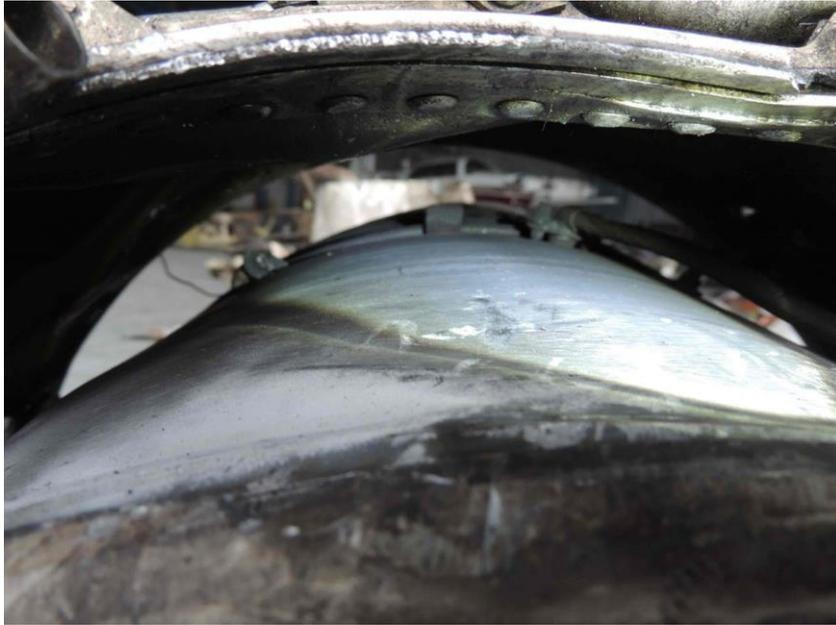
The first stage LP blades could not be observed, and the case could not be removed due to the damage sustained, however there was no damage to the rear housing/mixer that would have indicated 1st stage LP blade liberation. The diffuser outer case showed no outward dents or any other signs of High-Pressure Turbine (HPT) damage that would have indicated HPT blade or disk liberation (Figure 6).

Figure 6. Right Engine Diffuser Case.

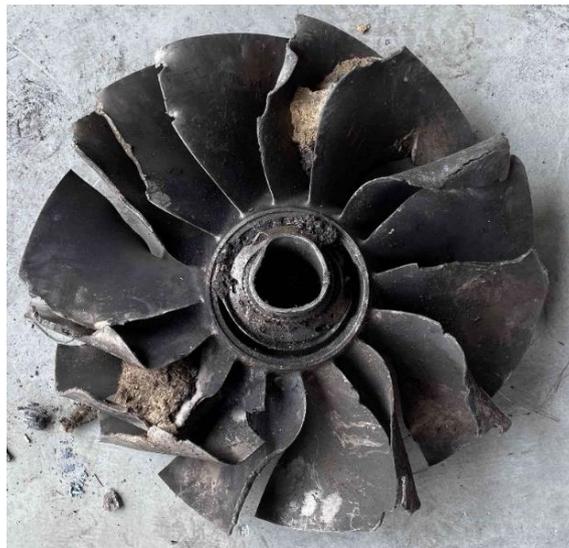
The fan had detached, but the fan nut and locking plate were in place; none of the blades had separated, but all exhibited significant leading edge gouges and tip separation, along with embedment of mud material (Figure 7). The blades were covered in black soot.

Figure 7. Left Engine Fan.

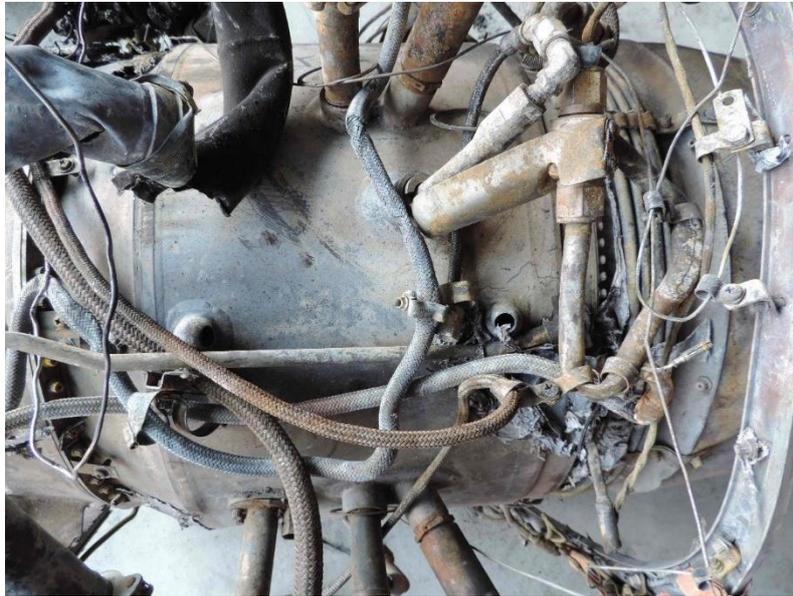
observed, and the case could not be removed due to the damage sustained. However, there was no damage to the rear housing mixer assembly that would indicate 1st stage LP blade liberation. The diffuser outer case showed no outward dents or any other signs of HPT damage that would indicate HPT blade or disk liberation (Figure 9).

Figure 9. Left engine diffuser case.

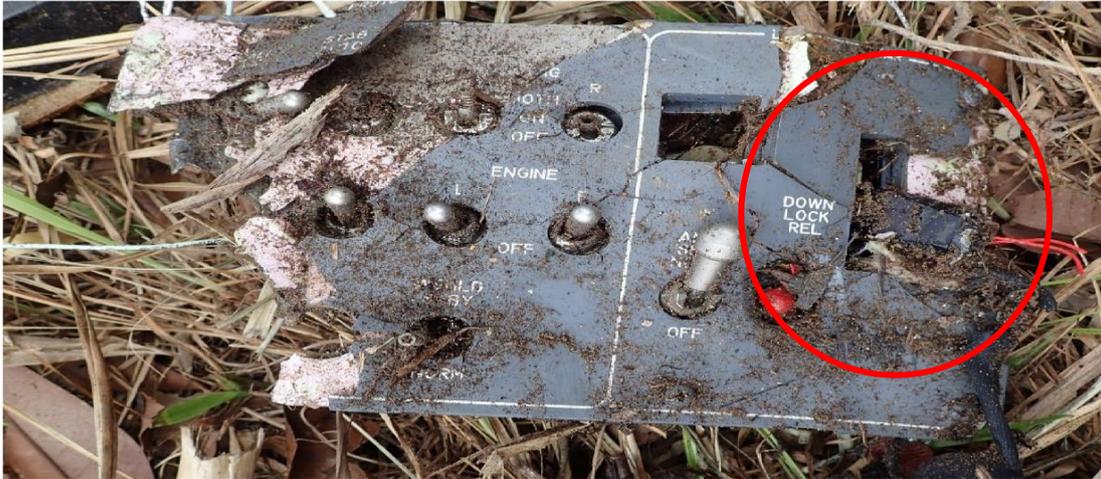
The cockpit was highly fragmented. The cockpit controls were examined. The landing gear handle was found in the down position, but the handle was damaged (Figure 10). The lift dump handle was damaged and found in an intermediate position (normal range is retracted or extended) (Figure 11).

Figure 10. Landing Gear Handle.

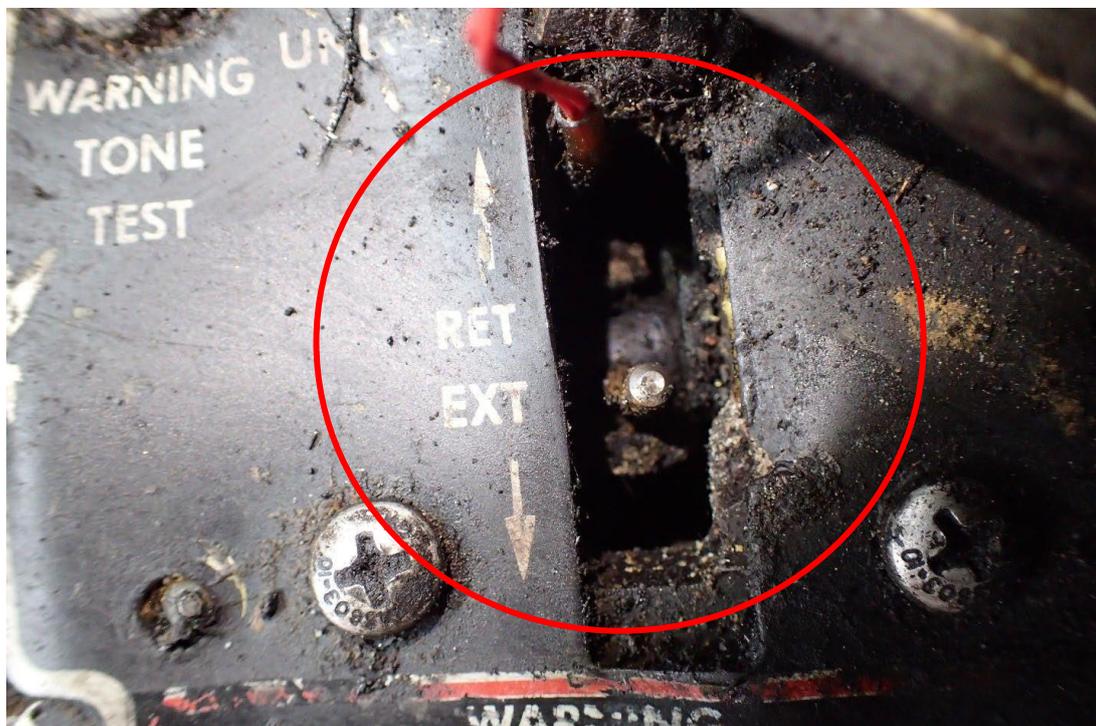
Figure 11. Lift Dump Handle.

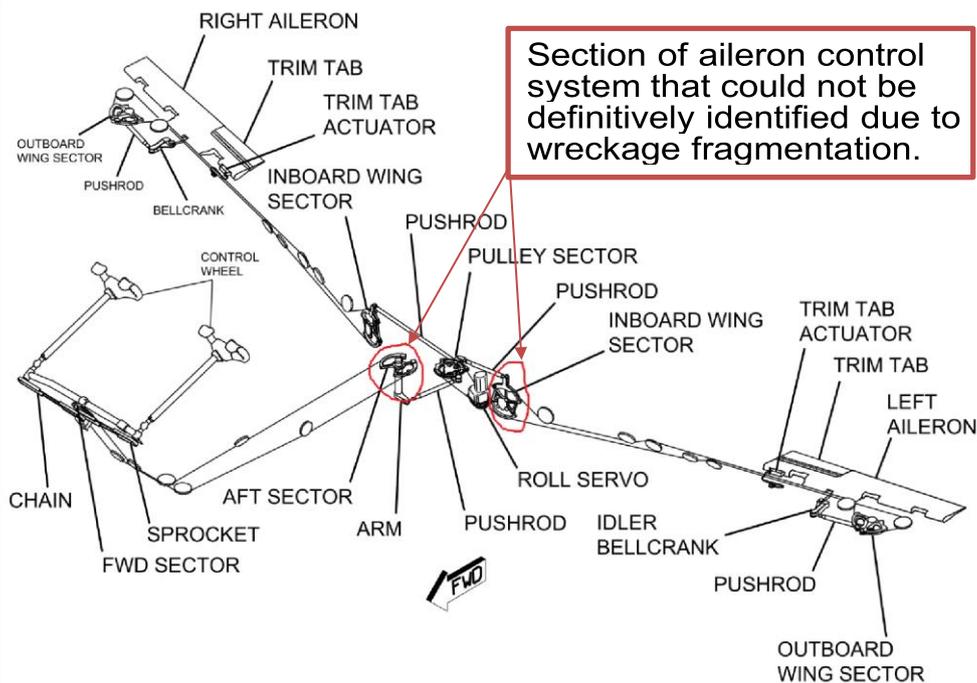
The aileron system was retrieved from the wreckage and examined. The aileron system from the control column to the left and right ailerons were recovered and examined except for the aft sector and the left wing inboard sector (Figure 12). These components could not be definitively identified due to wreckage fragmentation. The breaks in the cables had ends that had a splayed, broom straw appearance consistent with tension overload. All remaining control sectors and their associated fittings were either intact or exhibited damage consistent with overload.

Figure 12. Aileron control system components examined during investigation.

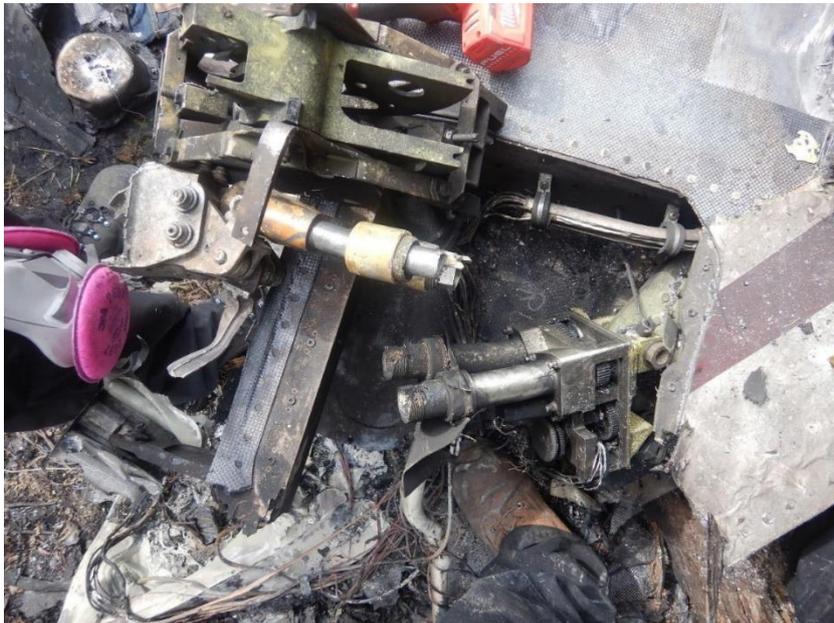
The pitch trim actuator was found broken with the severed links exhibiting indications of tensile overload. (Figure 14) The parts of the actuator were placed together and the extension distance was measured at approximately 16.5 inches. This corresponds to -3.6 degrees leading edge down. The take-off range is -3.2 degrees to -4.4 degrees. The pitch trim actuator range is -7.0 degrees to +1.4 degrees.

Figure 14. Pitch trim actuator.

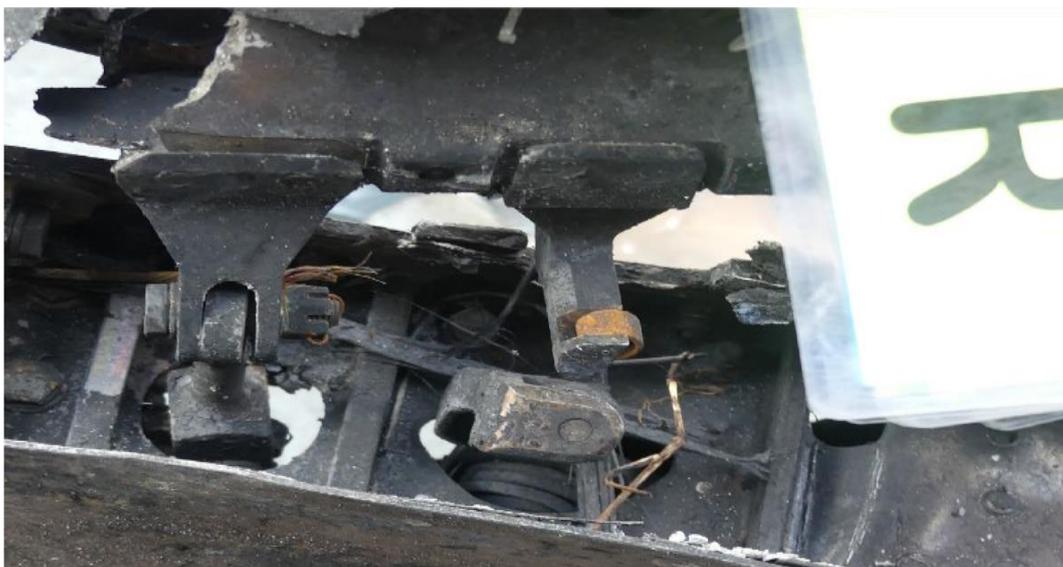
The right lift dump actuator was found in an extended position, while the left lift dump actuator was found in the retracted position. The down-lock striker on the right lift dump panel was bent from impact. Both the left and right middle and outboard spoilers were in the stowed position. The Hydraulic Spoiler Control Module (HSCM) and Spoiler Control Unit (SCU) were thermally damaged and retained for further examination. The lift dump actuators, roll control actuators, and pull (blow) down actuators were removed for further examination. The results of the detailed examination by the NTSB, original equipment manufacturer (OEM) and other relevant facilities on the spoiler components and parts are provided in Appendices E and F.

Figure 16. Right lift dump panel down-lock striker and locking actuator.

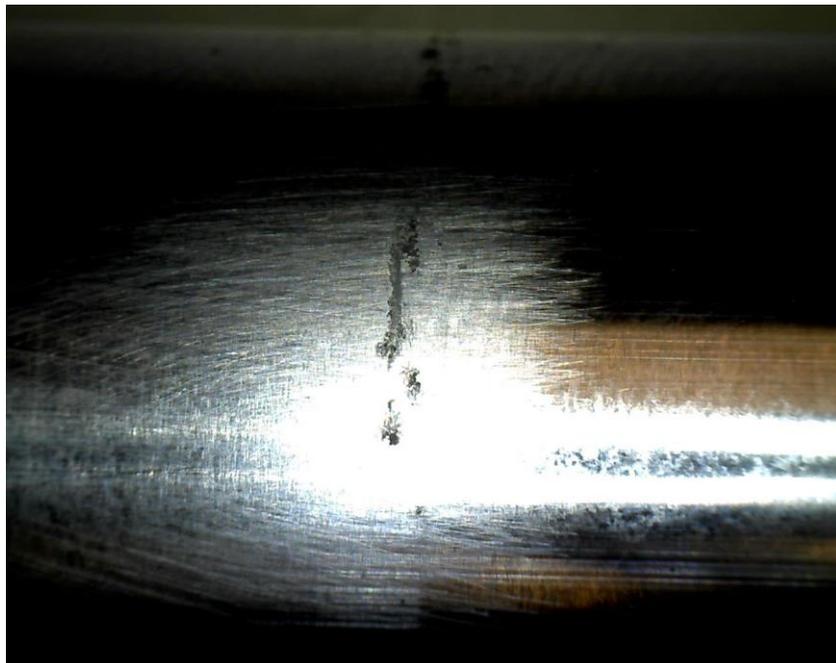
Figure 26. Left roll control actuator piston showing the abrasion area under a microscope.

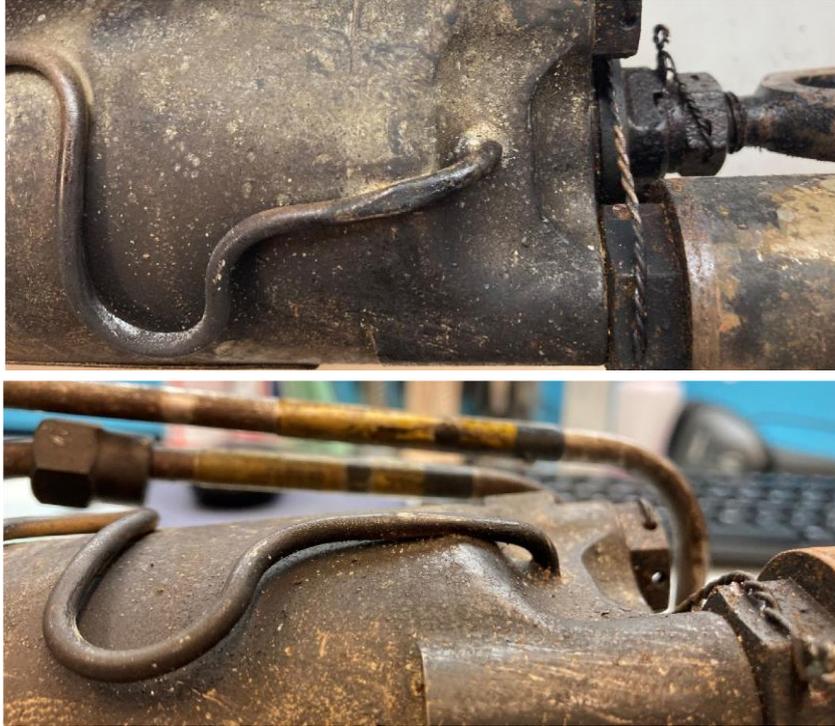
Figure 29. Left pull down actuator showing the crushed transfer tube.
