Final Report

BOEING B737, REGISTRATION 9M-MLL RUNWAY INCURSION AT CHANGI AIRPORT

TIB/AAI/CAS.246

Transport Safety Investigation Bureau
Ministry of Transport
Singapore

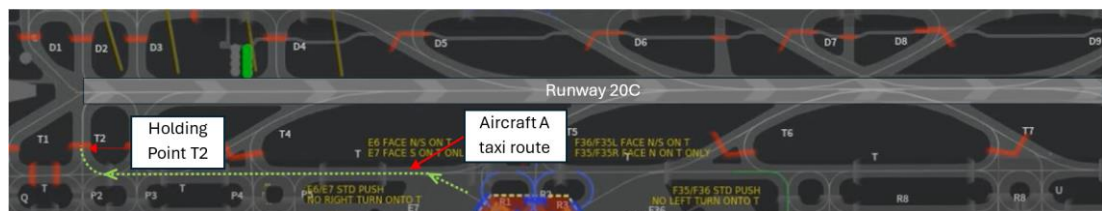
Figure 1: Taxi route of Aircraft A

1.1.2 At about 1649LT, the aircraft was cleared to taxi via Taxiway T and Taxiway T2 to the runway holding point on Taxiway T2 (hereinafter referred to as Holding Point T2) for departure on Runway 20C (see **Figure 1**).

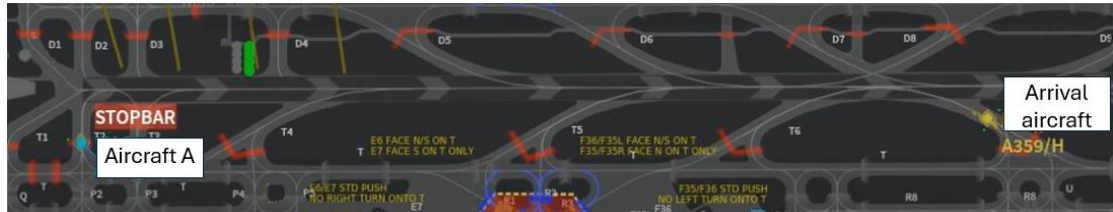
Figure 2: STOPBAR visual alert on ASMGCS.

- 1.1.9 At about the same time, the RWC noticed the “STOPBAR” visual alert appearing on the ASMGCS (see **Figure 2**) and understood the alert as an indication that Aircraft A had taxied across the red stop bar lights⁸.

⁸ The “Runway Incursion” audio alert was also generated but the RWC did not notice the alert.
