## **AIRCRAFT ACCIDENT PRELIMINARY REPORT**

**A 06/25**

**Air Accident Investigation Bureau (AAIB)  
Ministry of Transport, Malaysia**

**Fixed Wing Aircraft Piper PA-28-181 Archer III,  
Registration HS-AMY at Pangkor Island Airport,  
Perak, Malaysia  
on 30 July 2025**

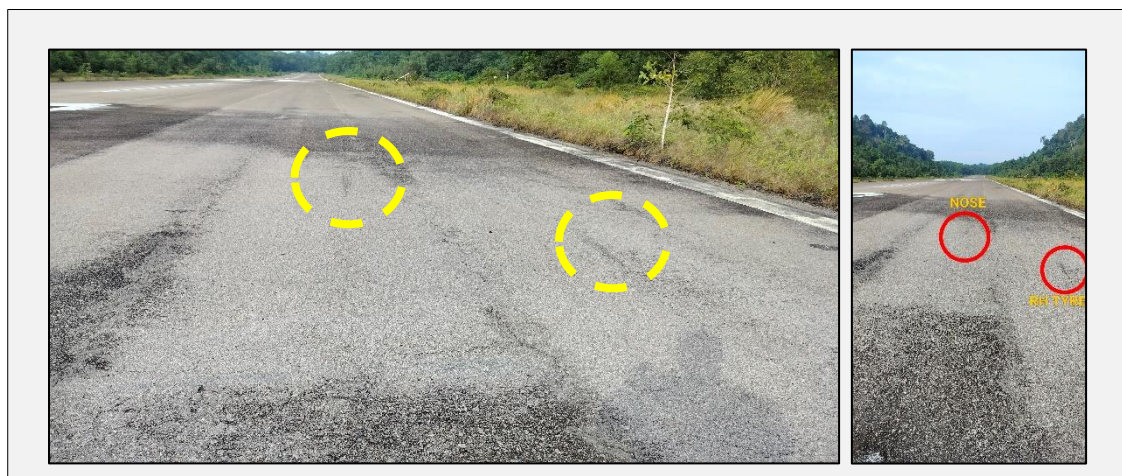
During the landing roll, the aircraft deviated to the right of the runway centreline. Tyre mark evidence indicated that the aircraft initially touched down on the nose landing gear and right main landing gear, while the left main landing gear remained off the runway surface.

Figure 1: Nose and RH Main Landing Gear tyre marks were observed on Runway 22

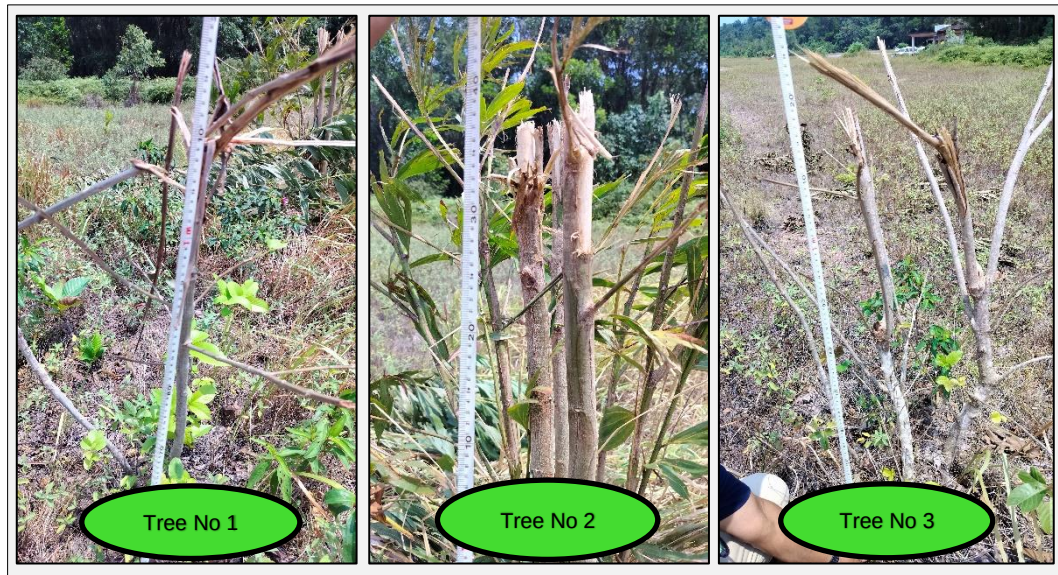
Once all landing gears were on the ground, the aircraft veered further to the right and entered the grassed area adjacent to the runway. The right wing struck a small tree three (3) times near the runway edge, resulting in structural damage to the RH wing leading edge.

Figure 2: The trees were struck three time by HS-AMY. The trees diameter approximately 2.0 cm to 2.5cm and height more than 100cm

**4.3.1 Safe Obstacle-Free Zones.:** Establish a regular vegetation control programme, to clear grass and remove small trees within the aerodrome area, particularly near the runway edges, in order to ensure safe operating conditions.

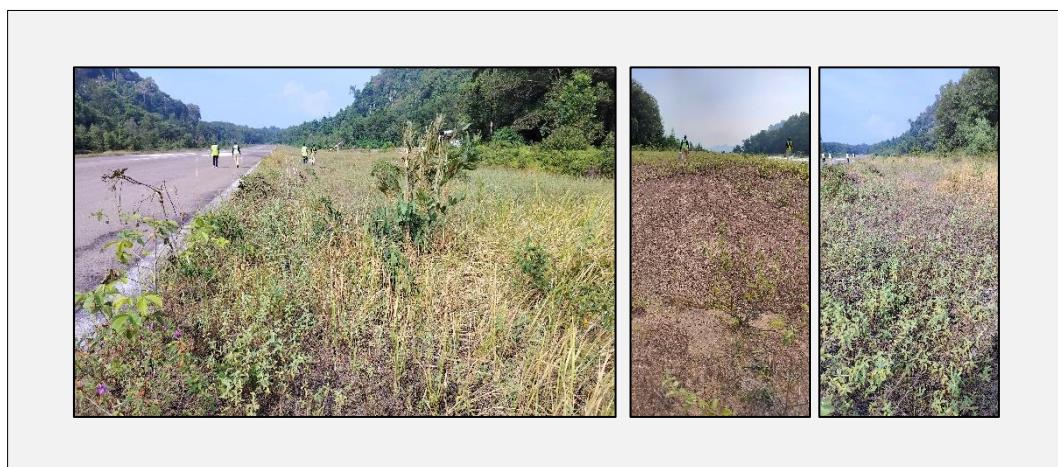
The aircraft continued along the grassed area for approximately 300 metres before regaining the runway and subsequently taxied to the apron via Taxiway Alpha. The occurrence resulted in no injuries to the pilot or occupants. Damage was confined to the RH wing structure of the aircraft.

Figure 3: The tyre marks were observed on the grasses area along a distance approximately 300 metres

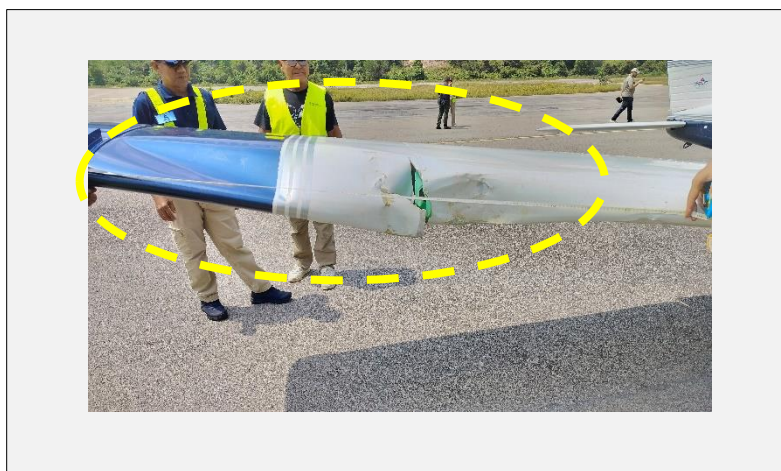
A general visual inspection was conducted to assess and identify any damage to the aircraft after the occurrence. No damage was found on or around the fuselage and other major components. However, significant damage was observed on the RH wing, as shown in Figures 4, 5, and 6, with noticeable cracks and puncture damage on the leading-edge area. Preliminary analysis indicates that the RH wing sustained multiple impacts with a small tree near the runway edge. Based on the initial assessment, it is apparent that the RH wing assembly has exceeded the permissible limit for aircraft structure damaged.

Figure 4: Front View – Structural condition of the  
RH Wing Leading Edge

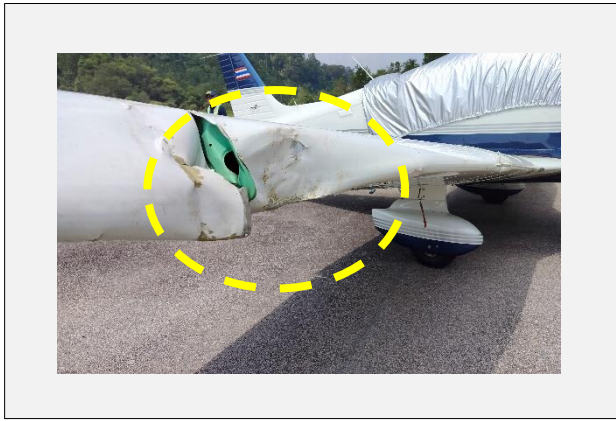
Figure 5: Side View – RH Wing Leading Edge damage area

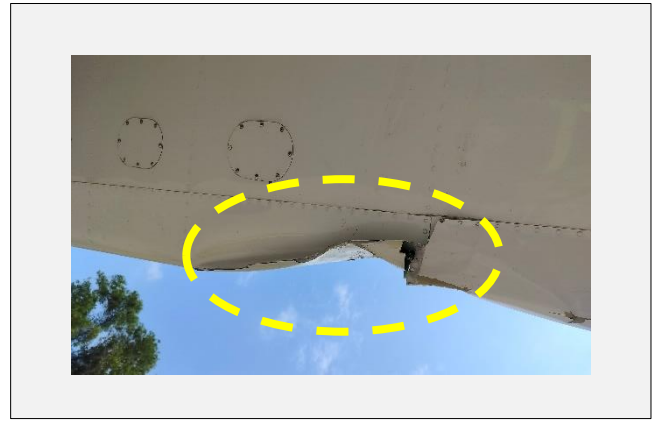
Figure 6: Bottom View – RH Wing Leading Edge damage area

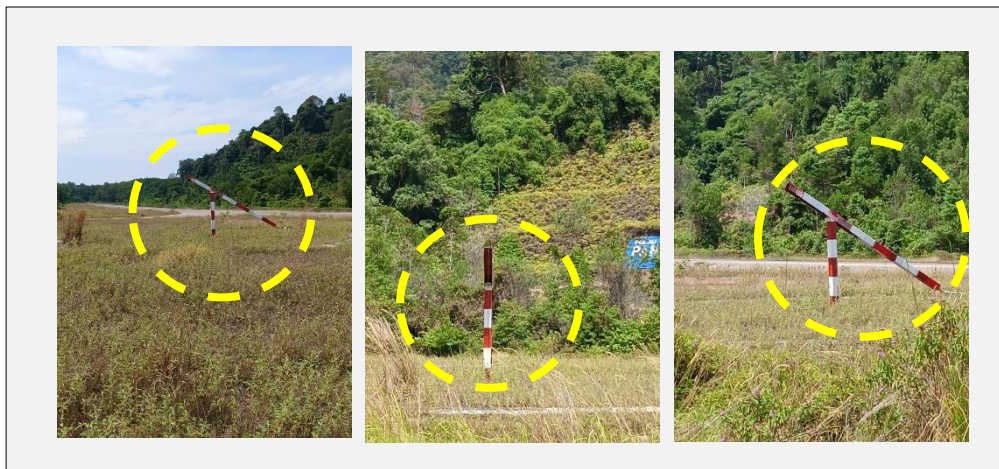
All navigation aids fitted on the aircraft were serviceable at the time of the occurrence. The windsock at the aerodrome, however had been unserviceable since 5 May 2025.

Figure 8: The windsock at the aerodrome was found broken and unserviceable condition.

- i) Excessive vegetation growth, including tall grass and small trees near the runway edges, was observed within the aerodrome area. This condition could obstruct visibility, create hazards to aircraft operations, and compromise safe operating conditions.
- ii) The lack of a serviceable windsock at Pangkor Island Airport represented a safety deficiency, as it prevented pilots from obtaining a direct visual indication of wind direction and strength during approach and landing.

**4.3.2 Windsock:** The Aerodrome Operator of Pangkor Island Airport shall ensure the installation and proper maintenance of a serviceable windsock in accordance with ICAO Annex 14 and CAD 14.

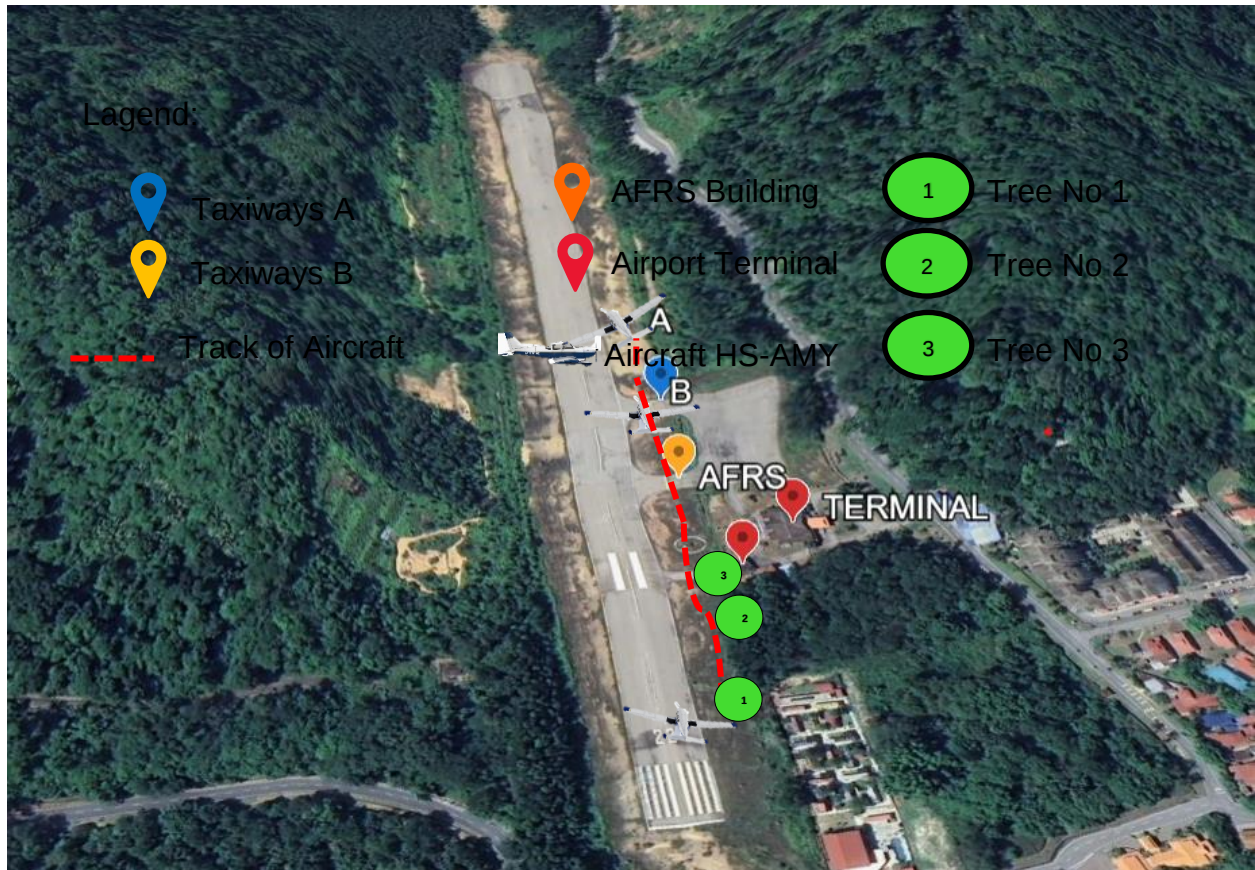
Figure 10 below provides a general description of Pangkor Island Airport. The aircraft veered off Runway 22, with the nose tyre mark observed on the grass approximately 16.5 meters to the right of the runway centreline.

Figure 10: General description of the accident at Pangkor Island Airport

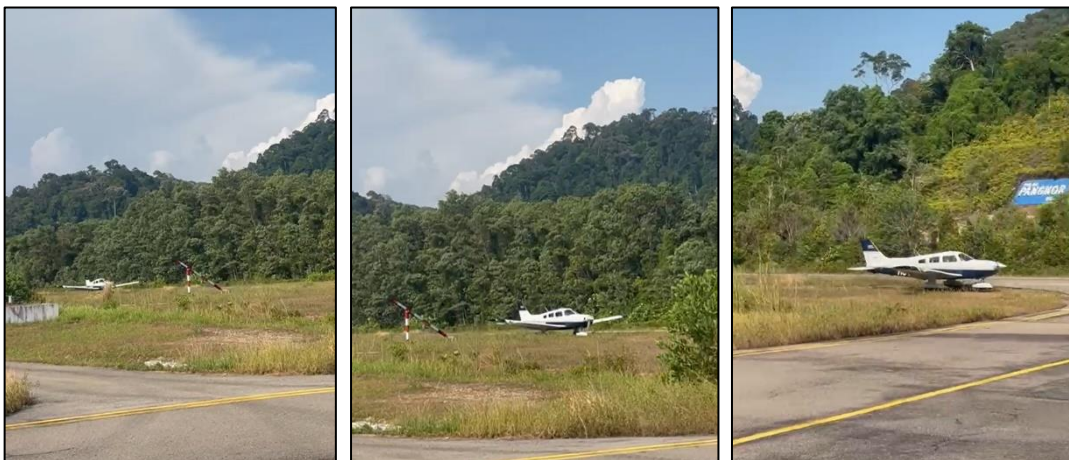
Figure 10: HS-AMY veered to the right of Runway 22
