# **AIRCRAFT ACCIDENT**

**A 10/25**

**Fixed Wing Aircraft PIPER PA28-181 Archer III, Registration 9M-SKR**

**on 18 November 2025**

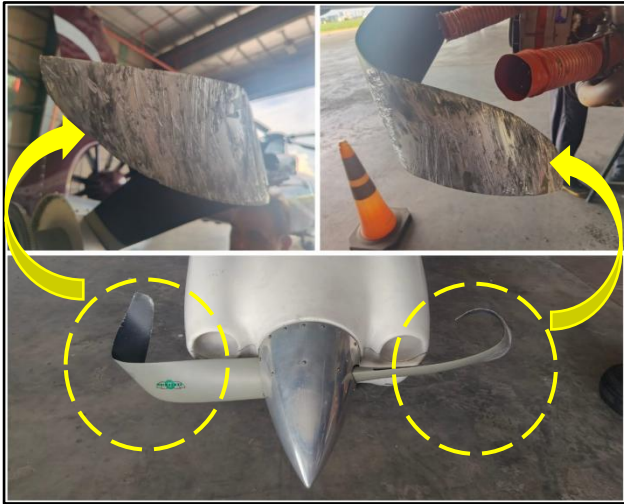
Preliminary examination identified substantial damage to the propeller blades, as shown in Figure 1. Deformation and abrasion marks were observed on the lower fuselage area of the aircraft, as depicted in Figure 2.

Figure 1: Condition of the aircraft propeller blades

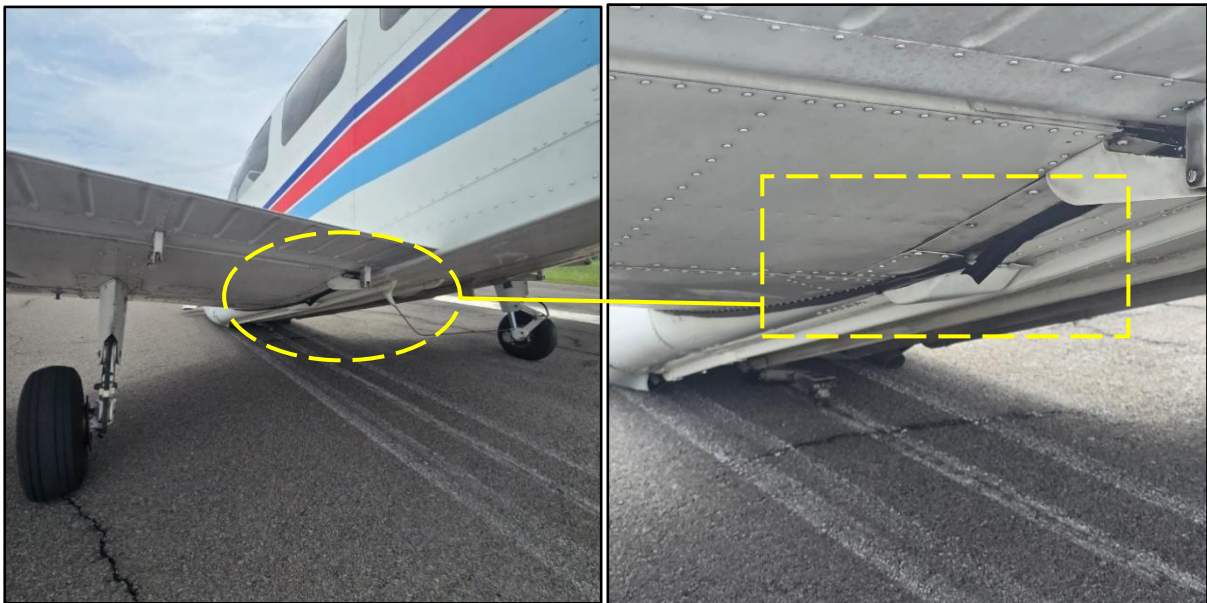
Figure 2: Deformation and abrasion marks on the lower fuselage area of the aircraft

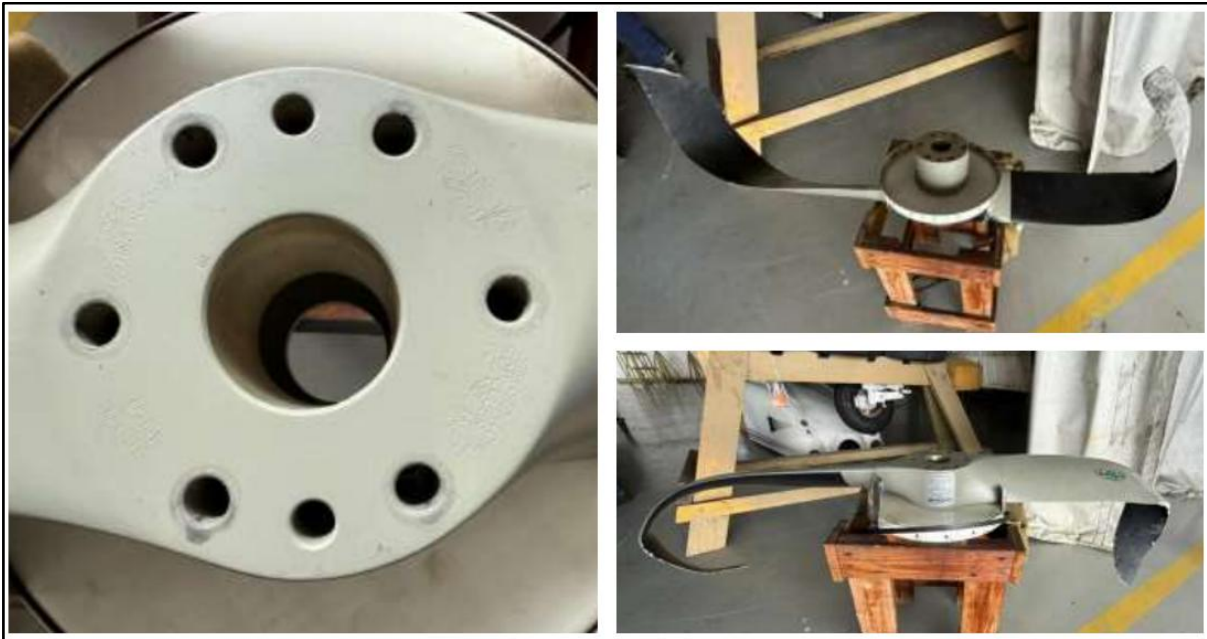
Figure 3: Both blade tips twisted inward, causing serious damage to blade and hub

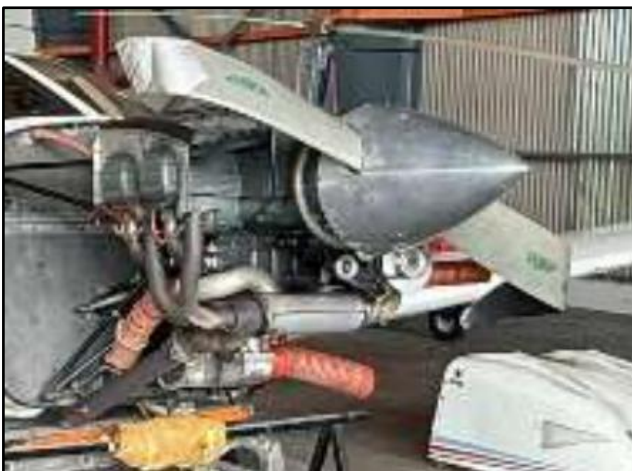
Figure 4: As specified in Lycoming's mandatory service bulletin SB533C, any sudden engine stoppage or propeller strike should be removed and engine shock load called for.

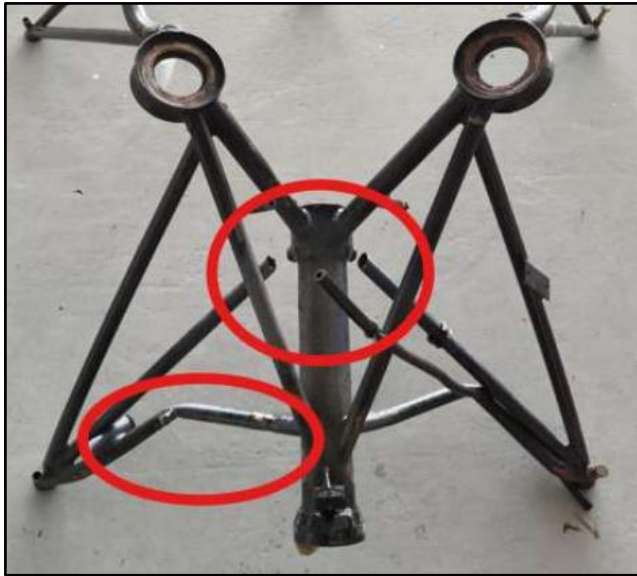
Figure 5: Both lower engine mount tubes bent inward as a result of the strong impact. Due to a hard impact, both centre engine mount tubes cracked, had completely broken off at the welding spot.

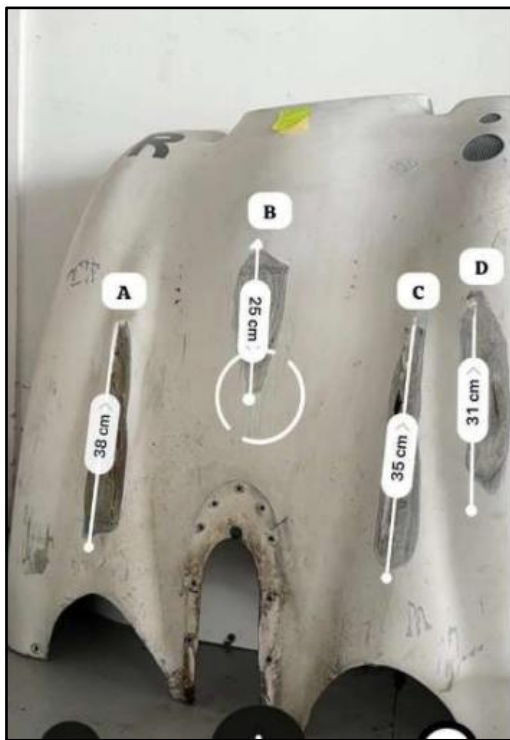
Figure 6: The lower engine cowling is heavily scratched in four places, and the length of the scratches is shown in the picture below. Scratch A and B were severely damaged, with holes appearing as a result of the propeller strike.

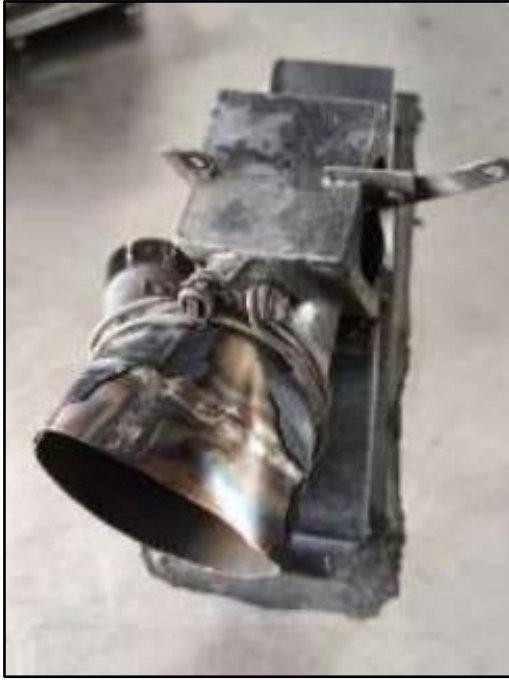
Figure 7: The box assembly was severely damaged, and a dent was observed

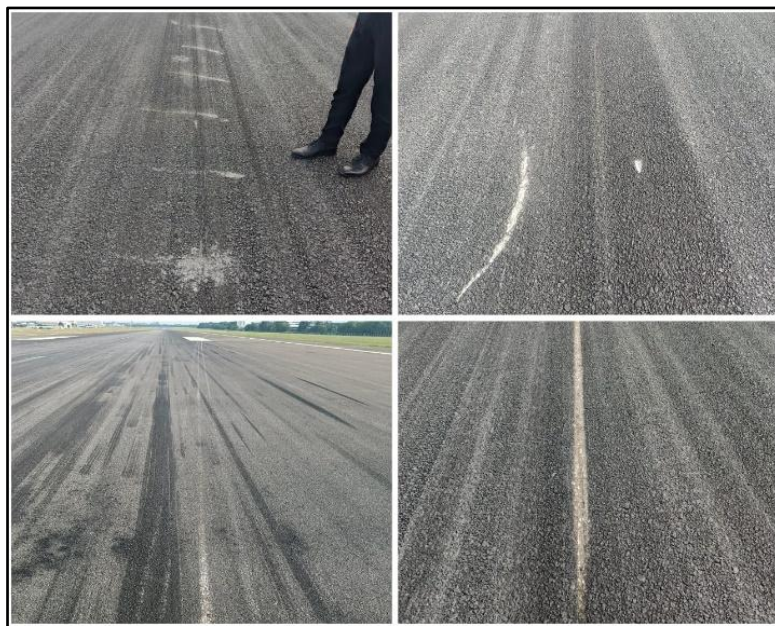
During the site investigation, scrape marks consistent with propeller blade contact were observed on the runway surface, as shown in Figure 8. Additionally, shallow potholes caused by the broken oleo from the nose landing gear were identified along the skid path.

Figure 8: Scrape marks on the Runway

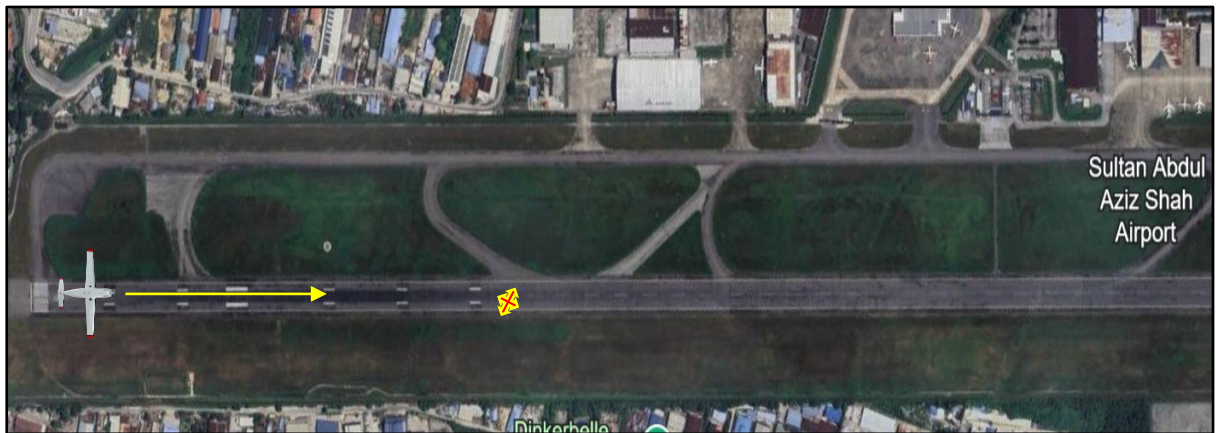
Figure 11: 9M-SKR wreckage and impact information (WMSA)

Figure 11 depicts the wreckage and impact information of aircraft 9M-SKR at WMSA on the day of the occurrence. The yellow line represents the aircraft's inbound track toward Runway 15, while the red cross indicates the aircraft's final resting position.
