## **AIRCRAFT ACCIDENT**

### **FINAL REPORT**

**A 06/25**

**Fixed Wing Aircraft Piper PA-28-181 Archer III,  
Registration HS-AMY at Pangkor Island Airport, Perak  
on 30 July 2025**

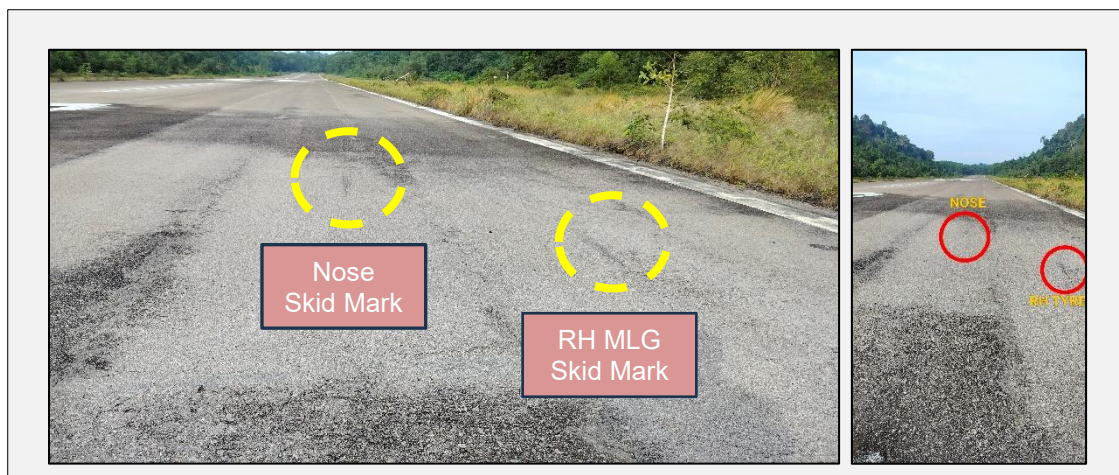
During the landing roll, the aircraft deviated to the right of the runway centreline. The skid marks evidence indicated that the aircraft initially touched down on the nose landing gear and right main landing gear, while the left main landing gear remained off the runway surface as illustrated in Figure 1.

Figure 1: Nose and RH Main Landing Gear Skid marks were observed on Runway 22

This observation was consistent with physical evidence found at the occurrence site. Initial ground marks indicated contact by the nose wheel and right main gear on the runway surface, with no corresponding left main gear mark in the initial touchdown area.

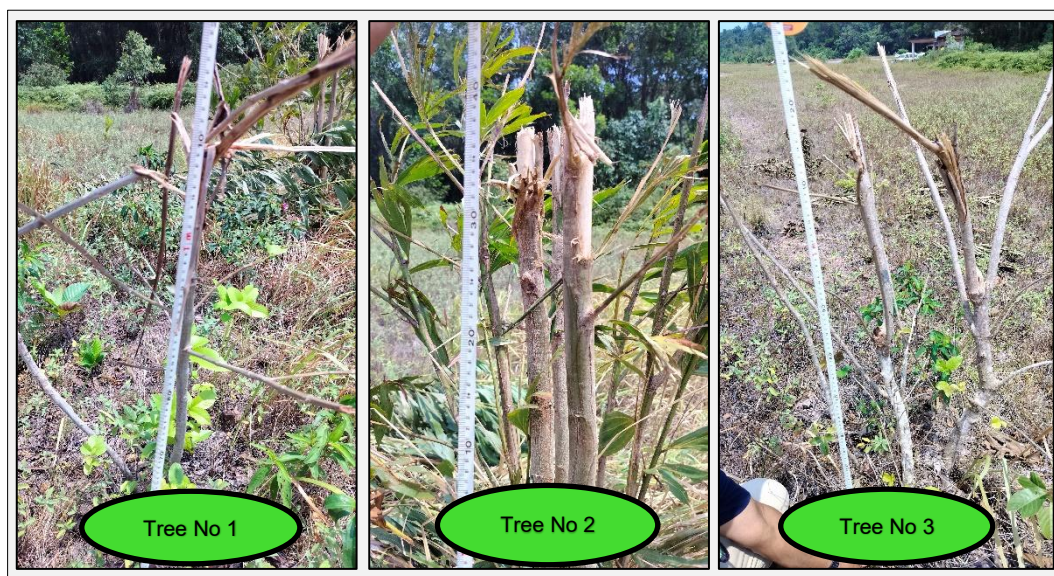
Once all landing gears were on the ground, the aircraft veered further to the right and entered the grassed area adjacent to the runway. The pilot applied left rudder input to correct the deviation however, the aircraft continued to pull to the right. The pilot then applied further left rudder input and braking to stabilise the aircraft's movement and maintain directional control. The wind was recorded as calm at the time of the accident. After the aircraft's veered off to the right side of the runway, the right wing struck a small tree near the runway edge on three (3) occasions, as illustrated in Figure 2. The impact resulted in structural damage to the RH wing leading edge.

Figure 2: The trees were struck three time by HS-AMY. The trees diameter approximately 2.0 cm to 2.5cm and height more than 100cm

Vegetation and small trees near the runway edge contributed to the substantial damage sustained by the RH wing of HS-AMY.

***Safe Obstacle-Free Zones.:*** *Establish a regular vegetation control programme, to clear grass and remove small trees within the aerodrome area, particularly near the runway edges, in order to ensure safe operating conditions.*

i) It is recommended that the Aerodrome Operator review and restructure its vegetation management and obstacle removal framework at Pangkor Island Airport (WMPA) to implement a formalized, scheduled trimming program, ensuring the Runway Strip and Obstacle-Free Zones are strictly maintained in accordance with CAD 14 regulatory standards

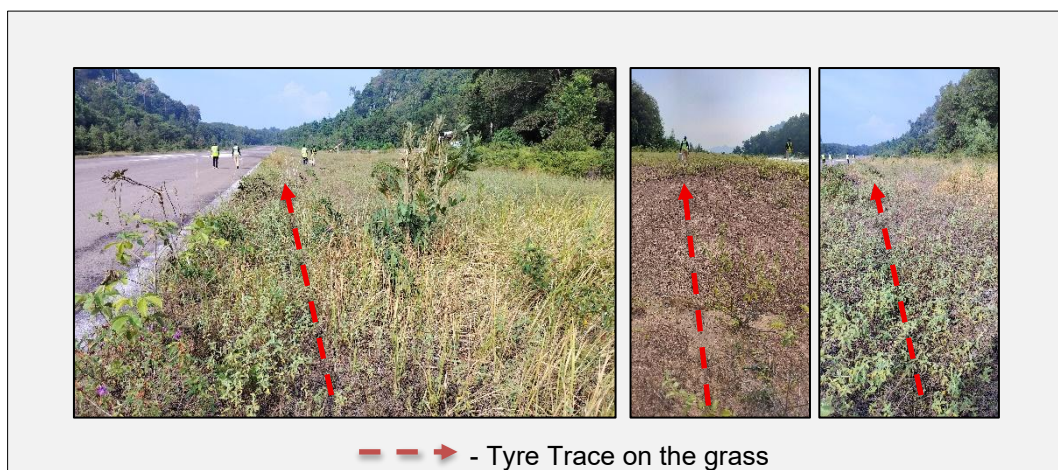
The aircraft continued along the grassed area for approximately 300 metres before re-entering the runway. Three (3) tyre marks were visible in the grass area off the right side of the runway, consistent with the aircraft's ground track during the runway veered off. The aircraft subsequently taxied to the apron via Taxiway Alpha. The occurrence resulted in no injuries to the pilot or occupants. Substantial damage was confined to the RH wing structure of the aircraft.

Figure 3: The tyre marks were observed on the grassed area along a distance approximately 300 metres

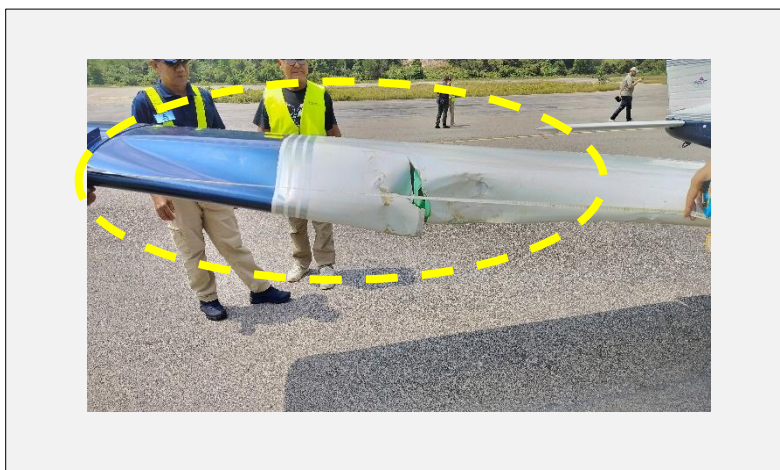
wing, as shown in Figures 4, 5, and 6, with noticeable cracks and puncture damage on the leading edge area. Preliminary analysis indicates that the RH wing sustained multiple impacts with a small tree near the runway edge. Based on the initial assessment, it is apparent that the RH wing assembly has exceeded the permissible limit for aircraft structural damaged.

Figure 4: Front View – Structural condition of the  
RH Wing Leading Edge

Following the occurrence, maintenance rectification was carried out on the aircraft. The work included structural skin replacement and rib repair on the right-hand (RH) wing.

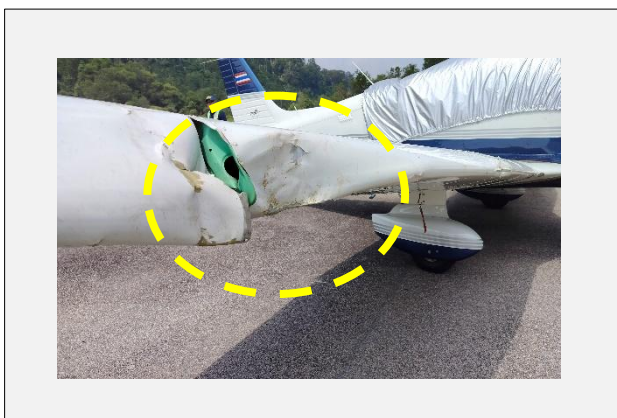
Figure 5: Side View – RH Wing Leading  
Edge damage area

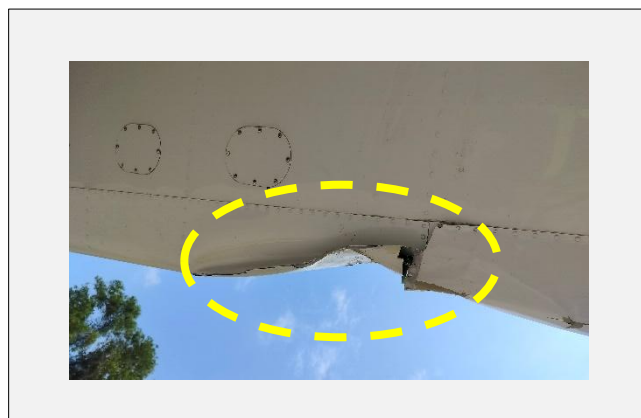
Figure 6: Bottom View – RH Wing  
Leading Edge damage area

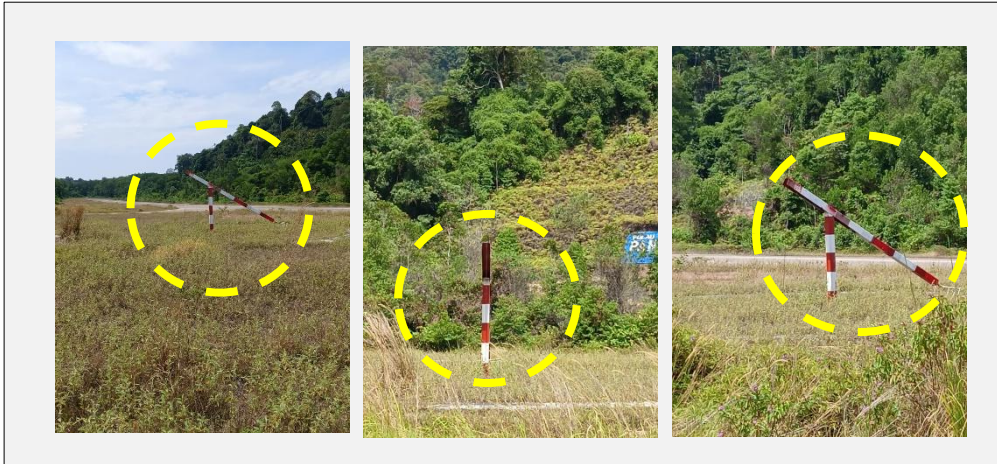
All navigation aids fitted on the aircraft were serviceable at the time of the occurrence. The windsock at the aerodrome, however had been unserviceable since 5 May 2025.

Figure 8: The windsock at the aerodrome was found broken and unserviceable condition.

iii) It is recommended that the Aerodrome Operator establish a rigorous maintenance tracking log to ensure that critical visual aids for navigation, specifically aerodrome windsocks are subjected to routine serviceability inspections and replaced promptly upon failure.

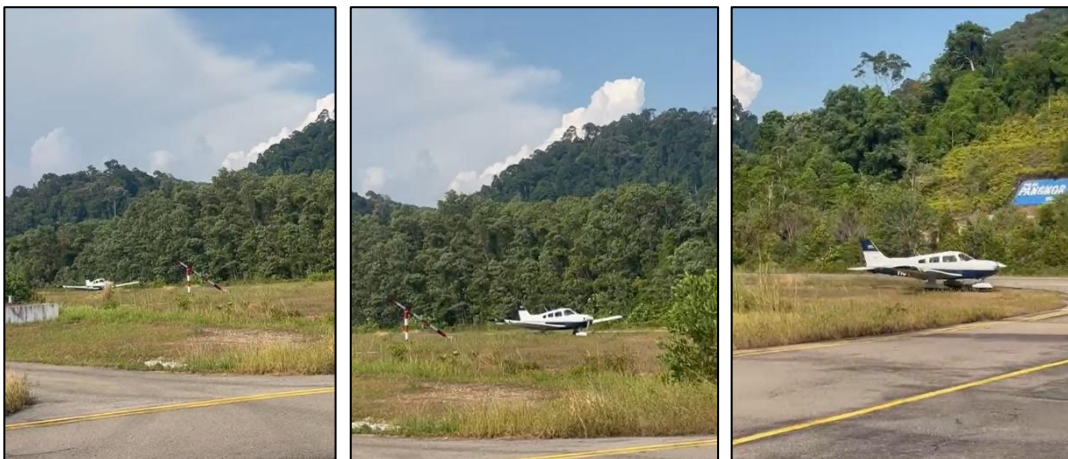
Figures 10 and 11 below provide a general description of the occurrence at WMPA. The aircraft veered off Runway 22, with the nose tyre mark observed on the grass approximately 16.5 meters to the right of the runway centreline.

Figure 10: HS-AMY veered to the right of Runway 22

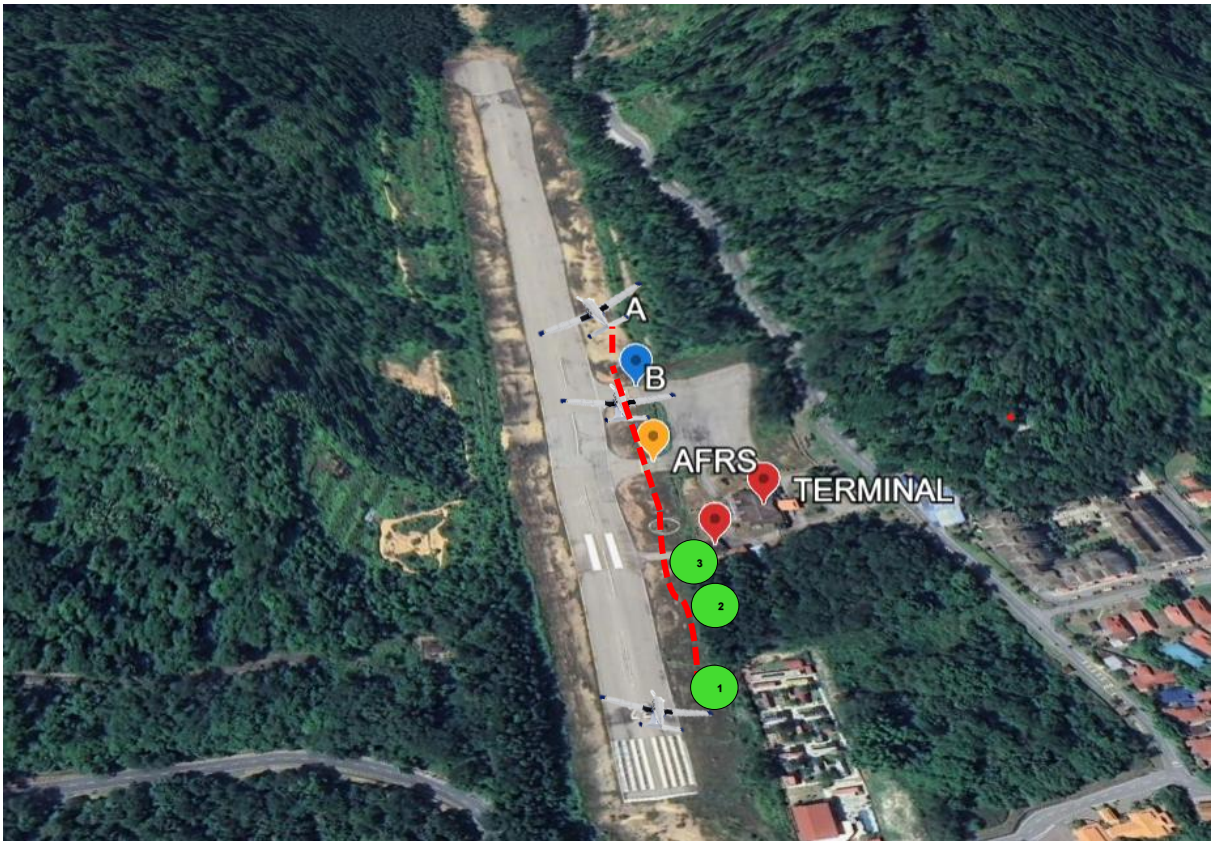
Figure 11: General description of the accident at WMPA

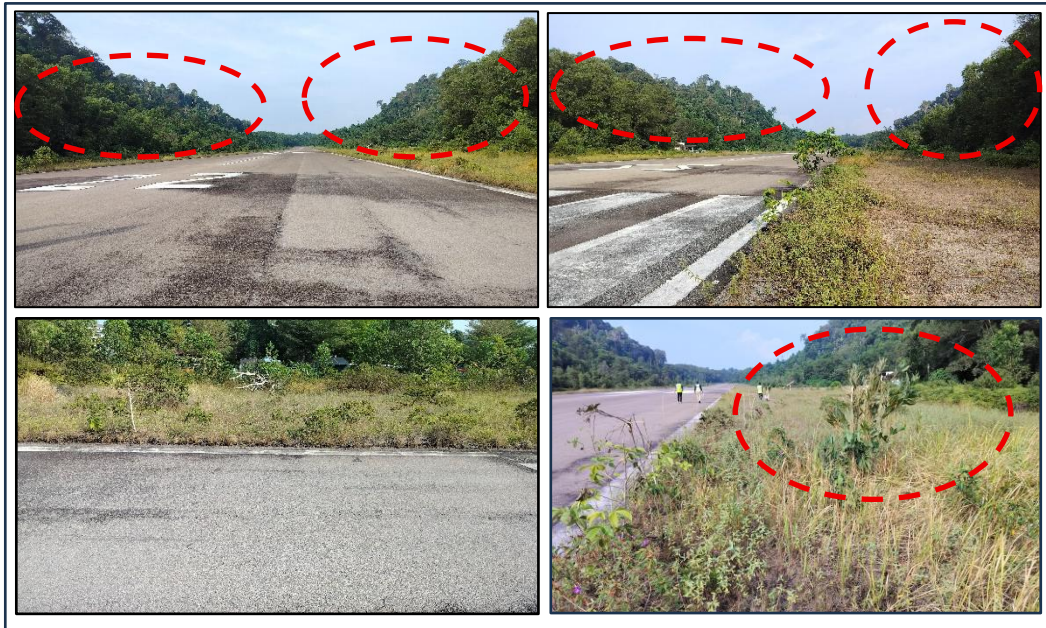
At the time of the occurrence, WMPA did not have an appointed maintenance contractor to conduct routine grass cutting, vegetation control, or tree removal works. This included the management of larger trees that could potentially obstruct pilots' visual references during approach and landing.

Figure 12: Larger Trees and Vegetation Had Grown Higher

- i) Excessive vegetation growth, including tall grass and small trees near the runway edges, was observed within the aerodrome area. This condition could obstruct visibility, create hazards to aircraft operations, and compromise safe operating conditions.
- ii) The lack of a serviceable windsock at the aerodrome represented a safety deficiency; however, its unserviceability was determined not to be a primary contributing factor to the occurrence.
