AIRCRAFT ACCIDENT PRELIMINARY REPORT

A 01/25

**Air Accident Investigation Bureau (AAIB)
Ministry of Transport, Malaysia**

**Rotary Wing Helicopter Bell 206L4, Registration PK-ZUV
near Kg. Janda, Bentong, Pahang
on 06 February 2025**

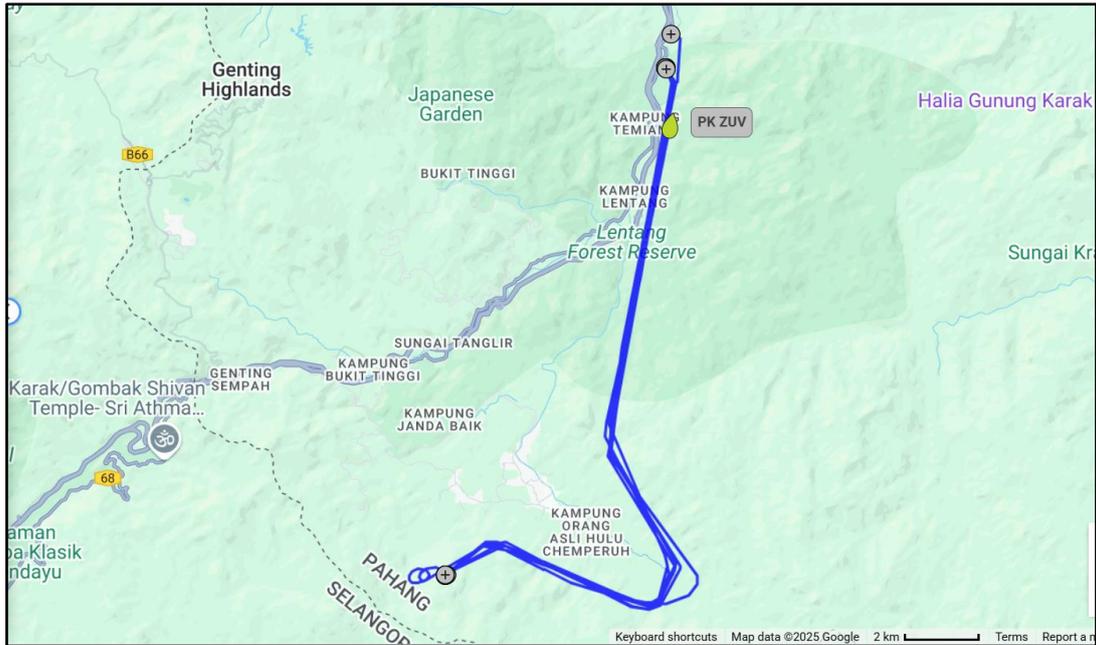
Figure 1: PK-ZUV flight tracks on the day of the accident
(Source: Spidertracks)

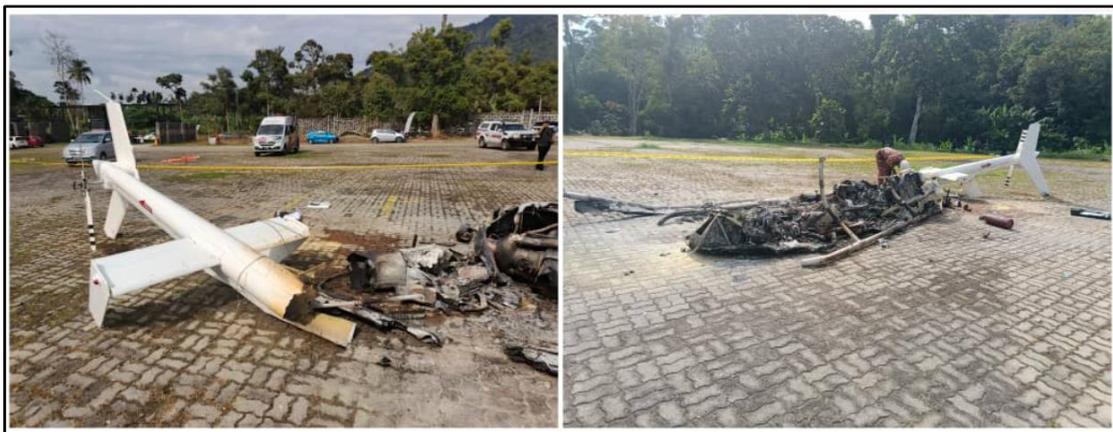
The tail boom section of the helicopter remained intact, however, the rest was destroyed by post-impact fire (Refer Figure 2).

Figure 2: Pictures of the destroyed helicopter

The helicopter was destroyed by a post-impact fire. The origin of the fire and the source of ignition remain undetermined.

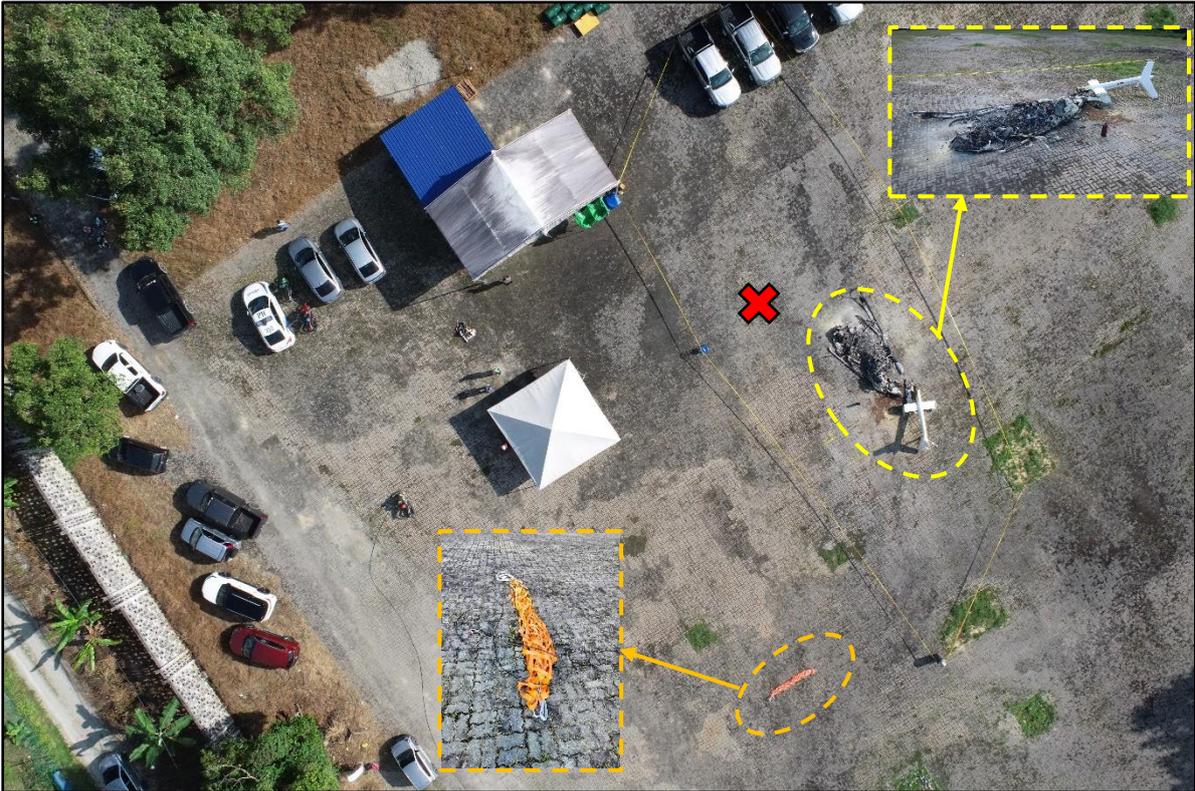
Figure 4 below provides a general description of the site, the helicopter wreckage location, the last location of the victim, and the location of the underslung cargo net. The 'broken yellow line circle' indicates the helicopter wreckage location, the 'red X' is the last location of the victim, and the 'broken orange line circle' illustrates the location of the underslung cargo net.

Figure 4: PK-ZUV general description map of the accident site and wreckage location

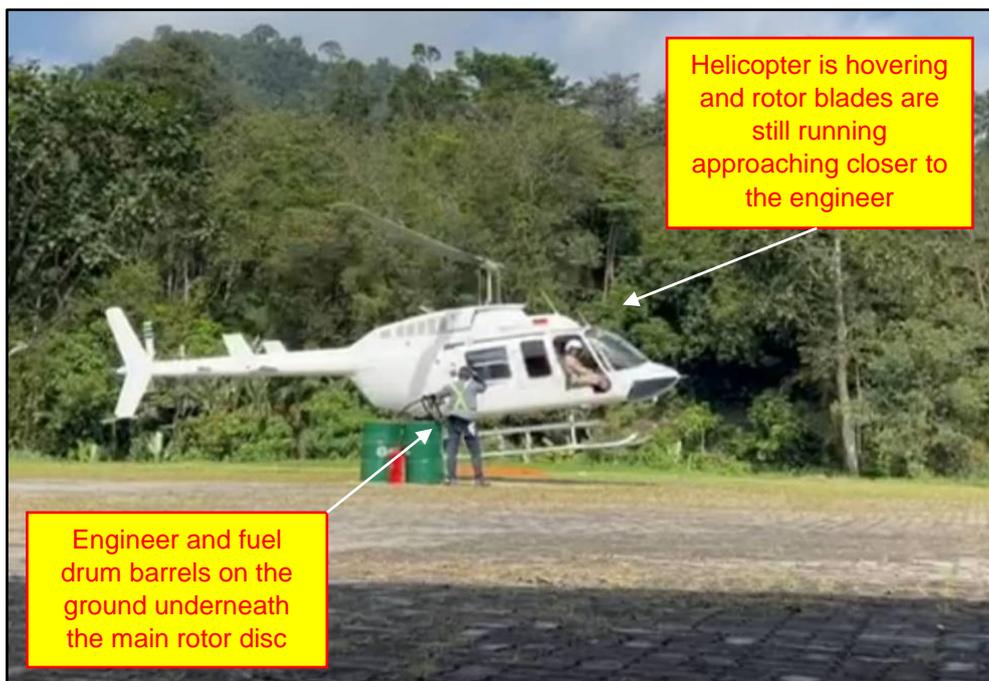
Based on video footage of PK-ZUV conducting hot refuelling a day before the accident (refer to Figure 6), it was observed that the crew from the Lessor did not adhere to the prescribed SWP for hot refuelling. Such non-compliance poses a potential risk and could lead to unsafe conditions.

Figure 6: PK-ZUV hot refuelling a day before

Figure 5, Paragraph 1.4.1 (c), (e), and (f) clearly define the SWP for conducting hot refuelling. However, as observed in Figure 6, the helicopter operator or the Lessor failed to adhere to these procedures.

The unsafe actions of both the pilot and the ground engineer introduced potential hazards. The helicopter was hovering with its rotor blades still running while moving closer to the ground engineer, who was positioned directly beneath the main rotor disc. This is a direct violation of paragraph 1.4.1 (c), which mandates that crew members must wait at a safe distance from the landing point.

Additionally, Paragraph 1.4.1 (e) states that the refuelling crew should only approach the helicopter after receiving a clear instruction (thumbs-up) from the pilot. However, as shown in Figure 6, the crew is already positioned beneath the helicopter while it is still hovering and approaching for landing, indicating a clear violation of this procedure.

When the Lessor fails to comply with safety regulations, it is the Lessee's responsibility to oversee and monitor operations to ensure adherence to established requirements. In this case, the absence of a Safety Officer from the Lessee at HLS 2 to supervise the hot refuelling process contributed to crew complacency, further increasing operational risks.

- i) The Lessee shall ensure that a Safety Officer is present to oversee and monitor flight operations to ensure compliance with commercial requirements whenever activities are conducted at the site.

- i) The Lessor shall facilitate for the pilot to undergo a comprehensive mental and physical health evaluation with an aviation medical professional to ensure fitness for resuming flying duties.
- ii) The Lessor shall update the Company's Maintenance Manual (CMM) and Operations Manual – A to explicitly define the safe distance required for ground crew during helicopter approaches for landing during hot refuelling.
