## **AIRCRAFT SERIOUS INCIDENT**

### **PRELIMINARY REPORT**

**SI 08/26**

**Fixed-Wing Aircraft Boeing 737-8 (737 MAX 8)**

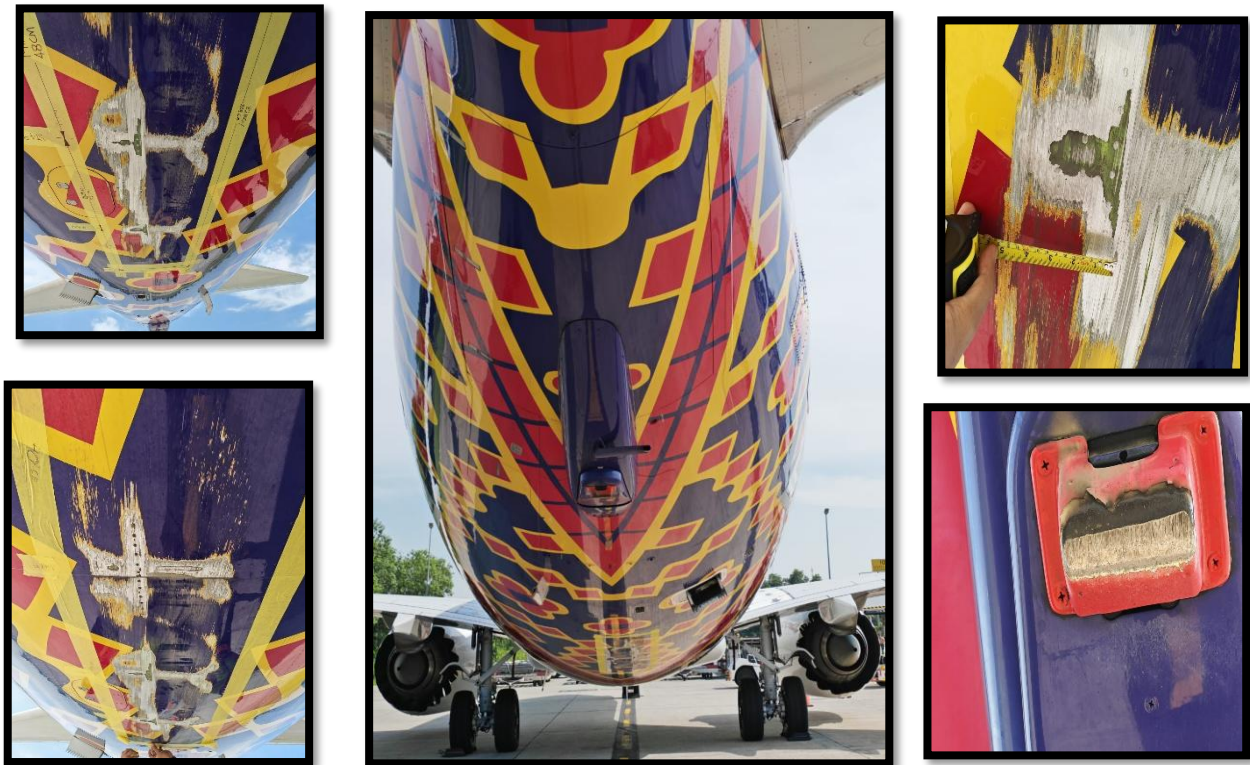
Figure 1: Tail Strike Damage to the Lower Aft Fuselage

The aircraft sustained damage to the lower aft fuselage because of the tail strike. Visual inspections identified extensive scraping and abrasion of the external skin, removal of paint and surface material, together with localised skin cracking and damage within the affected tail contact area. The damage was concentrated along the underside of the aft fuselage, consistent with contact with the runway surface during the landing occurrence.

Further detailed inspections, including removal of paint from the affected areas, were carried out to determine the extent of the structural damage. A comprehensive assessment of the aircraft damage, including the detailed inspection findings and subsequent repair actions, will be presented in the Final Report.

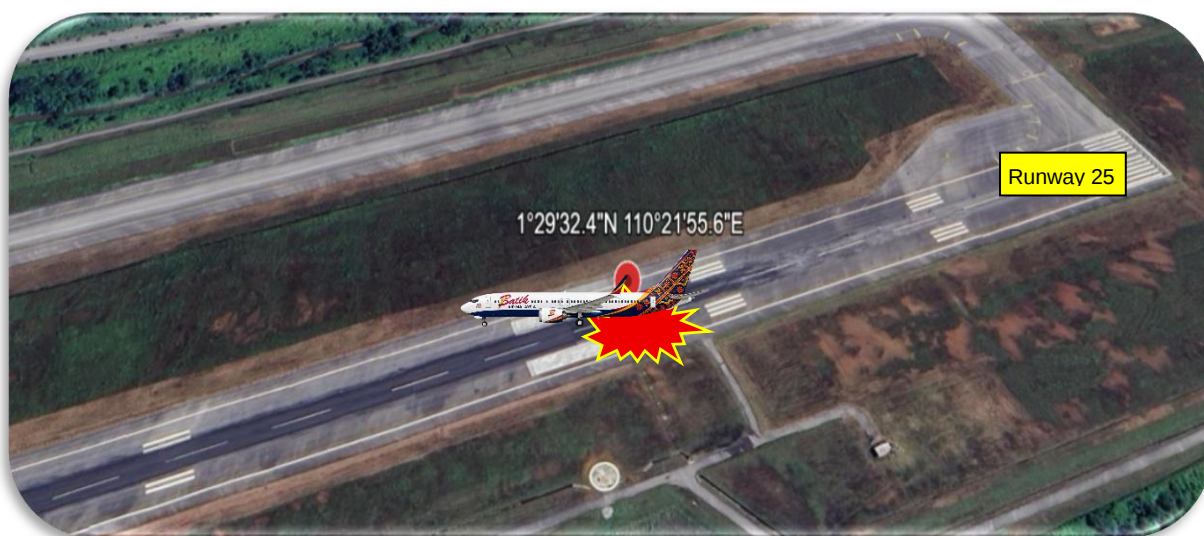
Figure 5: Approximate Location of the Tail Strike Contact Mark on Runway 25

During the site examination, a longitudinal scrape/contact mark was identified on the surface of Runway 25 at Kuching International Airport (WBGG) *Figure 5*. The mark was located at approximately 01°29'32.4"N, 110°21'55.6"E and was consistent with contact between the aircraft's lower aft fuselage and the runway during the tail strike.

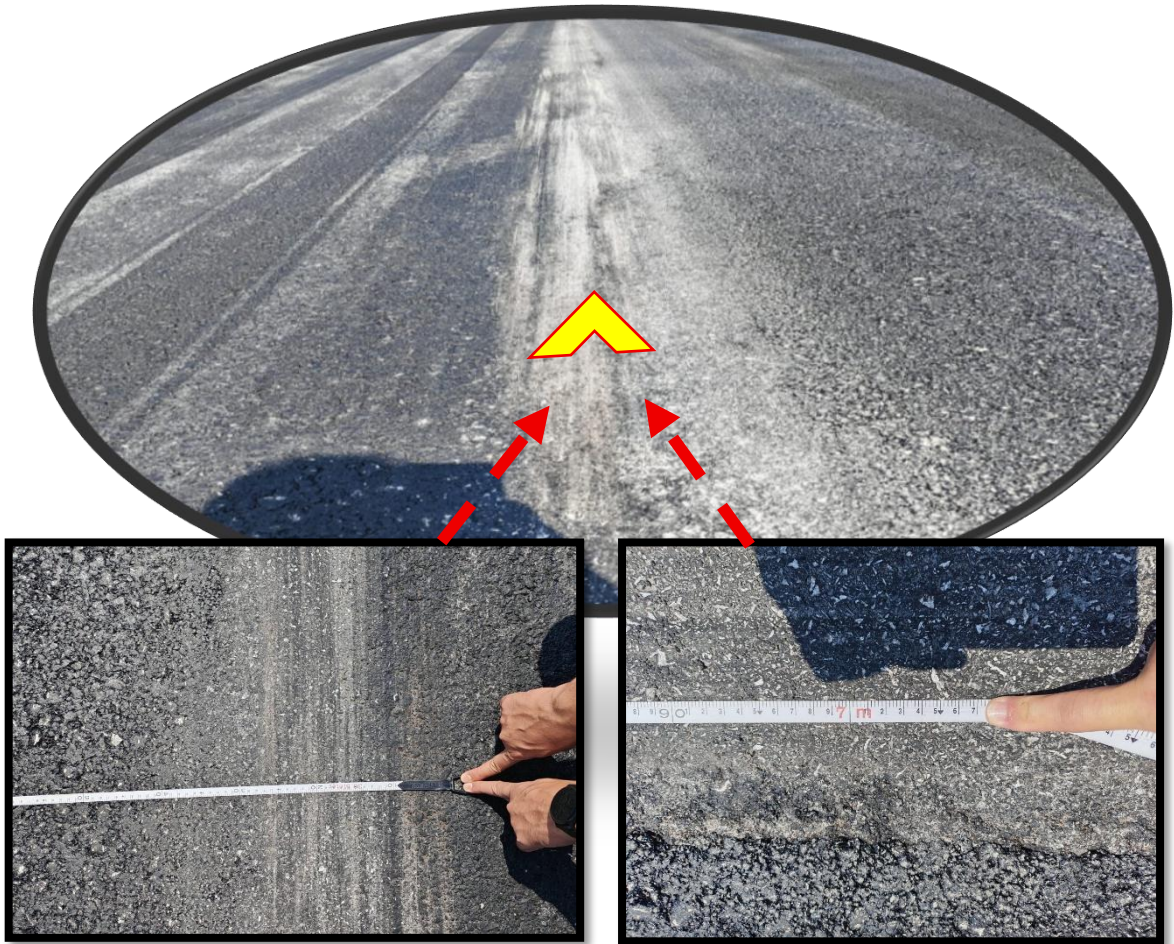
Figure 6: Measurement of the Runway Contact Mark Following the Tail Strike

The runway contact mark at *Figure 6* extended approximately 7 meters in length, with its width varying along the affected area. The mark consisted of surface scraping and light-coloured abrasion/deposits on the asphalt pavement, aligned generally with the aircraft's direction of travel. Measurements and photographs of the mark were taken during the site examination for further correlation with the damage observed on the lower aft fuselage.
