## **AIRCRAFT SERIOUS INCIDENT**

### **PRELIMINARY REPORT**

**SI 01/26**

**Fixed Wing Aircraft Piper Warrior III PA28-161, Registration 9M-NKD**

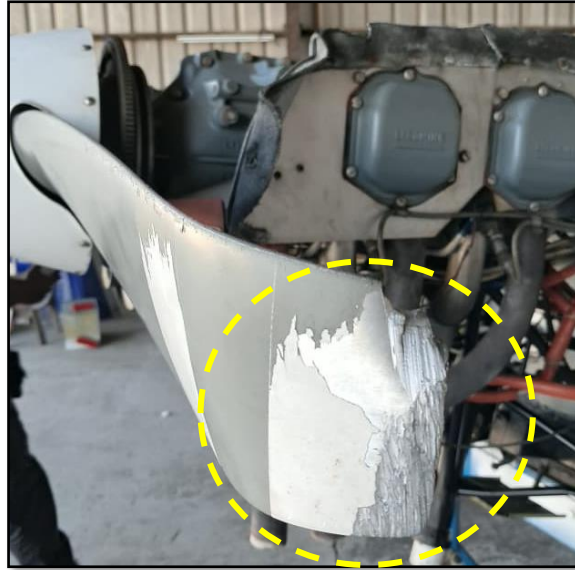
Figure 1: Condition of the aircraft propeller blades

Propeller Assembly as depicted in Figure 1, the propeller blades sustained significant damage consistent with a sudden ground strike. This includes severe "curling" or longitudinal deformation of the blade tips and deep abrasive scarring on the leading edges. These findings are consistent with the engine delivering power at the moment of impact.

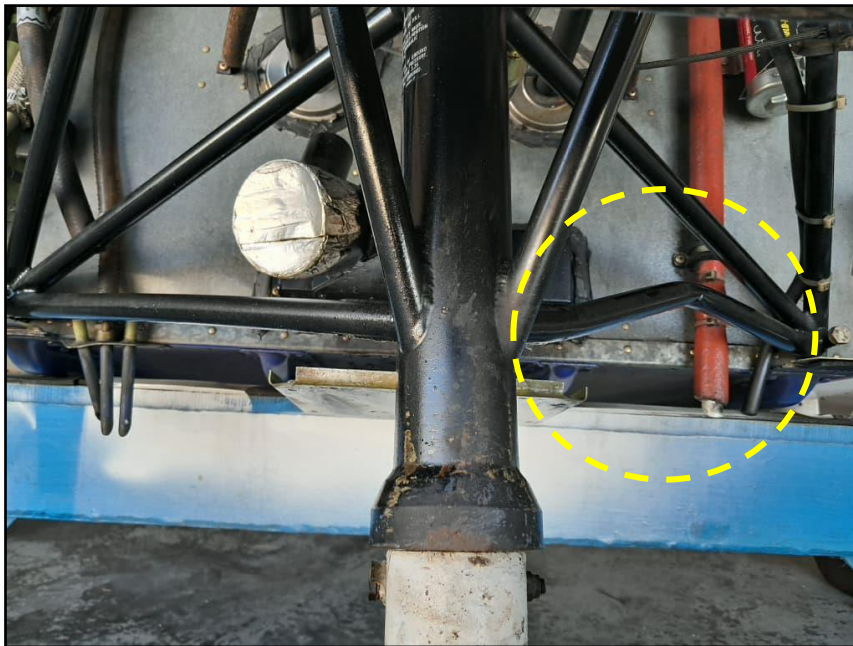
Figure 2: The nose landing gear assembly

The nose landing gear assembly exhibited signs of structural failure. As illustrated in Figure 2, structural bending indicates that the aircraft's underside made heavy contact with the ground during the landing sequences.

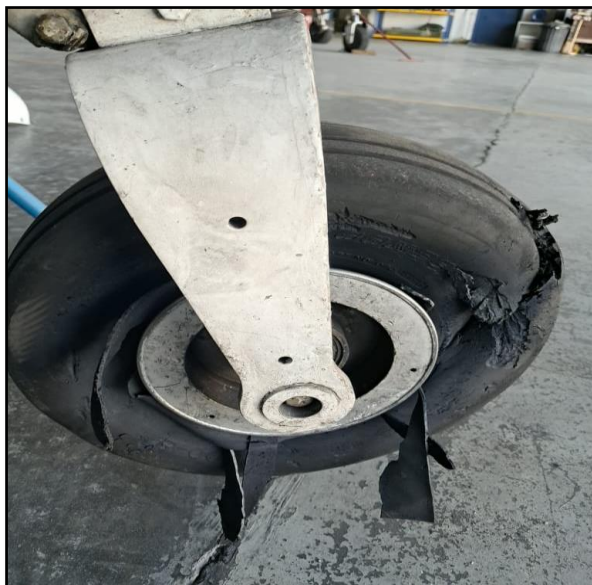
Figure 3: Nose Gear Tyre Condition

The nose wheel assembly exhibited signs of extreme mechanical distress. As illustrated in Figure 3, the nose wheel tyre sustained a catastrophic failure of its structural integrity, characterised by extensive circumferential shredding. The rubber

carcass was found in a fragmented state, with significant portions of the tread and sidewall delaminated and partially separated from the wheel flange.
