## **AIRCRAFT ACCIDENT**

### **FINAL REPORT**

**A 05/25**

**Accident Involving Airbus Helicopter AS355N,  
Registration 9M-PHG, at Sungai Pulai, Gelang Patah, Johor  
on 10 July 2025**

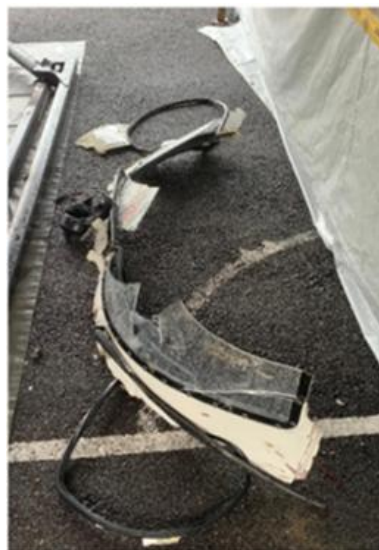
Windshield Frame

Figure 1: Debris (Windshield Frame, Seats, Fuselage Panels and Composite Fairings) detached and recovered floating within 30 to 40 metre radius of the primary impact point.

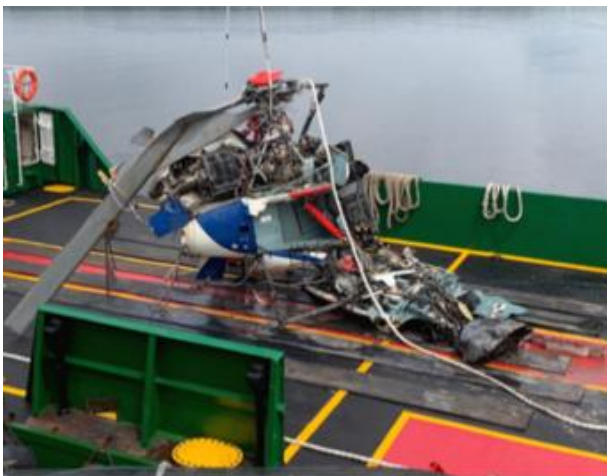
Main wreckage

- i) Several seats, fuselage panels and composite fairings were detached and recovered floating within a 30 to 40 metre radius of the primary impact point.
- ii) The main wreckage sank almost immediately after impact and came to rest fully submerged at an estimated depth of between 14 and 17 metres, depending on tidal conditions (ranging from 14 metres at low tide to 17 metres at high tide).
- iii) Recovered debris included seats, fuselage skin panels, access hatches and minor fairing components.
