**AIRCRAFT SERIOUS INCIDENT
PRELIMINARY REPORT**

SI 02/26

**Air Accident Investigation Bureau (AAIB)
Ministry of Transport, Malaysia**

**Fixed Wing Aircraft Diamond DA40 NG, Registration 9M-LIZ
at Malacca International Airport, Malacca
on 26 March 2026**

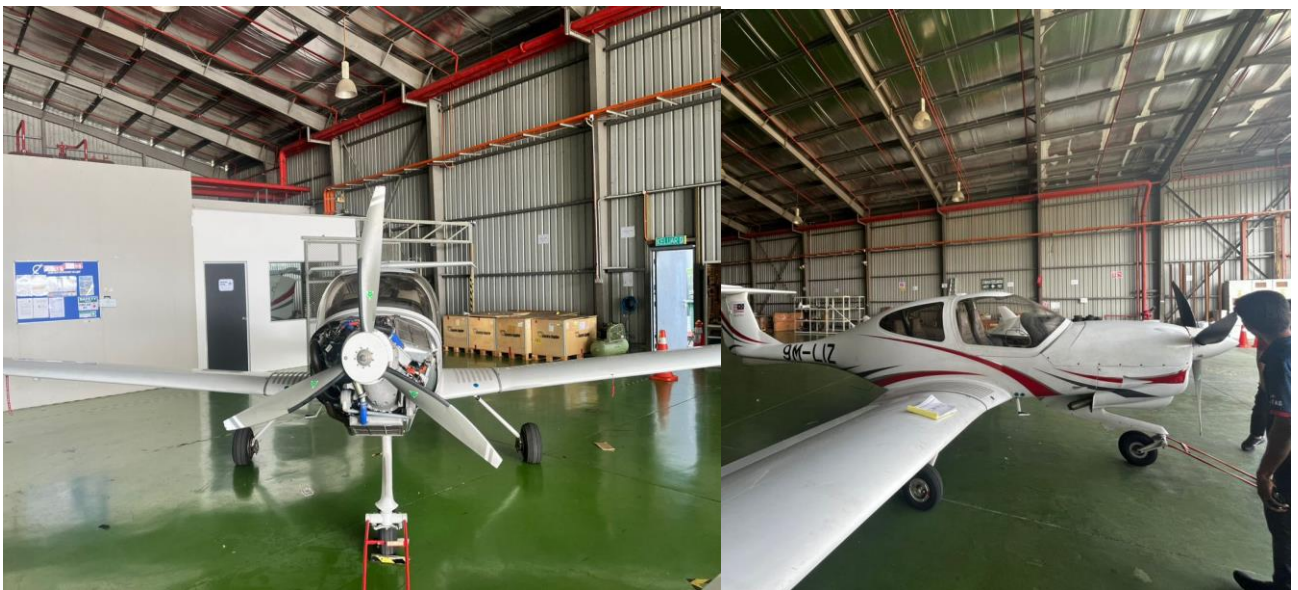
Figure 1: Aircraft parked in the AATA hangar after declared unserviceable.

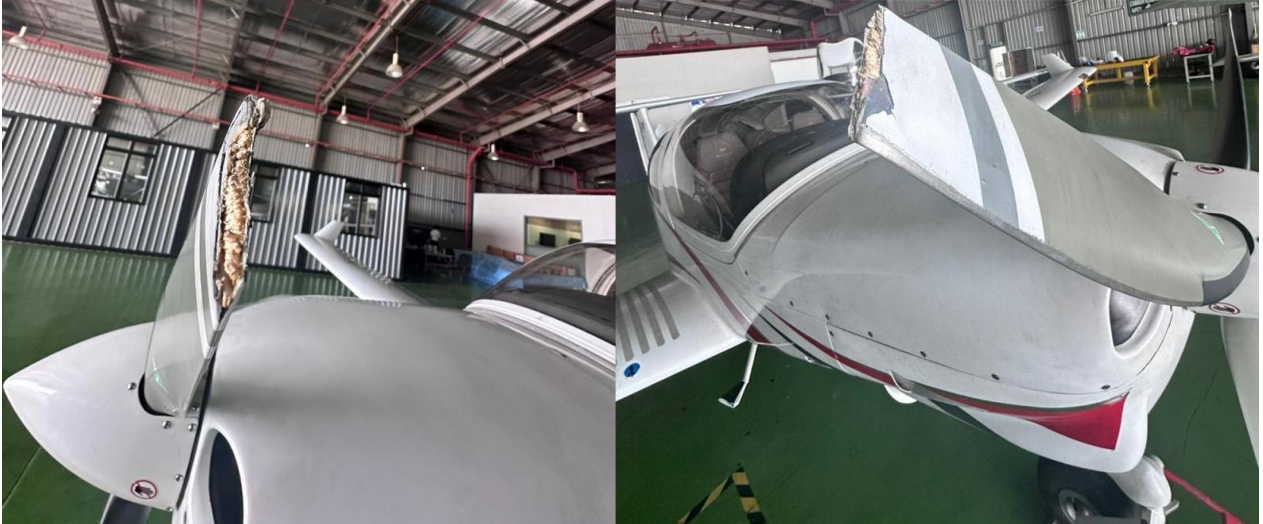
Preliminary analysis indicates significant damage has been observed on the tip of the propeller. There are noticeable scratch marks and damage on the propeller as shown in Figure 1 to Figure 3 at 1.12 Wreckage and Impact Information. The Aircraft Dimension is per Appendix A and Initial Damage Assessment Report as per Appendix B.

Figure 2: Condition of propeller blade tip.

Following the inspection and consultation with the Original Equipment Manufacturer (OEM), the following components are required to be replaced: Propeller, Gearbox, Flywheel and Engine mounting. No other damage has been confirmed to date. A full airframe and engine inspection remain ongoing. The aircraft remains grounded pending completion of repairs and further investigation. No injuries were reported.

The aircraft was inspected by a Licensed Aircraft Engineer (LAE), who determined that the propeller is beyond repair. Additional inspections of the airframe were also carried out. The Continuing Airworthiness Management Organisation (CAMO) has coordinated with the Original Equipment Manufacturer (OEM), and all required data has been submitted for analysis, as referenced in the email trail.

Following consultation, the OEM recommended that inspections be conducted in accordance with SI-E4-020_1, Paragraph 1.4.2 (Shock Load Inspections). Based on this service instruction, the following major components are required to be replaced:

- 1) Engine Shock Mounts
- 2) Propeller
- 3) Flywheel
- 4) Gearbox

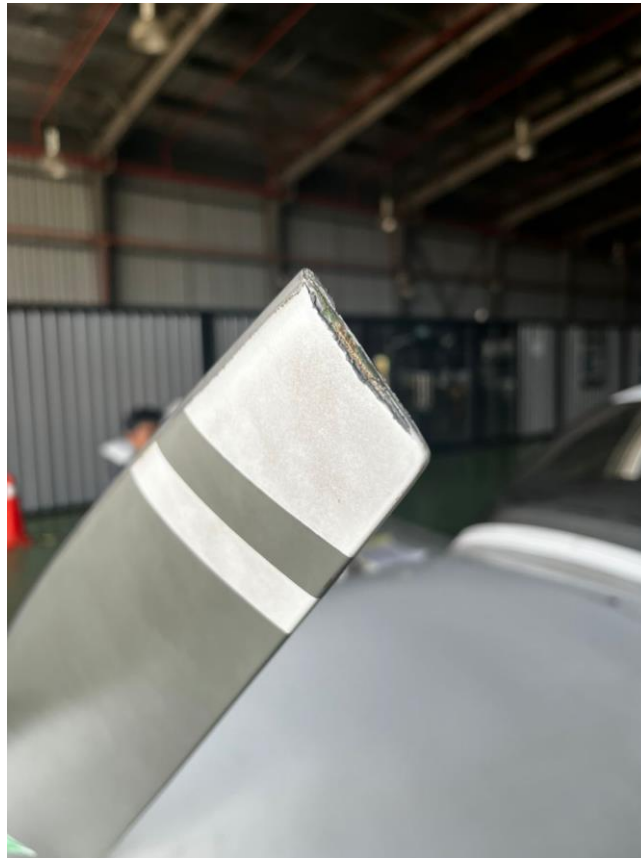
Figure 3: Condition of propeller blade tip.
