## **AIRCRAFT ACCIDENT PRELIMINARY REPORT**

**A 07/26**

**Fixed-Wing Aircraft Diamond DA 40 D,  
Registration 9M-HMJ at Kuah, Langkawi, Kedah  
on 12 May 2026**

**PRELIMINARY REPORT NO: A 07/26**

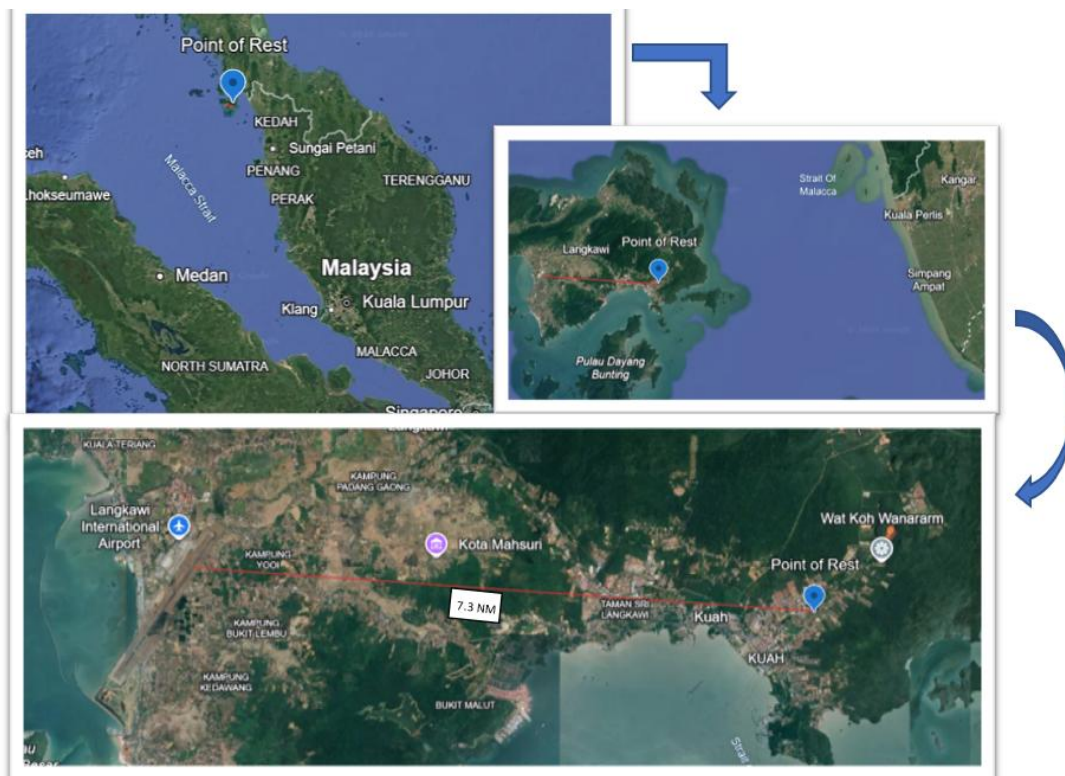
Figure 2 : Location of the Accident

While maintaining the pattern, the crew executed troubleshooting procedures in accordance with the ECU caution checklist, which included attempting to reset the ECU by holding the test button for more than 2 seconds. When these actions failed to restore engine control, the FI declared a 'MAYDAY' to local ATS at 1029 LT, reporting the engine malfunction and their intent to land at the nearest grass area at Kuah area as shown in Figure 2.

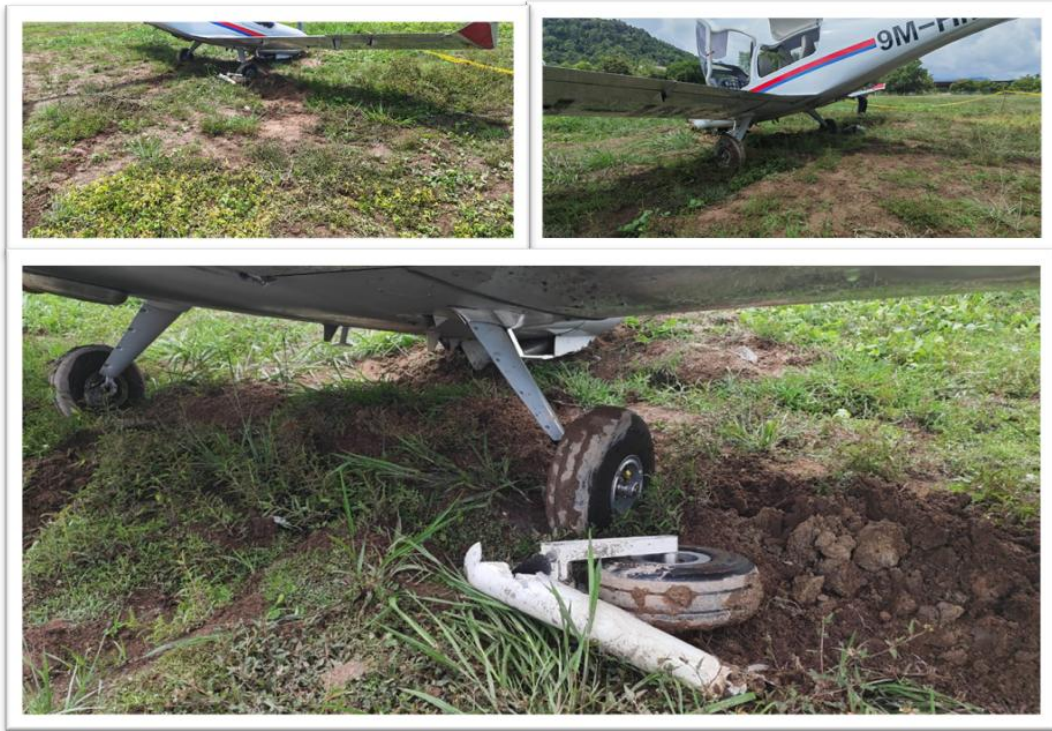
Figure 3 : Condition of Main Landing Gear

- **Landing Gear:** Following a ground roll, the nose wheel became stuck in uneven, soft soil, resulting in the complete collapse of the nose landing gear. The forward strut suffered a structural fracture, severing the wheel assembly and lower fairing from the aircraft. The left and right main landing gear assemblies remained structurally intact and securely attached to the airframe. Both Main Landing Gear (MLG) tyres exhibited heavy mud accumulation and soil embedment consistent with the soft-field ground roll.

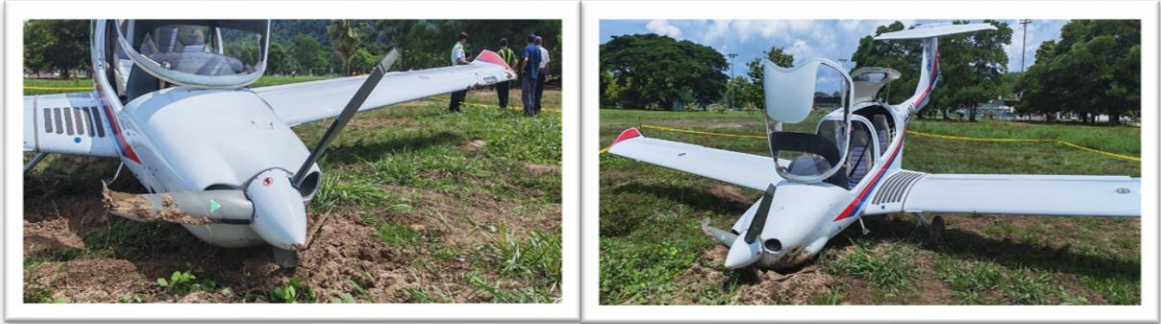
Figure 4 : Close-up View of Propeller Assembly

- **Propeller Assembly:** Two of the three composite propeller blades sustained damage, including splintering and aft-bending, while the third blade remained intact and undamaged. The absence of uniform chordwise scratching and the pristine condition of third blade indicate that the propeller was not rotating under power at the time of impact. The damage pattern is consistent with the stationary propeller striking the terrain subsequent to the collapse of the nose landing gear.

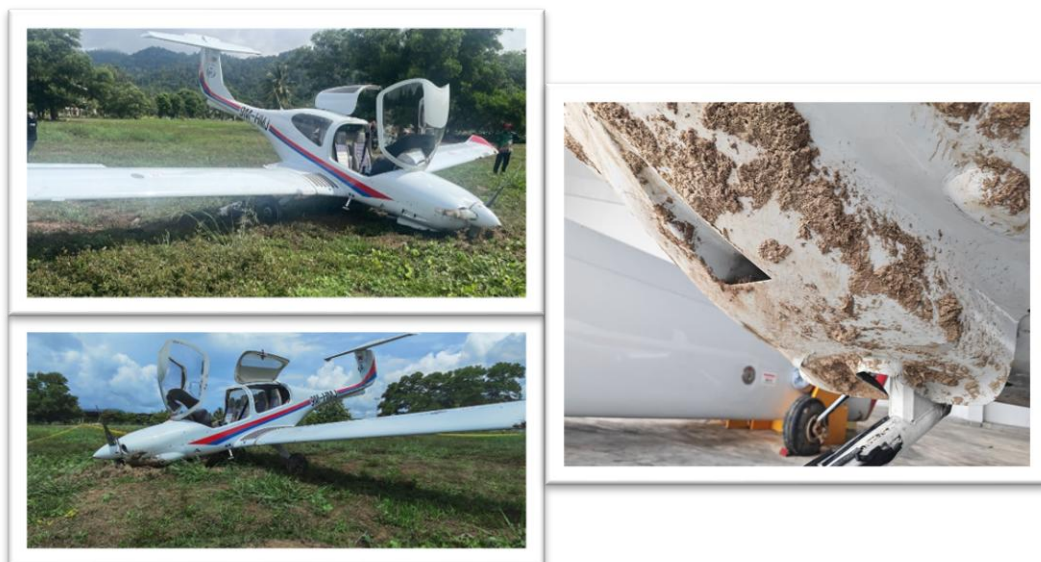
Figure 5 : Condition of Lower Fuselage (Nose Wheel Fuselage)

- **Lower Fuselage (Belly):** With the nose landing gear collapsed, the nose of aircraft rested entirely on its belly. The underside of the nose wheel fuselage sustained abrasion and mud packing consistent with sliding across the dirt and grass surface.

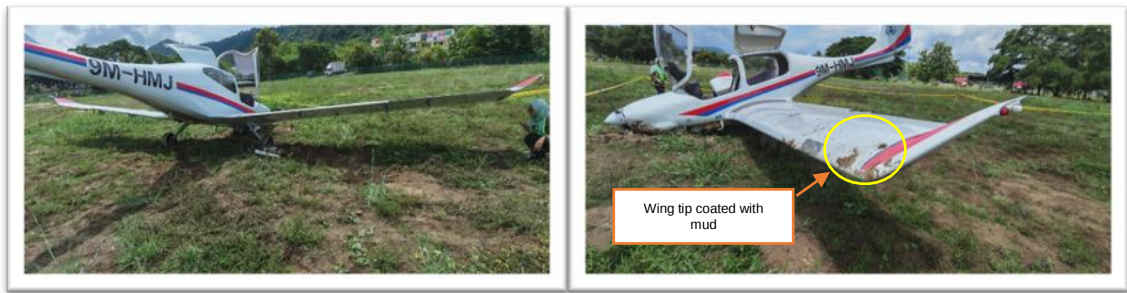
Figure 6 : Condition of Wings and Empennage

- **Wings and Empennage:** The left and right wings, including the wingtips, as well as the T-tail empennage assembly, remained attached to the primary structure and appeared fundamentally intact, though left wing tip coated in mud displaced during the sliding sequence. The canopy remained intact with no signs of shattering.

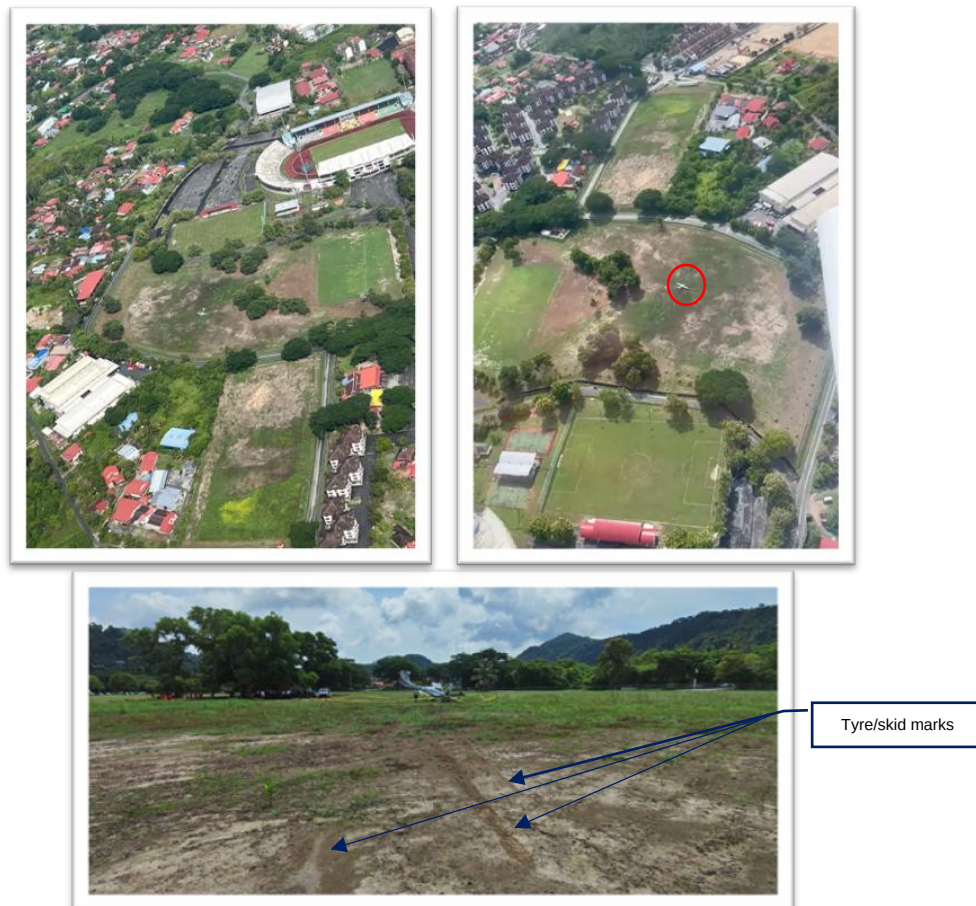
Figure 7 : View of Environmental Impact at the Site

There was no evidence or report of damage to third-party structures, public infrastructure, or nearby buildings, and environmental impact was limited strictly to surface scarring of the soft open field, characterized by distinct grooves and tyre/skid marks created as the aircraft slid to its final resting position (red circle).

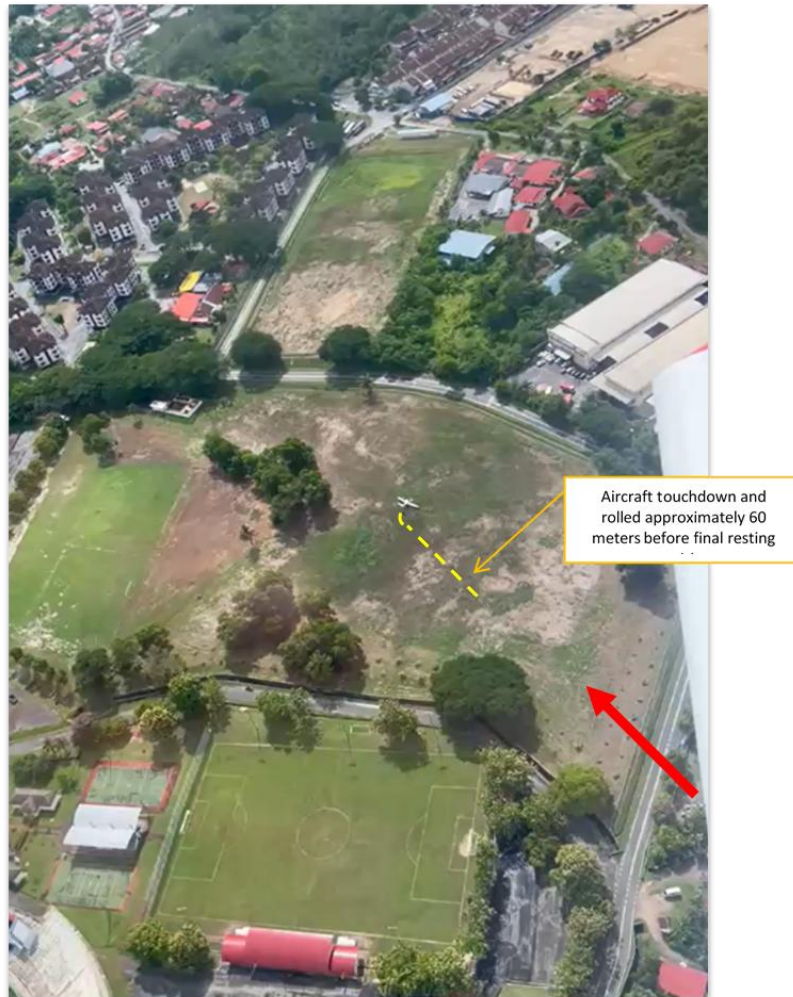
Figure 8 : Description View of the Accident Site and Wreckage Location

Figure 8 provides a general description of the accident site and the location of the aircraft wreckage. The approach direction for the aircraft's landing is indicated by a red arrow, while a broken yellow line circle illustrates the initial touchdown point. Following touchdown, the aircraft rolled for approximately 60 meters before its nose wheel became trapped in a soft, uneven surface. This entrapment caused the nose wheel to collapse, which subsequently forced the aircraft to swing to the right and come to a complete stop in its final resting position.

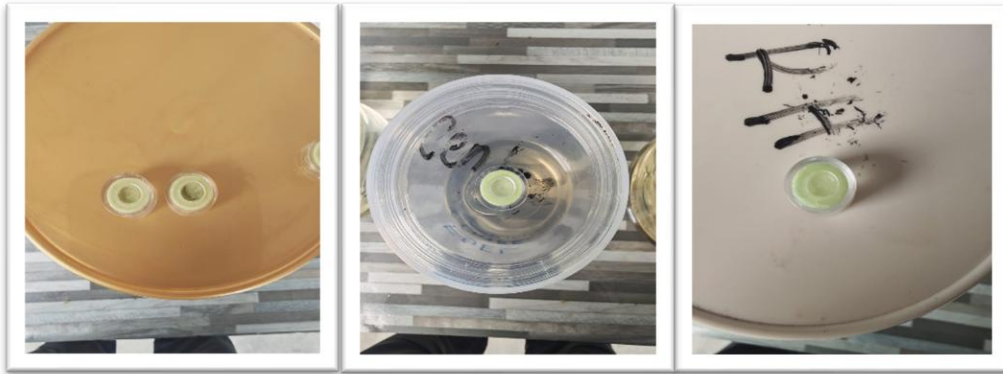
Figure 9 : Fuel Water Contamination Test Results Using Strips Kit

Immediately following the accident, a fuel sample recovered from the wreckage was subjected to an on-site water contamination test utilizing a chemical strip kit. This prompt field analysis was conducted to identify and mitigate any immediate systemic safety risks, as the same fuel source was actively supplying other aircraft operating at WMKL. The initial on-site testing indicated nil presence of water in the aircraft's fuel as shown in Figure 9.

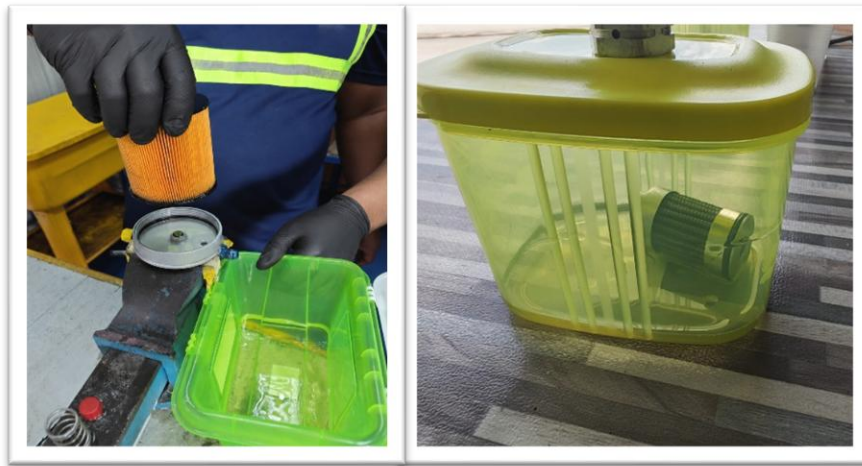
Figure 10 : Filter Components Retrieved for Laboratory Examination

To ensure comprehensive verification, representative samples of the aircraft's fuel were subsequently secured for detailed laboratory analysis. Furthermore, samples of the fuel filter, engine filter, gearbox filter, engine oil, and gearbox oil were extracted from the wreckage for specialized technical evaluation in the laboratory. The comprehensive findings and analytical results from these ongoing laboratory tests are currently pending and will be incorporated into the final investigation report.
