## **AIRCRAFT ACCIDENT PRELIMINARY REPORT**

**A 11/26**

**Helicopter BOLKOW BO105,  
Registration 9M-LLF at STOLPort Long Lellang, Miri, Sarawak  
on 8 September 2026**

**PRELIMINARY REPORT NO: A 11/26**

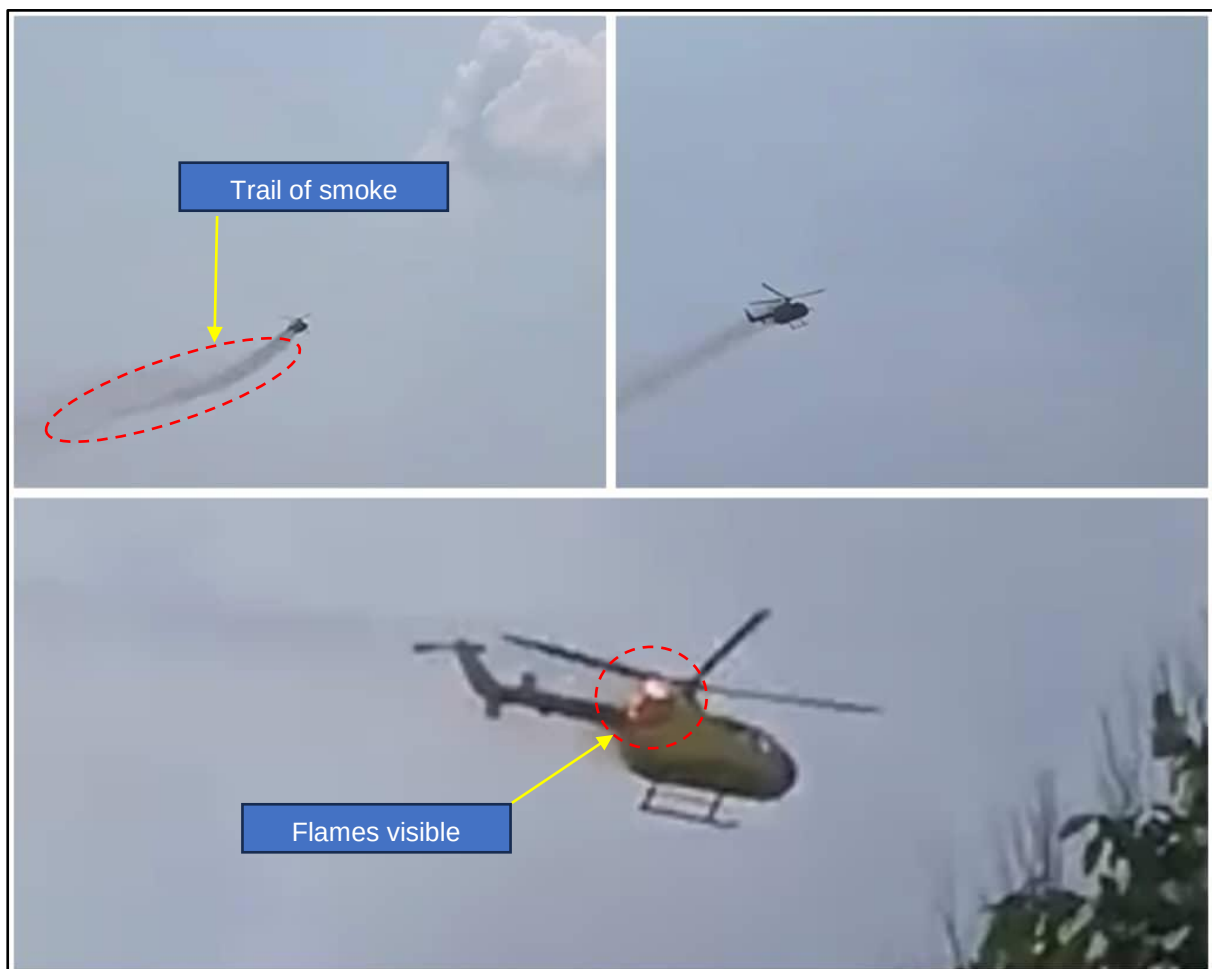
Figure 1: Photos from video recording footage from witness on ground

A 37-second video recording made by a person on the ground provides visual information concerning the final portion of the flight. An initial examination of the video shows the helicopter in flight with a visible trail of smoke. Visible flames were also observed in the vicinity of the area aft of the main gearbox, as viewed in the recording. The helicopter was subsequently observed continuing towards Long Lellang STOLport. The recording shows the helicopter continuing towards the STOLport and approaching Runway 04 but does not show how it subsequently contacted the ground. When the first responders approached the accident site, the helicopter was engulfed in fire near the Runway 04 threshold. The helicopter was substantially destroyed by the fire.

A ground-based video recording of the final portion of the flight showed a visible smoke trail and apparent flames in the vicinity of the area aft of the main gearbox. After the helicopter came to rest, witnesses and responders observed the wreckage fully engulfed in fire. The origin, development and sequence of the fire remain under investigation.

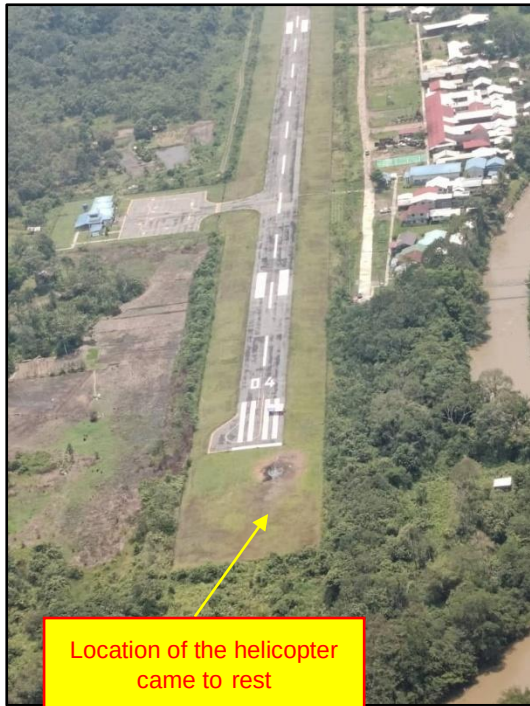
Figure 4: Location of the helicopter came to rest

The main wreckage was located near the Threshold 04 area, approximately 25 metres from the edge of the runway threshold (Figure 4 and 5). The circumstances in which the helicopter contacted the ground have not yet been established.

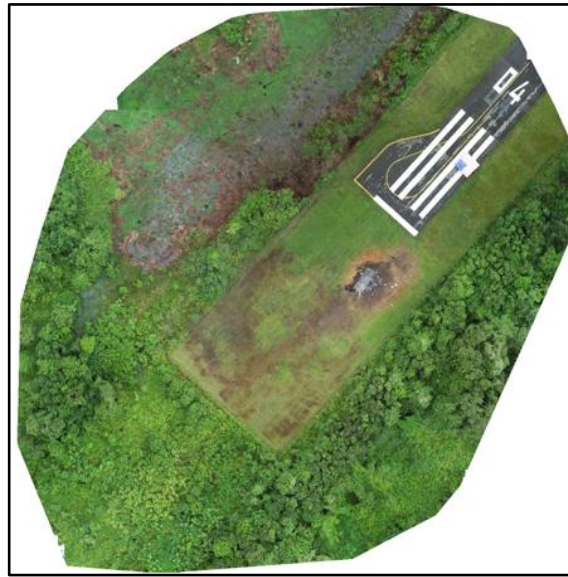
Figure 5: Drone-Generated Orthomosaic image of the accident site

Initial examination of the accident site indicated that the helicopter sustained substantial damage from fire and ground contact. The main wreckage and associated debris were located within the immediate vicinity of the accident site (Figure 6). Small items and components detached from the helicopter were identified within the accident site and were recovered for further examination and analysis.

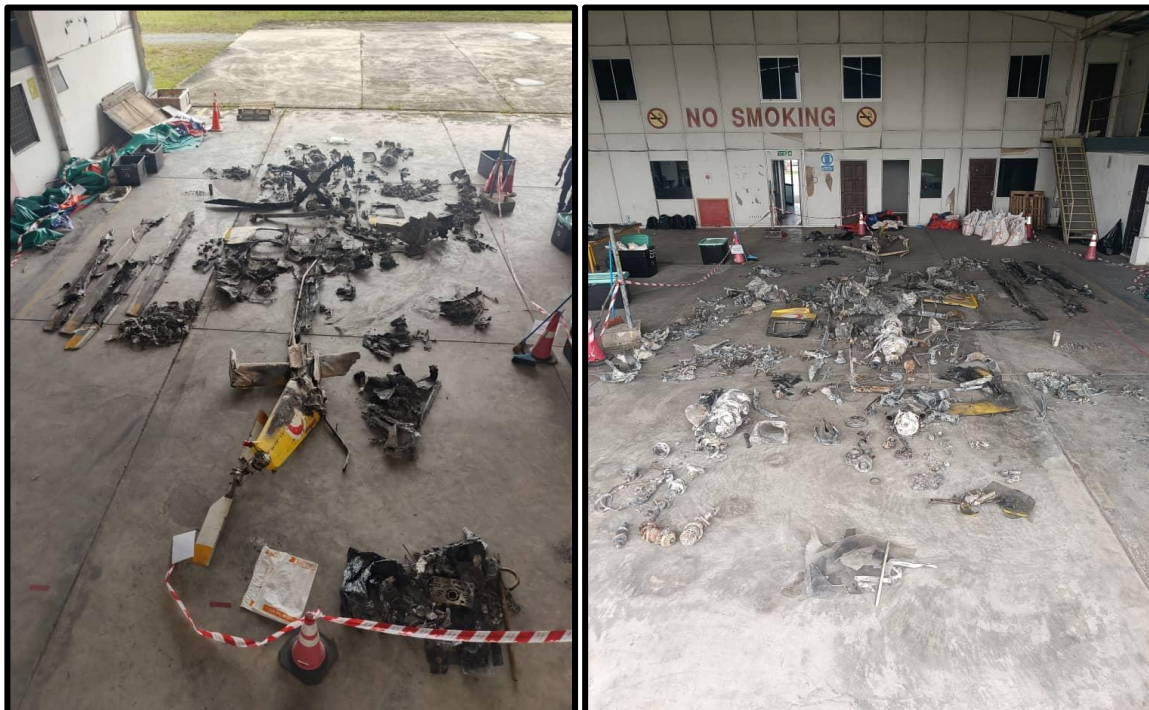
Figure 7 : Wreckage reconstruction in the hanger at WBGR

The extent of damage to the airframe, engines, transmission system, flight controls and other helicopter components is subject to further detailed examination. All components and debris recovered from the accident site were transported to Miri for further examination and analysis (Figure 7).

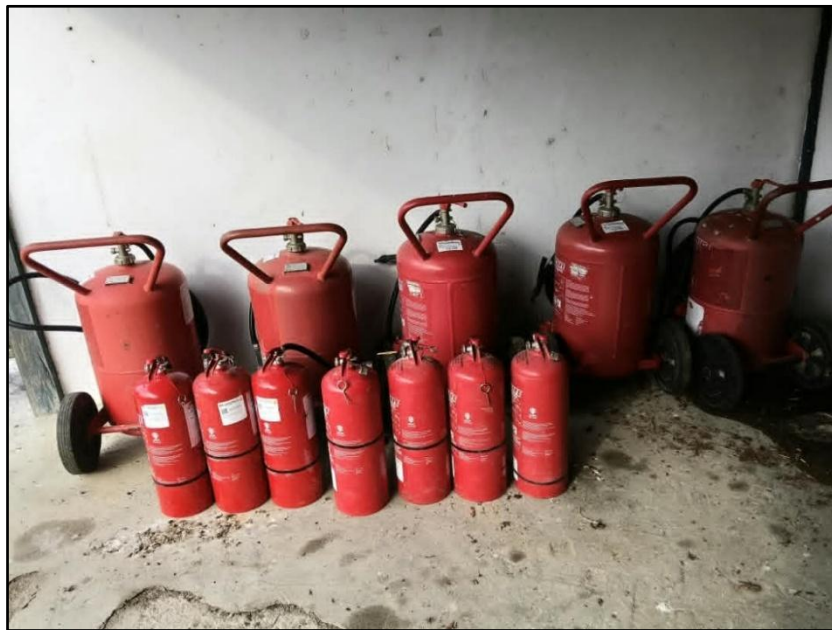
A total of twelve (12) dry powder fire extinguishers available at the STOLport terminal were deployed in an attempt to extinguish the fire, comprising five (5) units of 50 kg capacity and seven (7) units of 9 kg capacity (Figure 8). Despite the use of the available fire extinguishers, the fire could not be extinguished and continued to burn for several hours.

Figure 8: Dry powder fire extinguishers available at Long Lellang STOLport and used during the emergency response

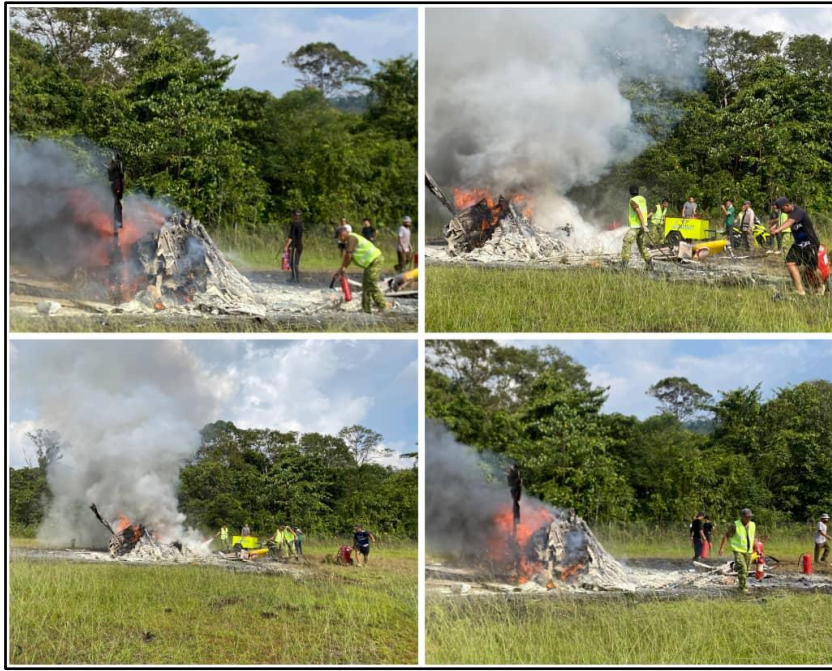
Photographic evidence of the initial emergency response showed that the personnel involved in the firefighting activities approached the burning wreckage and discharged portable fire extinguishers without wearing firefighting Personal Protective Equipment (PPE) (Figure 9).

Figure 9: Personnel attempting to extinguish the fire using portable fire extinguishers

The Aerodrome Operator is recommended to review the rescue and firefighting arrangements at its STOLports to ensure that auxiliary personnel are appropriately trained and equipped, and that firefighting equipment and PPE are properly maintained and serviceable.

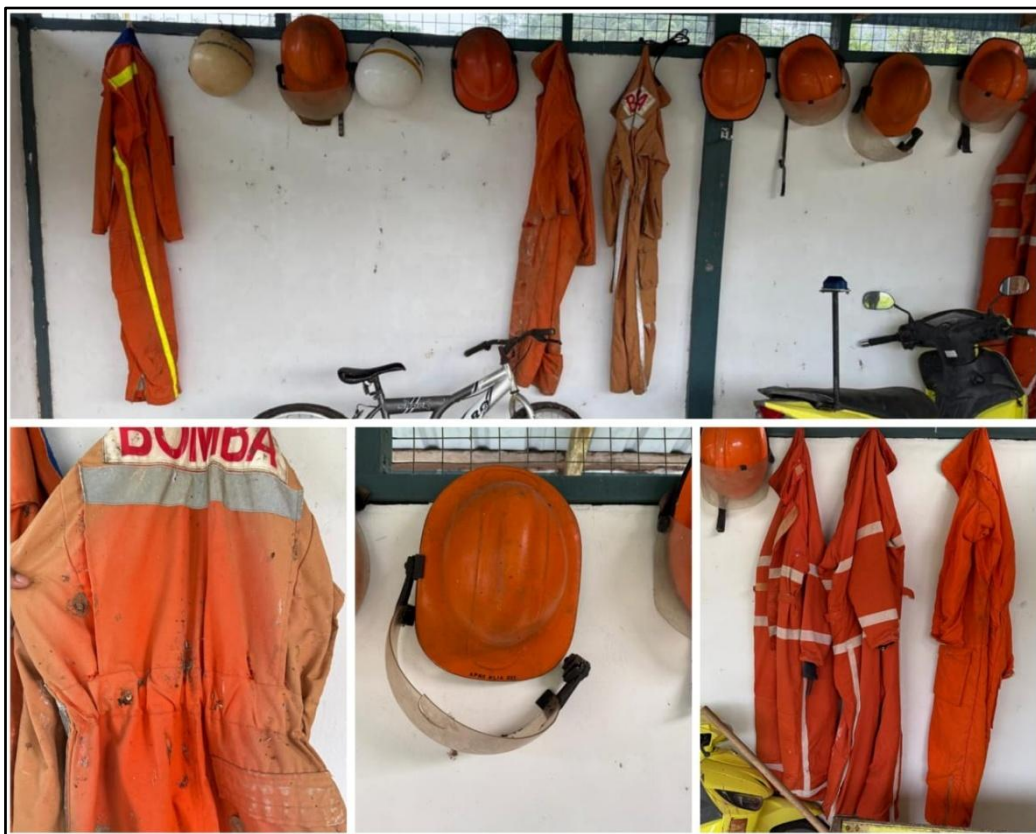
Firefighting PPE was available at the STOLport. Examination of the available PPE following the accident identified visible signs of deterioration and damage to some of the equipment, particularly the protective clothing (Figure 10).

Figure 10: Firefighting protective clothing and helmet available at Long Lellang STOLport showing visible signs of deterioration and damage.

Finding as to Risk — AVSEC RELA personnel assigned auxiliary rescue and firefighting duties responded to the fire without appropriate firefighting PPE. Some of the available PPE exhibited visible signs of deterioration and damage, which could adversely affect the safety and effectiveness of the emergency response.
