## **AIRCRAFT SERIOUS INCIDENT PRELIMINARY REPORT**

**SI 03/26**

**Air Accident Investigation Bureau (AAIB)  
Ministry of Transport, Malaysia**

**Fixed Wing Aircraft Boeing B737-300F, Registration PK-MBM  
at Kuching International Airport, Malaysia  
on 3 May 2026**

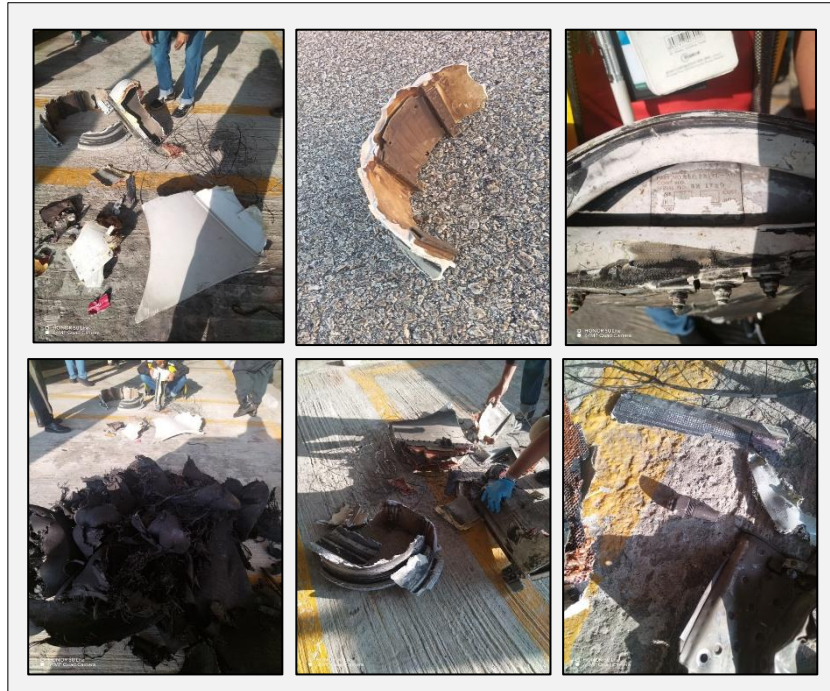
Figure 2: FOD Recovered on Runway 14R/32L  
Between Intersections C2 and C7 at WMKK

Following the occurrence, tyre debris was observed scattered along Runway 14R/32L, extending from Intersection C2 to Intersection C7. Figure 2 illustrates the recovered debris, which comprised approximately 58.375 kg of rubber material and 18.756 kg of metallic fragments, as further illustrated in Figures 3 and 4.

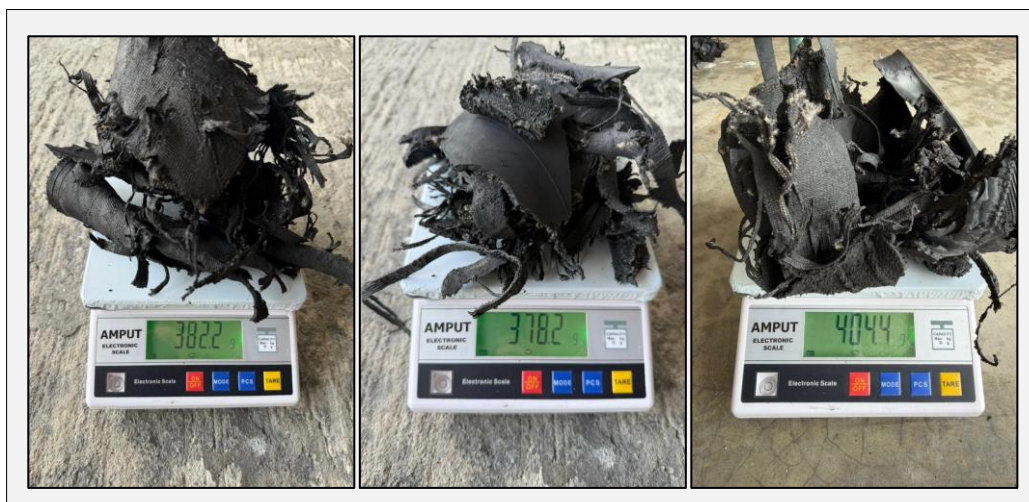
Figure 3: Sample of Recovered Tyre Rubber Debris

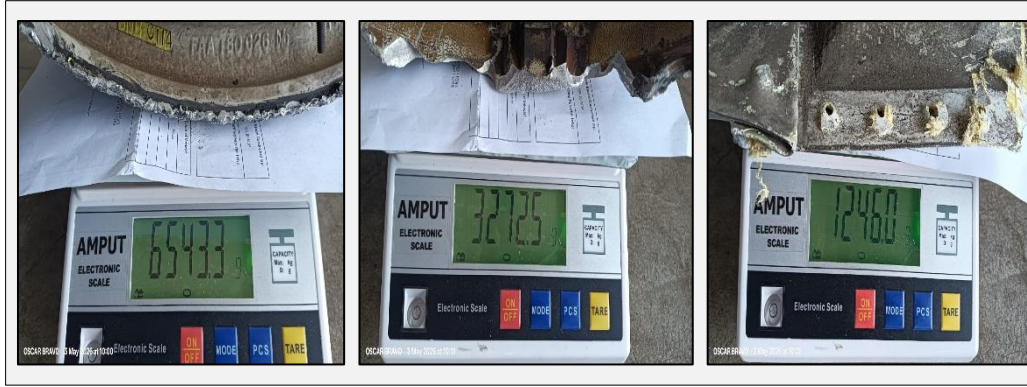
Figure 4: Sample of Recovered Metallic Fragments

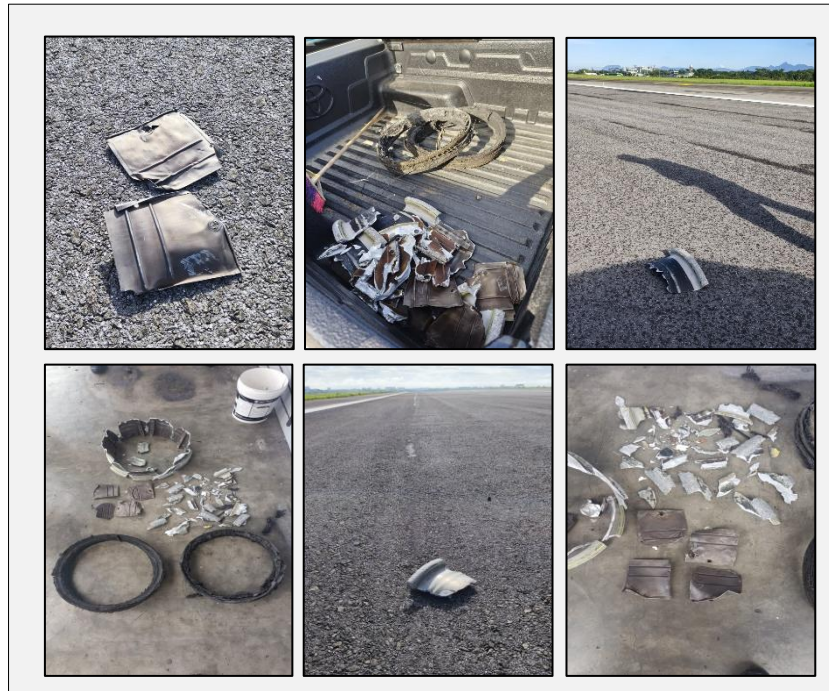
Figure 5: FOD Found on Runway 25 at WBGG

During the runway inspection conducted by Airside Safety Personnel, continuous scratch marks were observed on the pavement surface extending from the 750 ft marker on Runway 25 to Parking Bay 10B, corresponding to the path travelled by PK-MBM until the aircraft came to a complete stop.

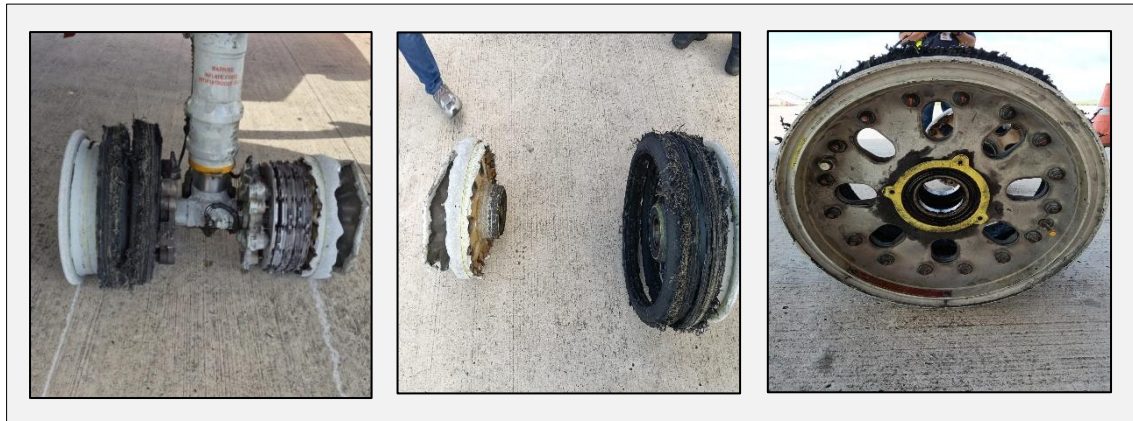
However, substantial damage was observed in the area beneath the RH wing and MWA as illustrated in Figure 6 to Figure 20. MWA Tyres No. 3 and No. 4 were found to have disintegrated, resulting in extensive damage to adjacent aircraft structures and associated components.

Figure 6: MWA No. 3 & No. 4 Damaged

The aircraft operator took proactive measures by engaging Boeing for technical assistance in performing temporary repairs prior to the aircraft undergoing permanent rectification, which is to be determined later.

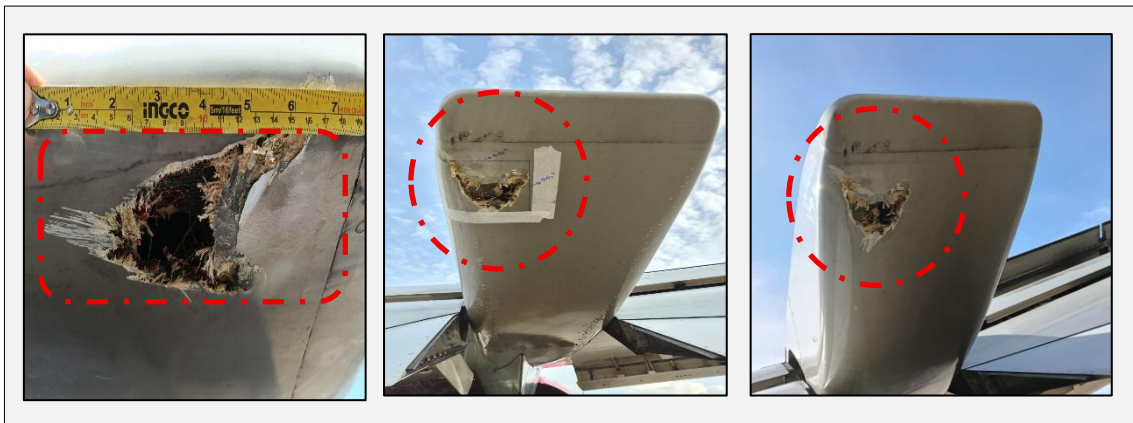
Figure 7: RH Canoe No 4 Ruptured

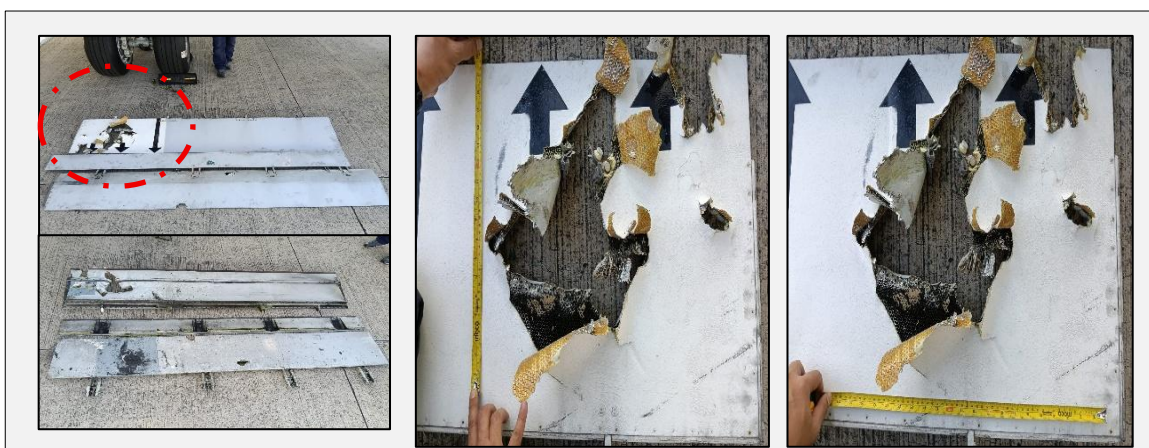
Figure 8: RH Ground Spoiler No 5 Ruptured

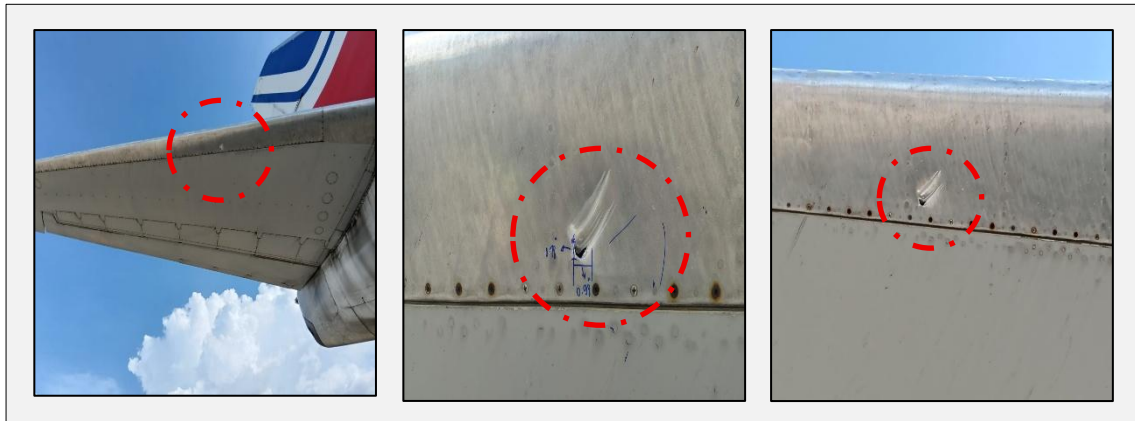
In addition, the horizontal stabilizer exhibited puncture and penetration damage, which was assessed as being consistent with high-velocity fragments travelling aft following the tyre failure.

Figure 9: RH Skin Leading Edge Horizontal Stabilizer Punctured

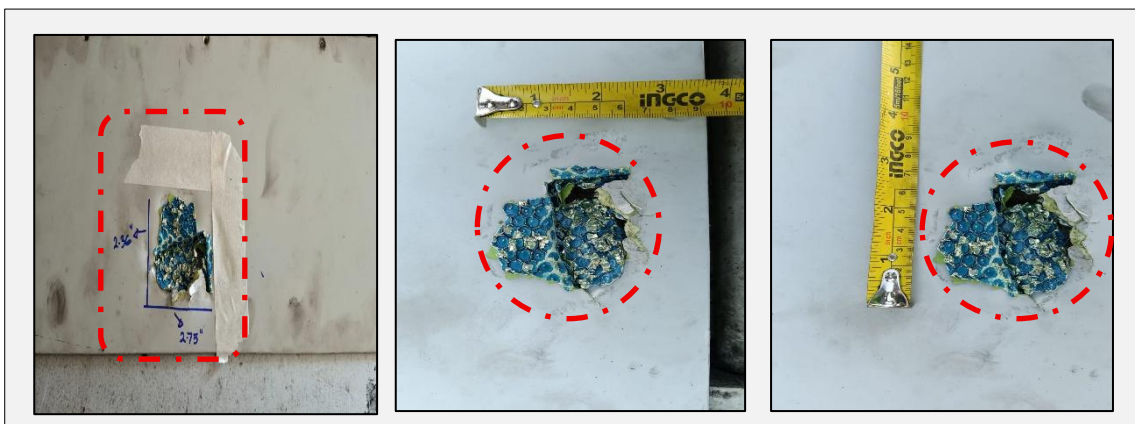
Figure 10: RH Upper Middle Tailing Edge Flap Panel Crushed

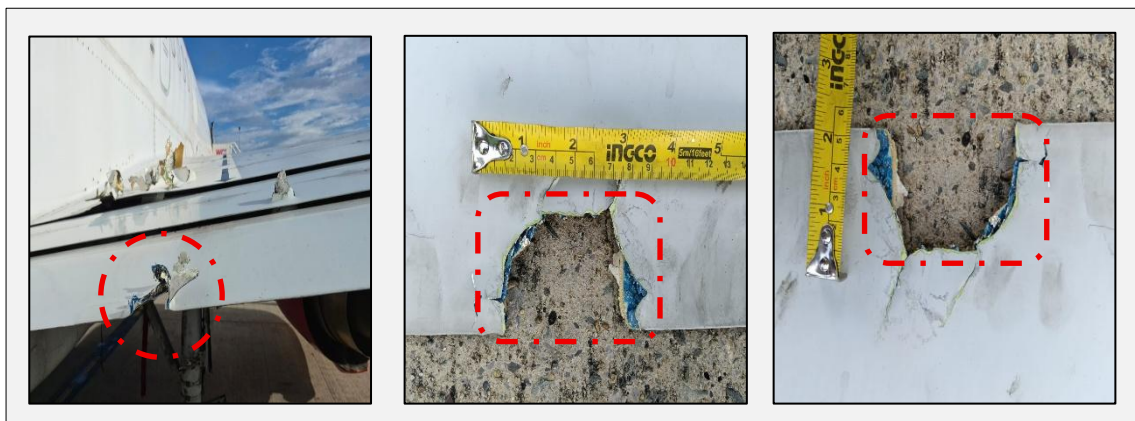
Figure 11: RH Inboard Aft Trailing Edge Flap Ruptured

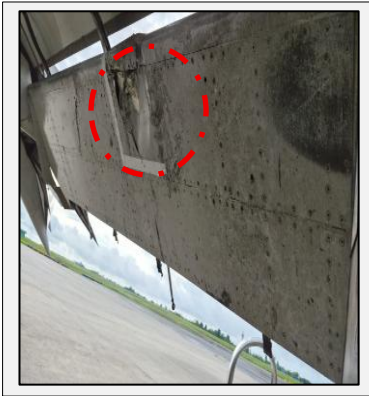
Figure 12: RH Inboard Trailing Edge Flap Dented

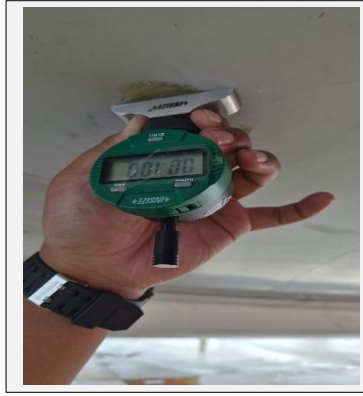
Figure 13: RH Inboard Lower Tank Dented

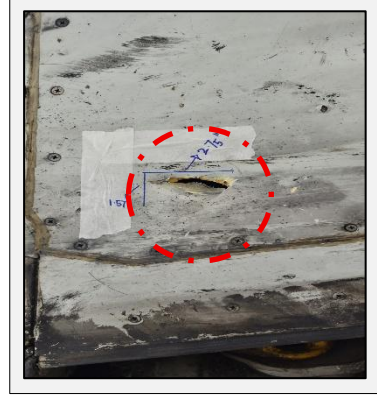
Figure 14: RH Lower Panel Main Landing Gear Ruptured

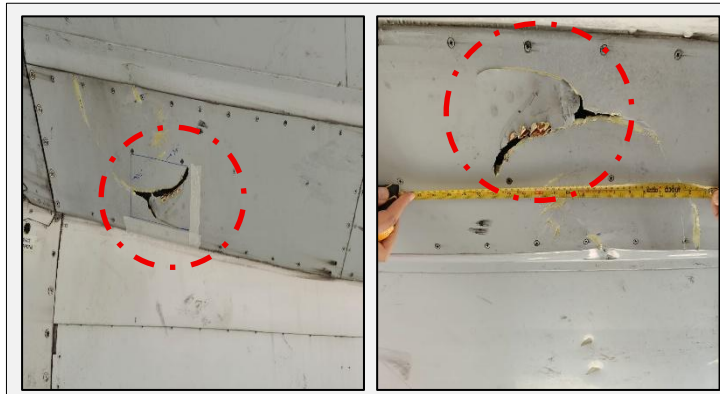
Figure 15: RH Aft Lower Wing Root Panel Ruptured

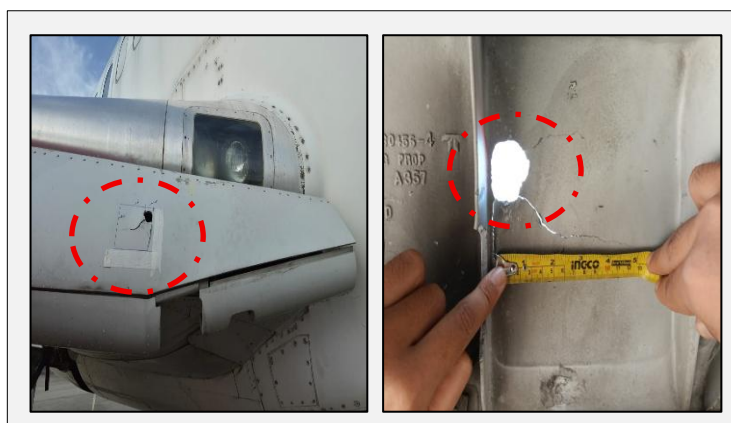
Figure 16: RH Inboard Leading Edge Flap Punctured

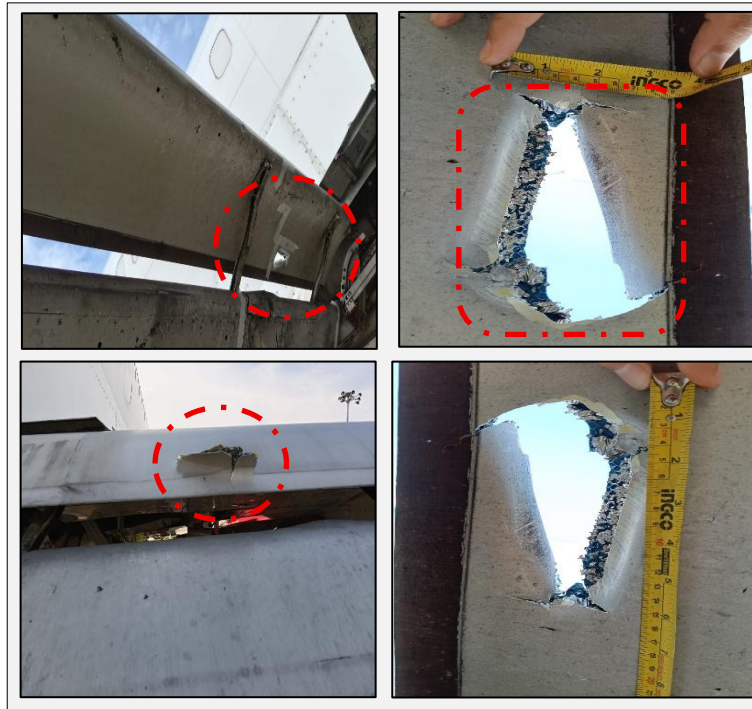
Figure 17: RH Inboard Fore Trailing Edge Flap Punctured

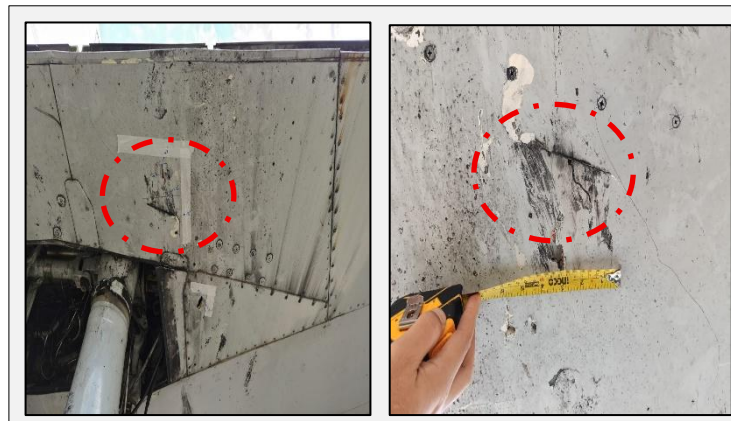
Figure 18: Lower Aft Panel RH Main Landing Gear Ruptured

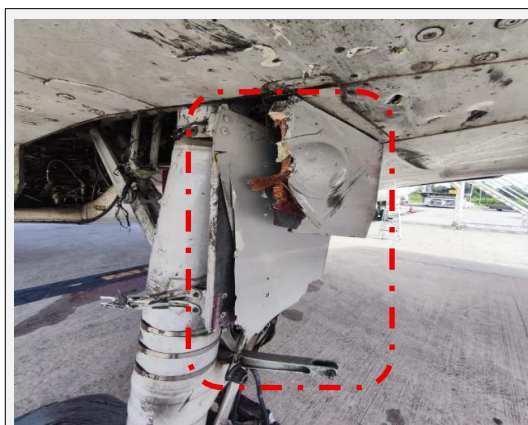
Figure 19: RH Outer, Centre and Inner Doors Main Landing Gear Broken and Fractured

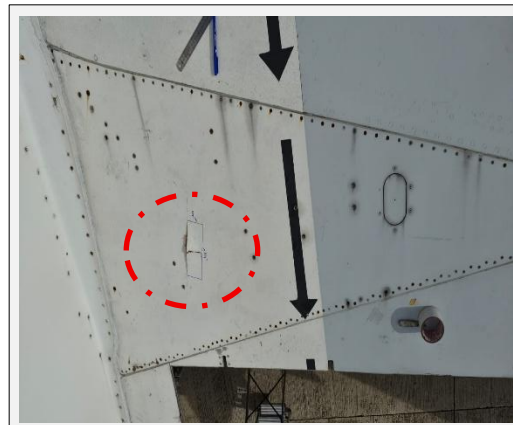
Figure 20: Upper Panel RH Main Landing Gear Cracked

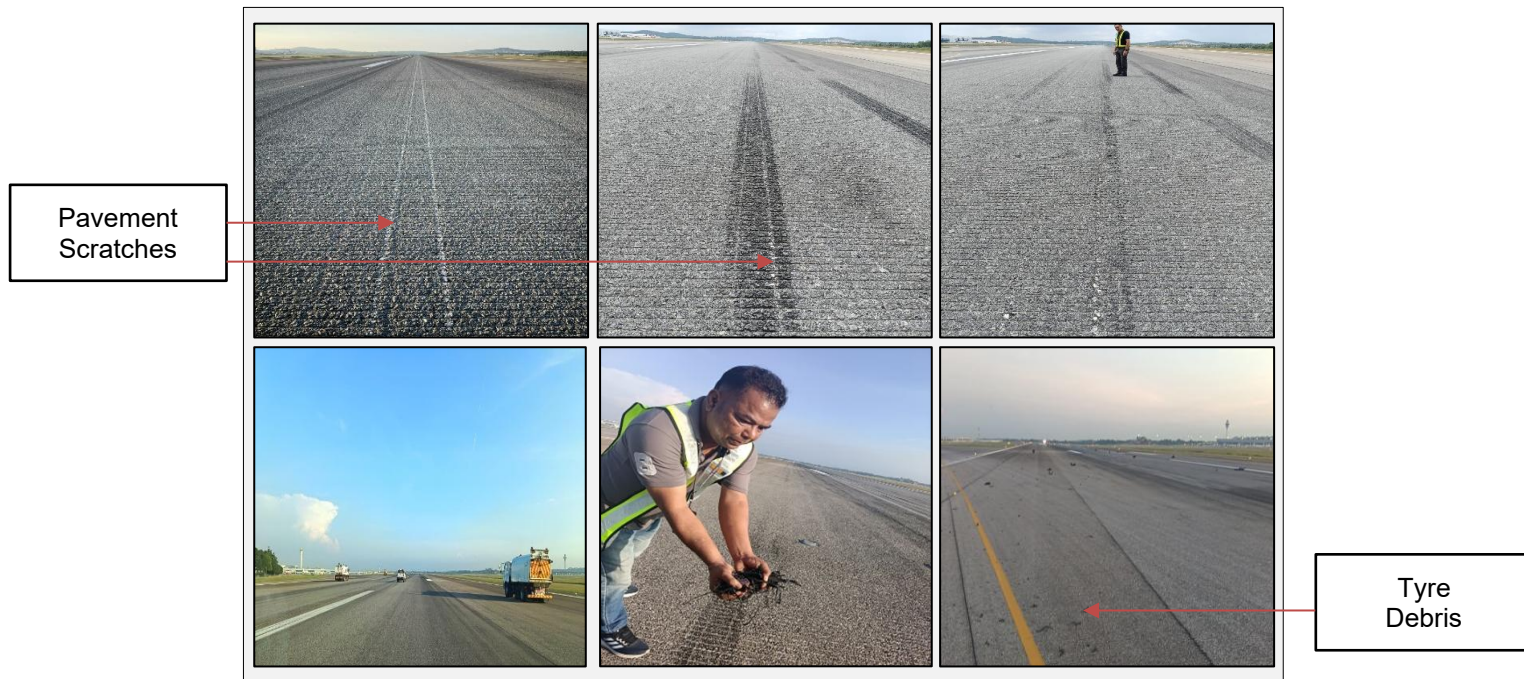
Subsequent examination of Runway 14R/32L at WMKK identified continuous scratch marks and pavement abrasion on the asphalt surface extending from Intersection P4 to Intersection C7 over an approximate distance of 2 km. The observed pavement scoring and abrasion were consistent with contact between the exposed wheel hub and the runway surface following tyre failure.

Figure 21: Pictures of Pavement Scratches and Tyre Debris Observed at WMKK

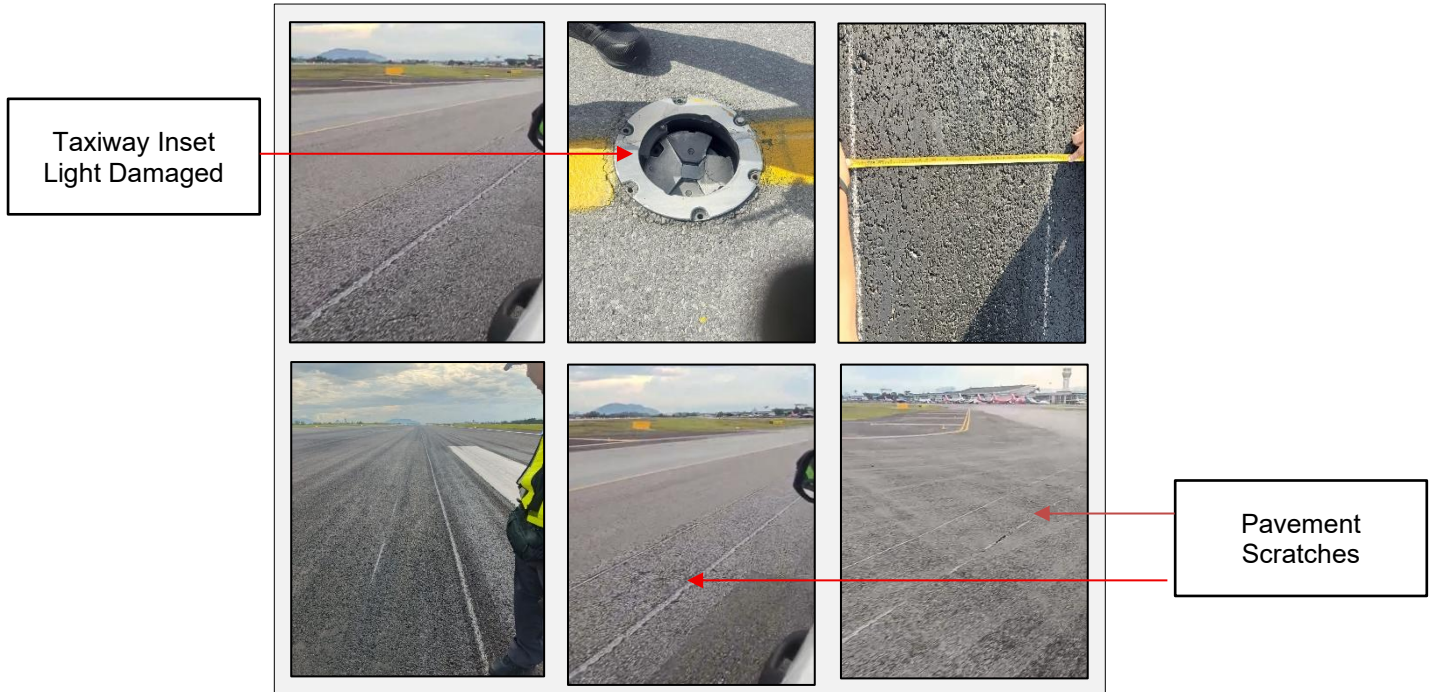
At WBGG, the initial scratch marks were identified approximately 750 ft from the runway marker and continued along the aircraft ground track after the aircraft vacated the runway via Taxiway A3. Continuous scratch marks were subsequently observed along the aircraft taxi route through Apron A3, Taxiway H, the Main Apron, Taxiways B, A, and L, extending to Parking Bay 10B. The occurrence also resulted in damage to three (3) taxiway inset lights located in the vicinity of Taxiway A3, as illustrated in Figure 22.

Figure 22: Pavement Scratches on Runway 25 and Damage to Taxiway Inset Lights at WBGG

**4.3.2** The aerodrome operator is recommended to inspect, repair or replace, and verify the serviceability of the damaged taxiway inset lights near Taxiway A3.
