# **AIRCRAFT SERIOUS INCIDENT PRELIMINARY REPORT**

**SI 09/26**

**Fixed Wing Aircraft Piper-28-181 Archer III, Registration 9M-SKC**

**On 3 August 2026**

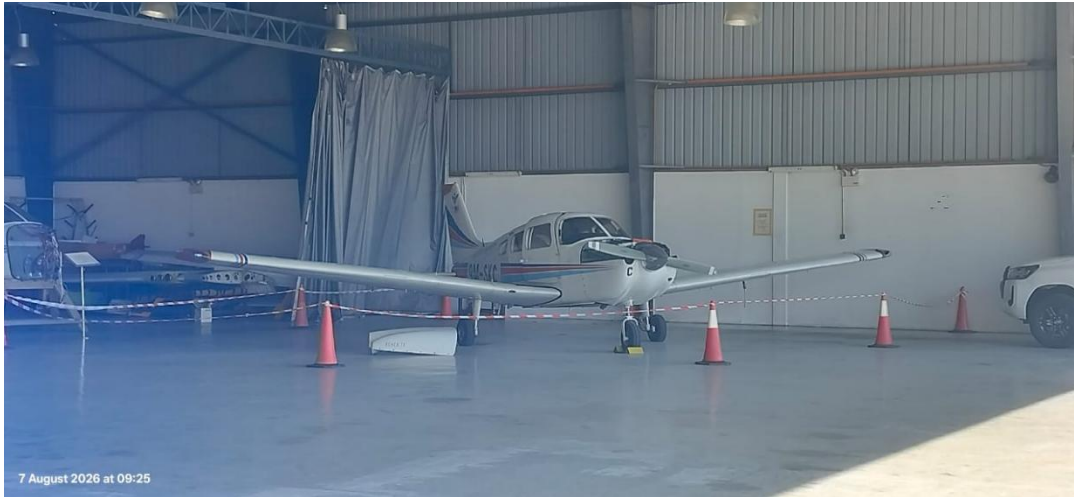
Figure 1 and Figure 2 show the condition of the aircraft and propeller blade tip condition. Impact point location unable to be determined.

Figure 1: Aircraft parked in the MFA hangar after declared unserviceable.

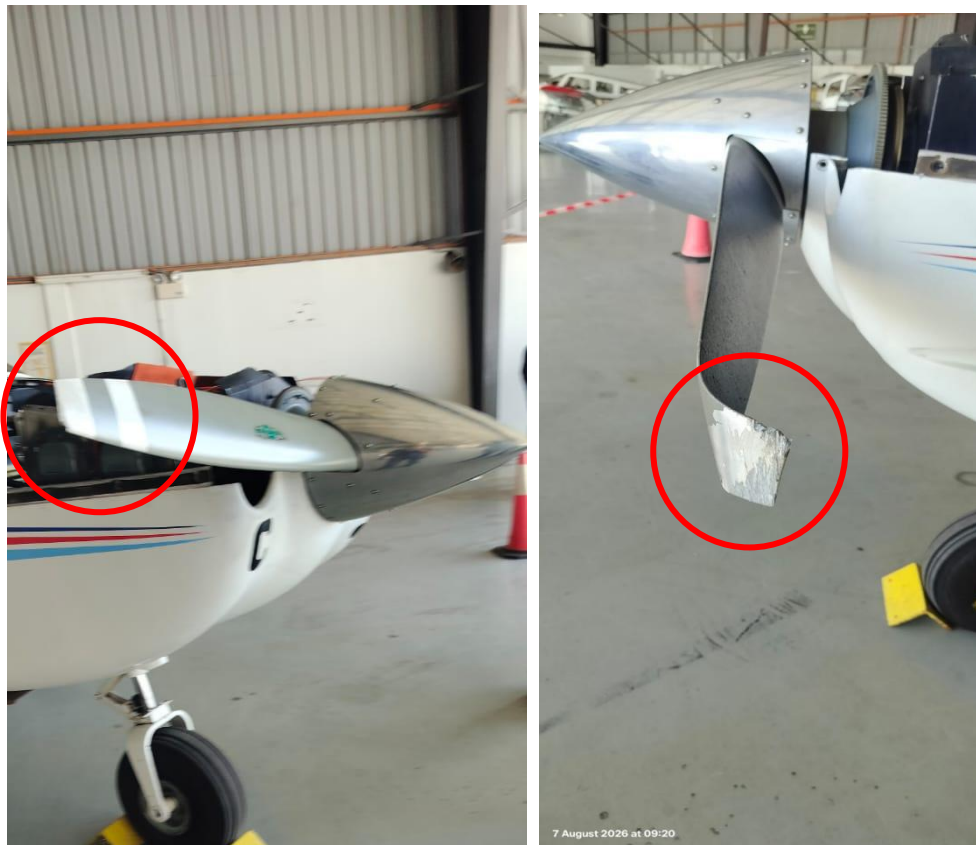
Preliminary observations indicate significant damage on the tip of the propeller. Noticeable scratch marks and bending are present on the propeller, as shown in Figures 1 and 2 in paragraph 1.12 - Wreckage and Impact Information. The aircraft dimensions are per Appendix A and the Initial Damage Assessment Report as per Appendix B.

Figure 2: Condition of propeller blade tips.

It was discovered that one propeller blade tip was bent inward while the opposite propeller blade tip was chipped. Preliminary analysis indicates that a momentary, light touch of a propeller blade against the ground is classified as a propeller strike. No additional defect has been identified until further inspection.
