## **AIRCRAFT SERIOUS INCIDENT PRELIMINARY REPORT**

**SI 10/26**

**Air Accident Investigation Bureau (AAIB)  
Ministry of Transport Malaysia**

**Fixed-Wing Boeing 737- 800NG,  
Registration PK-GFR, at Kuala Lumpur International Airport, Selangor  
on 15 August 2026**

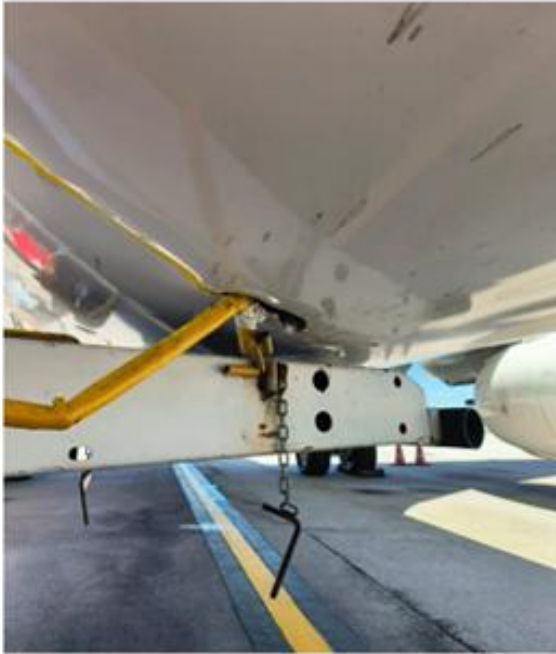
The aircraft sustained structural impact damage to the lower fuselage and the forward cargo hold undercarriage area following contact with the conveyor handrail of the belt loader.

**Belt loader conveyor handrail contacted  
A/C fuselage**

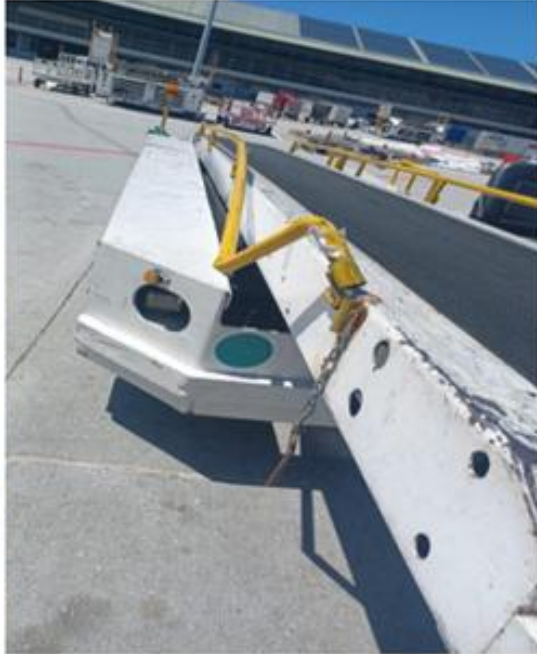
The POS Aviation belt loader NE904 sustained damage to its railing following contact with the aircraft. No damage to third-party airport infrastructure was reported or identified.

**Damage on the Belt loader conveyor handrail**

AAIB recommends that Pos Aviation Sdn Bhd conduct a comprehensive technical inspection of its belt-loader fleet and other relevant GSE to verify the mechanical integrity and serviceability of their braking systems, including service brakes and parking/emergency braking mechanisms. Particular attention should be given to identifying potential failure modes that could result in unintended movement of GSE during aircraft approach and positioning, and to ensuring that identified defects are rectified before the affected equipment is returned to airside service.

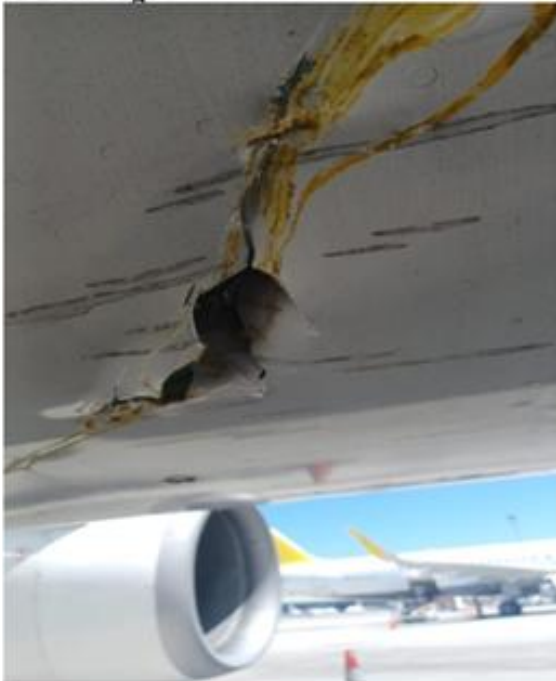
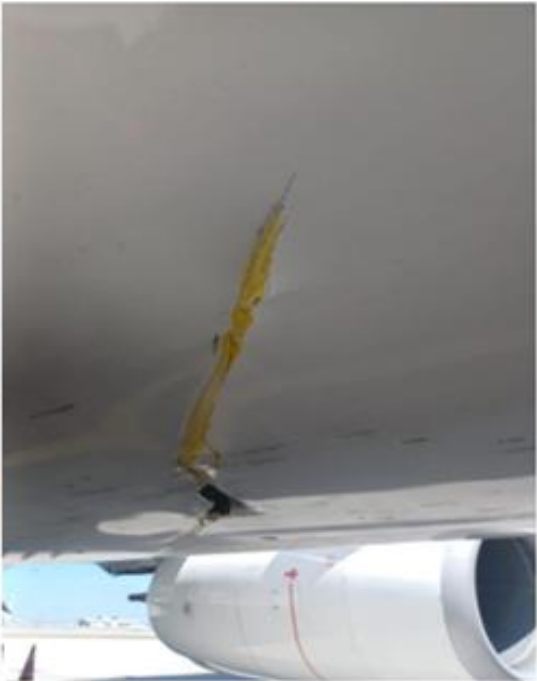
The observed damage included significant scratching and deformation of the lower fuselage skin, together with a puncture/perforation resulting in a hole in the fuselage skin.

**Damage on the lower sector of the a/c fuselage**

Following the occurrence, the aircraft was declared **Aircraft on Ground (AOG)** by D'viation Engineering pending further structural assessment, determination of the extent of damage, and completion of the required repairs and certification for return to service.
