**AIRCRAFT ACCIDENT  
FINAL REPORT  
A 07/18**

**Accident involving Rotorcraft Helicopter Robinson R66  
Registration 9M-RML  
at Sultan Abdul Aziz Shah Airport,  
Subang, Kuala Lumpur  
on the 15<sup>th</sup> August 2018**

**ACCIDENT REPORT NO. : A 07/18**

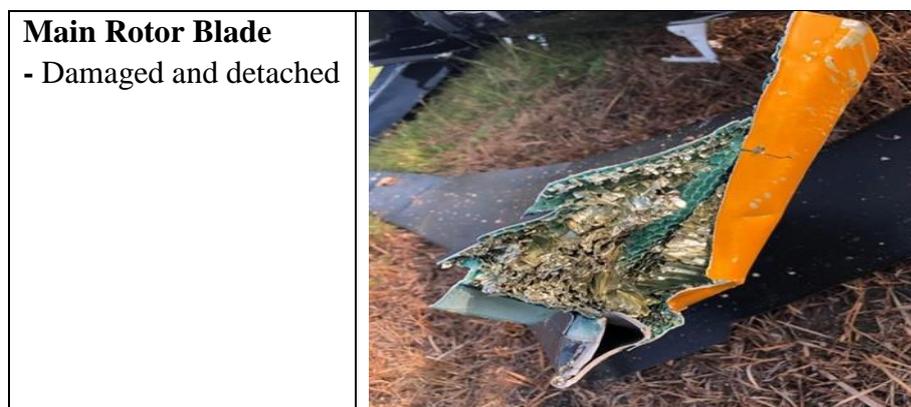
**Figure 1:** Main Rotor Blade

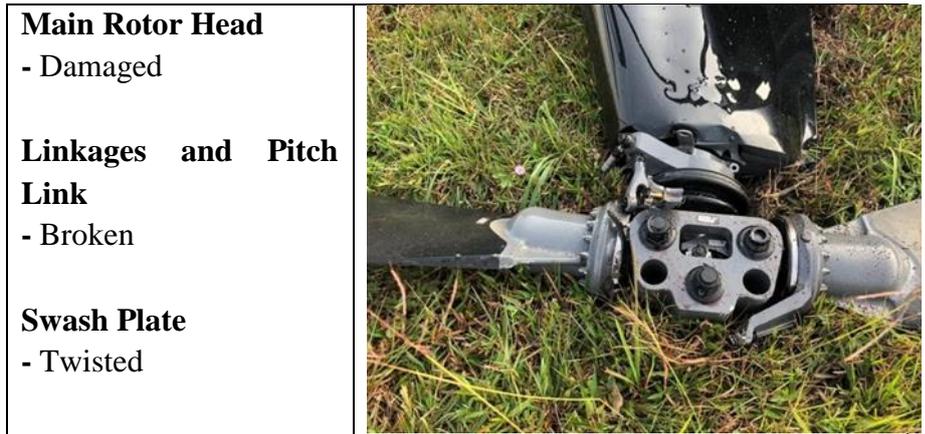
**Figure 2:** Main Rotor Head, linkages and pitch links and swash plate

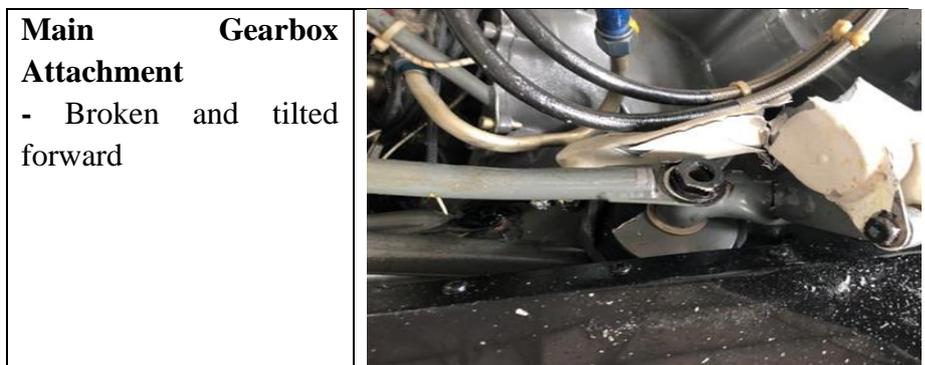
**Figure 3:** Main Gearbox Attachment

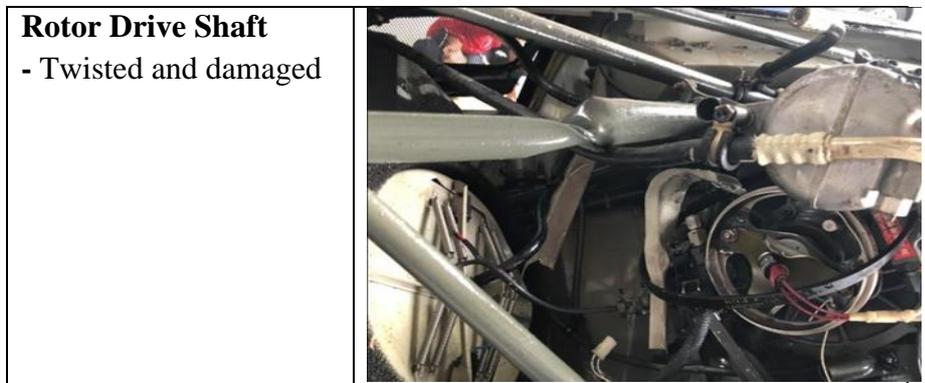
**Figure 4:** Rotor Drive Shaft

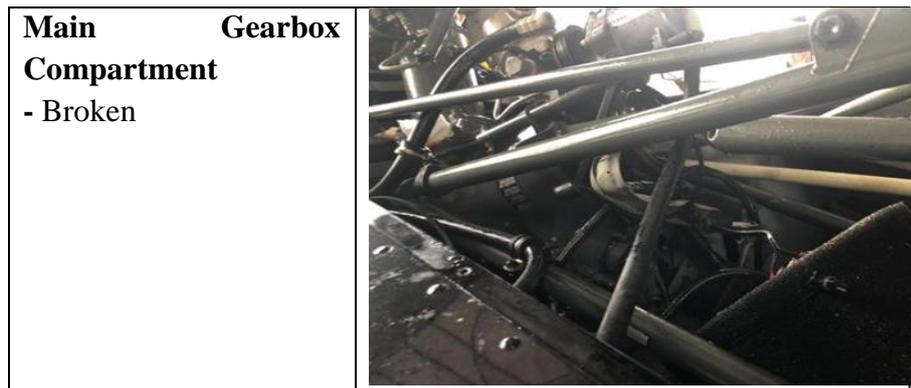
**Figure 5:** Main Gearbox Compartment

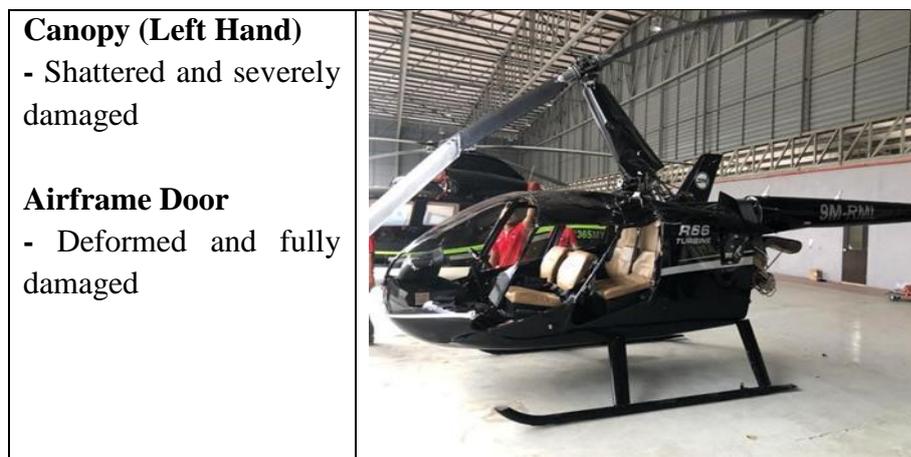
**Figure 6:** Canopy and airframe door

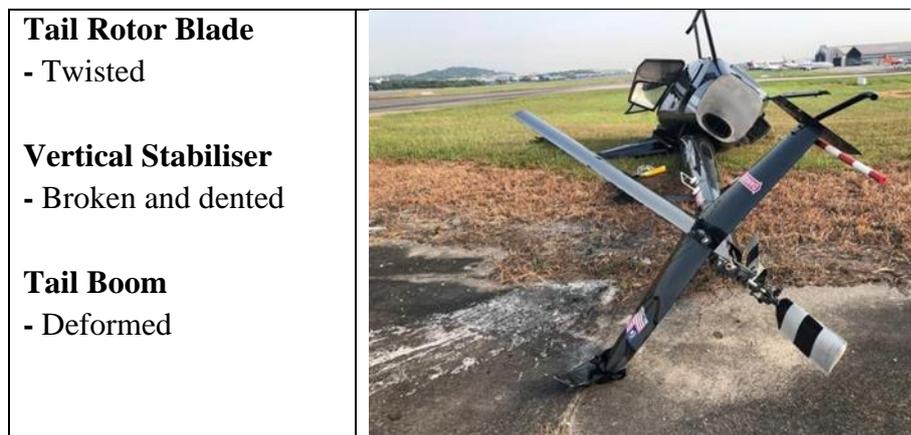
**Figure 7:** Tail rotor blade, vertical stabiliser and tail boom

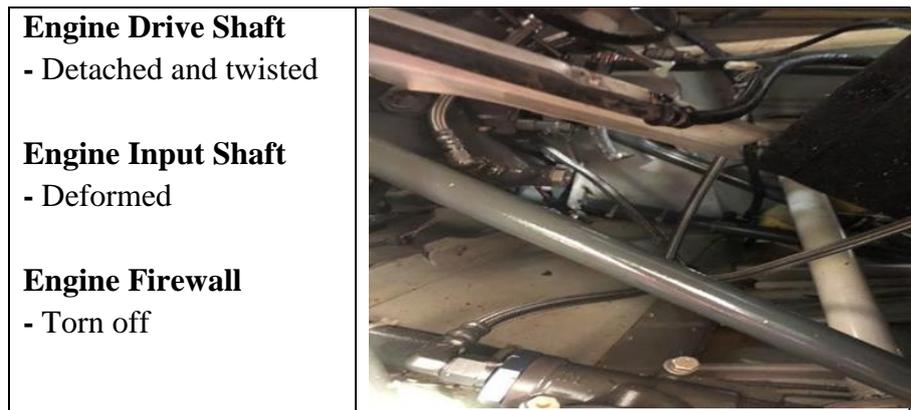
**Figure 8:** Engine drive shaft, engine input shaft and engine firewall

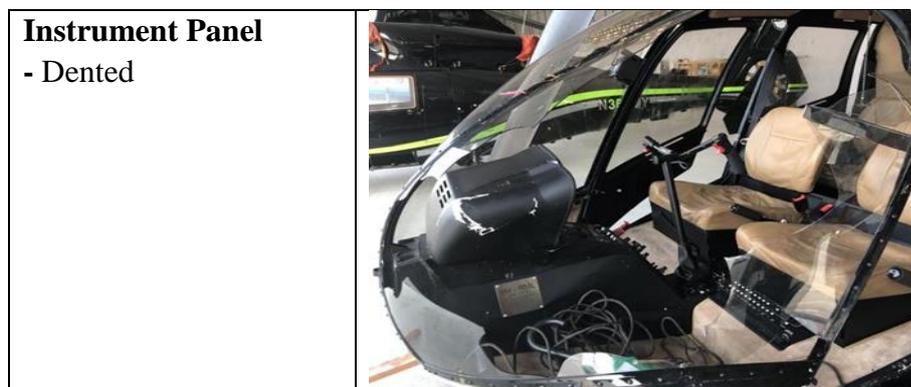
**Figure 9:** Instrument panel

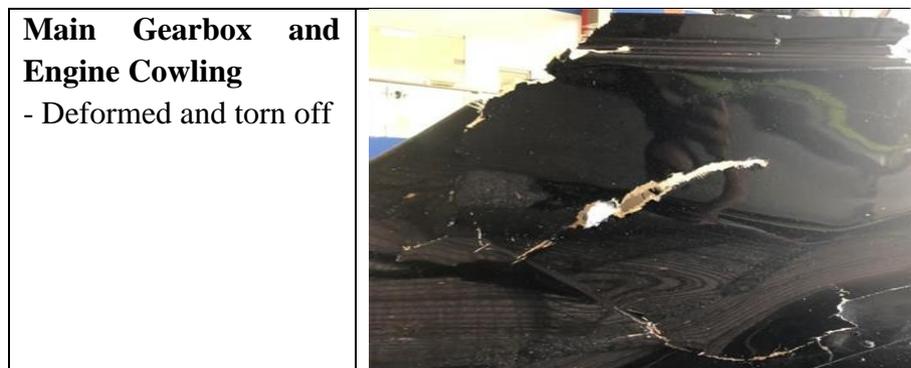
**Figure 10:** Main gearbox and engine cowling

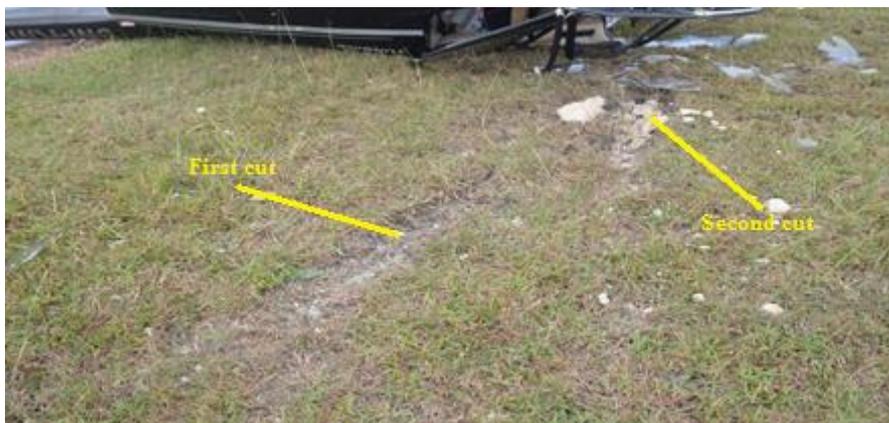
The quick reaction of the PIC causing excessive movement of the cyclic to the left subsequently tilt the main rotor blades downwards on the upslope area. Upon inspection of the area, there were two strike marks (Figure 11) found on the ground indicating the blade tips had struck the ground at high speed.

Figure 11: Damage to the ground area due to the blade strike

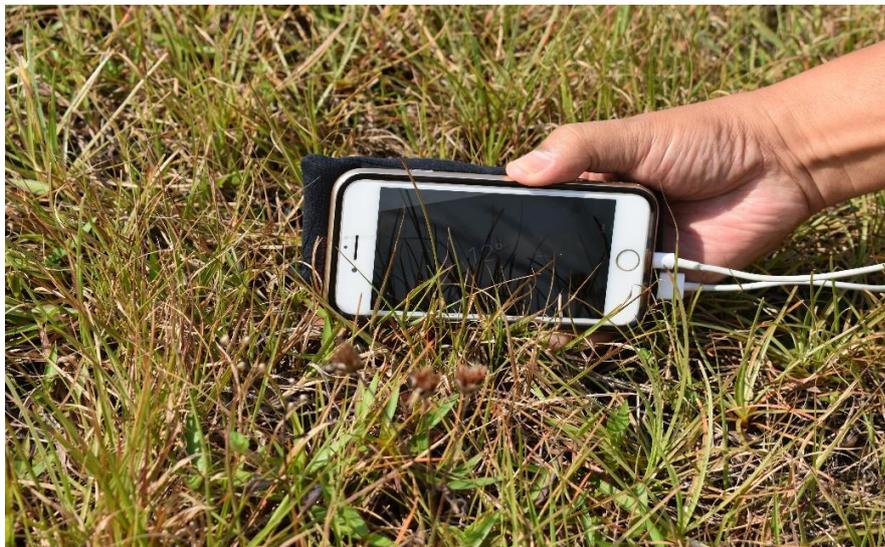
**Figure 13:** The measurement showing the angle of the slope ( $12^\circ$ )

It should also be emphasized here that the maximum recommended rate of angle for sloping ground exercise is  $5^\circ$ , while the actual angle of slope for the surface used during the occurrence is approximately from  $8^\circ$  to  $12^\circ$  which is on the high side. However, the angle of the slope couldn't be accurately determined by the pilot while flying the helicopter during hover.

3.1.8 The approximate angle of the slope area for the sloping ground exercise is from 8° to 12°, whereby the maximum recommended angle for sloping exercise is 5°.

4.2 The airport operator (MAHB) is to designate a suitable place for helicopter sloping ground exercise and a hovering area for precision flying preferably a slope of 5 degree with a trimmed grass.
