AIRCRAFT ACCIDENT REPORT SI 05/15

**Air Accident Investigation Bureau
Ministry of Transport, Malaysia**

**Final Report on the Serious Incident involving
Fixed wing aircraft ATR72-600 Registration 9M-LMG
in Penang, Malaysia on 28th May 2015**

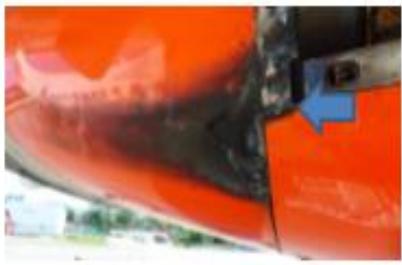
A photograph showing a close-up of an orange aircraft component. A blue arrow points to a dark, irregular mark on the surface, which is identified as a burn mark.	Burn mark observed on the aft cowling and panel on the underwing box. (LH View)

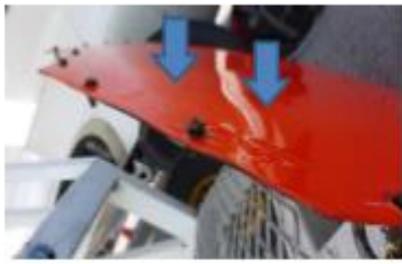
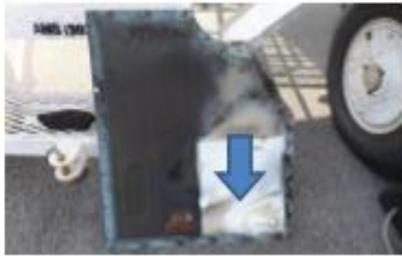
Two photographs showing damage to a red aircraft cowling. The top photo shows two blue arrows pointing to areas where the red surface has delaminated. The bottom photo shows a blue arrow pointing to a white, charred area on the inner pane, indicating overheating.	The rear RH cowling was delaminated. Observed sign of overheating on the inner pane.

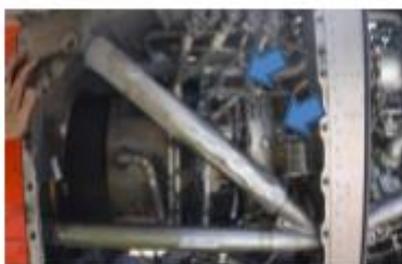
A photograph of an engine compartment. A blue arrow points to a dark mark on a metal component, identified as a sign of a burn mark on the engine harness near fuel nozzle adapters #3 and #4.	Sign of burn mark on the engine harness near the fuel nozzle adapter #3 and #4.

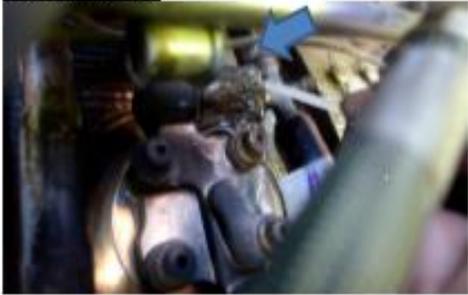
Photo	Description
<p>Fuel Nozzle No. 3</p>

<p><u>Step 1:</u> Nitrogen leak check at 150 psi and Snoop leak detector applied.</p> <p><u>Result:</u> All fuel nozzle connections (except fuel nozzle no. 3) to the primary and secondary fuel manifolds were verified and no bubbles were observed.</p> <p>Fuel nozzle no. 3 found with bubble leak at secondary manifold.</p>
<p>Fuel Nozzle No. 3</p>

1. Fuel nozzle no. 3 found with leak during nitrogen leak check. Further inspection found with B-nut cracked and subsequently sheared during torque check.
2. Fuel nozzle no. 4 found with loose B-nut. During nitrogen leak check, no bubbles were observed.

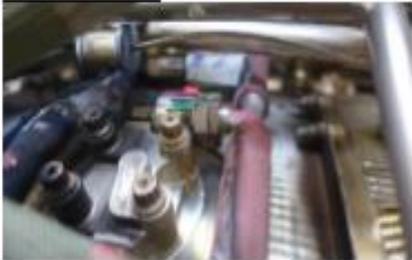
<p><u>Step 2:</u> Torque check using torque wrench PWC45200</p> <p><u>Result:</u> Found the B-nut able to turn more than 120 degree without much resistance. B-Nut was sheared.</p>
<p>Fuel Nozzle No. 3</p>

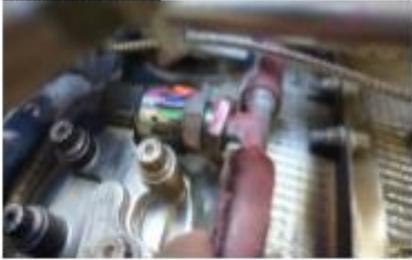
<p>B-nut completely sheared.</p>
<p>Fuel Nozzle No. 3</p>

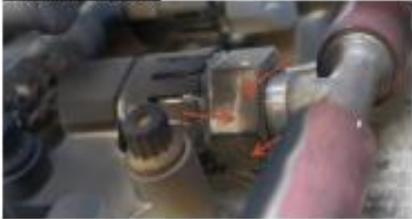
<p><u>Step 3:</u> Review of <u>previous</u> photo prior to torque check.</p> <p><u>Result:</u> Found the B-Nut was already cracked.</p>

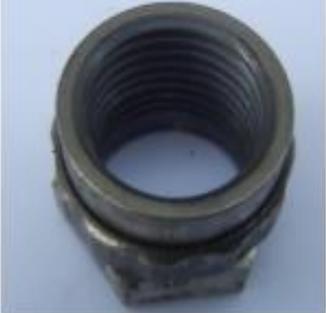
Photo	Description
<p data-bbox="370 566 810 589"><u>Secondary manifold connected to fuel nozzle no. 3</u></p>

<p data-bbox="880 589 1257 678">Secondary manifold attached to fuel nozzle no. 3, shown with B-nut sheared. Photo taken, after secondary manifold was removed at 02-June-15.</p>
<p data-bbox="370 947 810 969"><u>Secondary manifold connected to fuel nozzle no. 3</u></p>

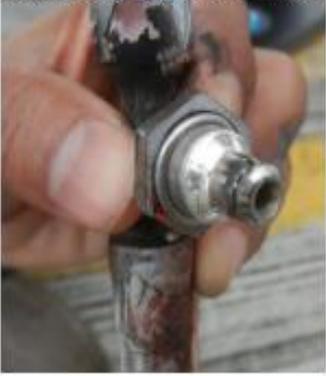
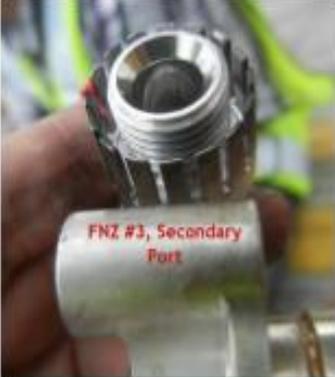
<p data-bbox="880 1406 1121 1429">Inspect fuel nozzle #3 threads.</p> <p data-bbox="880 1451 1034 1496"><u>Result:</u> Threads are clean.</p>

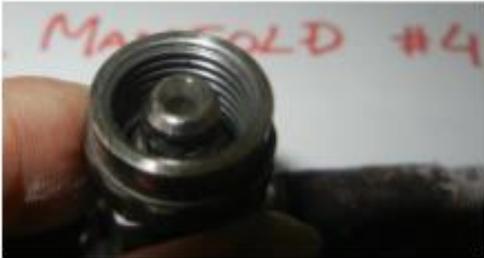
<p>Inspect fuel nozzle no. 4 thread and secondary manifold B-nut thread connected to fuel nozzle no. 4</p> <p><u>Result:</u> Found black substance in the thread area of the flex manifold B-nut</p>

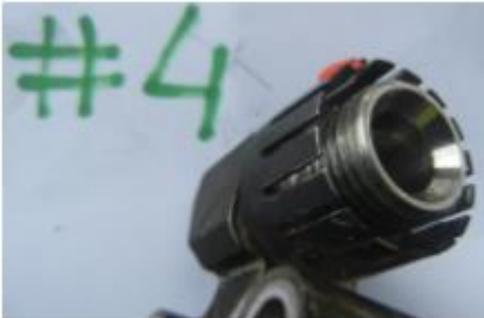
<p><u>Result:</u> Found black substance in the thread area of the fuel nozzle no. 4</p>
	<p>With using torque wrench dial-indicator type, check break-away torque at B-nuts connection in loosening direction.</p> <p><u>Result:</u> The result varies from 180 lb. Inch to 220 lb. inch. None of fuel nozzles were over torqued.</p>

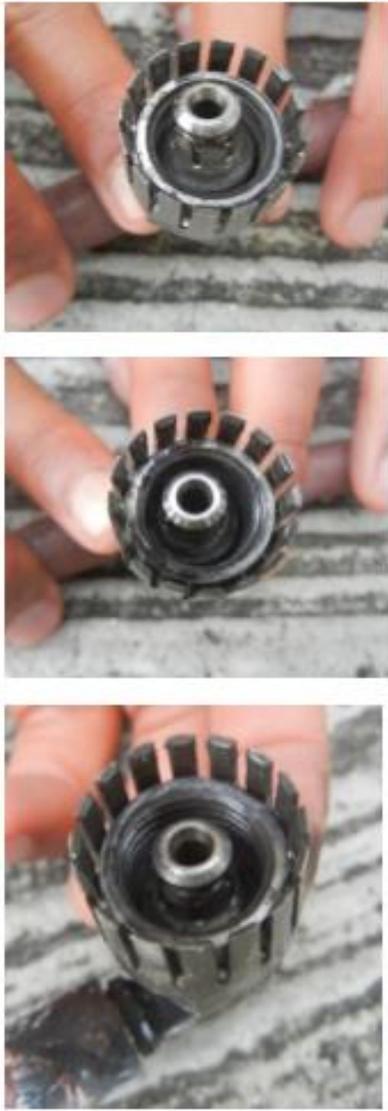
<p>Inspect B-nuts threads at fuel manifolds for anti-seize presence.</p> <p><u>Result:</u> Found residual of black substance alike at the thread area.</p>

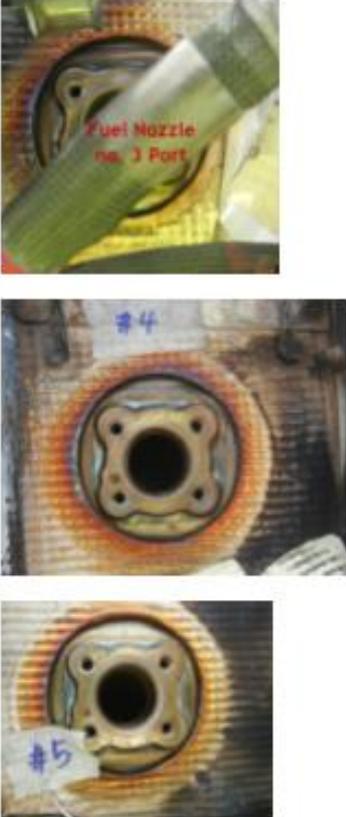
<p>Fuel nozzle #3, #4, and #5 ports.</p>

<p>Inspect conical gaskets.</p> <p><u>Result:</u> Found conical gasket at manifold #14 with tangs bent. The rest of conical gaskets are good, including conical gasket connected at fuel nozzle #3.</p>

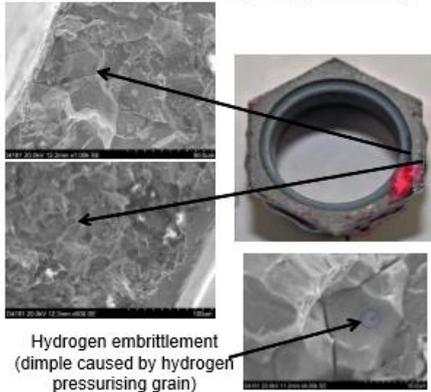
Malindo ED0673 (Engine Fire)

Hydrogen embrittlement (dimple caused by hydrogen pressurising grain)

Magnified view of the brittle intergranular fracture

Reddish corrosion products Suggesting a crack was present for some time in service

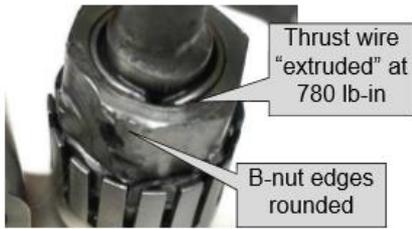
TORQUE TEST – PERFORMED AT P&WC

Tests performed to validate design margin
 B-nut inspected per FPI. No crack found
 EMM torque limit: 250-270 lb-in

Unable to replicate observed failure mechanism, overtorque ruled out

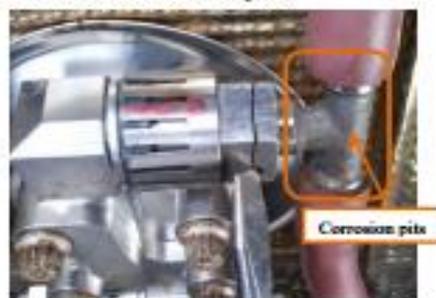
Figure 1 : Cracked B-nut

P&WC investigated two cases of flexible manifold B-nut reported cracked (Ref. Figure 1). Both cases were reported by the same operator group and the review of the material confirmed hydrogen embrittlement.

Hydrogen embrittlement occurs when hydrogen diffuses into the metal. It changes the material properties and the exposed metal becomes brittle. In the case of the flexible manifold, the B-nut may become susceptible to cracking in service, thus potentially causing an external fuel leak. The fractured surfaces analyzed by P&WC show no signs of a crack propagating by fatigue and suggests a sudden fracture mechanism.

P&WC would like to remind all customers of the importance to use the products recommended in the Engine Maintenance Manual "EMM" (Ref. 72-01-40, FUEL SYSTEM) for fuel nozzles and fuel manifolds removal, installation and cleaning. P&WC also confirms that all products approved by P&WC and listed in the EMM will not cause Hydrogen Embrittlement.

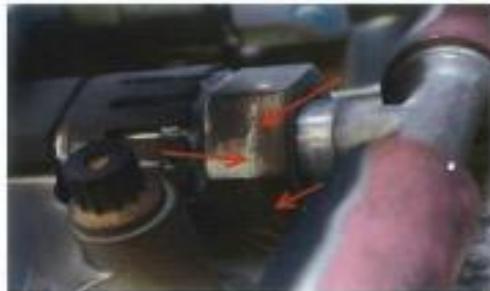
1.4 PW127M B-nut is made from stainless steel (17-4PH – hardened to H1075) which is in intermediate range of susceptibility. With the presence of acidic product onto the material whilst it is under tensile stress (torque) has created a condition susceptible for hydrogen embrittlement (**refer appendix**). With sufficient time for the hydrogen to react with the material, the material than become brittle thus causing it to crack/break.

Image above shows one of the findings of B-nut crack.

4.3 It is recommended that the engineer in-charge to perform a detailed inspection of the manifold hoses B-nut to ensure no early sign of corrosion is observed.

4.4 It is recommended that manifold with sign of corrosion shall be quarantined and reported to quality Assurance for further investigation.

4.5 It is recommended that the Licensed Engineer shall ensure that only approved solvent/materials listed in Maintenance Manual are to be used throughout the maintenance process.

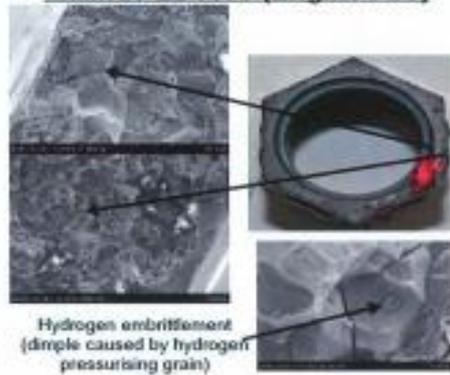
Malindo ED0673 (Engine Fire)

Image above shows magnified view of brittle intergranular fracture confirming on Hydrogen embrittlement.
