## AIRCRAFT ACCIDENT PRELIMINARY REPORT

A 06/20

Accident Involving Two Guimbal Cabri G2

Registration 9M-HCA & 9M-HCB

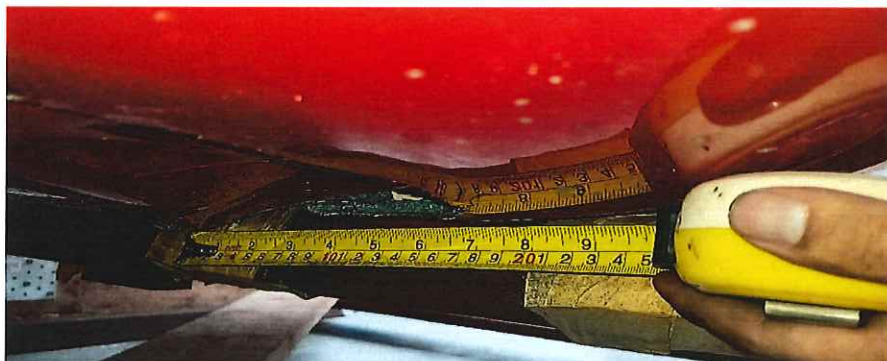
*Picture 1 shows the crack on the Right-hand side of lower fuselage looking from aft of the aircraft.  
Measurement of the crack spanwise is at 7 inches.*

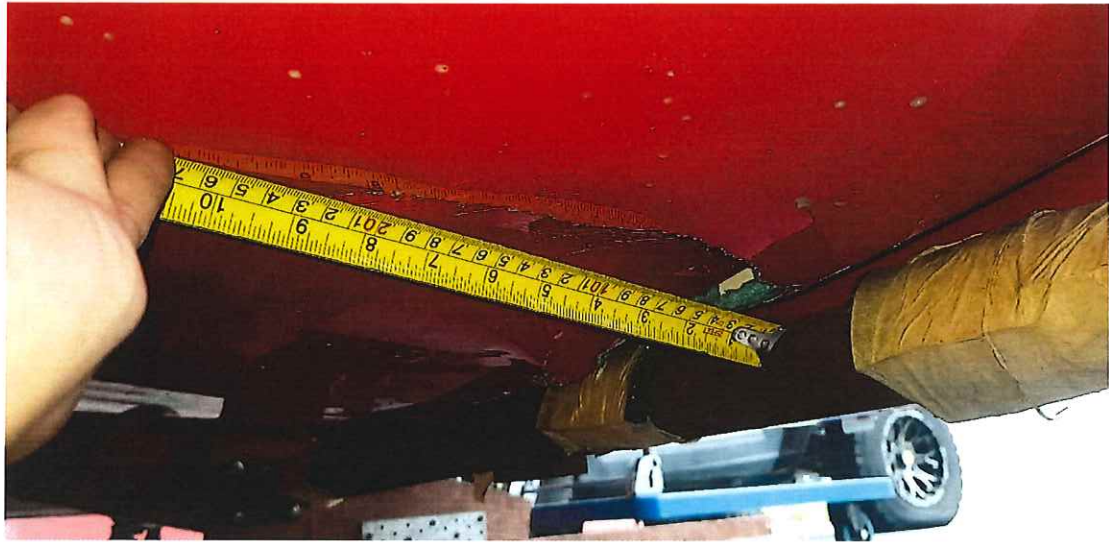
*Picture 2 shows the measurement of the crack along the fuselage is at 8.7 inches.*

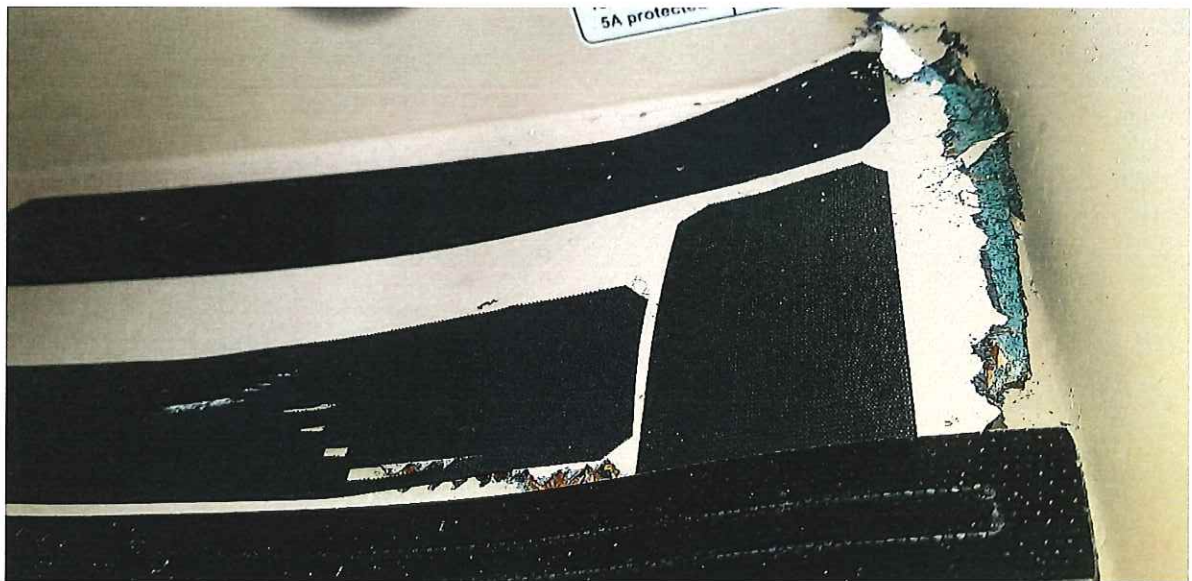
*Picture 3 show the extensive damage of the crack, view inside of the cabin on the Pilot side (Left-hand seat).*

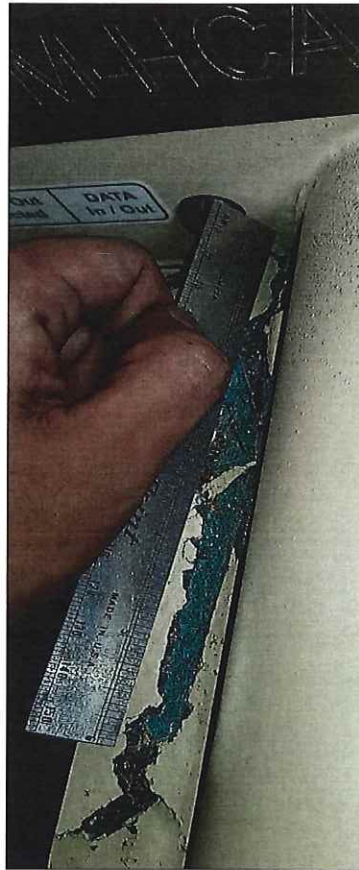
*Picture 4 shows the measurement of the crack view from inside of the cabin is measured more than 6 inches.  
(Measurement taken show 7 inches).*

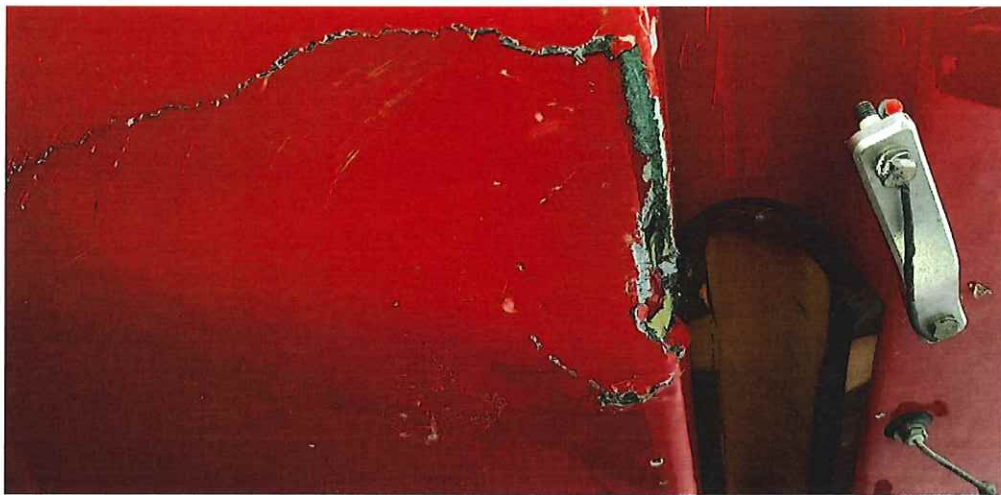
*Picture 5 shows the damage on the lower fuselage structure (top view).  
The bent ATC transponder antenna could be seen on the lower left side of the picture.*

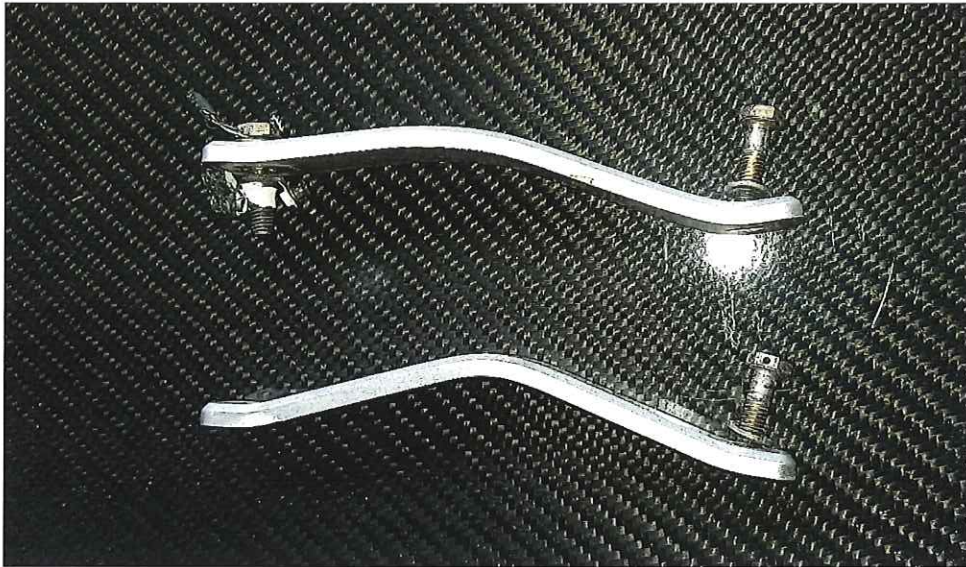
*Picture 6 shows the two-damaged front cross tube attachment bars of the aircraft.*

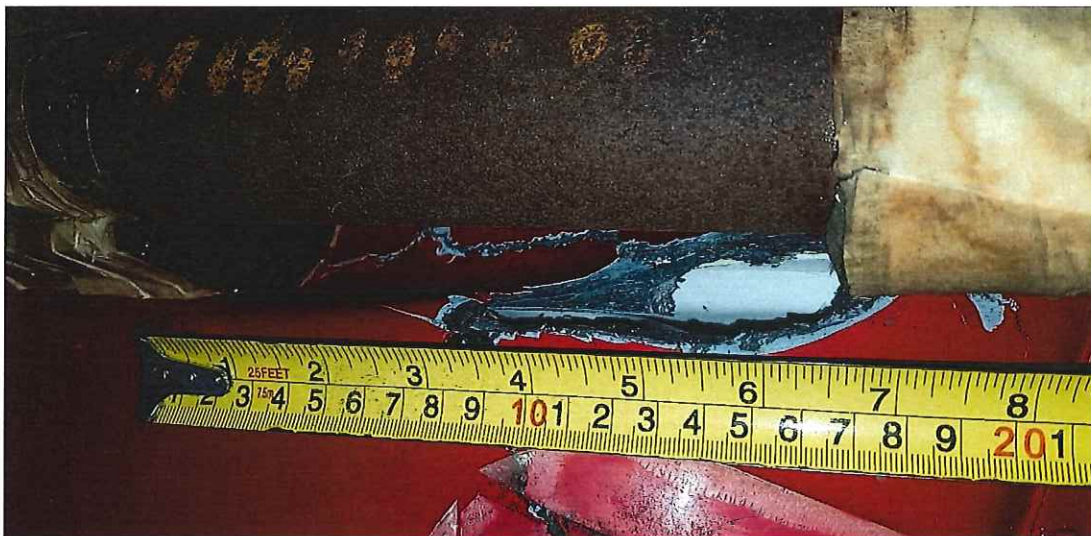
*Picture 7 shows the aft left-hand lower fuselage punctured found during inspection. The hole is measured roughly at 4 inches spanwise. Length including the crack spanwise is roughly at 8 inches.*

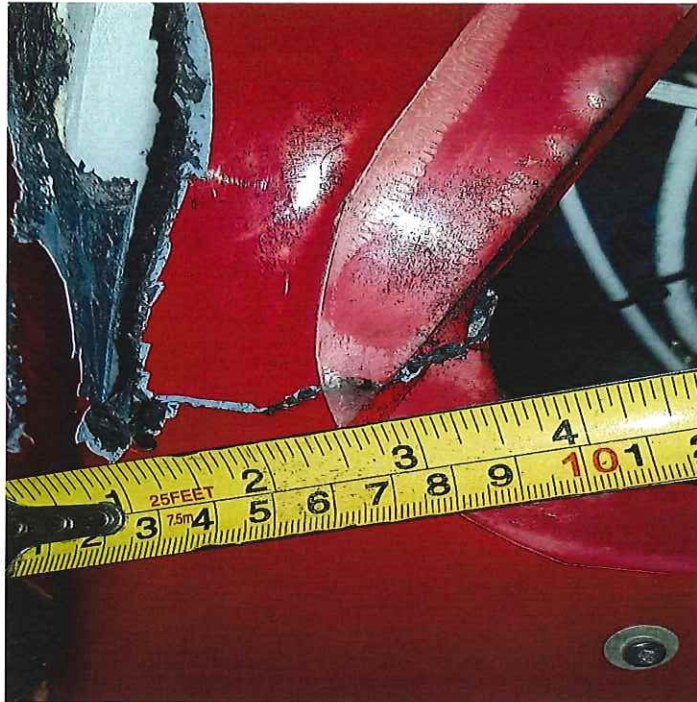
*Picture 8 shows crack on the fuselage adjacent to the punctured area. Measurement of the crack is roughly 3.5 inches. View is taken from the left-side of the fuselage. (Near to left engine cowl door latch).*

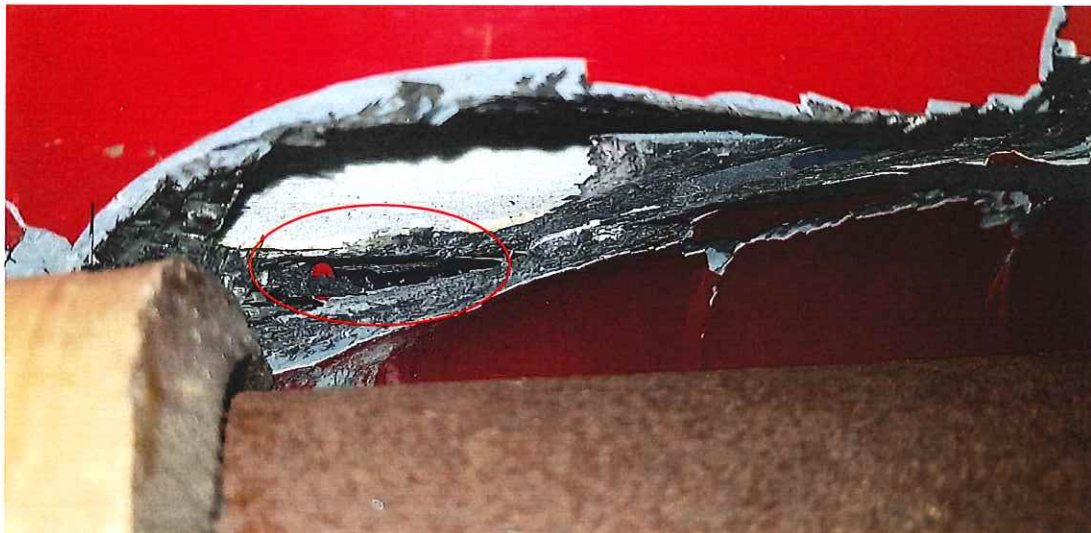
*Picture 9 shows the view from aft to forward of the aircraft. The circle shown the area where the fuel bladder cell is slightly visible from the outside.*

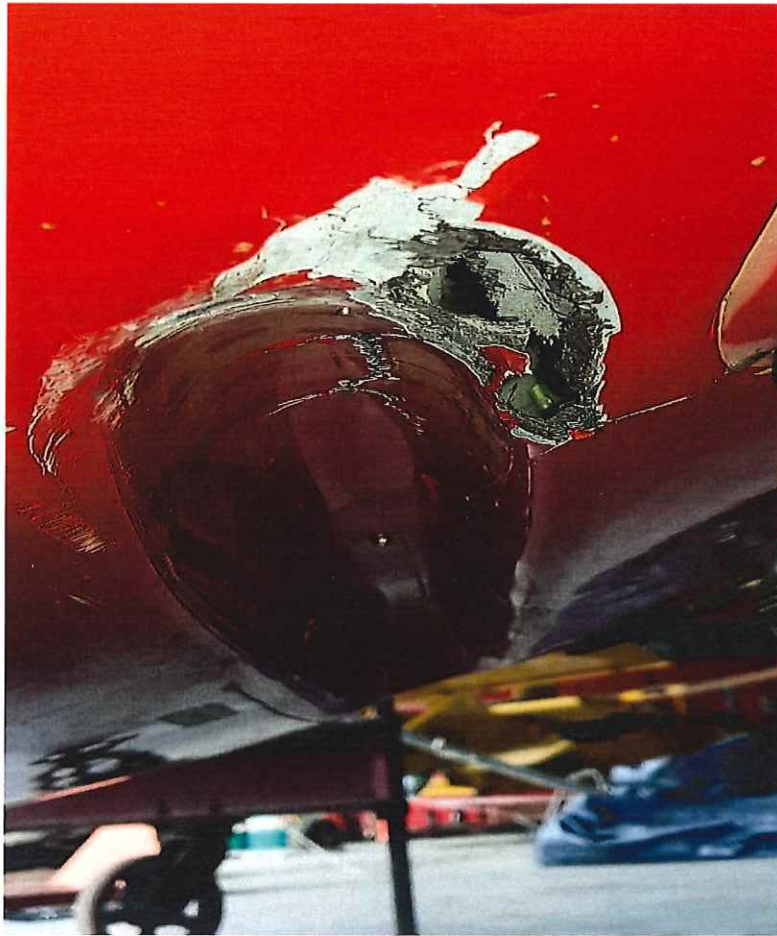
*Picture 10 shows the hole from the left-hand side of the fuselage body adjacent to the skid attachment.*

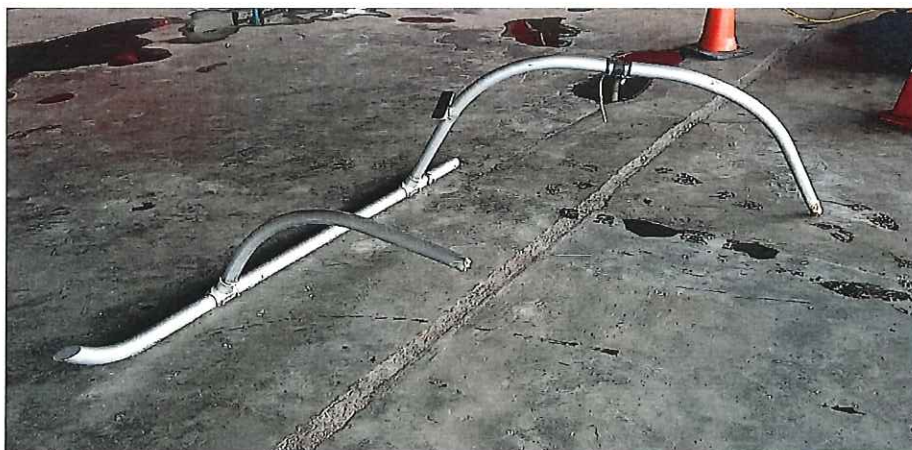
*Picture 11 shows the condition of the aircraft skid after the incident (the left-hand skid missing)*

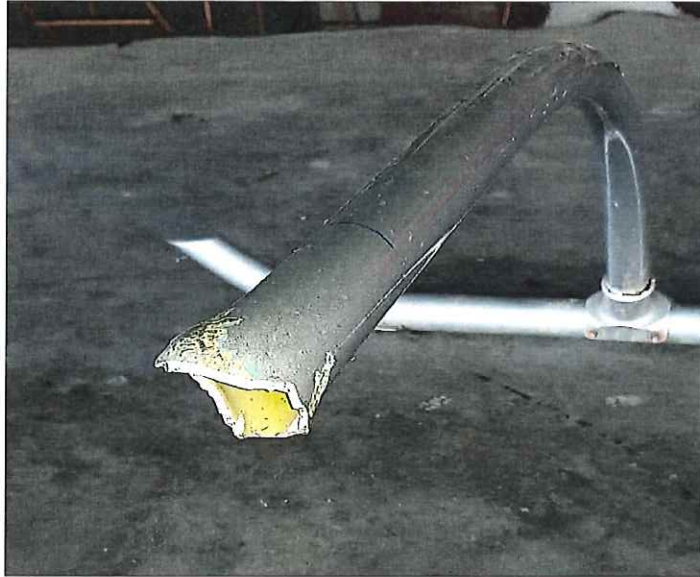
*Picture 12 shows the damage on the Left-hand side forward cross tube on the landing gear.*

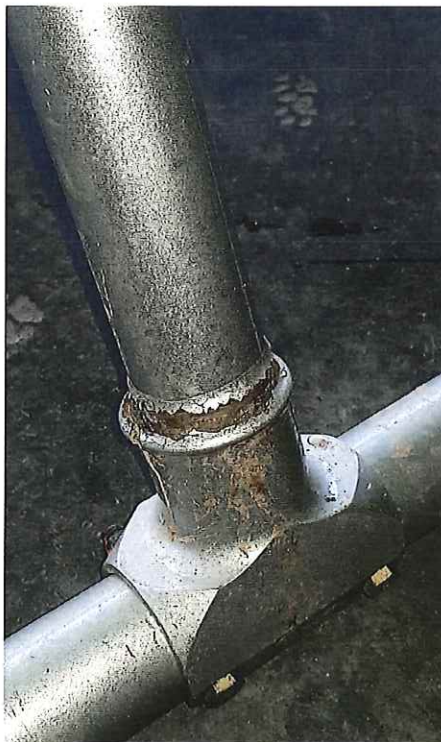
*Picture 13 shows the damage on the right-hand side of the forward cross tube attachment to the right-hand skid.*

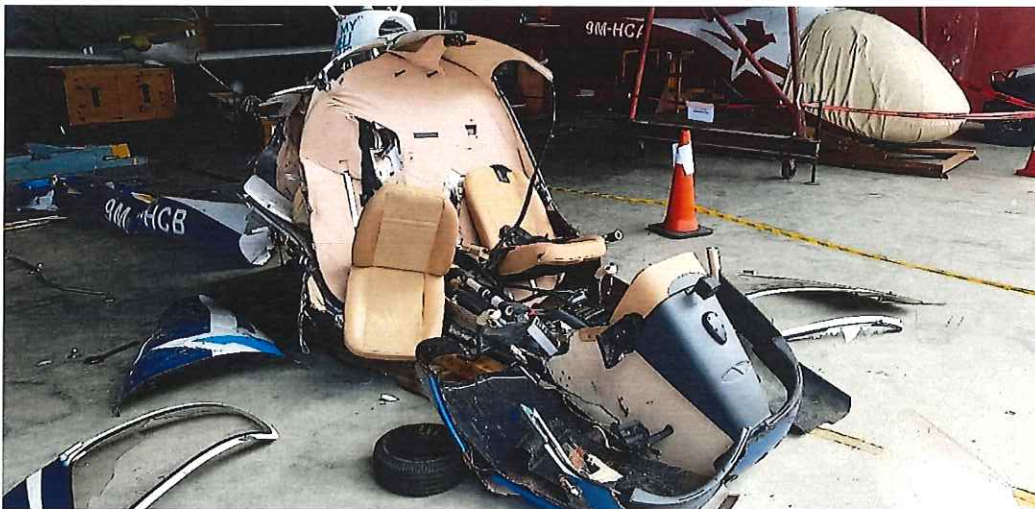
*Picture 1 shows the extensive damage of the front section of the fuselage. The windscreen and the doors of the aircraft were found detach at the crash site.*

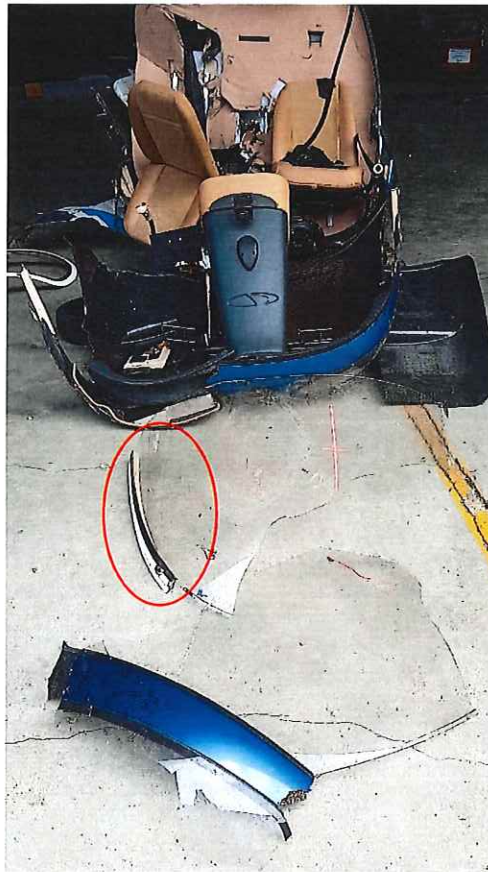
*Picture 2 shows the portions of the windscreen and the forward left-hand side of the fuselage. Shown in the circle are the forward right-hand member of the front portion of the fuselage.*

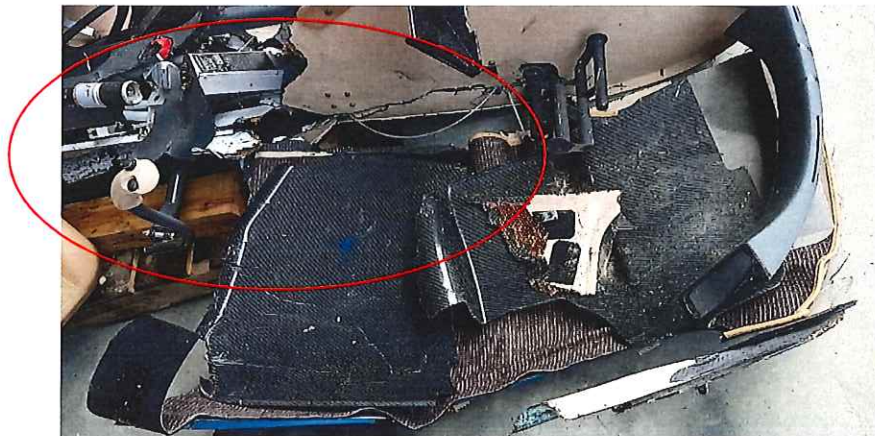
*Picture 3 shows the right-hand side of the fuselage. The circle shown in the picture shows the substantial damaged to the airframe structure.*

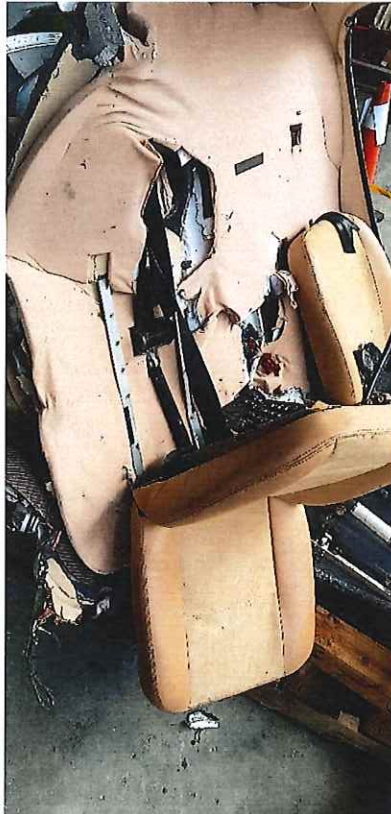
*Picture 4 shows the pilot seat are mostly detach from the rails on the wall of the cabin. Can be seen in the picture also most of the right-hand side of the lower fuselage are destroyed due to the crash.*

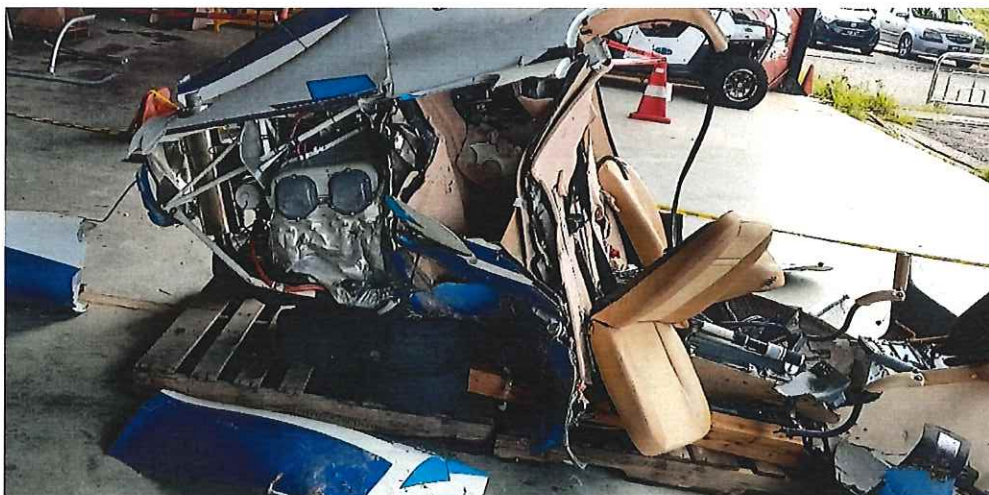
*Picture 5 shows the right-hand side of the of aircraft fuselage. Most of the sections were destroyed due to the crash. Shown in the picture the right-hand engine cowling.*

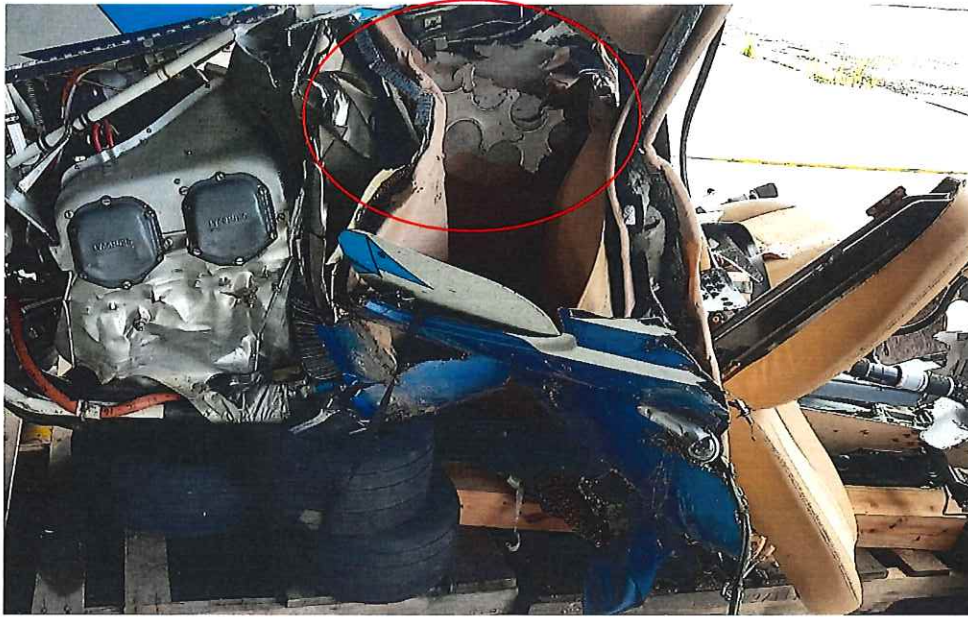
*Picture 6 shows the right-hand side of the aircraft fuselage. The circle shown in the picture shows the damage luggage compartment of the aircraft. Some portion of the main gearbox could be seen also in this picture.*

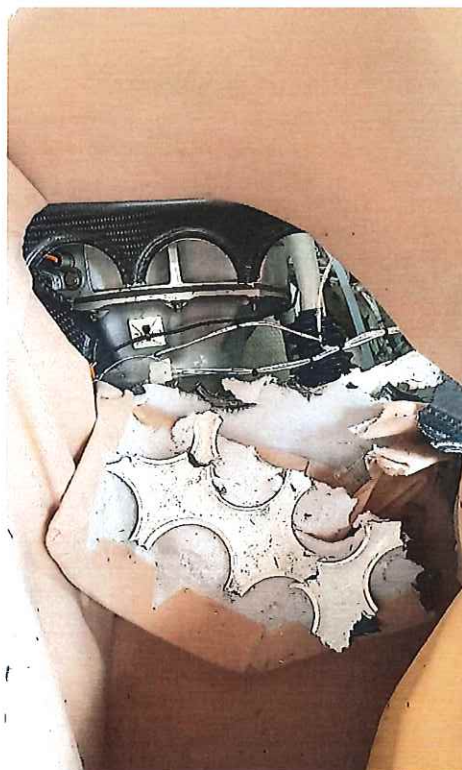
*Picture 7 shows the broken wall section of luggage compartment. Can be seen in this picture the main gear box of the aircraft.*

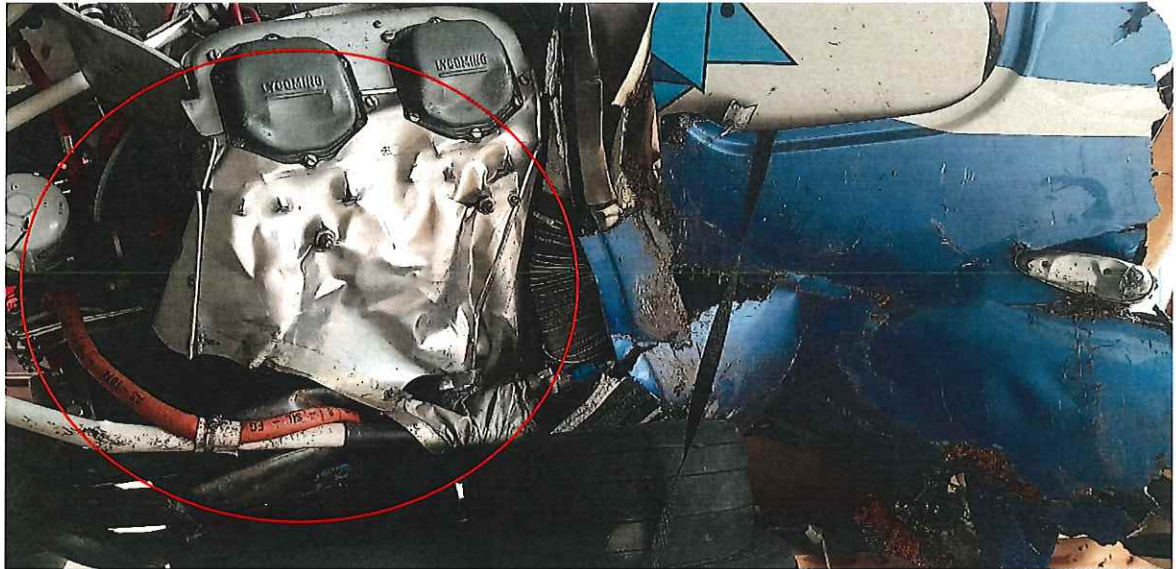
*Picture 8 shows the right-hand side of the engine. Shown in the circle in this picture are the damaged lower engine baffled and the bent left-hand engine truss.*

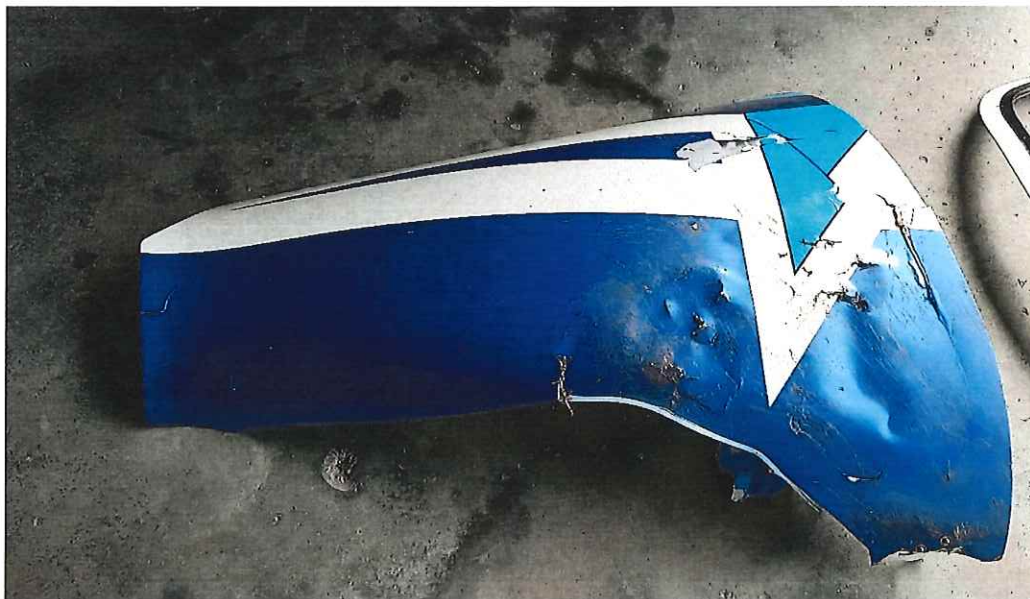
*Picture 9 shows damaged right-hand side of the engine cowling.*

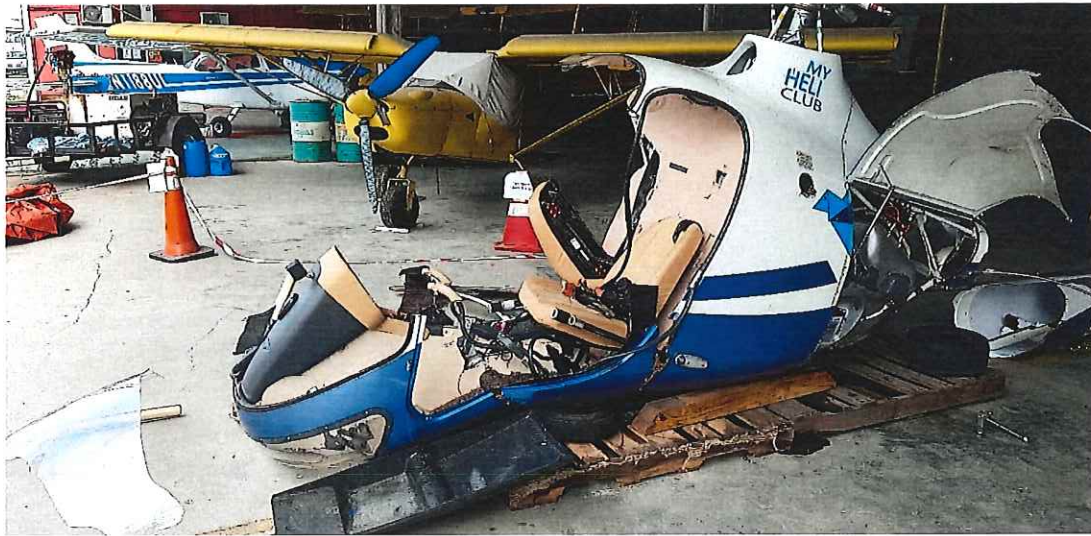
Picture 10 shows the left-hand side of the aircraft fuselage. In comparison to the left side, most of the structural parts of the aircraft are still attached. Can be seen in this picture, the co-pilot seat is still attached to wall of the cabin.

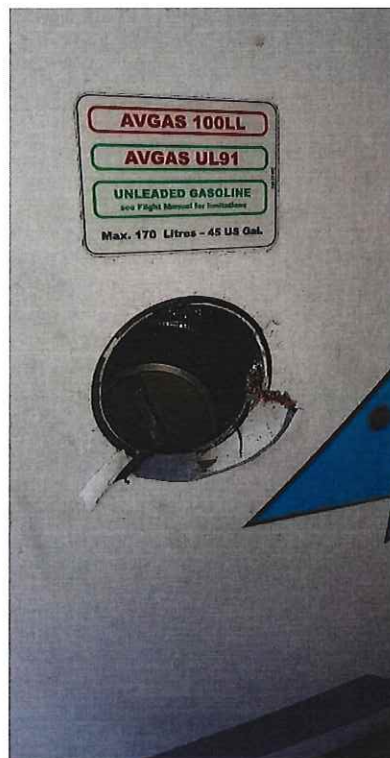
Picture 11 shows the left side of the aircraft where the fuel bladder is position. Can be seen the fuel cap is still attached to the fuel bladder and has move inwards into the fuselage. The fuel bladder is still intact, and no leak was found.

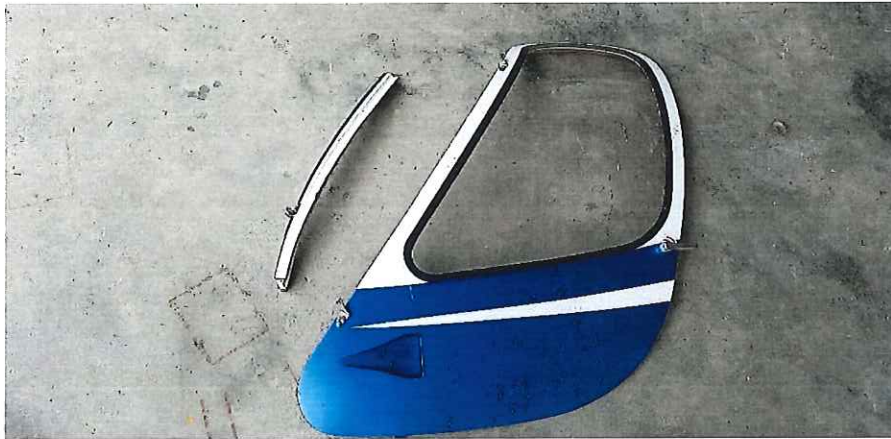
*Picture 12 shows the left-hand side door with the left-hand side of the front member of the forward fuselage. These parts were found detached from the aircraft and were recovered at the crash site.*

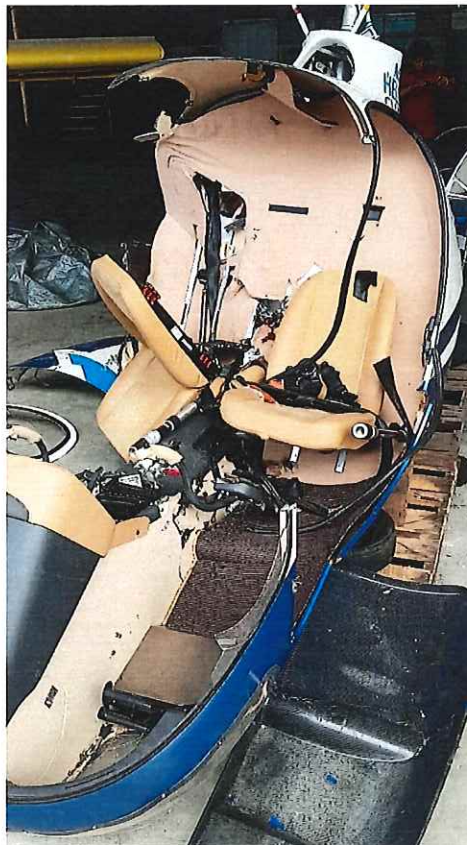
*Picture 13 shows the front portion of the left-hand side of the aircraft. Can be seen in this picture the damaged center pedestal and detached pilot seat.*

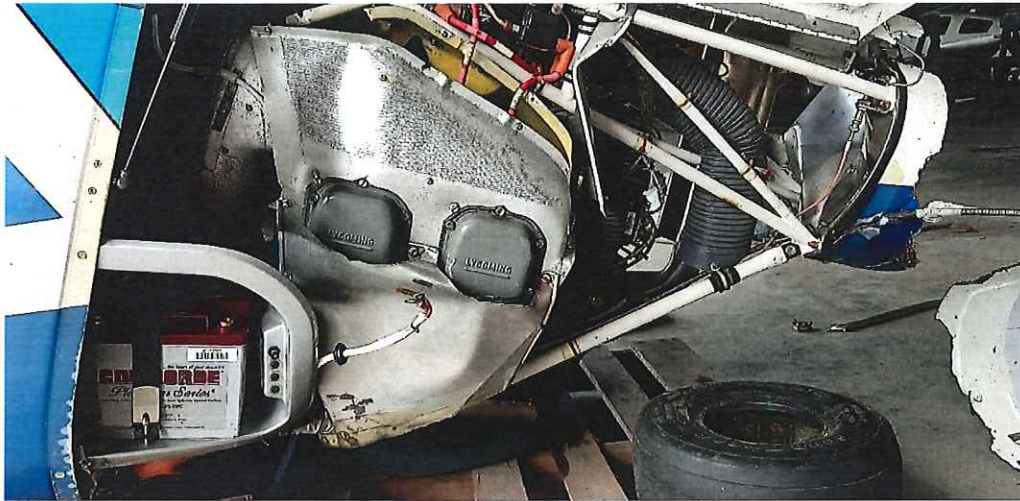
*Picture 14 shows the left-hand side of the engine. Can be seen in this picture the damaged upper and lower baffles of the engine. Also, can be seen in this picture the point where the tail section believed to be broken off from the aircraft.*

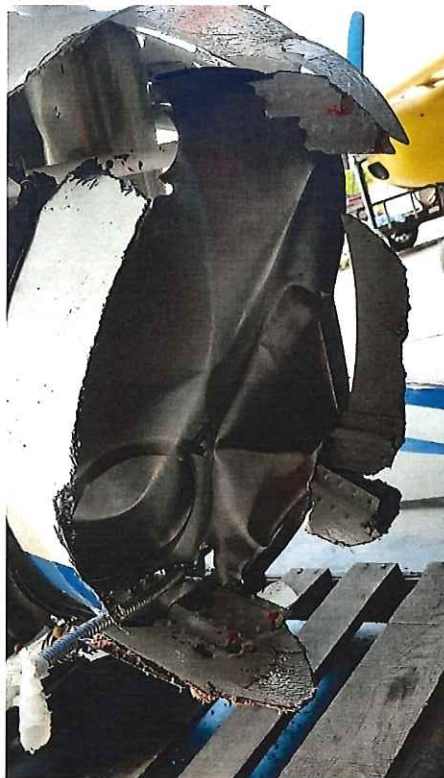
*Picture 15 shows the aft engine firewall of the aircraft. Can be seen in this picture the tail attachments of the aircraft still attached to the truss structure.*

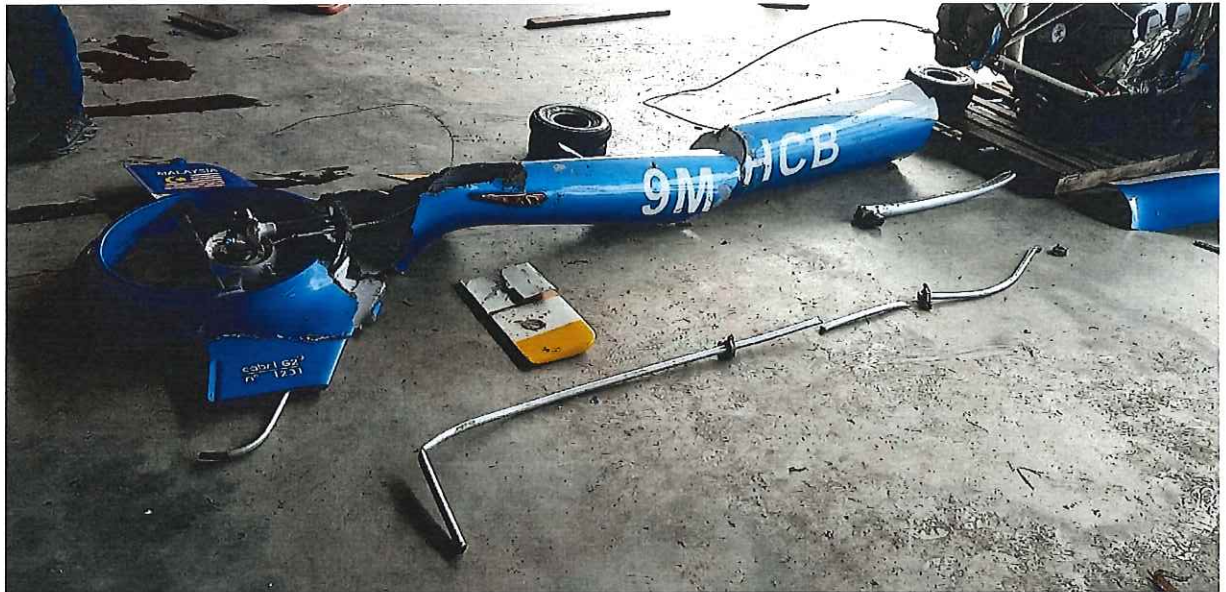
*Picture 16 shows the tail section and the tail driveshaft of the aircraft. Most of the tail section are broken and were recovered at the crash site.*

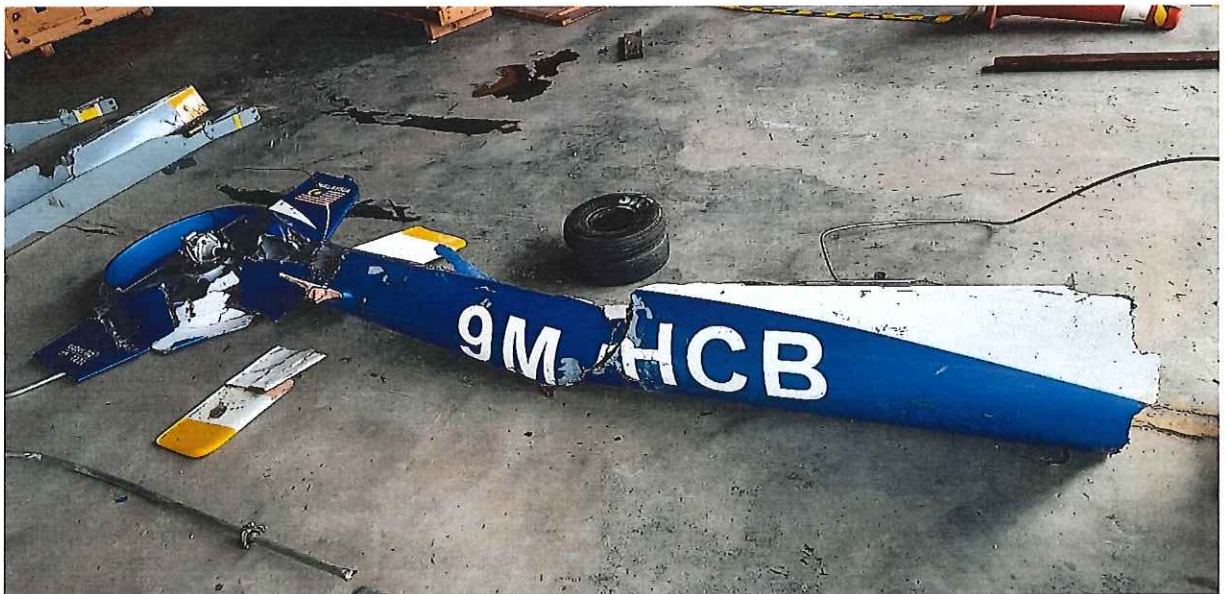
*Picture 17 shows another angle of the broken tail section. Can be seen in this picture the broken right-hand side of the horizontal stabilizer.*

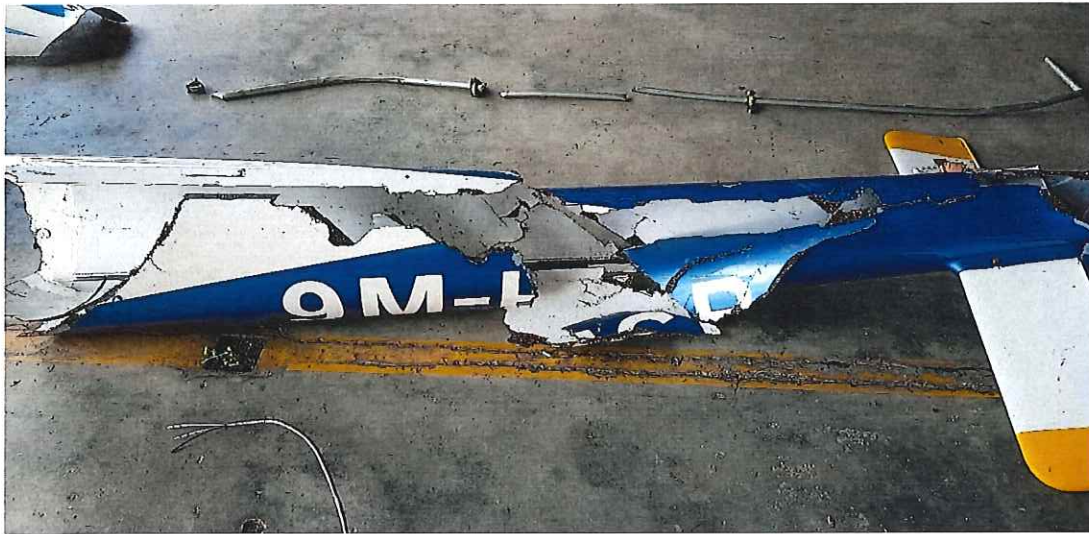
*Picture 18 shows the left-hand side of the tail boom. Can be seen in this picture most of the tail boom are broken to several pieces.*

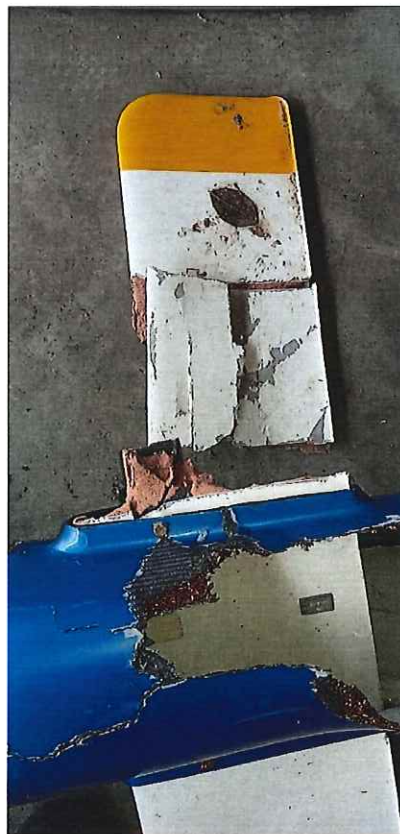
*Picture 19 shows the broken horizontal stabilizer view from above.*

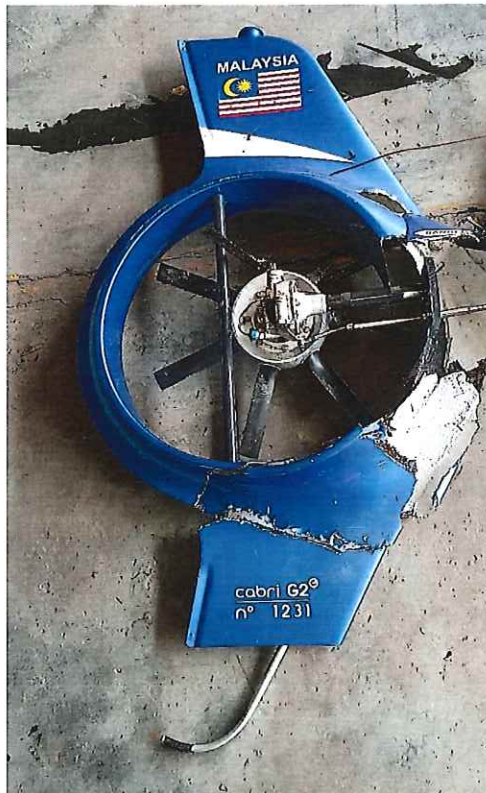
*Picture 20 shows the fenestron of the aircraft. Can be seen in this picture most of the fin structure was broken and were recovered at the crash site.*

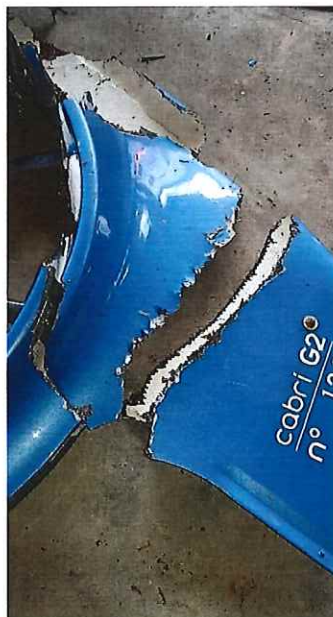
*Picture 21 shows the broken lower fin of the tail section of the aircraft.*

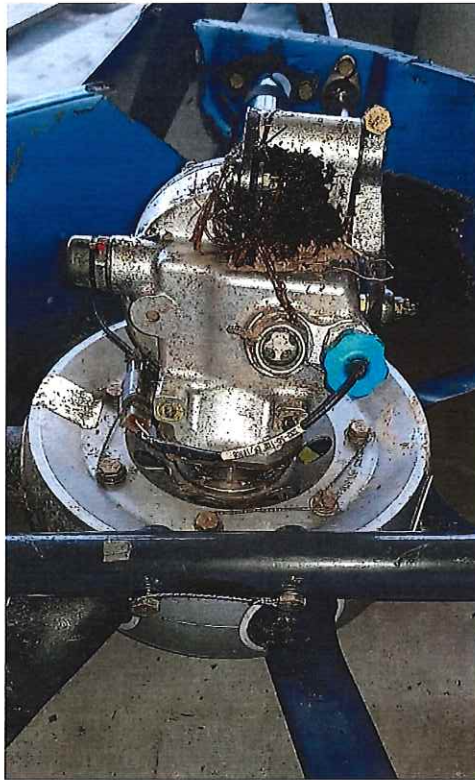
*Picture 22 shows the tail gearbox of the aircraft. The tail gearbox was found detached from the aircraft were recovered at the crash site. Most of the engine oil have leak out upon recovering the gearbox.*

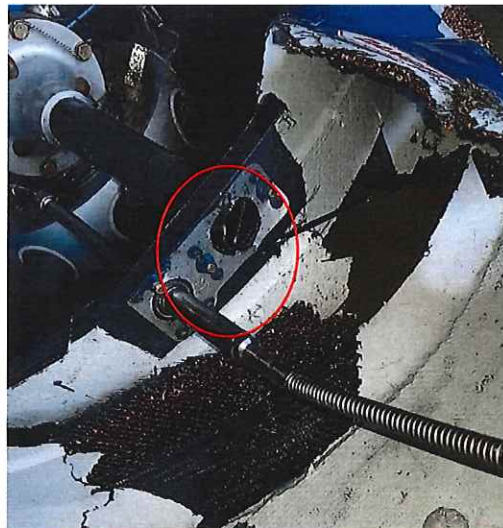
*Picture 23 shows broken section of the entire fin. The circle shown in the picture shows the sheared portion of the tail rotor driveshaft.*

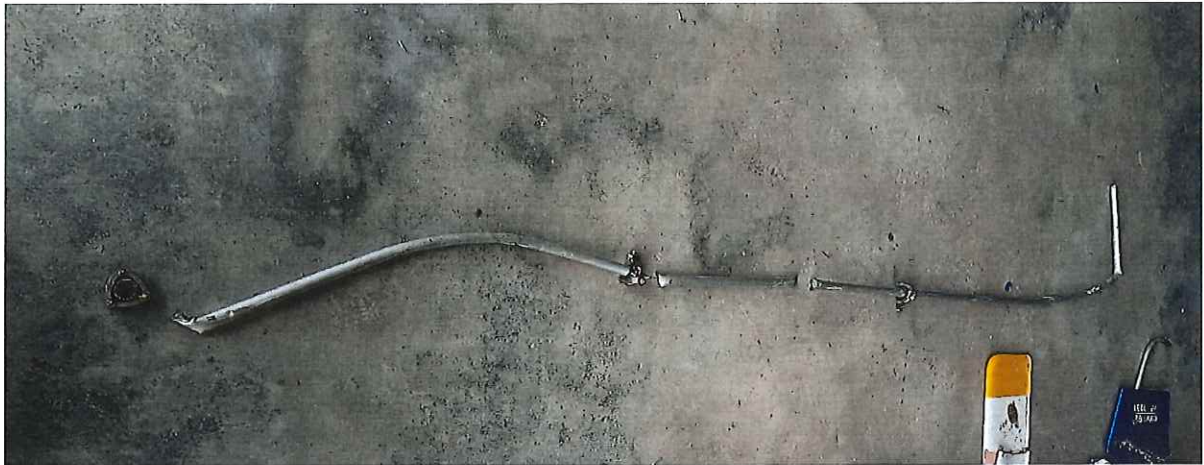
Picture 24 shows the broken pieces of the tail rotor driveshaft. Most of the driveshaft found evidence of torsional and shear damage. Can be seen also in this picture the hanger bearing that is detached from the aft engine firewall and were recovered at the crash site.

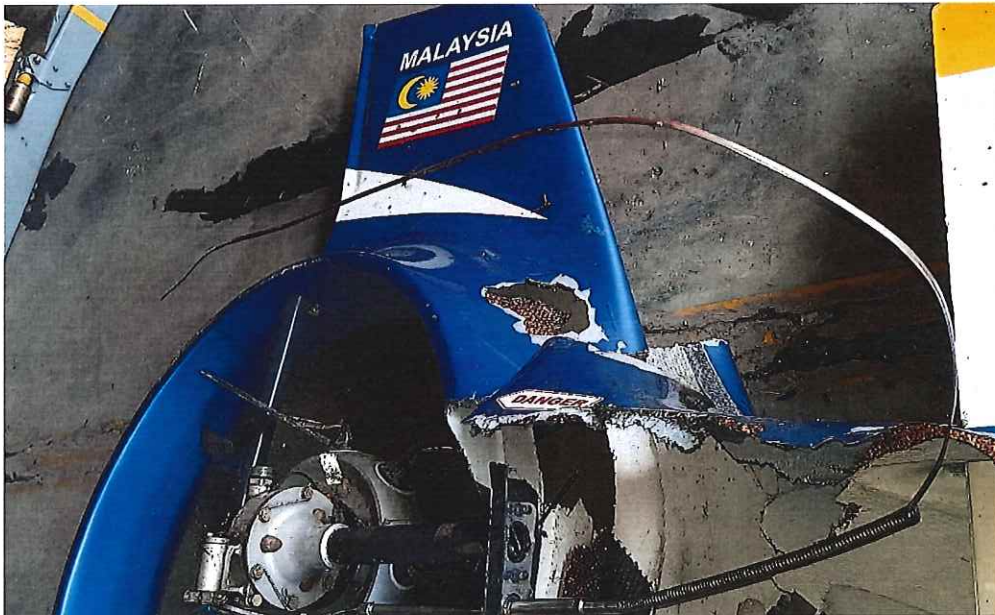
Picture 25 shows the damaged tail rotor cable. Half portion of the cable are found still attached to the fuselage of the aircraft. Can be seen also in this picture the damaged fin of the aircraft.

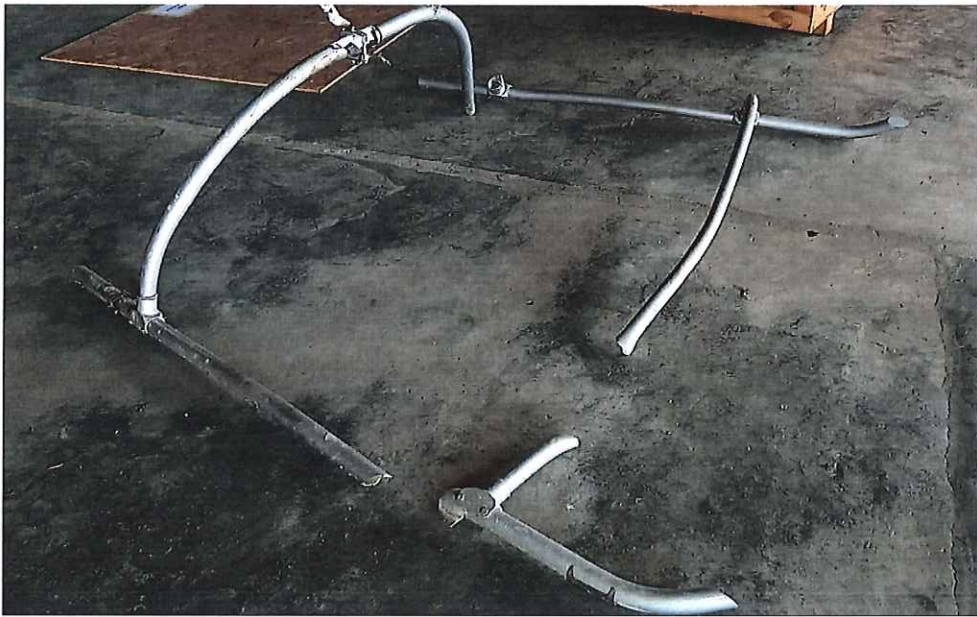
*Picture 26 show the broken landing gear of the aircraft. Can be seen in this picture the landing gear are broken to 3 pieces.  
All the broken pieces were recovered from the crash site.*

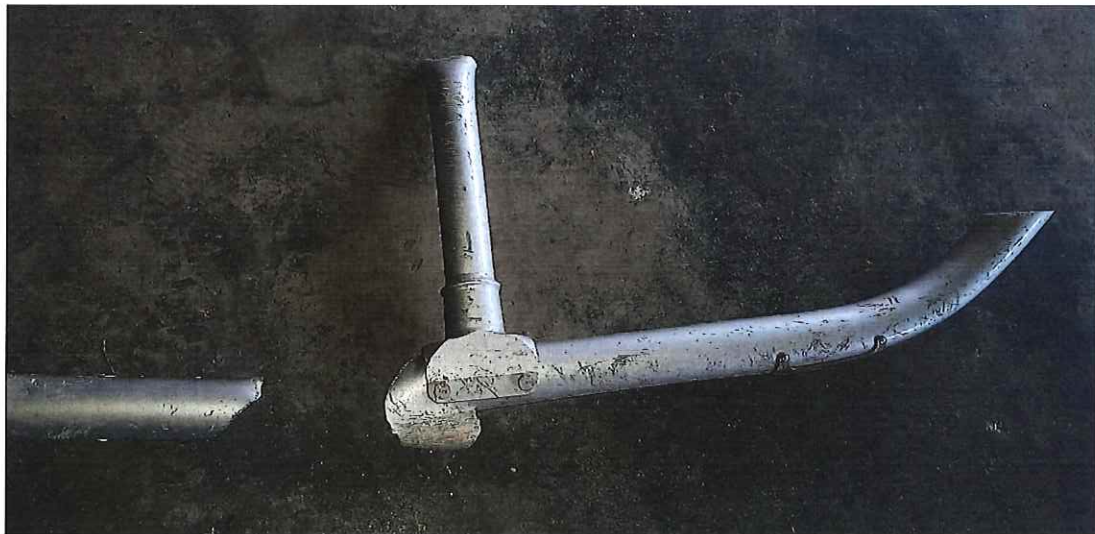
*Picture 27 shows the broken piece of the right-hand skid assembly.*

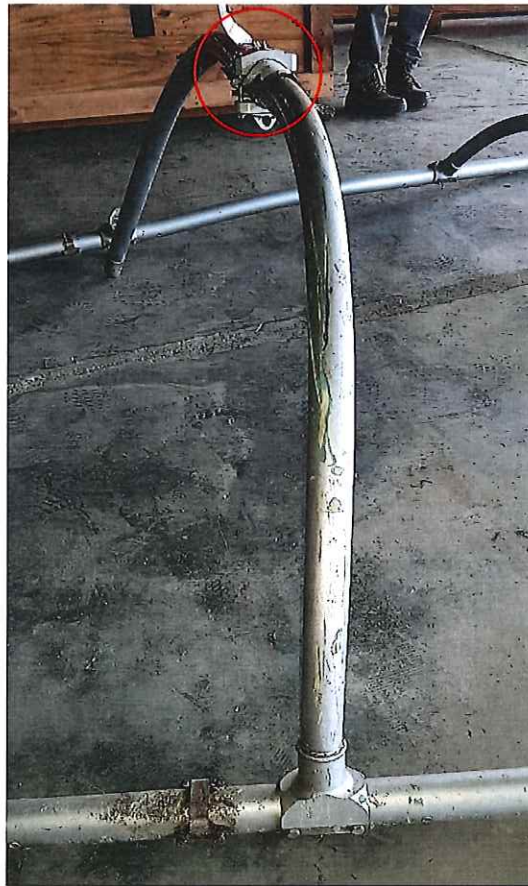
*Picture 28 shows the aft bow of the landing gear assembly. Shown in the circle the rear bow attachment to the fuselage detached from the lower fuselage.*

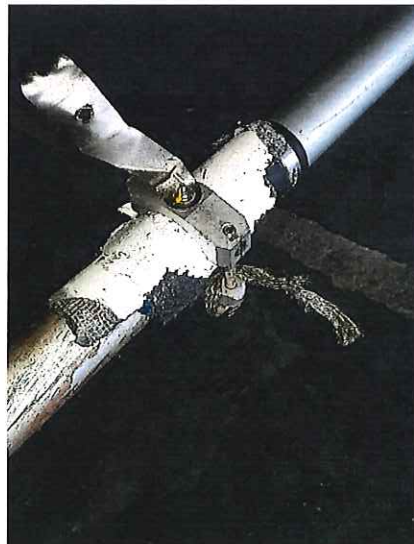
*Picture 29 shows another angle of the rear bow landing gear attachment found detach from the lower fuselage.*

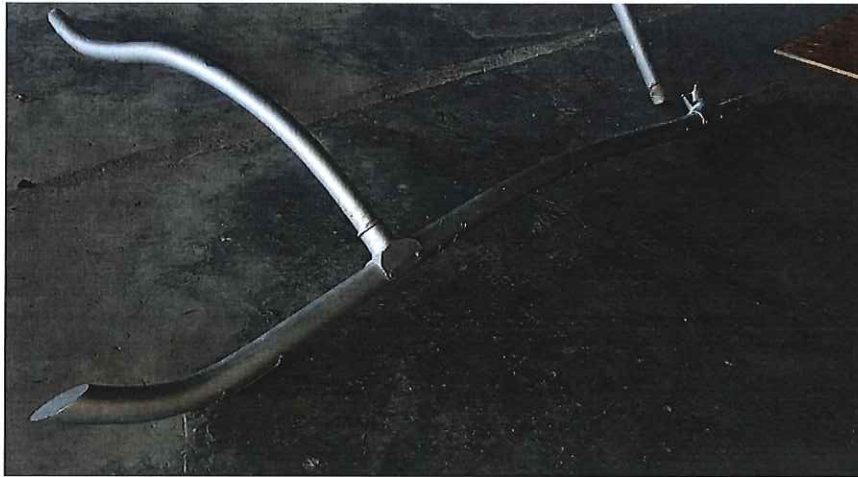
*Picture 30 shows the left-hand skid of the landing gear assembly. Shown in the picture the landing gear is bent and the rear bow is detached from the attachment to the skid.*

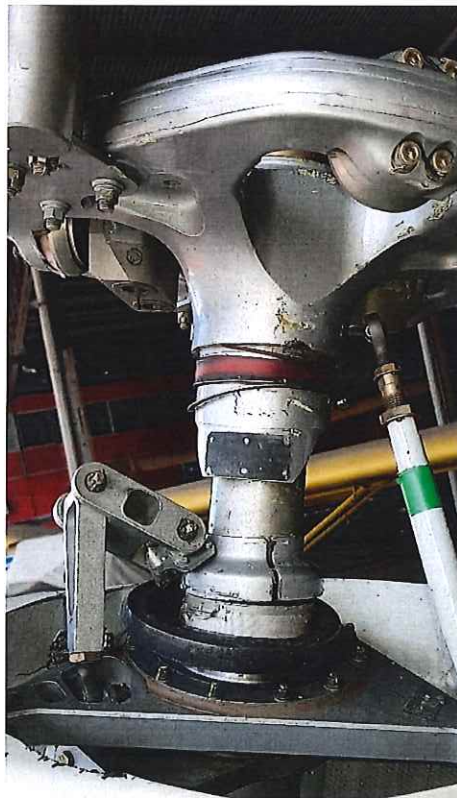
*Picture 31 shows the extensive damage to the main rotor head. Shown in this picture the upper scissors fittings rivets are sheared off from the rotor head. Can be seen also the droop stop ring were detached from the main rotor head. All of the pitch links and main rotor blades were removed for ease of transportation from the crash site.*
