## AIRCRAFT ACCIDENT PRELIMINARY REPORT

A 06/20

Accident Involving Two Guimbal Cabri G2

Registration 9M-HCA & 9M-HCB

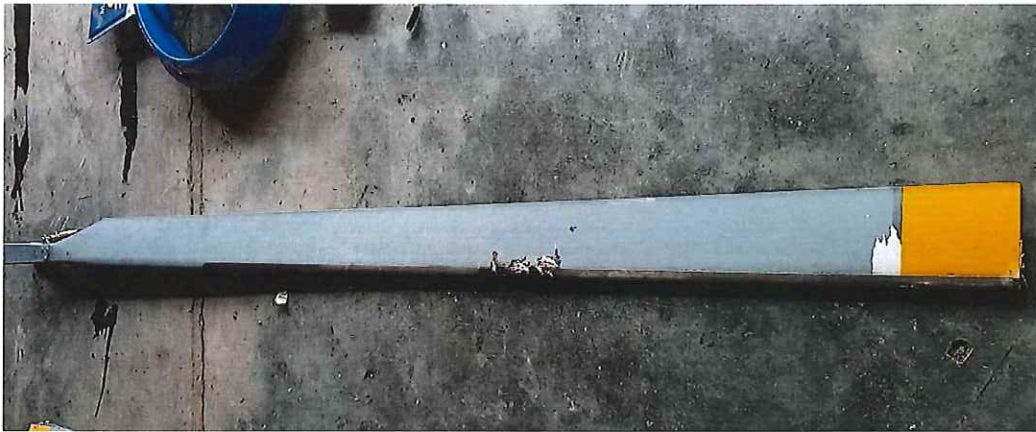
*Picture 32 shows the yellow main rotor blade of the aircraft. The blade suffered substantial damage to the leading edge of the blade and delamination. The lead-lag damper was found detached from its body.*

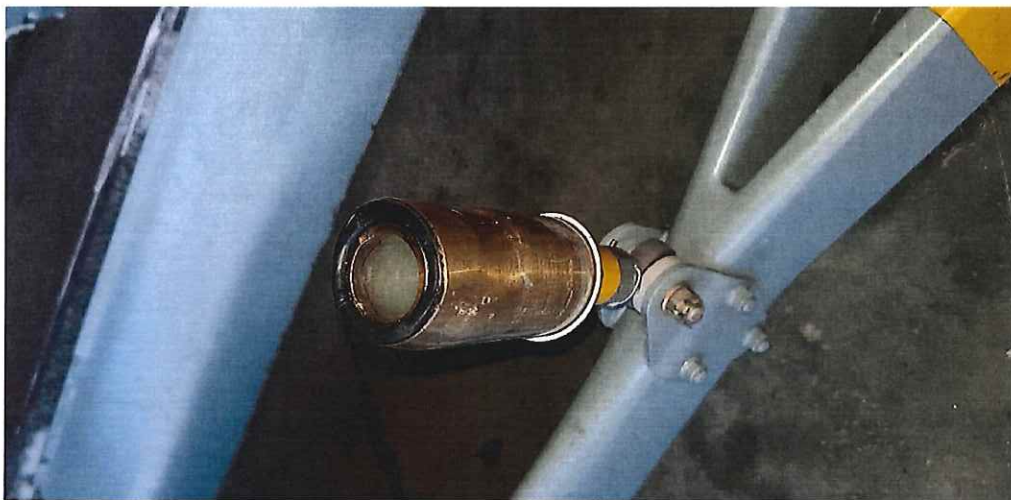
*Picture 33 shows the half portion of the yellow lead-lag damper that is found detached from the body.*

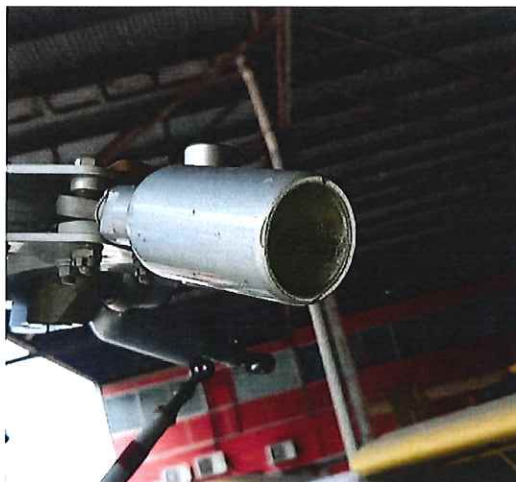
*Picture 34 shows the body of the yellow lead-lag damper still attached to the main rotor head.*

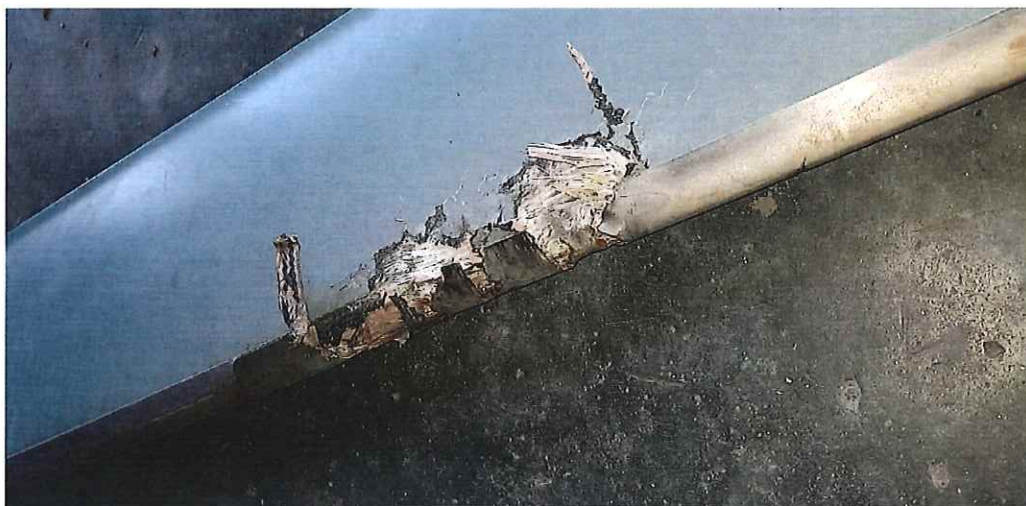
*Picture 35 shows the damage portion of the leading edge of the yellow main rotor blade.*

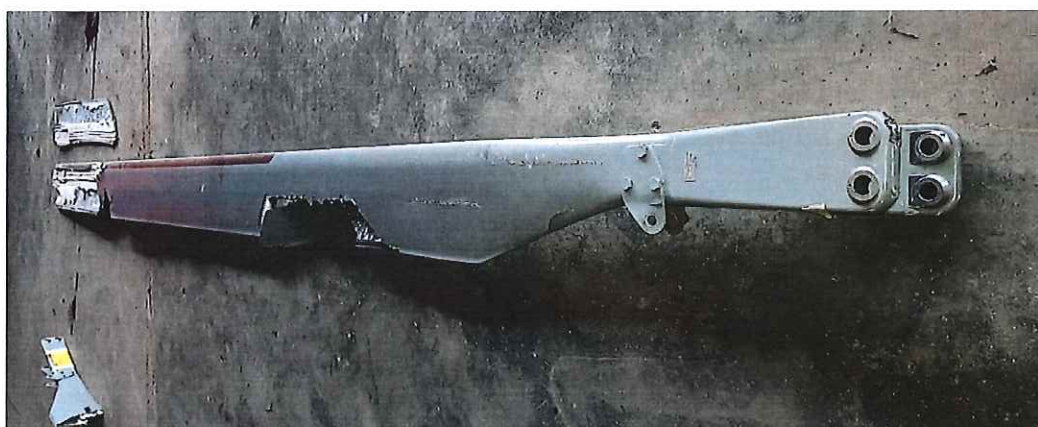
*Picture 36 shows the green main rotor blade of the aircraft. Substantial damage on the blade could be seen in this picture*

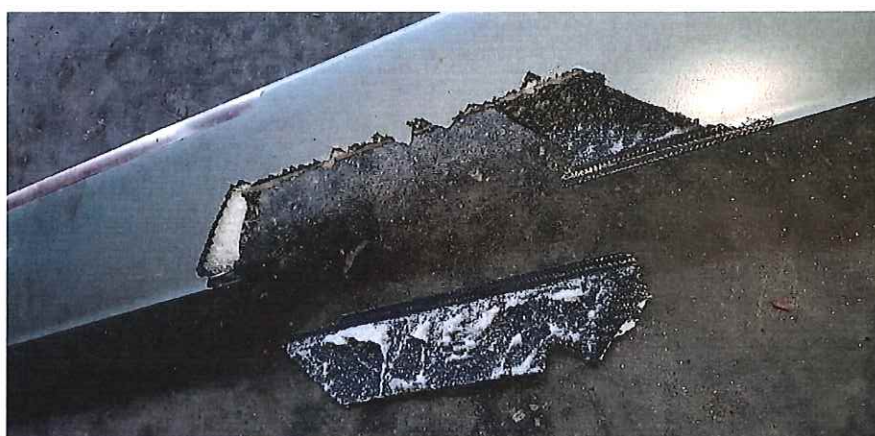
*Picture 37 shows the broken portion of the trailing edge of the green main rotor blade.*

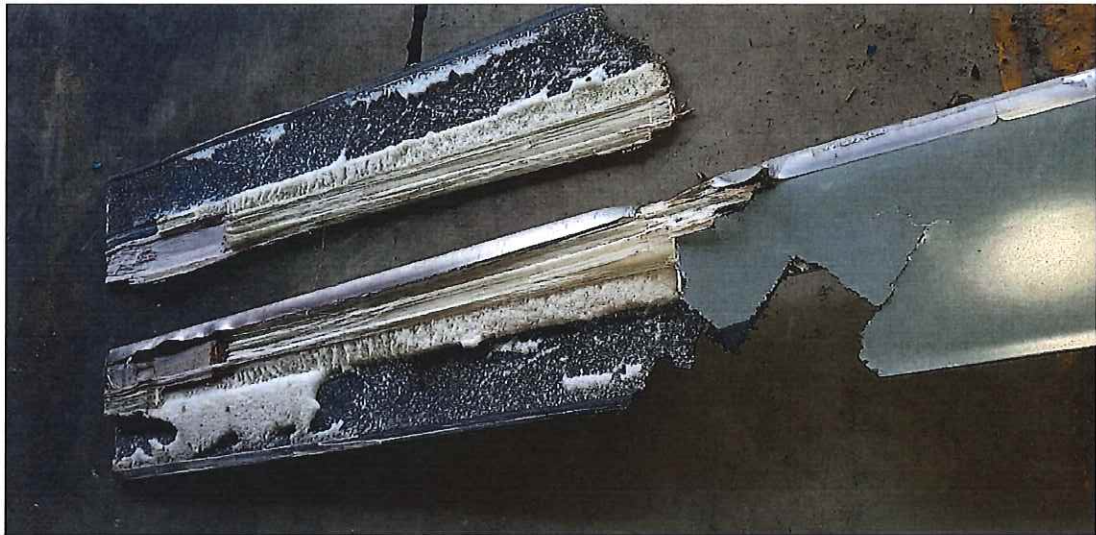
*Picture 38 shows the broken piece of the upper section of the green main rotor blade. Some portion of the trailing edge also can be seen missing from the blade.*

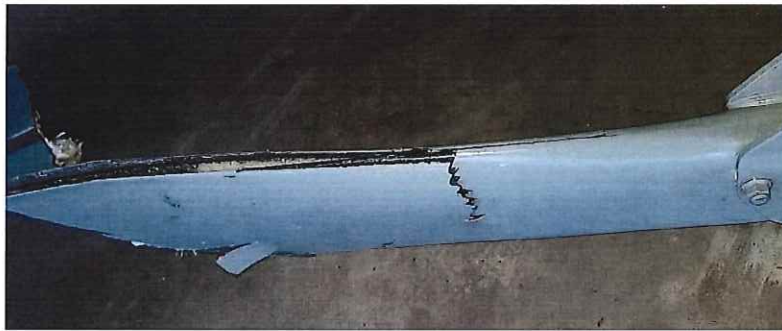
*Picture 39 shows the damaged blade root of the red main rotor blade. The rotor blade was found partially attached at the crash site.*

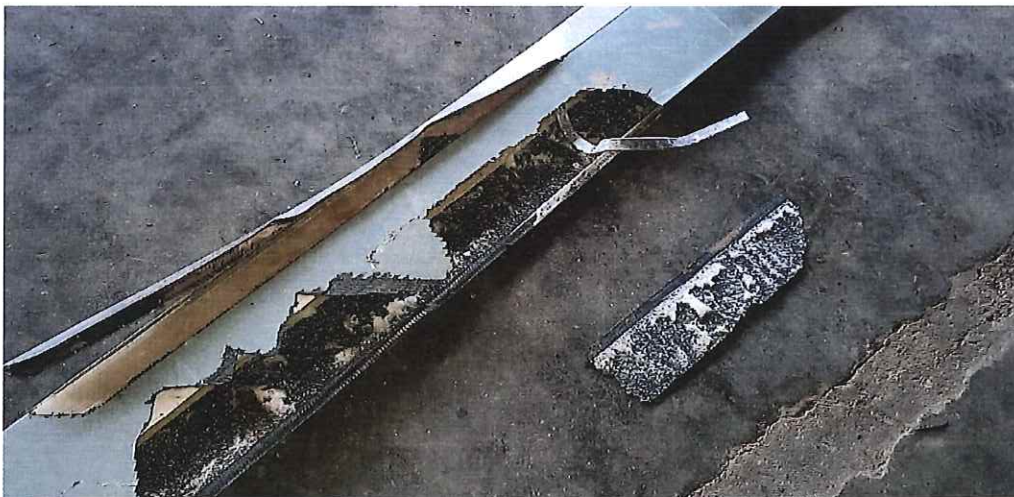
*Picture 40 shows the damaged leading and trailing edge of the red main rotor blade.*

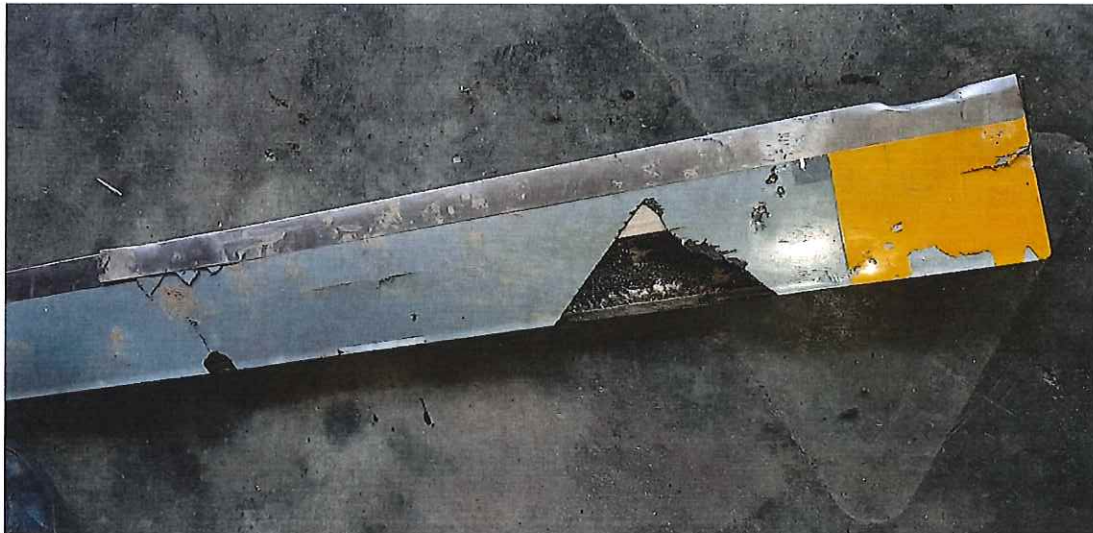
*Picture 41 shows the damaged tip of the red main rotor blade. Can be seen in this picture also missing portion on the trailing edge of the blade.*

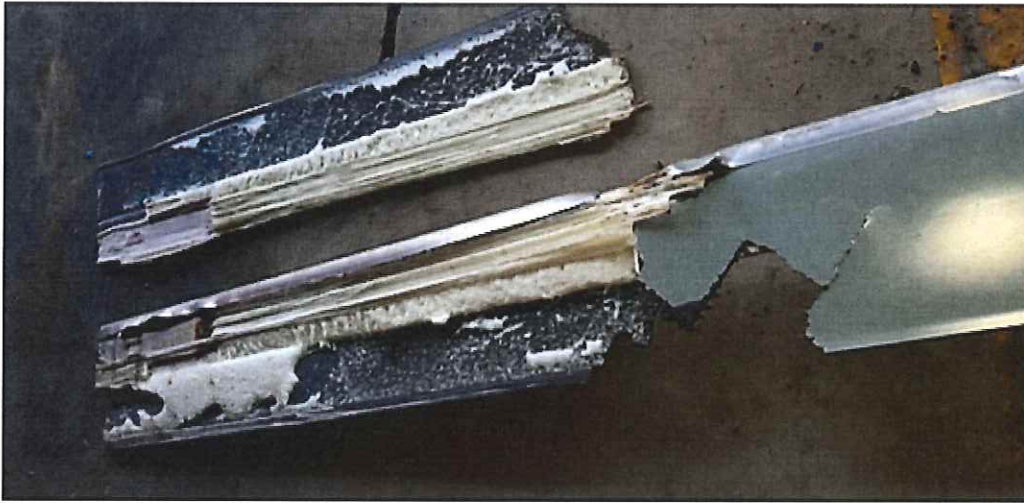
*Picture 38 shows the broken piece of the upper section of the green main rotor blade. Some portion of the trailing edge also can be seen missing from the blade.*

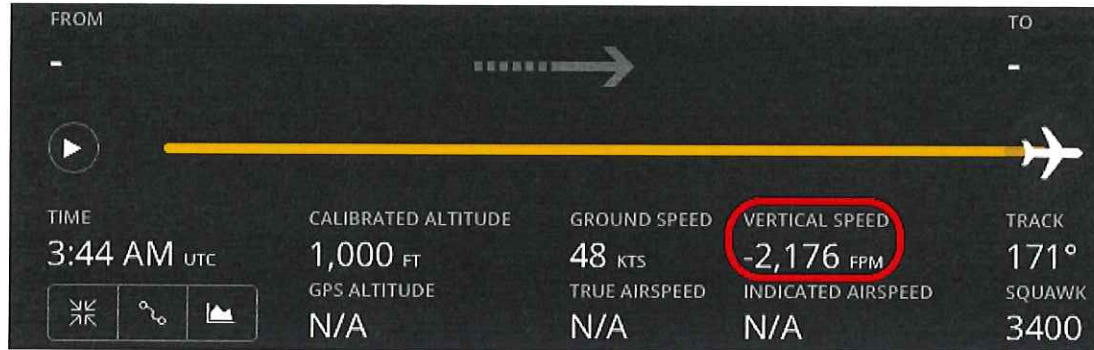
INITIAL RATE OF DESCENT

2.5 9M-HCA managed to safely land on SJKT Taman Melawati's school field. 9M-HCB on the other hand immediately entered into an auto-rotation but due to the severity of damage to its main rotors was unable to maintain a controlled rate of descent required for a safe landing. ADS-B Data shows that during the initial part of its auto-rotation 9M-HCB was already descending in excess of 2,000 ft/min (**Appendix H**).
