**AIRCRAFT ACCIDENT
PRELIMINARY REPORT**

A 03/24

**Accident Involving Fixed-Wing Aircraft Blackshape BK 160TR,
Registration I-POOC, at Kapar, Selangor
on 13 February 2024**

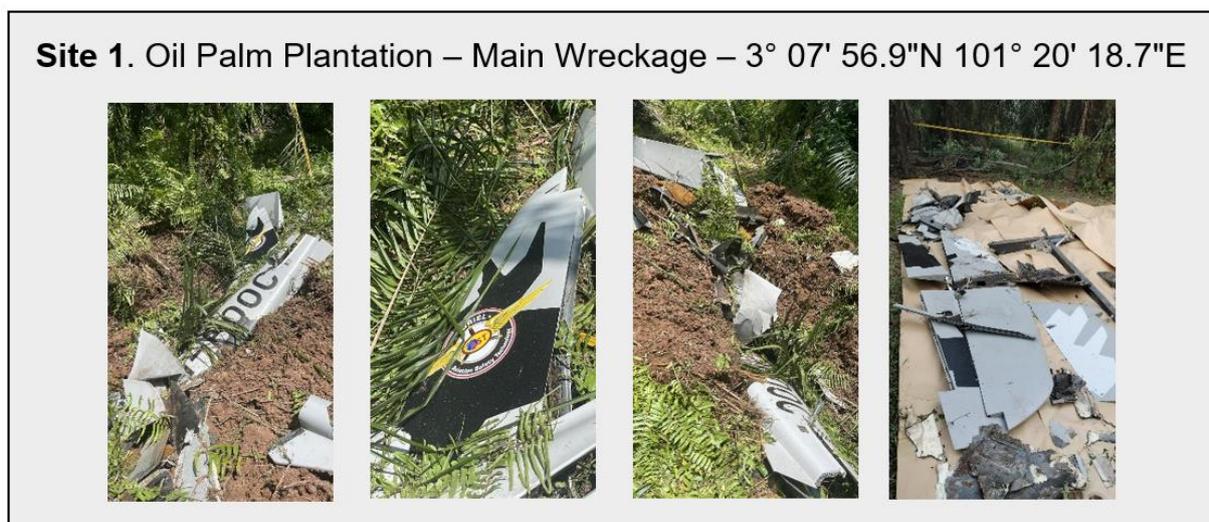
Figure 1.4: Site 1

Figures 1.4 to 1.7 show the sites of the wreckage and debris. Site 1 is the location of the main wreckage, along with the bodies of the pilot and passenger. Sites 2 to 4 are in an area of about 250 to 300 metres in diameter where various aircraft debris were scattered. Before the arrival of investigators, most of the scattered debris were found by local villagers who had then pooled the collection, particularly at Site 3. Site 2, the nearest of the three sites to the main wreckage, is about 560 metres to east of Site 1.

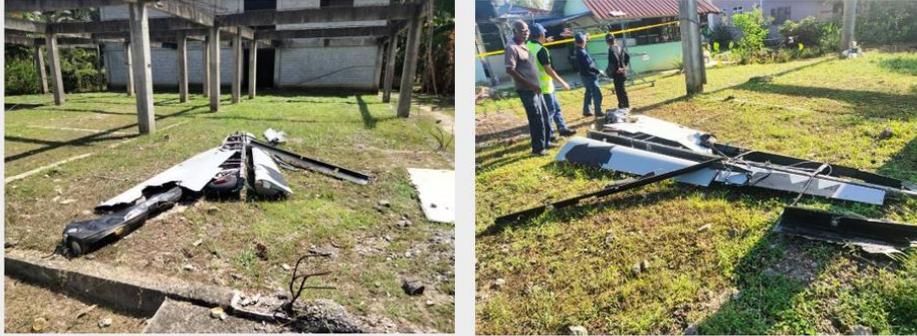
Figure 1.5: Site 2

Site 2. Next to House Kitchen – Right Wing – 3°07'57.8"N 101°20'36.8"E

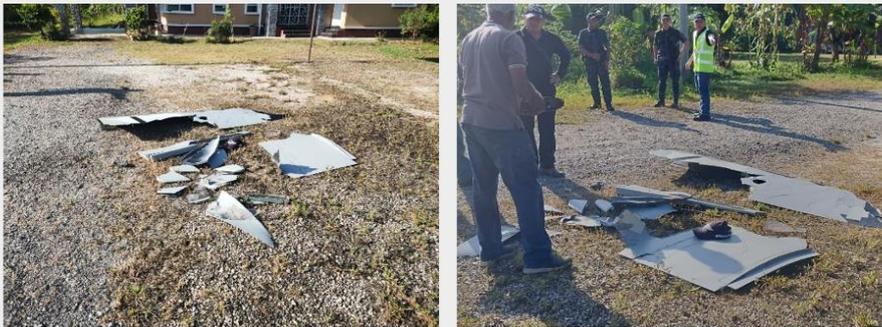
Figure 1.6: Site 3

Site 3. Uninhabited House – Various Debris & Cap – 3°07'56.1"N 101°20'42.1"E

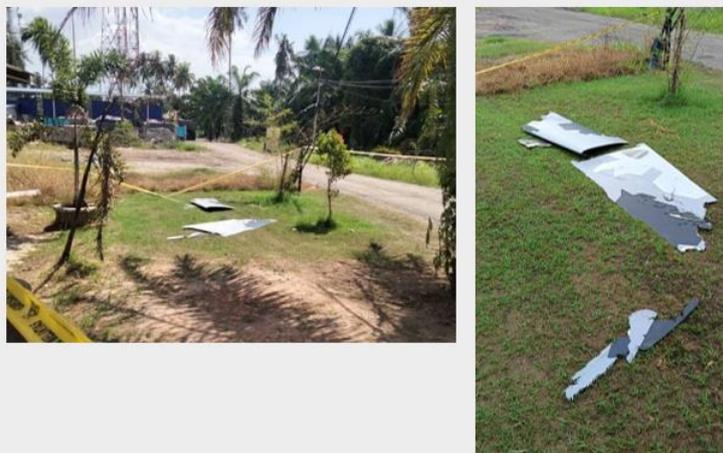
Figure 1.7: Site 4

Site 4. Front of House – Wing Parts – 3°07'53.3"N 101°20'42.7"E

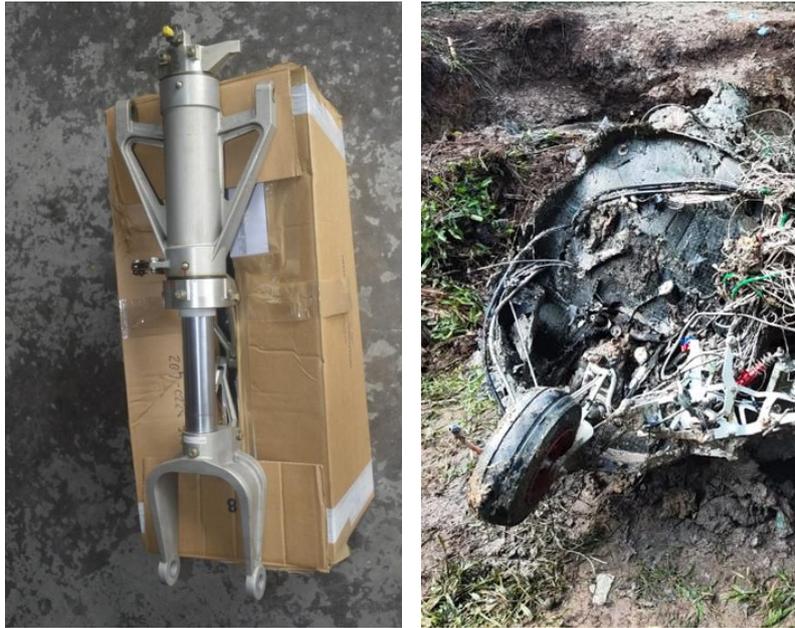
- Removal of the aircraft's nose landing gear (NLG) and installation of a new NLG in February 2024 by unauthorised maintenance personnel or persons who were not appropriately qualified. Installation of the new NLG was completed just prior to the accident flight on 13 February 2024. The apparent purpose of the accident flight was to test the newly installed NLG.

Figure 1.12: Old NLG Found at AAFC Hangar (Left) and Newly Installed NLG on Wreckage (Right)

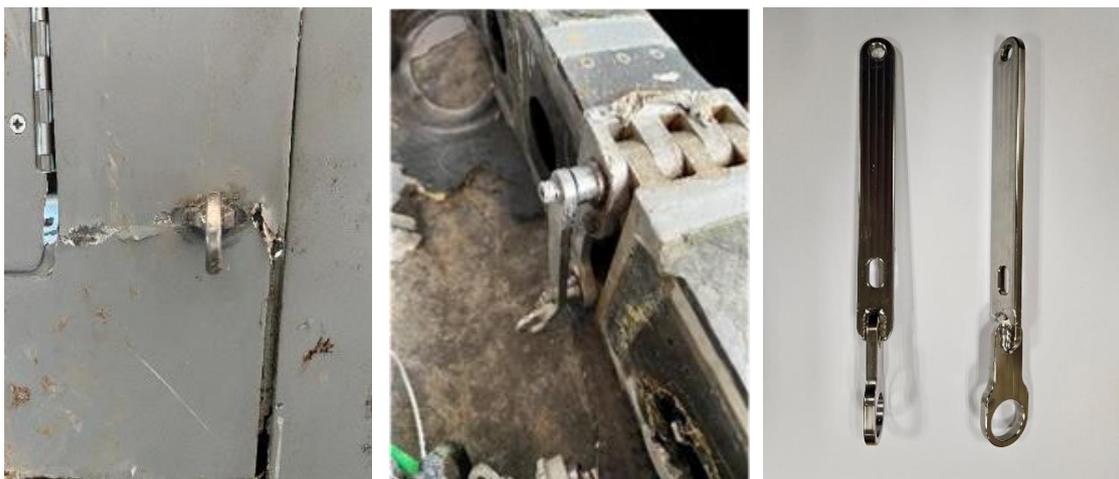
- Installation of a non-certified 'tie-down ring' part on the underside of each of the aircraft's wing near the main landing gear wheel well. The parts were installed through the composite material skin of the wing and were bolted onto the joint of the wing fitting with the main spar. Witness testimony indicates that the installation of these non-certified parts was completed by the pilot on 23 November 2023.

Figure 1.13: Tie-Down Ring Underside of Wing (Left); Tie-Down Ring Bolted to the Wing Joint (Centre); Two New Similar Parts Found at Pilot's Locker at AAFC (Right)

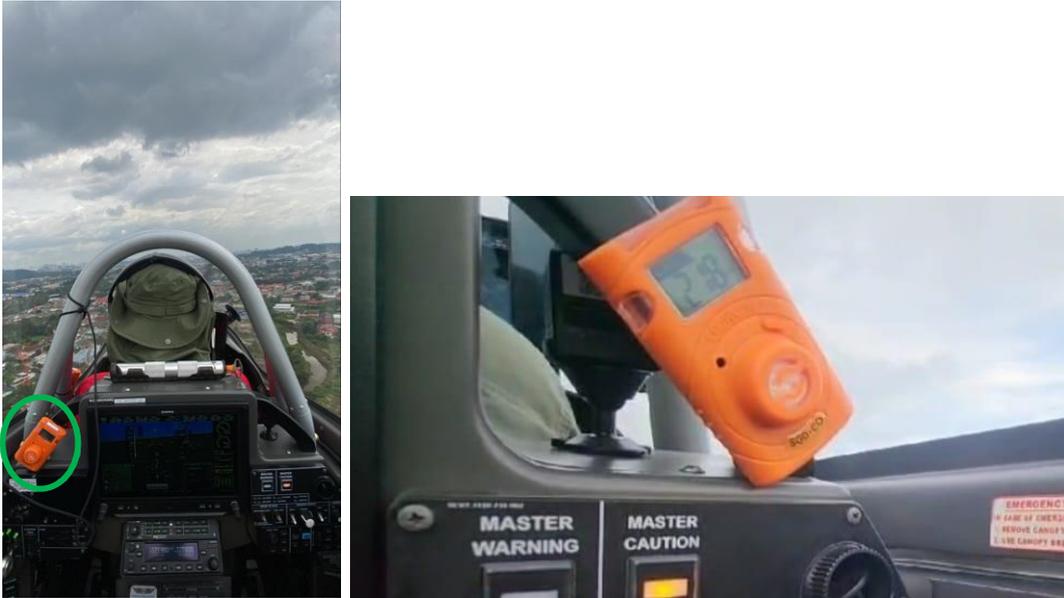
¹¹ The high level of CO apparently persisted even after the Blackshape Service Bulletin No BK-2023-08 dated 16/10/2023 for 'Improvement of Sealing of the Pass-Through in the Forward Cabin' was performed on I-POOC aircraft in October 2023.

Figure 1.14: Jury-Rigged Portable CO Detector

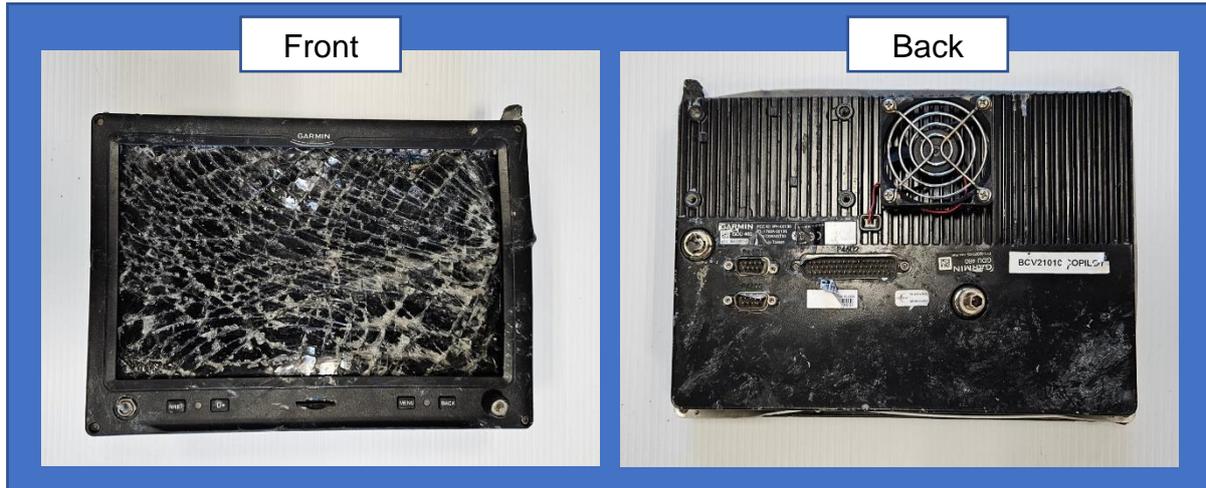
One of the Garmin G3X primary flight displays of I-POOC aircraft was recovered in heavily damaged condition from the aircraft wreckage. The damaged unit is being dispatched to the National Transportation Safety Board, USA (NTSB), who has offered to assist in recovering data from the unit. The details of the recovered flight display are as follows:

Figure 1.15: Damaged Garmin G3X GDU 460

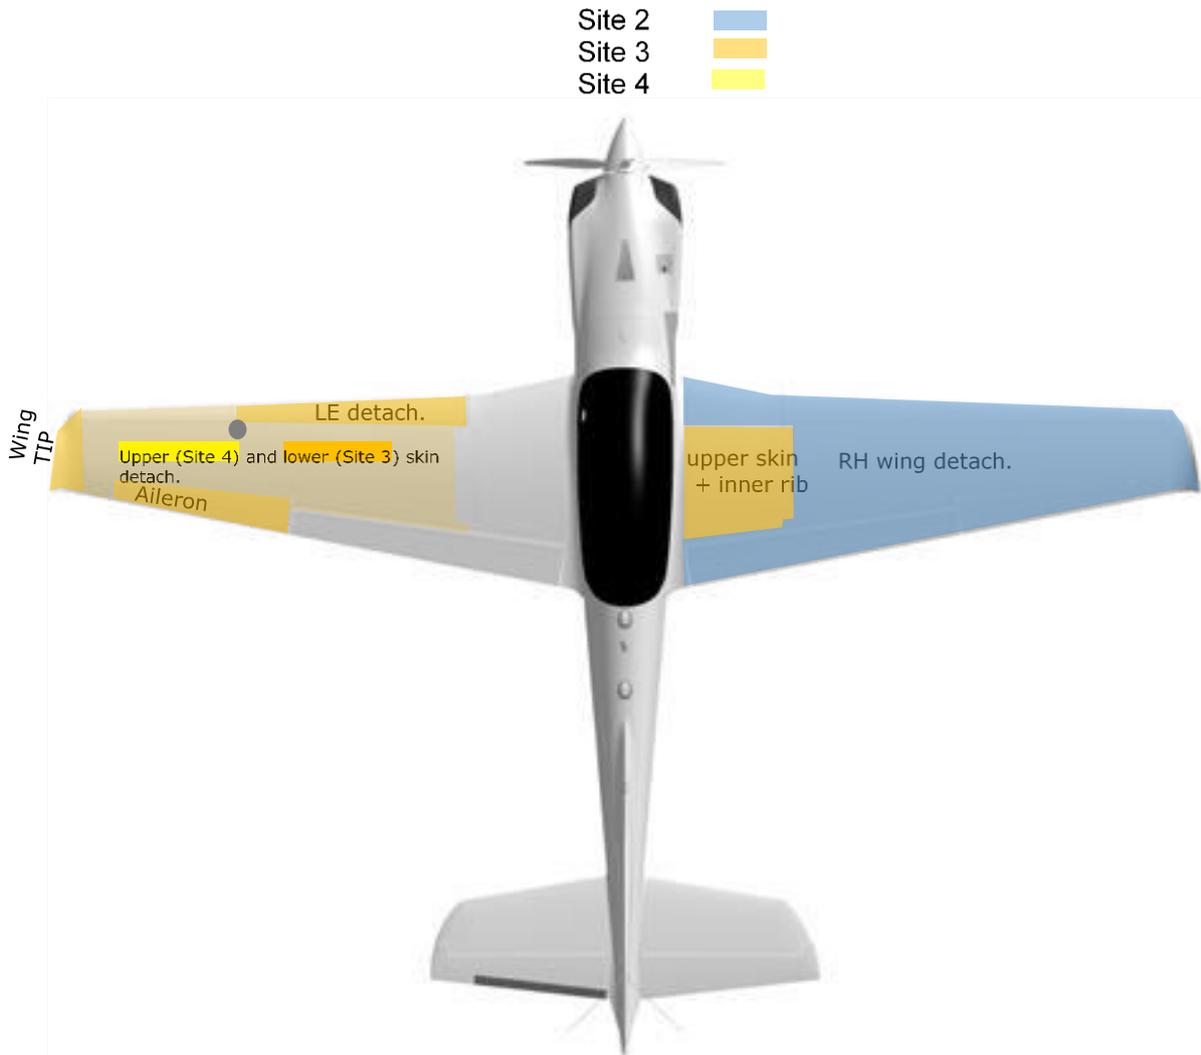
The distribution of the debris around the area at Sites 2, 3 and 4 strongly suggests that large structural parts had separated from the aircraft while in-flight before ground impact at the oil palm plantation. There was no sign of any pre-crash or post-crash fire on any of the debris found at all the sites.

Figure 1.16: Structural Parts Recovered from Various Sites Vs Main Wreckage¹²

¹² Smaller debris, including canopy fragments found in Site 3, are not shown. LH aileron detached was from the hinges. The aileron connecting rod was detached from the bellcrank. RH inner upper skin was detached together with the inner rib. RH wing was detached at the front and rear spar.

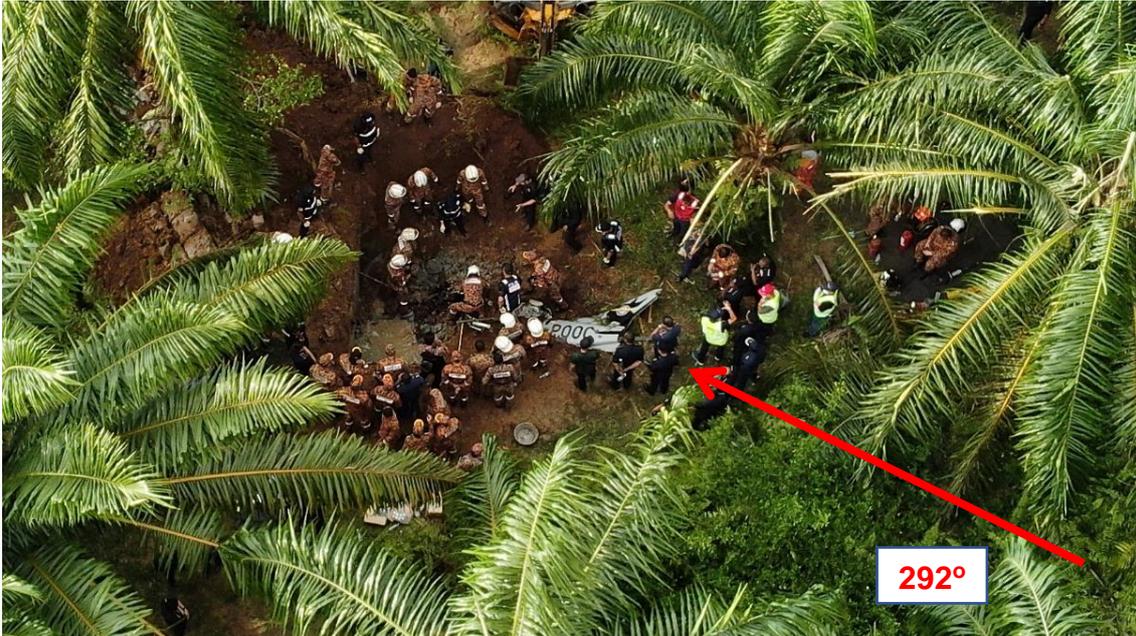
The front portion of the main aircraft wreckage, including the engine and front part of the cockpit, was buried about two (2) metres in the relatively soft ground of the oil palm plantation. The back section of the fuselage with the aircraft tail and vertical stabiliser remained above the ground. Numerous wreckage debris and aircraft parts were scattered around the impact point, but not more than 50 metres away, approximately. There was no sign of any pre-crash or post-crash fire on any of the wreckage found at and around the impact point.

Figure 1.17: Impact Point of Main Wreckage

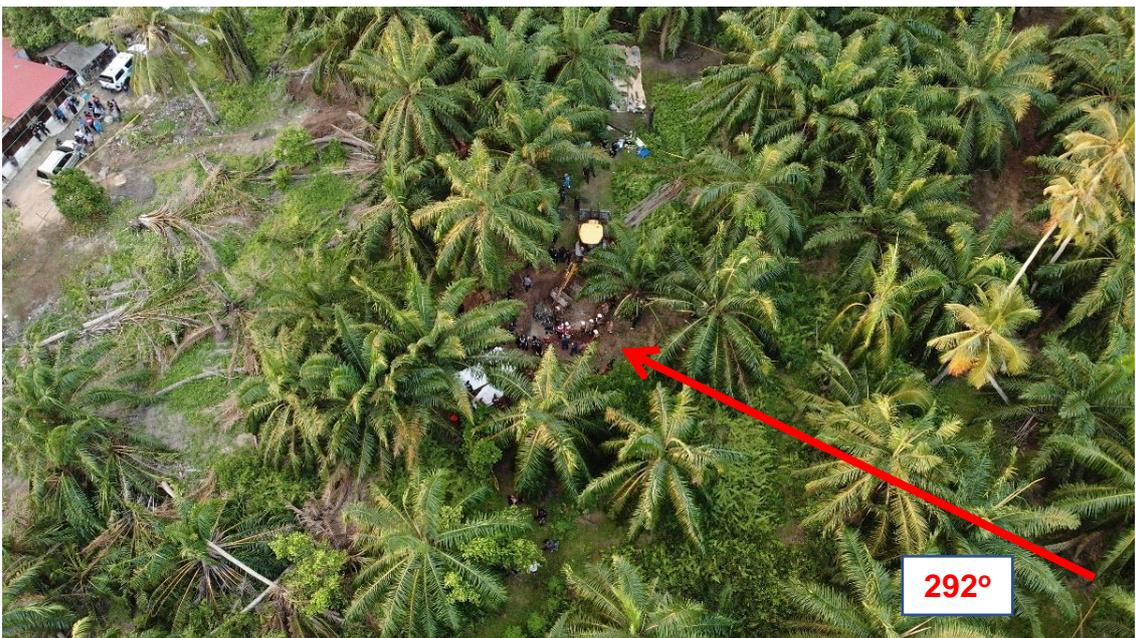
Based on the direction of partially buried fuselage, ground markings to the wreckage and freshly broken branches at the top of an adjacent palm tree, the aircraft impacted ground at an approximate direction of 292° . Based on the vertical angle from the impact point on the ground to the top of the broken branches of the adjacent palm tree, the aircraft had impacted ground at an approximately 45° downwards trajectory.

Figure 1.18: Impact Point of Main Wreckage and Travel Direction of Aircraft Impacting Ground

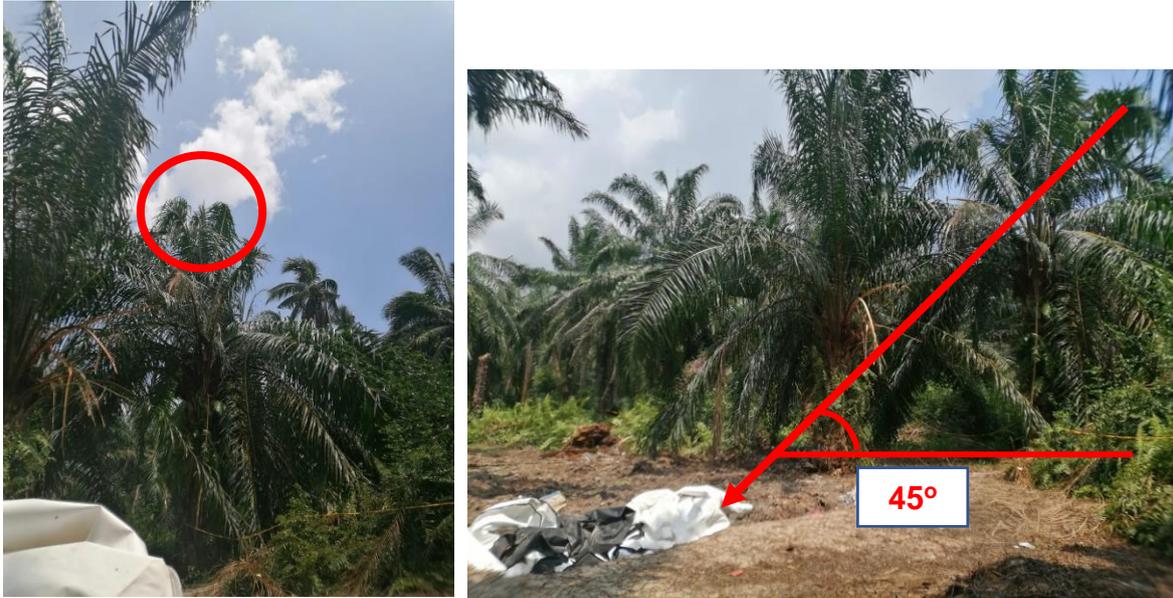
Figure 1.19: Broken Palm Branches (Left)
and Aircraft Downwards Trajectory (Right)

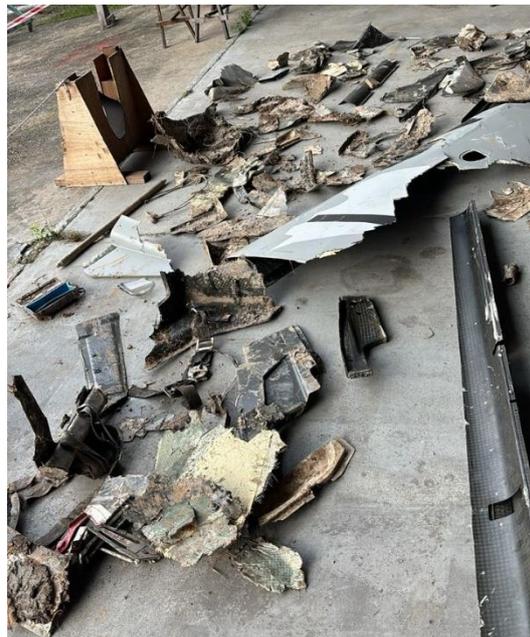
Figure 1.21: Container Shattered into Debris
Survivability Almost Impossible

The I-POOC aircraft container was shattered into pieces due to the high-energy impact. This disintegration of the container failed to prevent intrusion of outside objects, resulting in fatal injuries to the occupants.

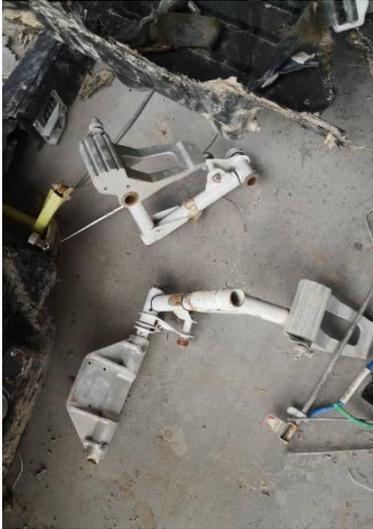
Figure 1.22: Pilot's Rudder Pedal
Broken into Two Pieces

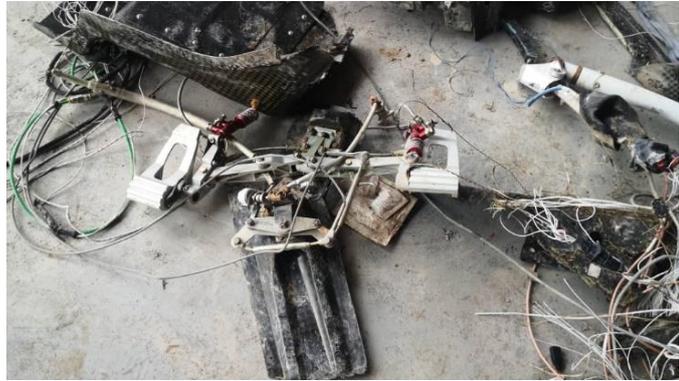
Figure 1.23: Rear Seat Rudder Pedal
Relatively Intact

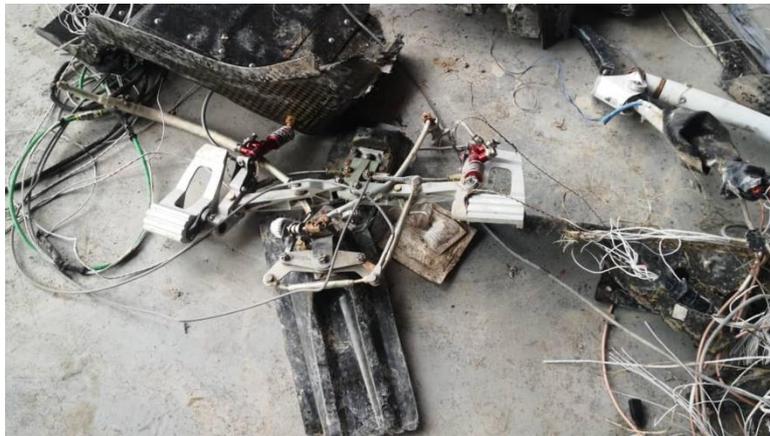
Figure 1.24: Pilot's Control Column Broken into Half.

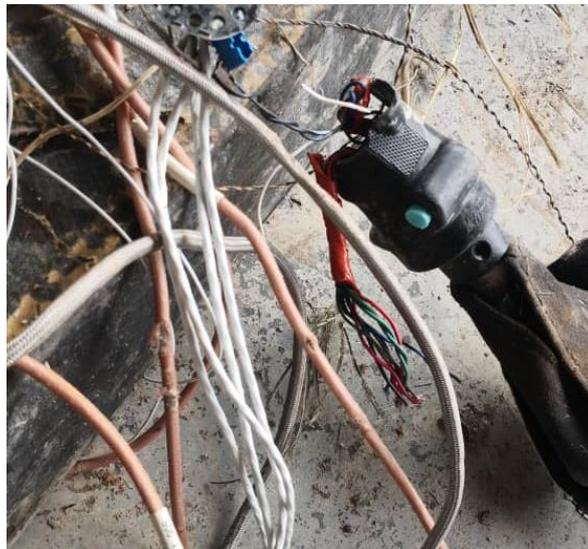
Figure 1.25: Rear Seat Control Column Broken into Half

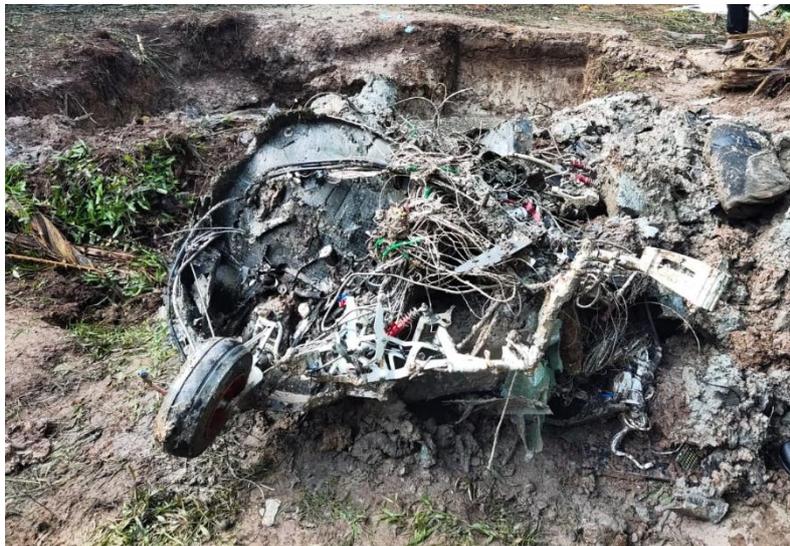
This crumple zone crushes and deforms in a controlled manner during the impact, increasing the stopping distance. This crushing and deforming ultimately reduced the deceleration force acting on the occupants. In this accident, the impact forces were not absorbed by the landing gear as all of the landing gear was in a stowed position. Besides that, the aircraft impacted on the ground in a 45° downwards attitude. In such aircraft attitude at the impact, the engine and its housing acted as the only crumple zone to increase the deceleration time.

Figure 1.26: Nose Wheel Retracted; Impact Not Absorbed by Landing Gear.

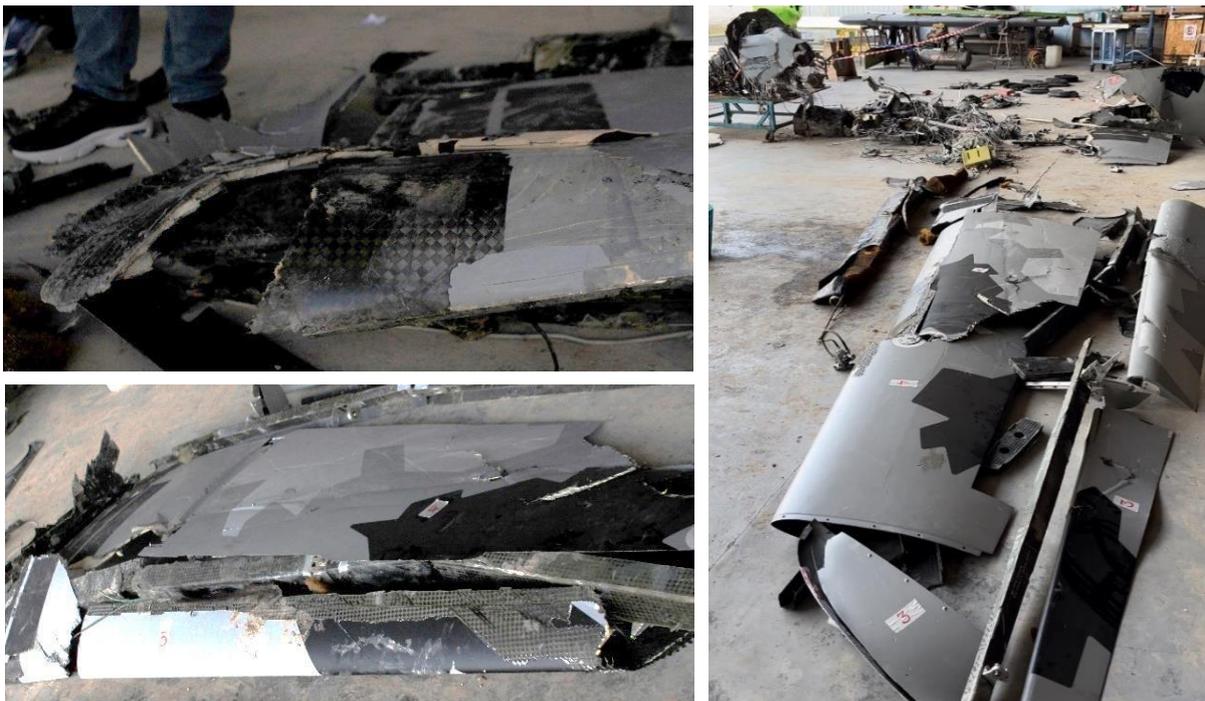
Figure 1: LH Wing

The LH wing main spar, aft spar and ribs were found at Site 1, the main wreckage area. The front and rear spar breaking points are compatible with high energy impact.

The wing upper skin, the lower skin with part of the wing leading edge and wing tip were detached. The wing upper skin was detached from the front and rear spar. The failure mode seems to be interlaminar failure of the skin. Part of the wing leading edge, i.e. from the wing fitting to the fuel cap location, was detached. The failure mode is also in this case interlaminar failure, in correspondence of the bonding flange.

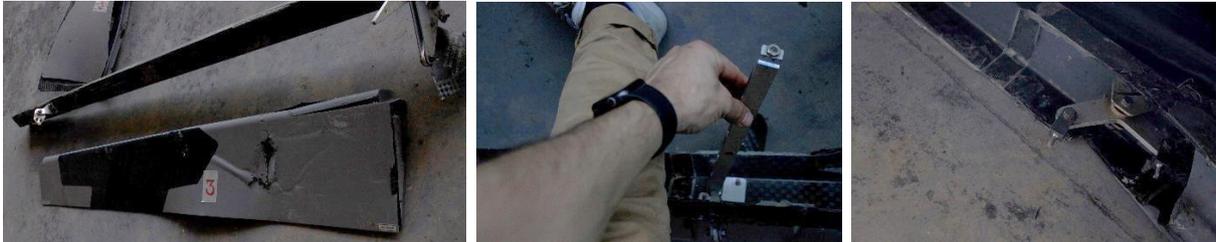
The LH aileron was found bent almost in the middle of its span. The aileron was detached from the hinges. The connecting rod was detached from the bellcrank.

Figure 2: LH Aileron, Connecting Rod, and Bellcrank

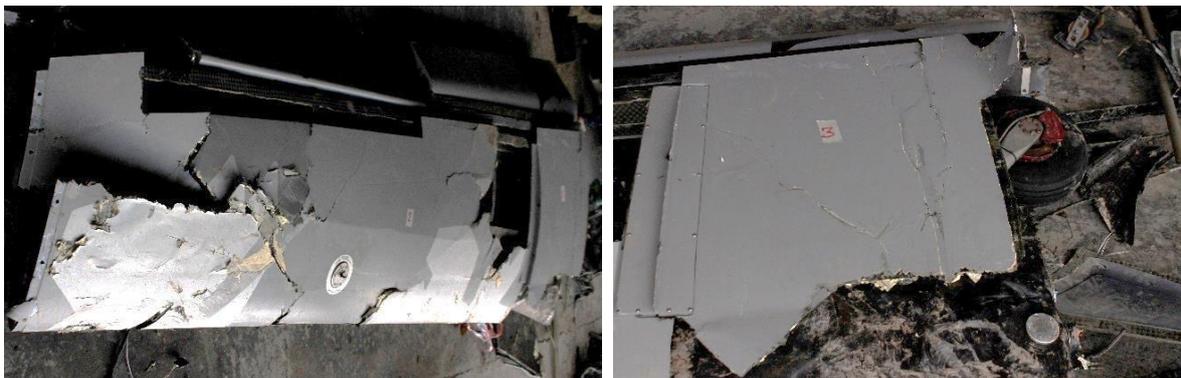
Figure 3: RH Wing

The whole RH wing (except for the inner upper skin) was found in a Site 2, about 560 metres to the east of the main wreckage. The RH wing inner upper skin, together with the inner rib, was found at Site 3. Refer to paragraph 5 below for the failure mode of the upper skin. The failure mode of the inner rib is interlaminar failure. The RH flap and aileron were found connected to the wing.

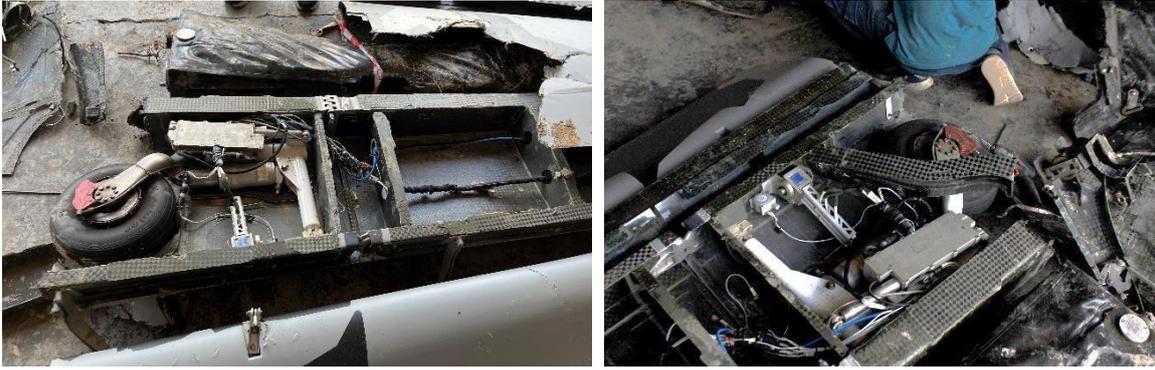
Figure 4: RH MLG

The MLG was found installed in the wing box in its retracted position. The forward (FWD) and rear (RWD) wing spars were totally cracked at the intersection with the fuselage monocoque, where the lower side fuselage spars are installed.

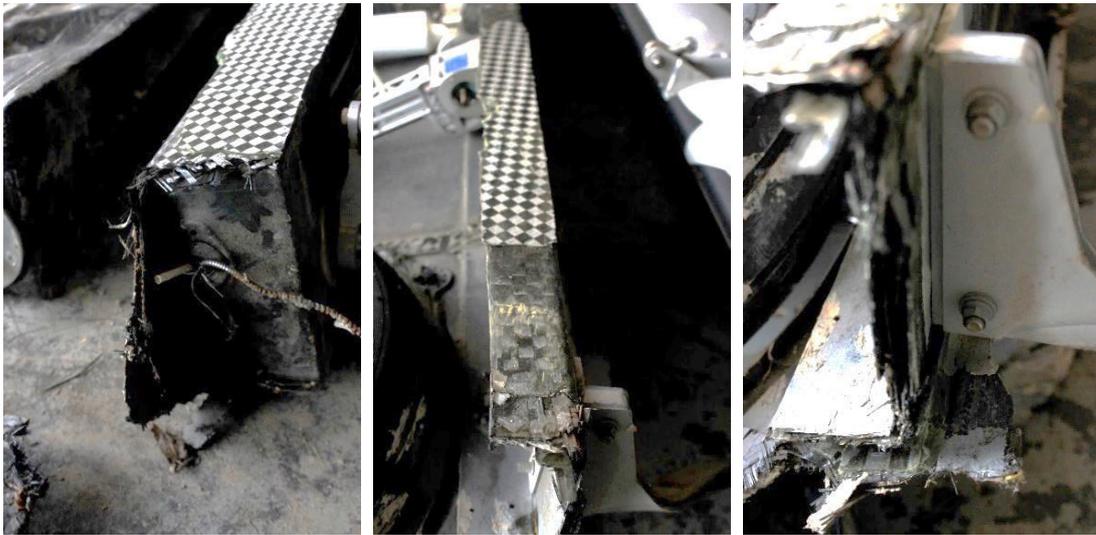
Figure 5: RH Wing Main and Rear Spar Crack

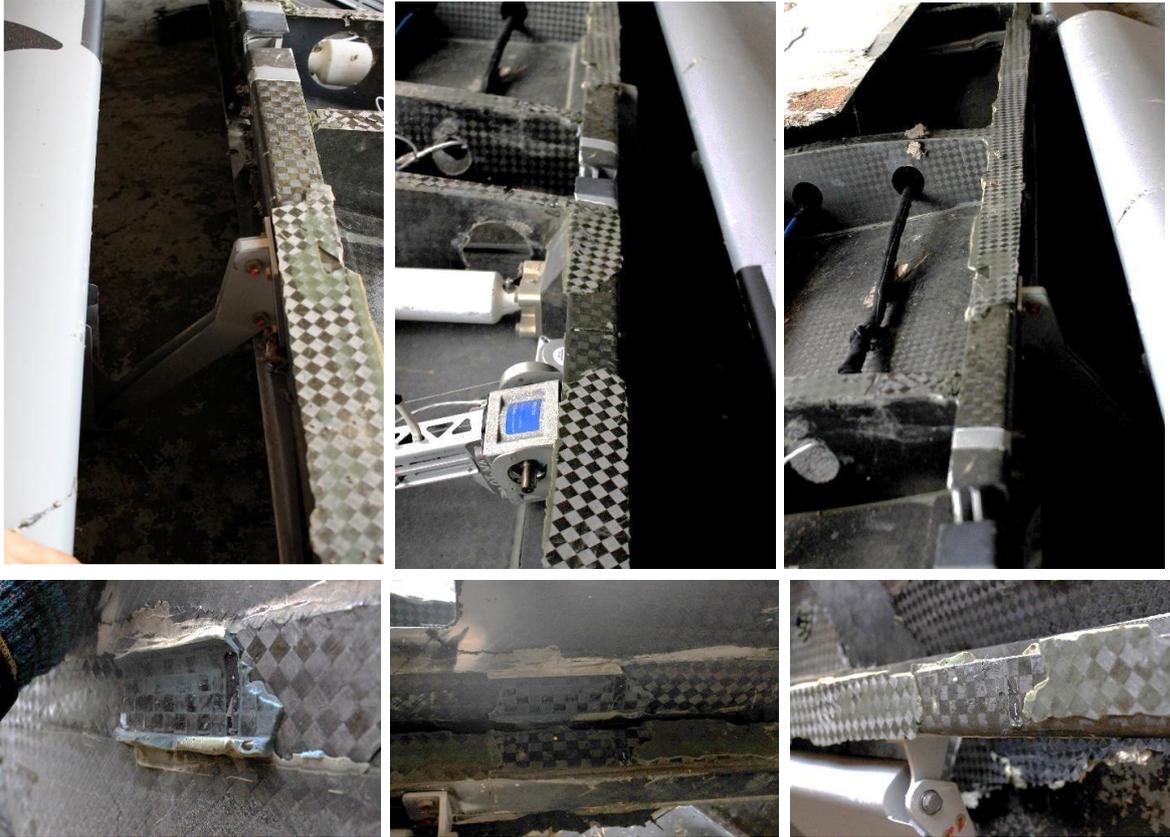
Figure 6: Skin/Spar Failure Mode

The failure of the skin/spar junction seems to be an interlaminar failure. The portion of laminate bonded to the wing spar remained attached to the spar cap revealing no failure of the bonding. The inner ribs of the wing box seem to have experienced the same failure mode.

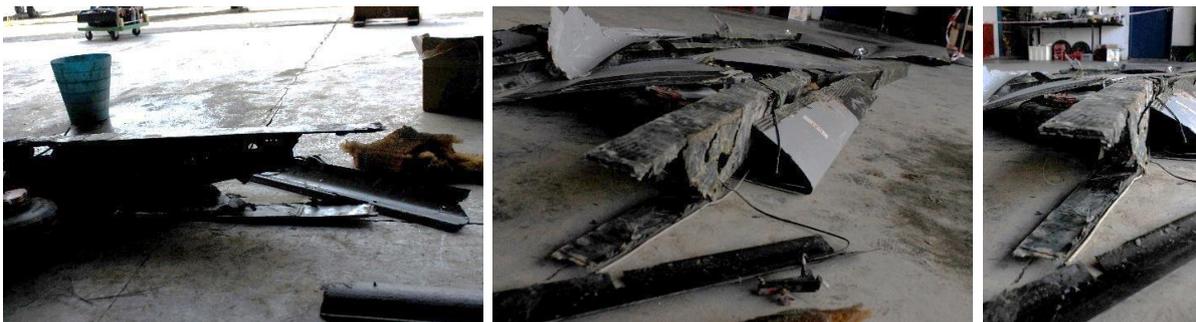
Figure 7: Main Spar Fuselage

The web of the main spar is totally lost.

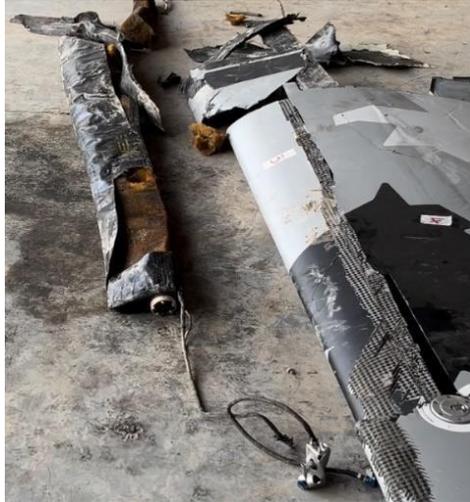
Figure 8: LH Fuel Tank

7.1 LH Fuel Tank. The bladder of the LH fuel tank appears to be torn apart in correspondence of the filler cap. The rest of the damage is probably due to the ground impact with the main wreckage.

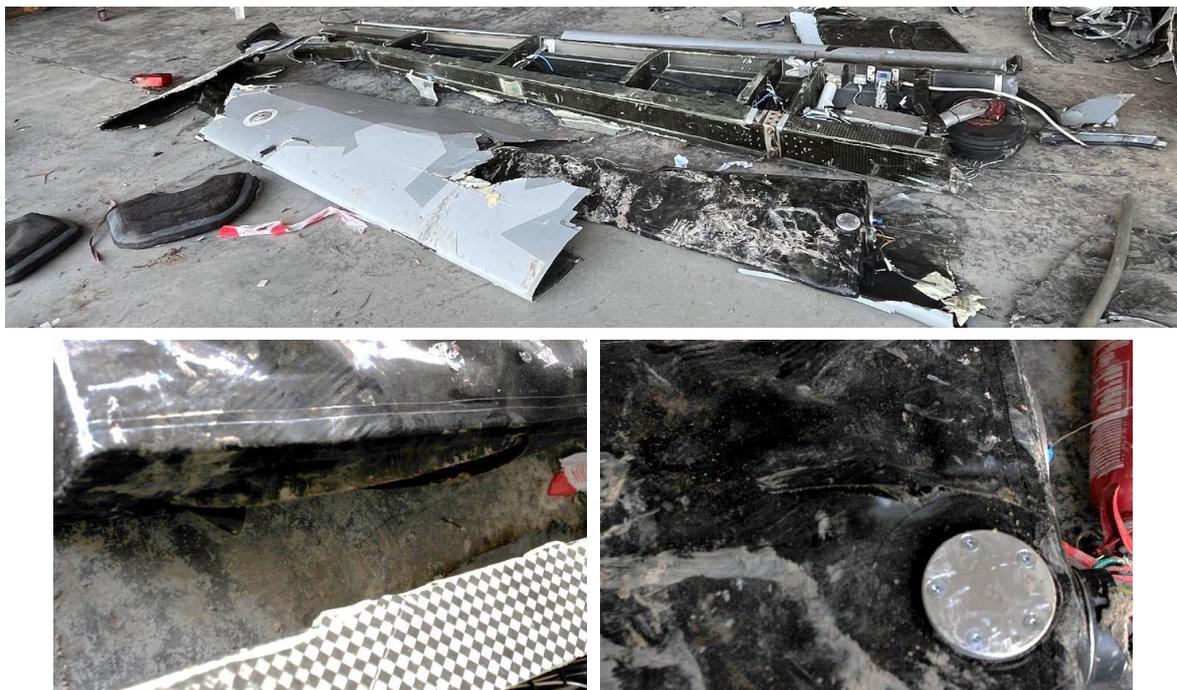
Figure 9: RH Fuel Tank

7.2 RH Fuel Tank. The RH fuel tank appears in good condition. There is no sign of collapse. Signs of rupture are found in the inner part of the tank.

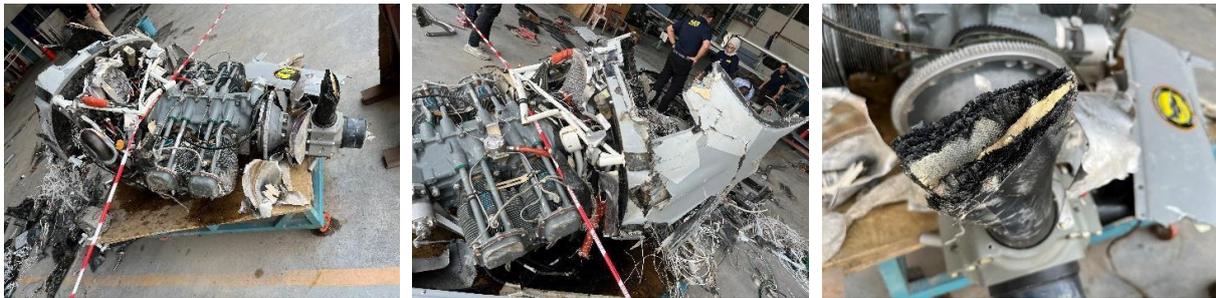
Figure 10: Engine Compartment and Propeller

The engine compartment was found two metres under the ground. All damages appear to be caused by the high energy ground impact. Two blades were found cracked around the root. One blade is missing from the rotating shaft.

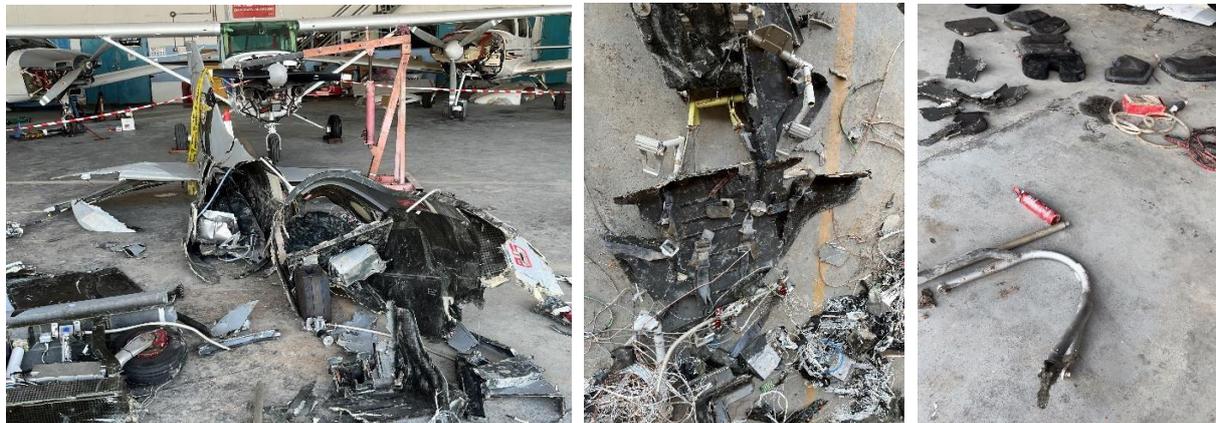
Both cockpits were found destroyed by the high energy ground impact. The roll bar and the seat cushions are retrieved as shown below.

Figure 11: Cockpit (Destroyed)

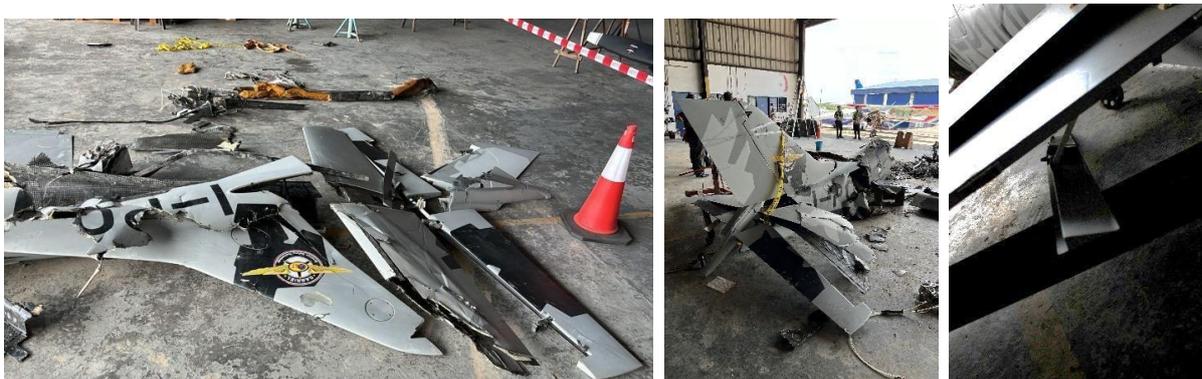
The rudder was found detached from the vertical stabiliser through the hinges. The horizontal stabiliser was found detached from the fuselage. The elevator was partially detached from the horizontal stabiliser through the hinges. The elevator trim was found detached from the elevator through the hinges. The lever to the trim motor was found in place.

Figure 19: Tail Destroyed (Left), Tail Reconstructed (Middle),
Trim Tab (Right)

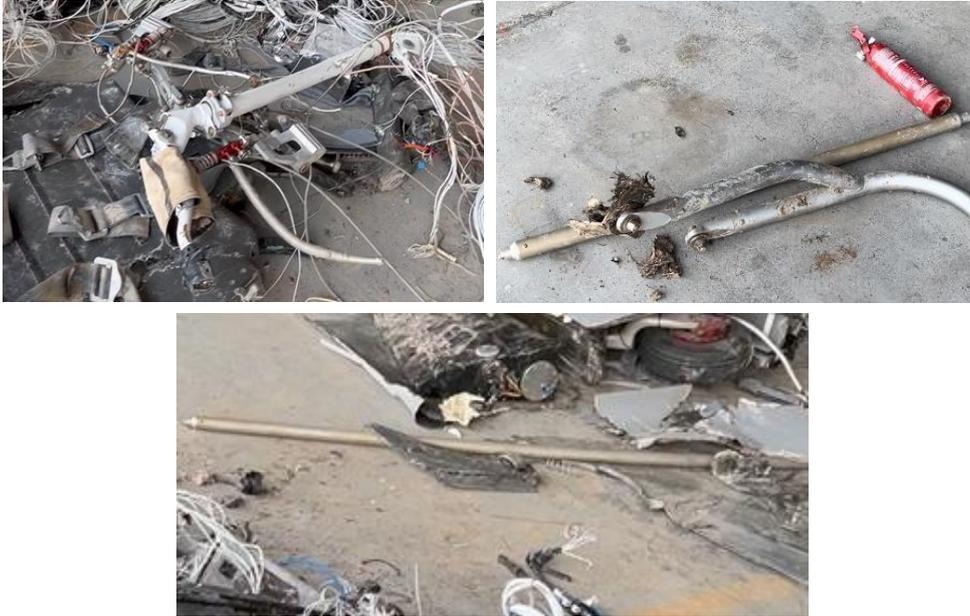
12.1 Longitudinal. All connecting rods are found disconnected from the forks (weakest elements).

Figure 20: Longitudinal Control: Control Column (Top Left),
First Connecting Rod (Top Right), Last Connecting Rod (Bottom)

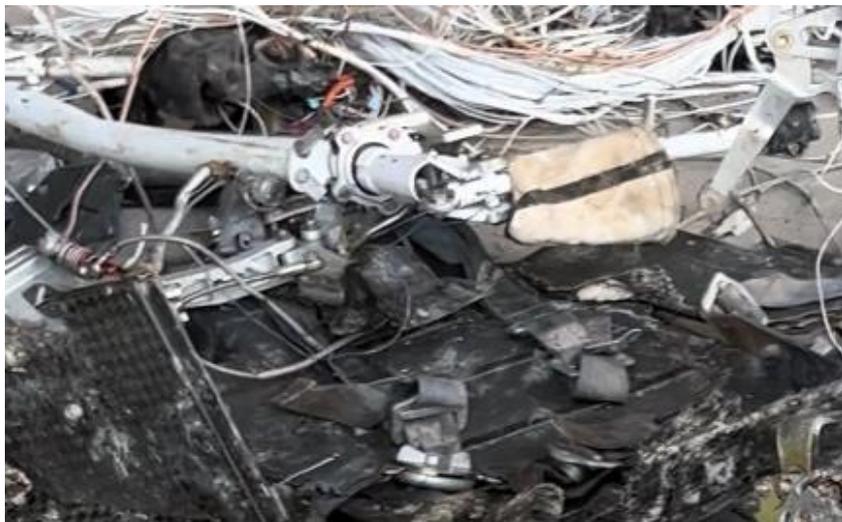
12.2 Lateral. The connecting forks to the control column are broken, probably due to high energy impact. The end connecting rod is detached from the bellcrank (refer to paragraph 3).

Figure 21: RH and LH Aileron Connecting Forks to The Control Column

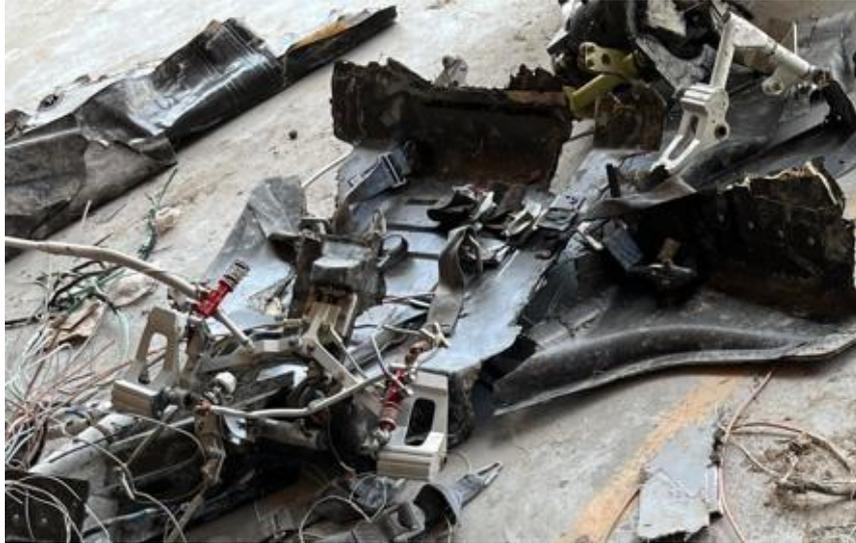
Figure 22: Front and Rear Pedal Assembly

12.3 Directional control. The forward and aft pedal systems, and their connecting elements are found broken, compatible with the high energy impact,

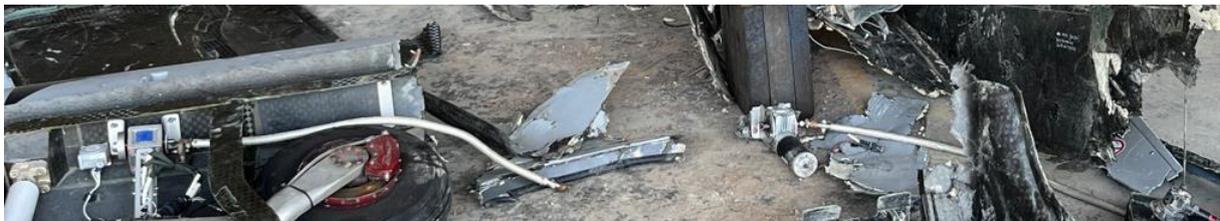
12.4 Flap Control. The flap motor is found detached from the rear spar, compatible with high energy impact. The RH connecting rod is disconnected from the gear motor and from the wing flap actuator by the rotating joints. The RH connecting is bent, probably due to the in-flight RH wing detachment.

Figure 23: Flap Control System: Flap Motor and Connecting Rods

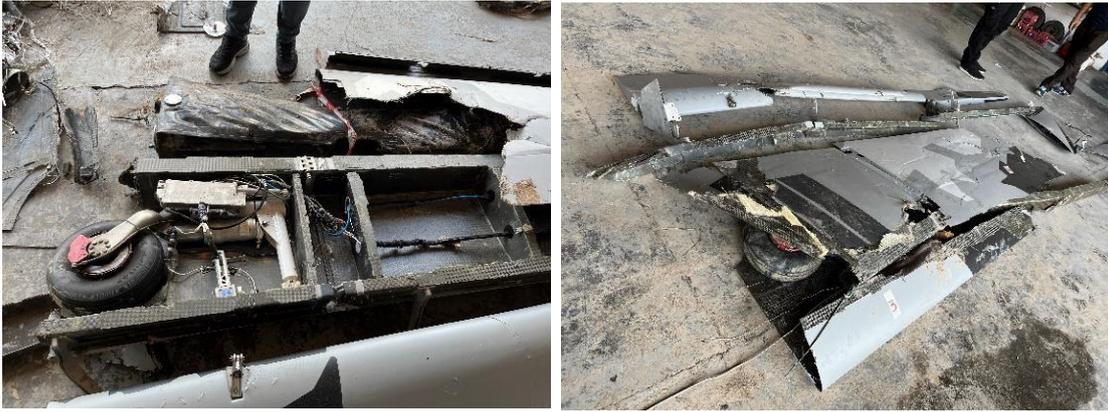
Figure 24: Main Landing Gear (LH and RH)

The RH Main Landing Gear (MLG) was found installed in its compartment (RH wing box) apparently in retracted position. The LH MLG was found attached on the LH wing main spar only. The Nose Landing Gear (NLG) was found installed in its position (engine mount), apparently in retracted position.

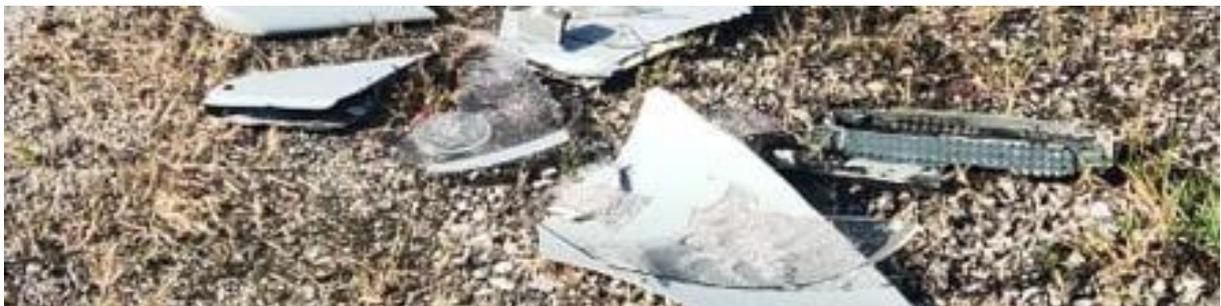
Fragments of the canopy was found at or around Site 3. The front canopy handle was retrieved. The position of the handle was not closed. However, the opening system was broken.

Figure 26: Fragments of Canopy Found at or Around Site 3

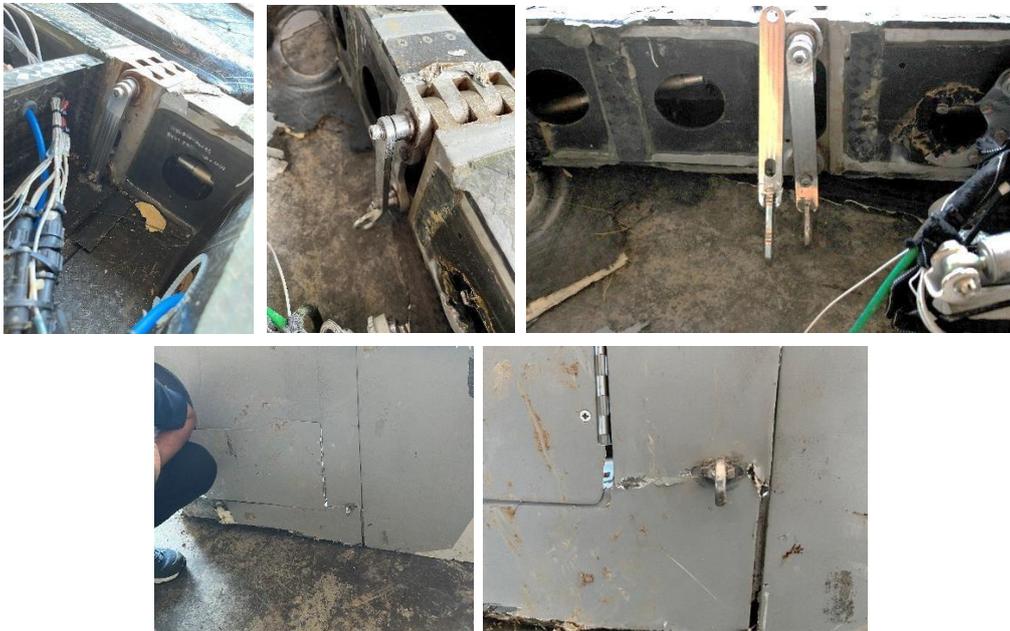
As discussed in paragraph 1.6.5, two 'tie-down ring' parts were installed at the joints of the wing fitting and main spar, i.e. one 'tie-down ring' on each wing. These parts are not part of the approved aircraft configuration.

Figure 28: Non-Conforming Parts Installed on The RH And LH Wing Fitting

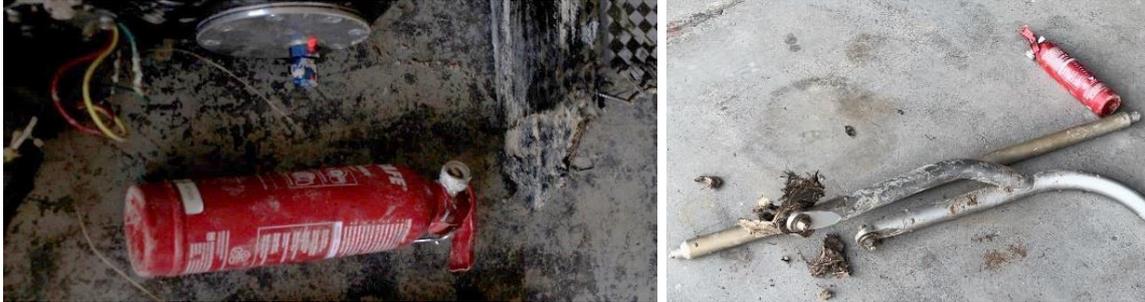
Figure 29: Fire Extinguisher

A fire extinguisher was found together with the wreckage. It was not part of the approved configuration. There is no provision of a storage place in the cabin for the fire extinguisher.
