AIRCRAFT ACCIDENT REPORT NO: 1/77

CHIEF INSPECTOR OF ACCIDENTS & SAFETY,  
DEPARTMENT OF CIVIL AVIATION,  
MALAYSIA,

MCDONNELL DOUGLAS DC8 (SUPER 62) - JA8051 -  
REPORT ON THE ACCIDENT NEAR KUALA LUMPUR  
INTERNATIONAL AIRPORT, SUBANG, SELANGOR  
ON 27TH SEPTEMBER, 1977.  
03° 11'N 101° 30'E

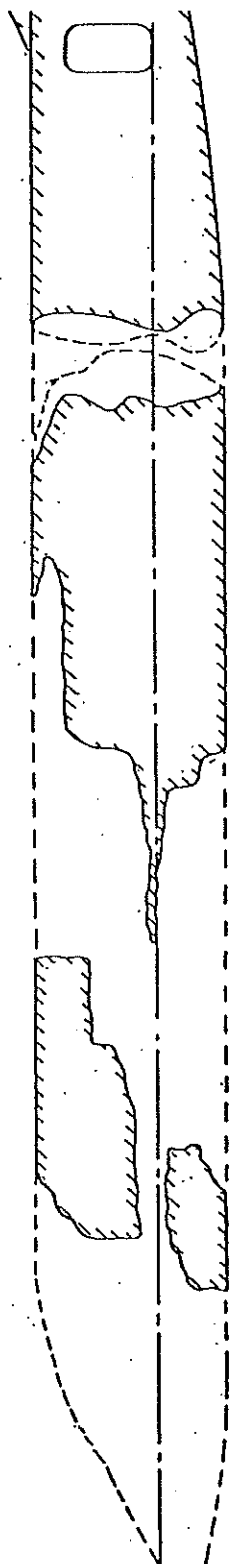
# MAJOR SECTIONS OF WRECKAGE

The wreckage lay with its main components roughly in their normal relationship and displaced to port from its original track. The nose area and forward fuselage had disintegrated in a first tree collision near the top of the hill. Below them, the fuselage centre section, still attached to the port wing and inner starboard wing was almost completely burnt out. A large portion of the starboard wing, with the engine pylons attached, had broken away but lay close to the fuselage. All four engines lay separated behind their respective pylons in approximate line of track.

The tail section had broken off at station 1220 and was comparatively lightly damaged.

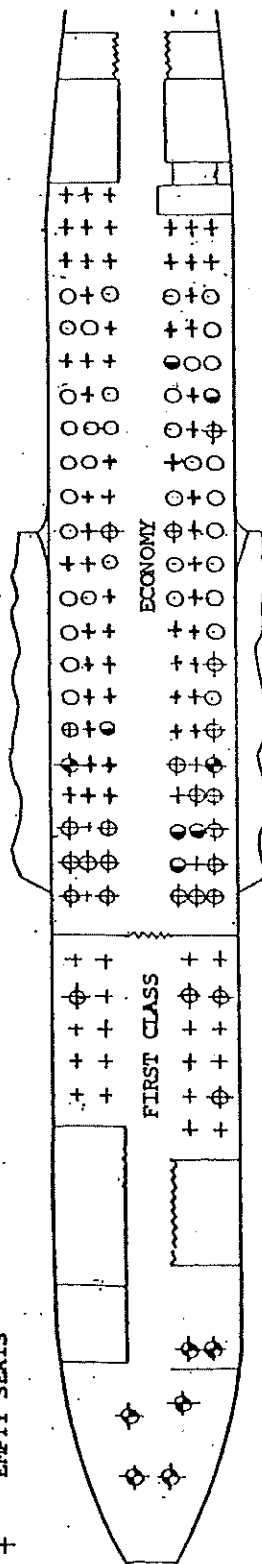
The passengers and crew were all seated with their safety belts fastened for landing when the aircraft struck the ground. The interior cabin lights had also been dimmed for landing in accordance with JAL operating procedures. In the tail section, seat rows 24 (starboard only), and rows 25 to 28 were still in place. Several of the locking bars had been dislodged and the seats held secure only by their rear attachments. The seat belts were all found unfastened, undamaged and with their anchor points secure on passenger evacuation after the accident. The

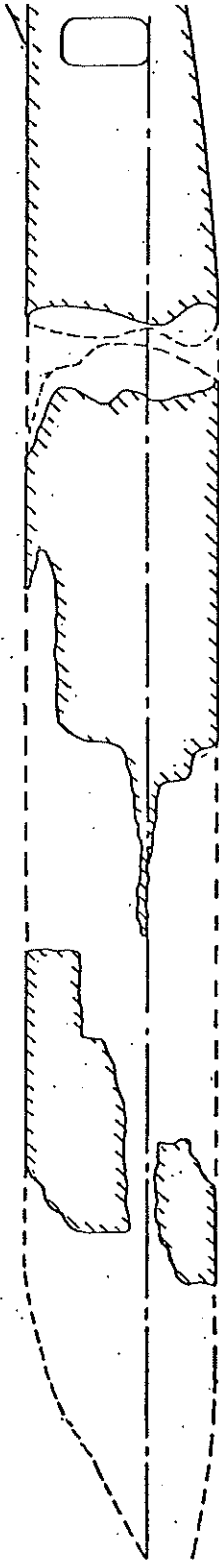
# MAJOR SECTIONS OF WRECKAGE

The wreckage lay with its main components roughly in their normal relationship and displaced to port from its original track. The nose area and forward fuselage had disintegrated in a first tree collision near the top of the hill. Below them, the fuselage centre section, still attached to the port wing and inner starboard wing was almost completely burnt out. A large portion of the starboard wing, with the engine pylons attached, had broken away but lay close to the fuselage. All four engines lay separated behind their respective pylons in approximate line of track.

The tail section had broken off at station 1220 and was comparatively lightly damaged.

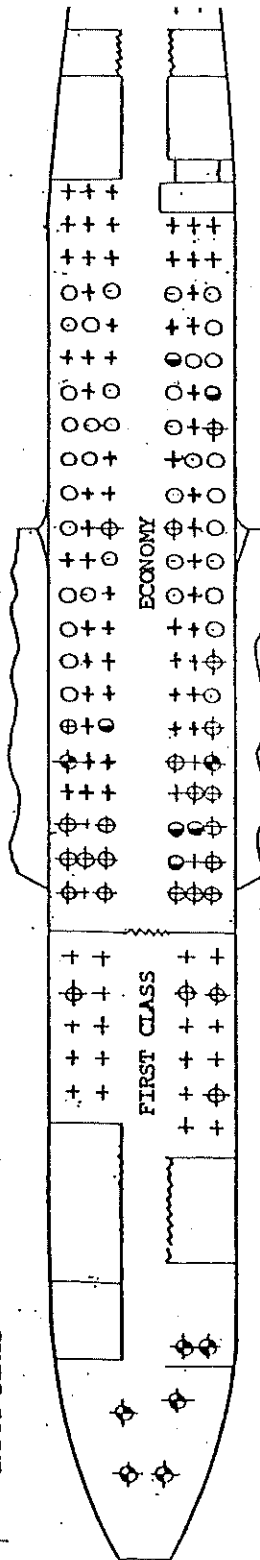
The passengers and crew were all seated with their safety belts fastened for landing when the aircraft struck the ground. The interior cabin lights had also been dimmed for landing in accordance with JAL operating procedures. In the tail section, seat rows 24 (starboard only), and rows 25 to 28 were still in place. Several of the locking bars had been dislodged and the seats held secure only by their rear attachments. The seat belts were all found unfastened, undamaged and with their anchor points secure on passenger evacuation after the accident. The
