DEPARTMENT OF CIVIL AVIATION

FOKKER F.27 9M - MCI

REPORT OF THE ACCIDENT AT PENANG INTERNATIONAL AIRPORT

ON 30th. DECEMBER 1981

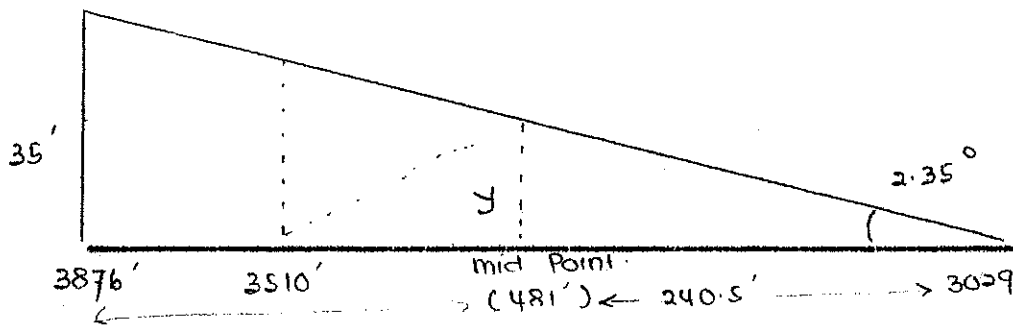
With the final contact point at (in this case would be at 3910 feet - 400 feet = 3510 feet, or (1070.12 meters). The height above the ground is calculated to be "y" = see diagrams.

To Obtain y from the diagram.

$$\begin{aligned} \text{Tangent } 2.35^\circ &= \frac{y}{240.5} \\ &= 9.9 \text{ feet.} \end{aligned}$$

2.1.21. From calculation it is possible to conclude that the aircraft could not exceed more than 9.9 feet above the runway and the eye witnesses confirmed that this figure is very close. This height is more than sufficient to initiate the landing gear retraction sequence.
