JABATAN PENERBANGAN AWAM

AIRCRAFT TYPE & REGISTRATION : PIPER PA28-180 9M-ASK  
ENGINE : AVCO LYCOMING O-360A4A  
REGISTERED OWNER : MR. M.K. GRAHAM  
SABAH FLYING CLUB  
KOTA KINABALU  
CREW : AIRCRAFT COMMANDER - FATAL  
PASSENGERS : NONE  
PLACE OF ACCIDENT : PRIVATE AIRSTRIp, SABAH PALM ESTATE  
APPROX 177°22'E 5°97'N  
DATE AND TIME : 6TH FEBRUARY 1982, BETWEEN 16.00 AND  
17.00 LT.

SUMMARY

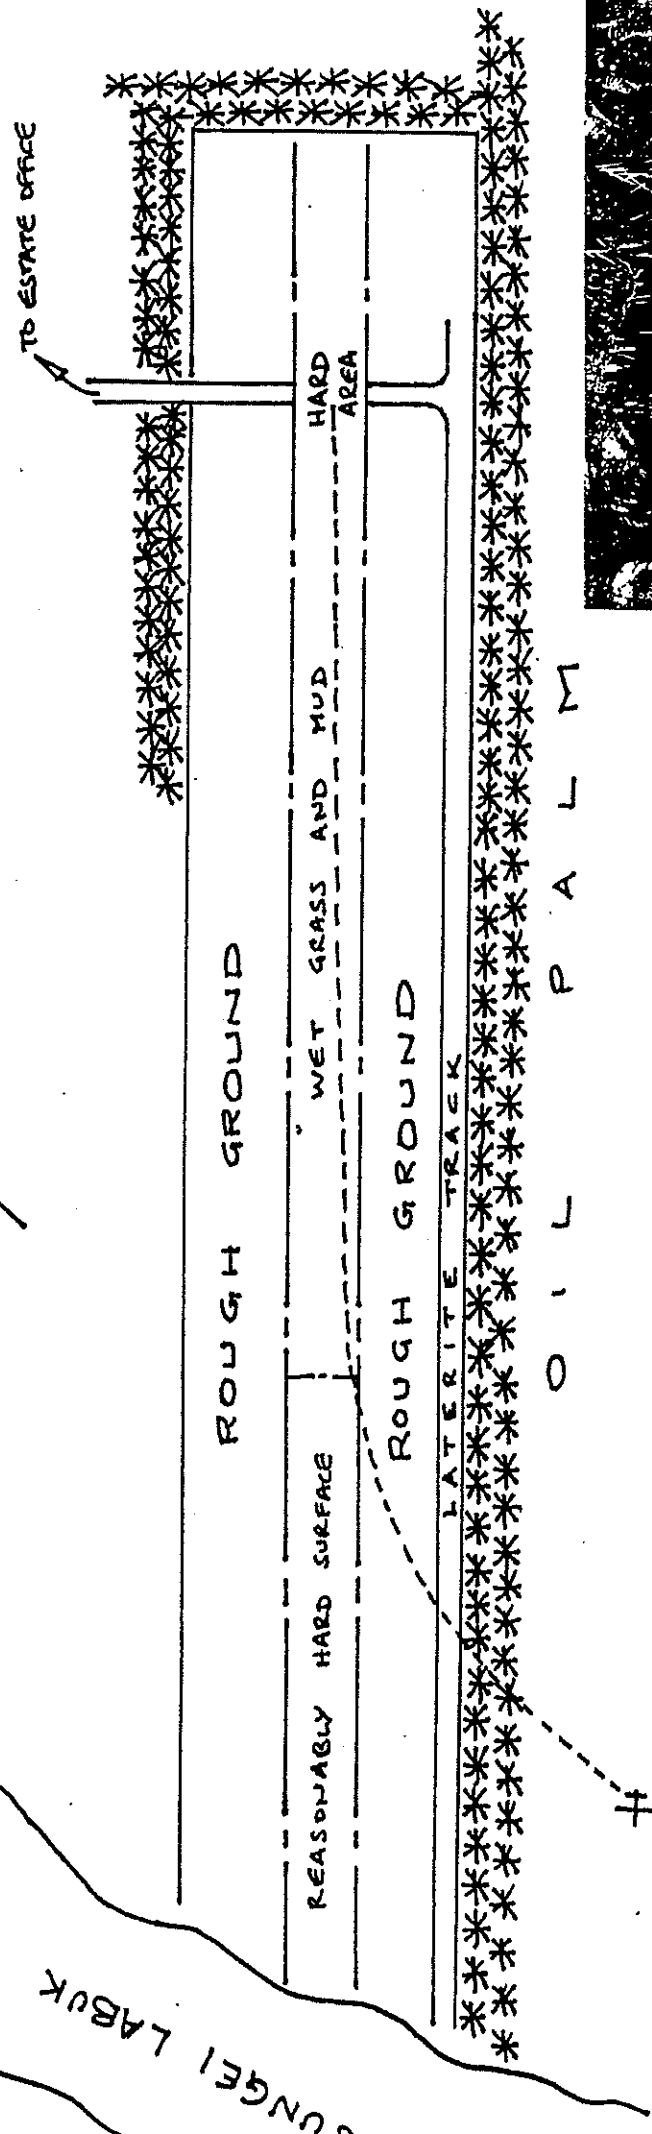
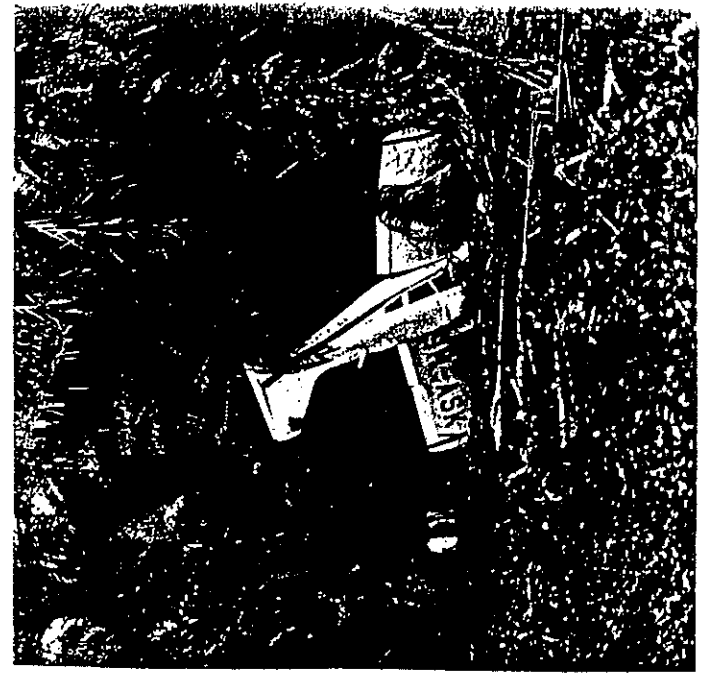
SABAH PALM AIRSTRIP ~ NOT TO SCALE

The take-off marks ran for approximately 1100 feet, starting from a point slightly to the left of centre and then curving towards the left hand, eastern, edge of the strip to give a heading divergence of between  $20^{\circ}$  and  $30^{\circ}$  from runway centreline. From the estimated take-off point to the edge of the oil palm on the divergent heading is a distance of approximately 190 feet, with the point of impact somewhat further again amongst the palms.
