**AIRCRAFT ACCIDENT REPORT 01/12**

**REPORT ON THE ACCIDENT TO SEBIRO HOLDING SDN BHD  
AT BATANG LUPAR RIVER, KUCHING, SARAWAK, MALAYSIA  
ON 20 July 2012**

**Aircraft Type:** EC120B

**Aircraft Registration:** N8899

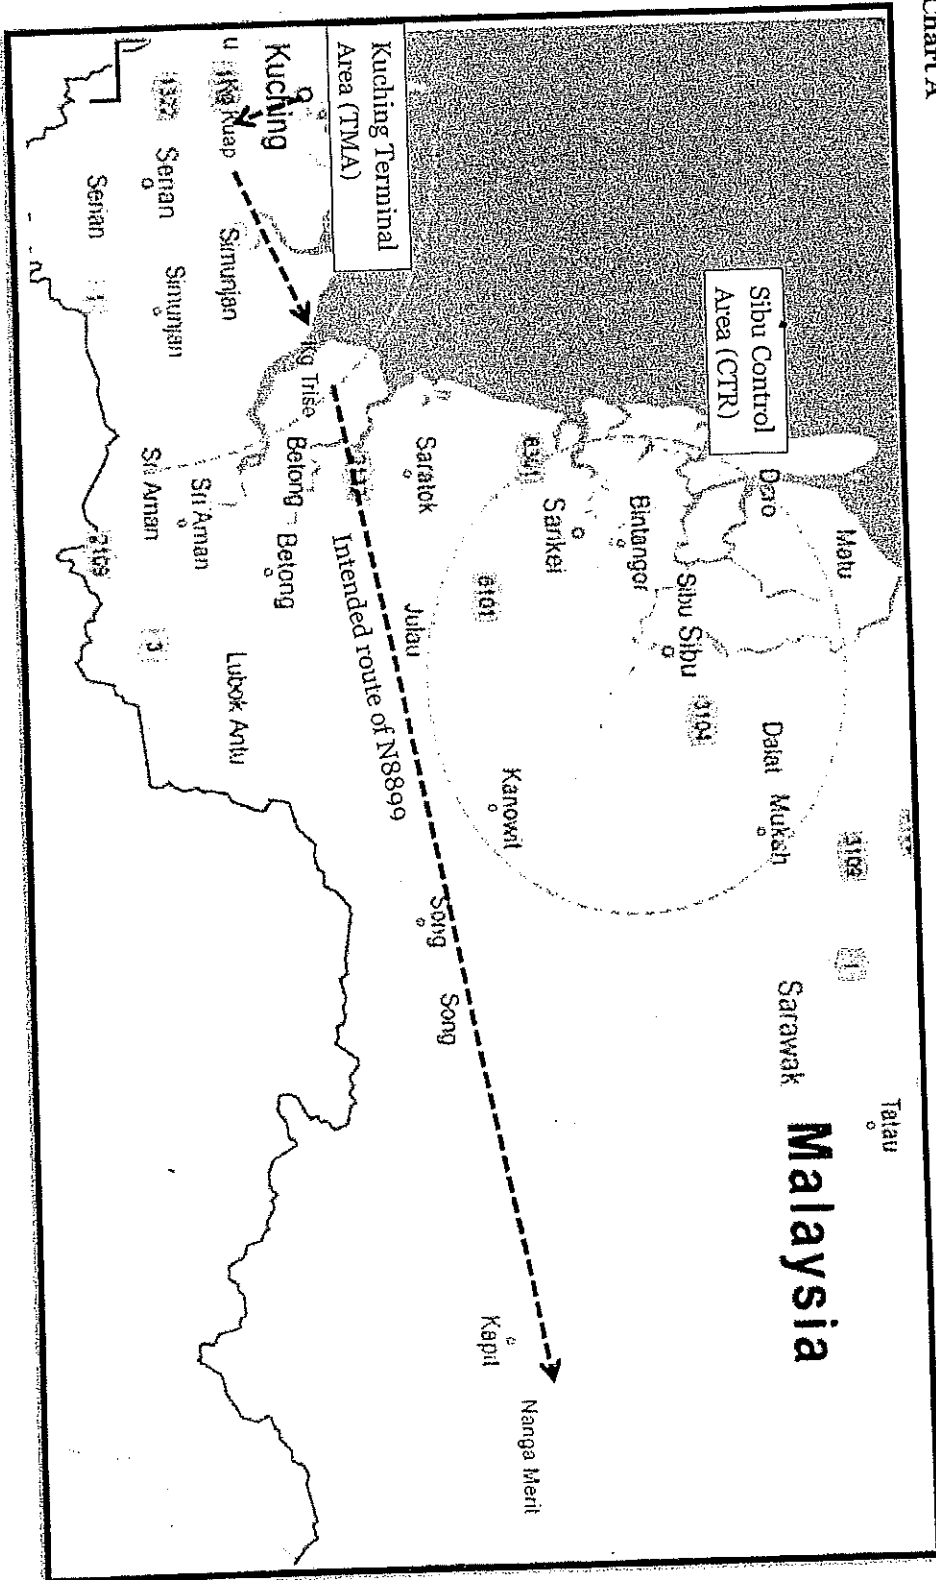
Chart A

The helicopter originally lifted off from Simpang Tiga helipad at 0007UTC (08:07am LT) and landed in Kuching Aerodrome at 0010UTC (08:10am LT) It was airborne again at time 0057UTC (08:57am LT) bound for Nanga Merit. The flight plan noted that it will be on ground for 1 hour at Nanga Merit before proceeding to Sibü (Attachment C). The approximate routing of N8899 and associated significant locations are depicted in Chart A.
