**AIRCRAFT ACCIDENT
FINAL REPORT
A 07/18**

**Air Accident Investigation Bureau (AAIB)
Ministry of Transport, Malaysia**

**Accident involving Rotorcraft Helicopter Robinson R66
Registration 9M-RML
at Sultan Abdul Aziz Shah Airport,
Subang, Kuala Lumpur
on the 15th August 2018**

ACCIDENT REPORT NO. : A 07/18

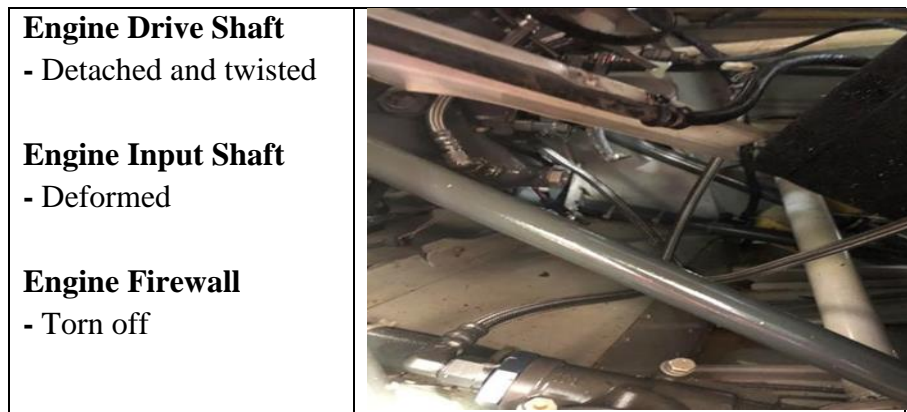
Figure 7: Tail rotor blade, vertical stabiliser and tail boom

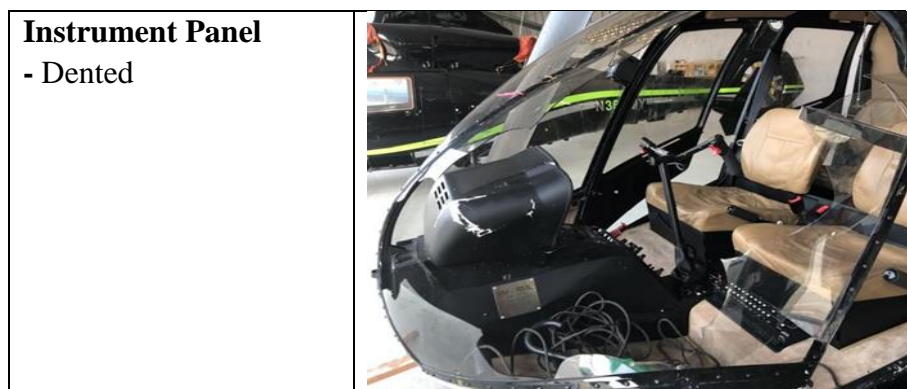
Figure 8: Engine drive shaft, engine input shaft and engine firewall

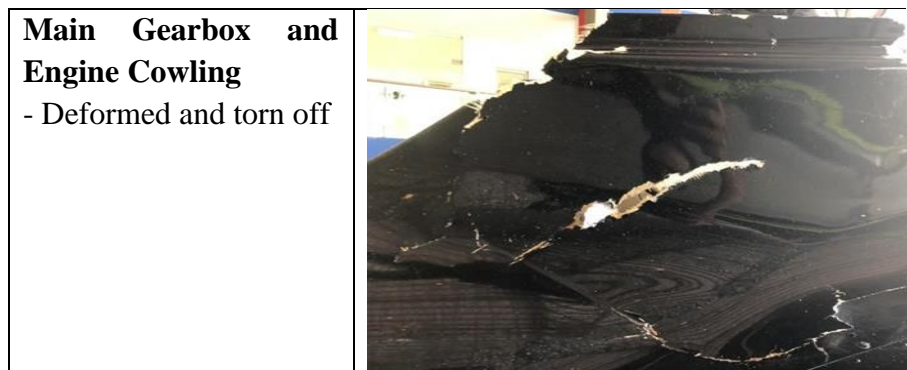
Figure 9: Instrument panel

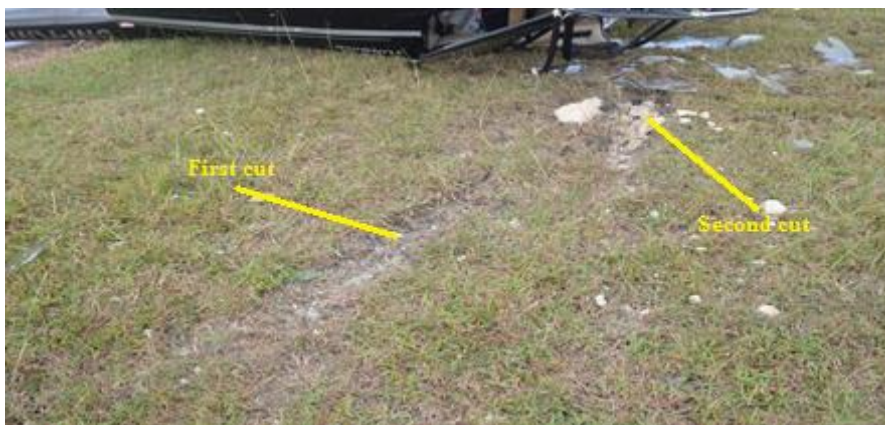
Figure 10: Main gearbox and engine cowling

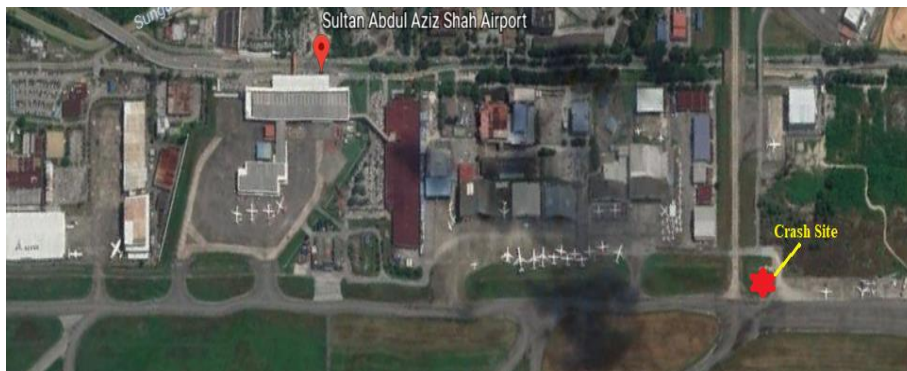
The quick reaction of the PIC causing excessive movement of the cyclic to the left subsequently tilt the main rotor blades downwards on the upslope area. Upon inspection of the area, there were two strike marks (Figure 11) found on the ground indicating the blade tips had struck the ground at high speed.

Figure 11: Damage to the ground area due to the blade strike

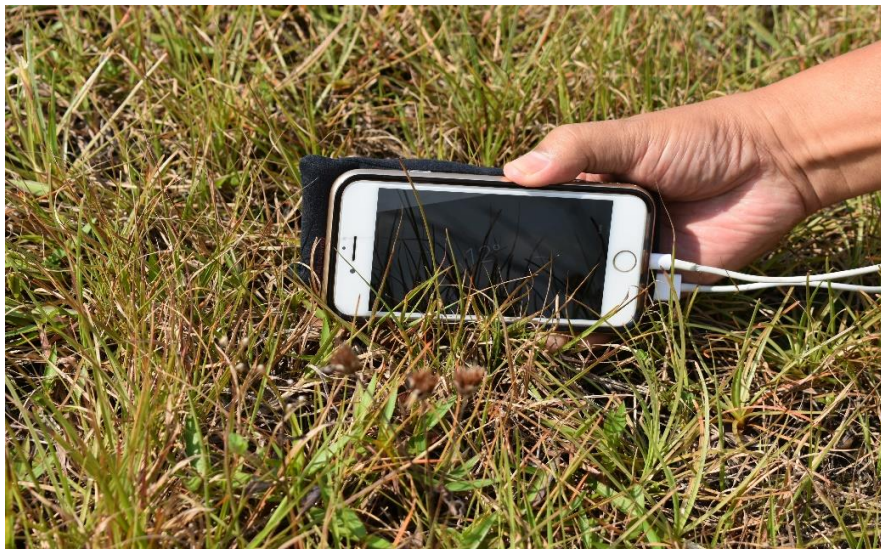
This place was accepted by trainers due to its nature of uneven surface with sloping angles varies from 8° to 12° as per shown below.

Figure 12: Investigator is measuring the slope angle

It should also be emphasized here that the maximum recommended rate of angle for sloping ground exercise is 5° , while the actual angle of slope for the surface used during the occurrence is approximately from 8° to 12° which is on the high side. However, the angle of the slope couldn't be accurately determined by the pilot while flying the helicopter during hover.

4.2 The airport operator (MAHB) is to designate a suitable place for helicopter sloping ground exercise and a hovering area for precision flying preferably a slope of 5 degree with a trimmed grass.

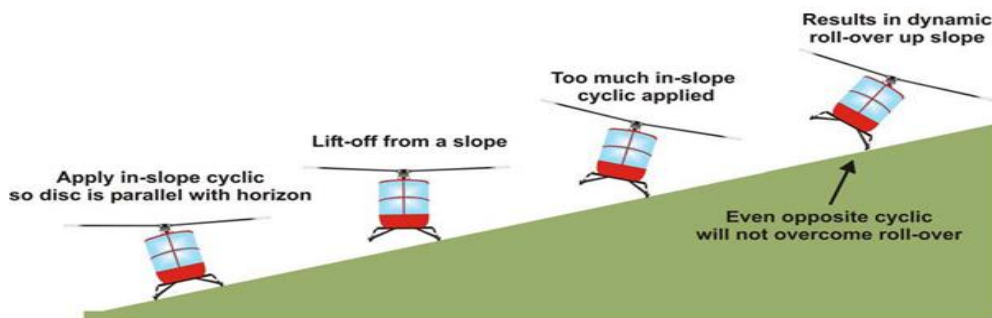
Figure 13: The measurement showing the angle of the slope (12°)

3.1.8 The approximate angle of the slope area for the sloping ground exercise is from 8° to 12°, whereby the maximum recommended angle for sloping exercise is 5°.
