AIRCRAFT ACCIDENT FINAL REPORT
A02/19
Air Accident Investigation Bureau (AAIB)
Ministry of Transport, Malaysia

BD100 Challenger Registration 9M-TST
at Sultan Abdul Aziz Shah Airport, Subang, Selangor
on 18 March 2019

ACCIDENT REPORT NO. : A 02/19

OPERATOR	:	BERJAYA AIR
AIRCRAFT TYPE	:	BOMBARDIER BD100-1A10
NATIONALITY	:	MALAYSIA
REGISTRATION	:	9M-TST
PLACE OF OCCURRENCE	:	SULTAN ABDUL AZIZ SHAH AIRPORT, SUBANG, KUALA LUMPUR
DATE AND TIME	:	18 MARCH 2019 AT 0311LT

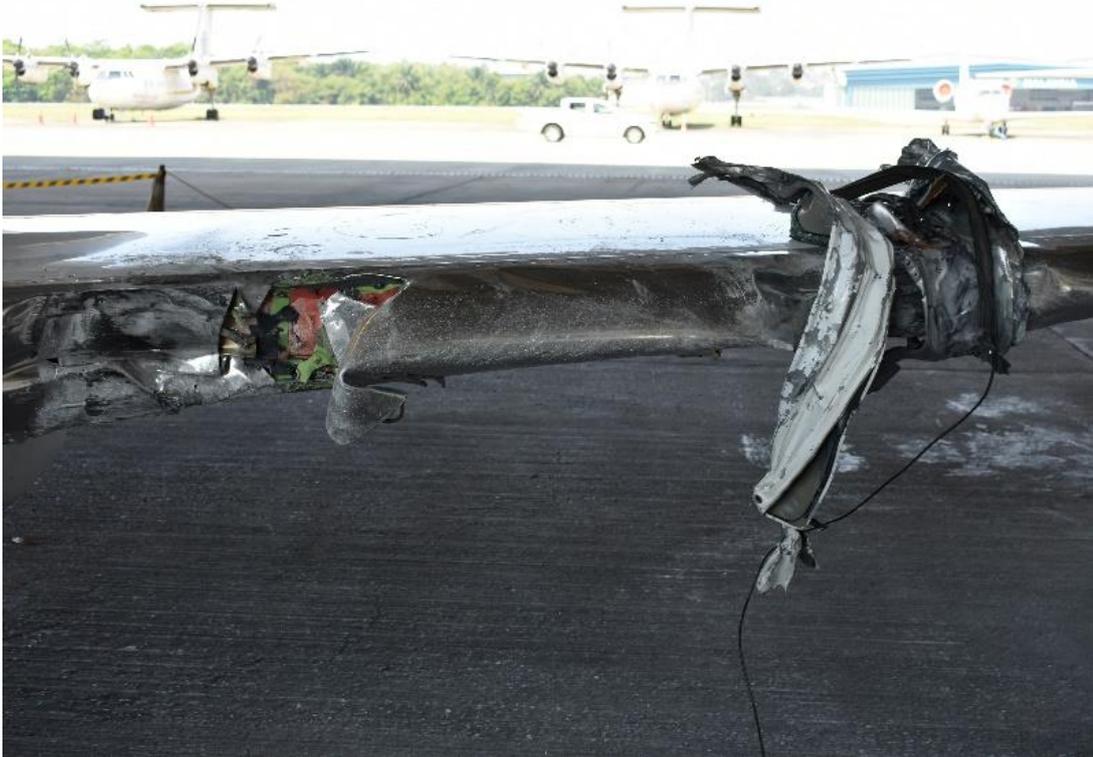
Severe damage to LH mid wing leading edge and front Spar.

Picture 1 – Mid wing leading edge damages with parts of Kembara vehicle's roof stucked to it.

One ground vehicle severely damaged after being hit by the aircraft with the roof was totally ripped off and parts of the roof stuck on the left wing leading edge of the aircraft.

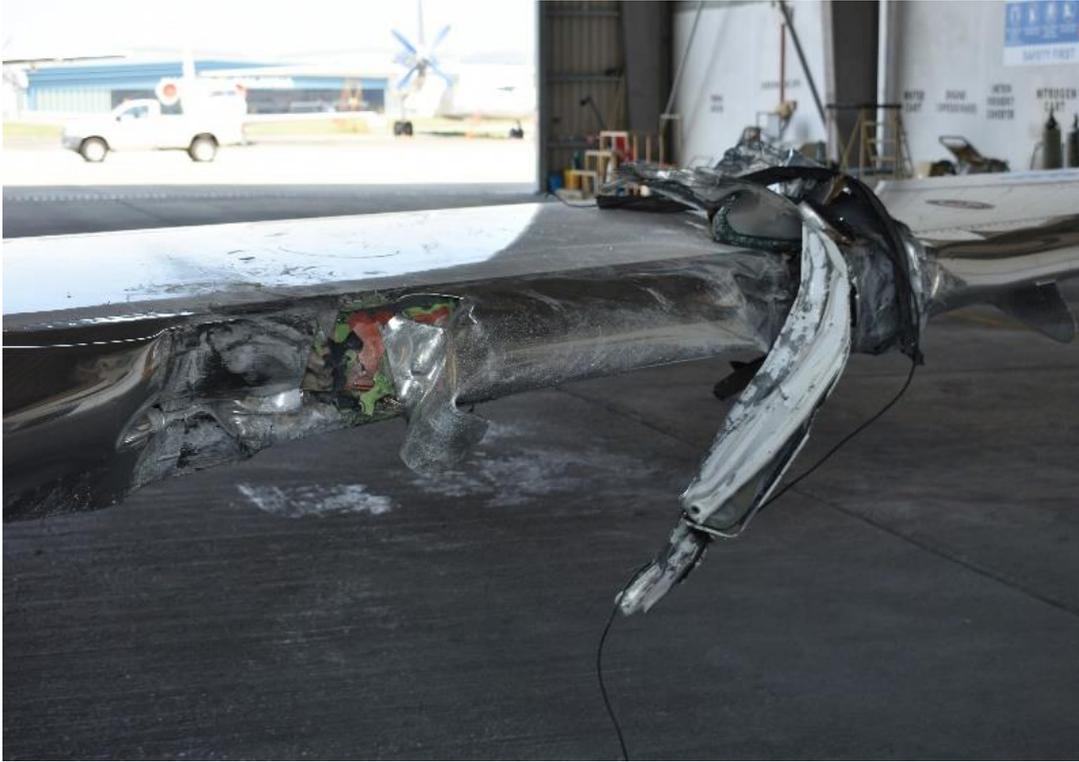
Severe damage to LH mid wing leading edge

Picture 2 – LH mid wing leading edge

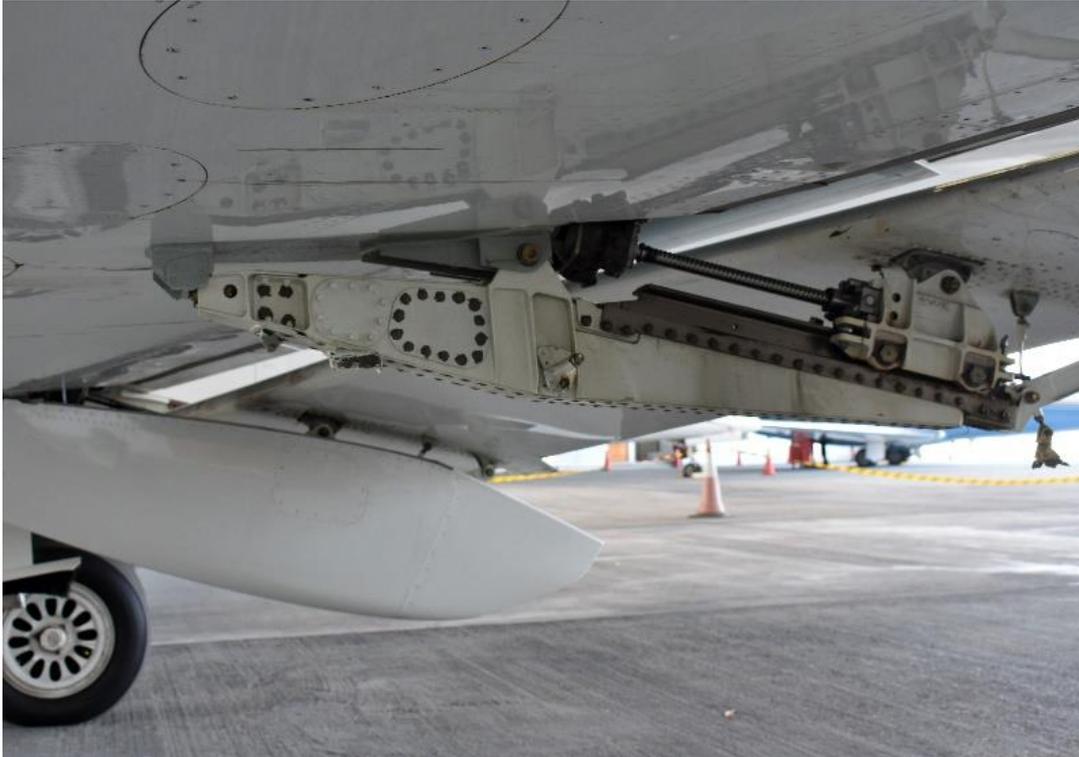
Lower wing surface and fuel panel dented and numerous gauges and scratches on upper and lower wing surface areas.

Picture 3 – Damages to the lower wing surface.

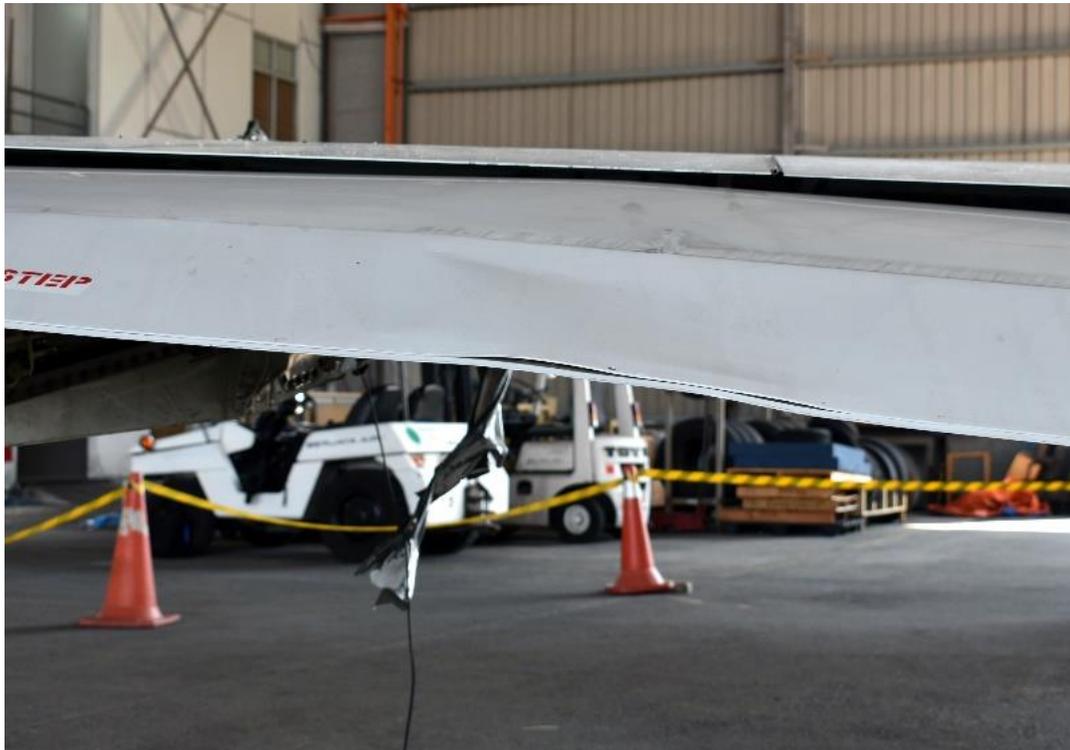
Damages to the trailing edge flaps and flaps carriage.

Picture 4 – Trailing edge flaps and flaps carrier

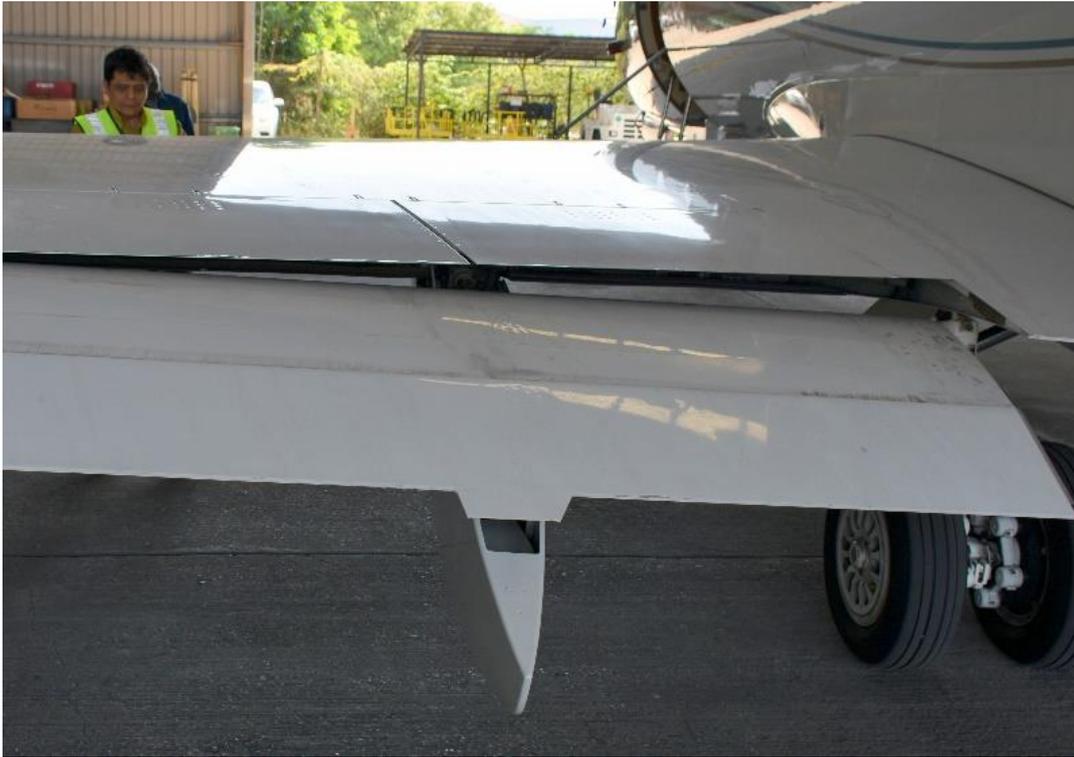
Damages to the trailing edge flaps and flaps carriage.

Picture 5 - Trailing edge flaps and flaps carrier

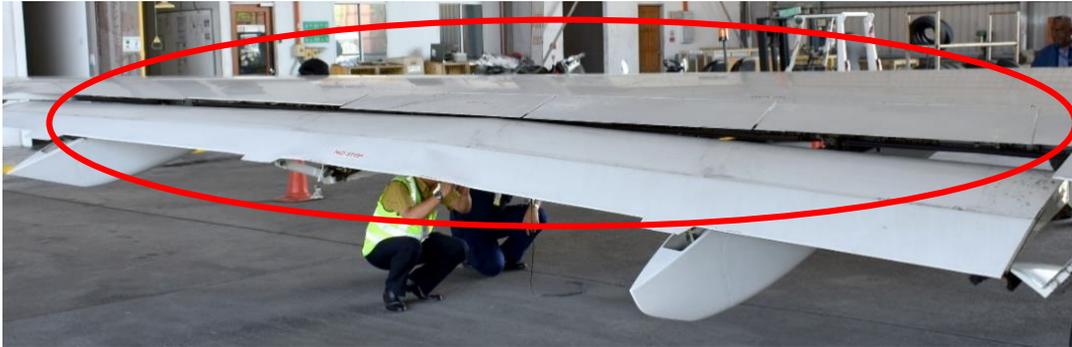
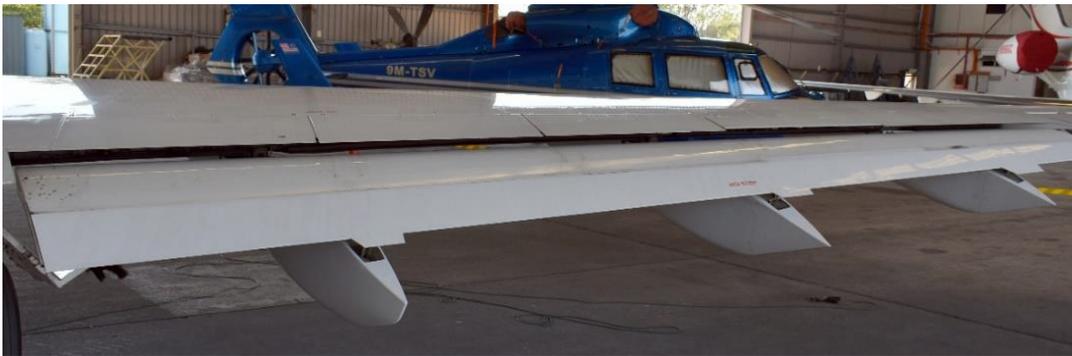
Comparison between left wing (top) and right wing (bottom) of the aircraft

Picture 6 - The flaparon of the Left Wing was badly damaged as compared to the Right Wing Flaparon

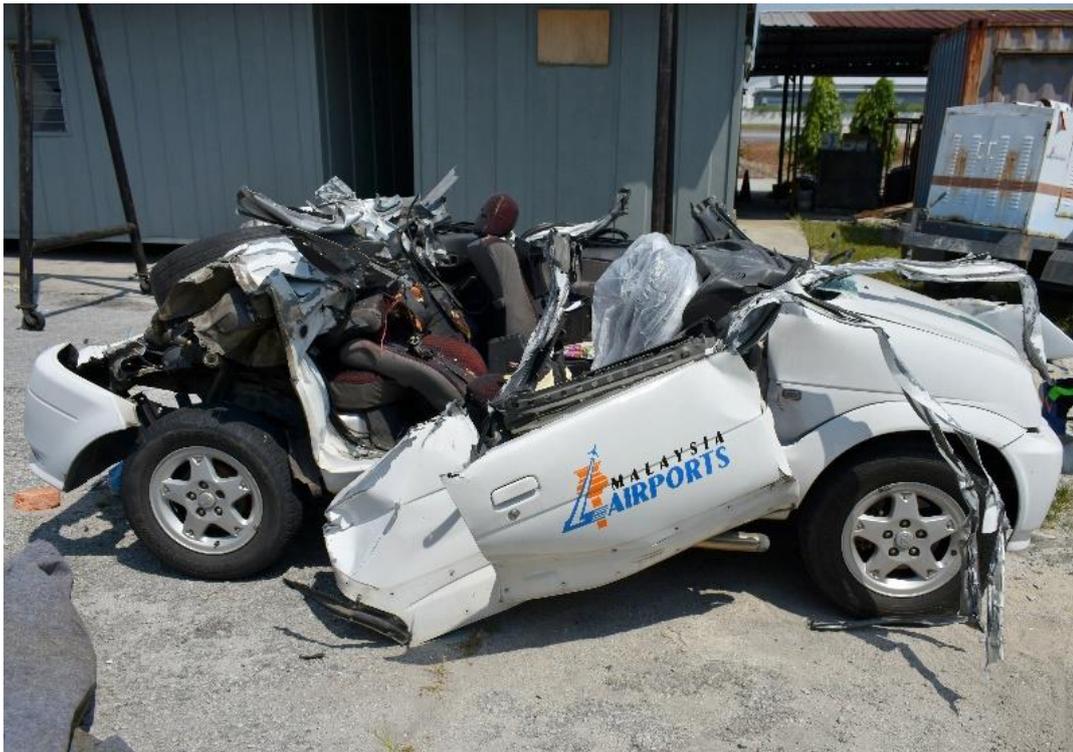
The vehicle was hit by the aircraft from the rear. The top parts were ripped off totally with some parts stuck to the left wing of the aircraft.

Picture 7 - Perodua Kembara belonging to MASB

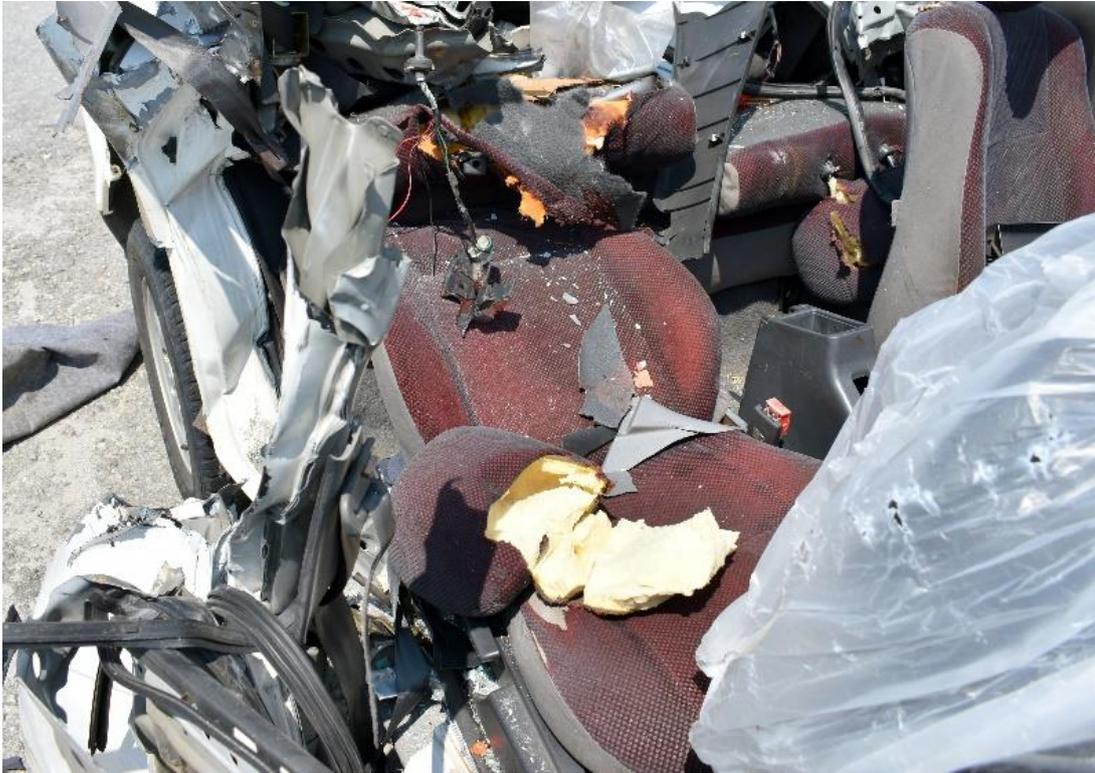
AFRS had to cut off and remove the driver's side door in order to remove the victim from the vehicle

Picture 8 – The driver's seat was in reclining position

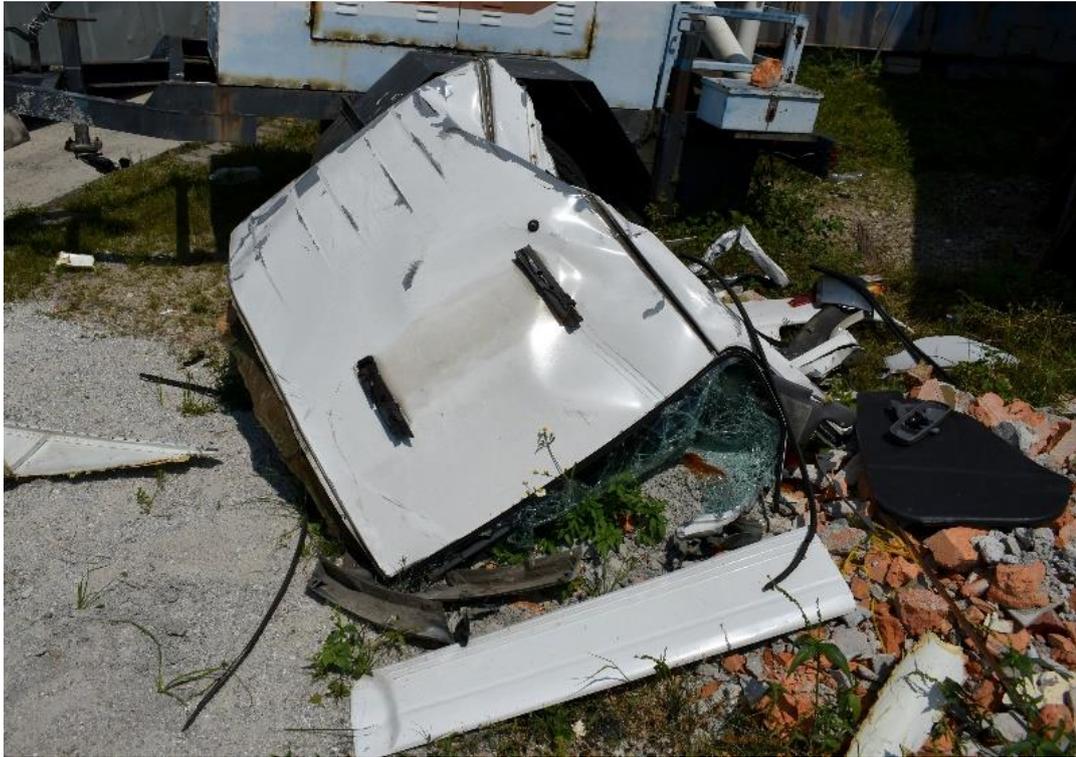
The top part of the vehicle

Picture 9 – The roof was totally ripped of from the vehicle
