**AIRCRAFT ACCIDENT  
FINAL REPORT**

**A 03/24**

**Fixed-Wing Aircraft Blackshape BK 160TR, Registration I-POOC  
at Kapar, Selangor  
on 13 February 2024**

**FINAL REPORT NO: A 03/24**

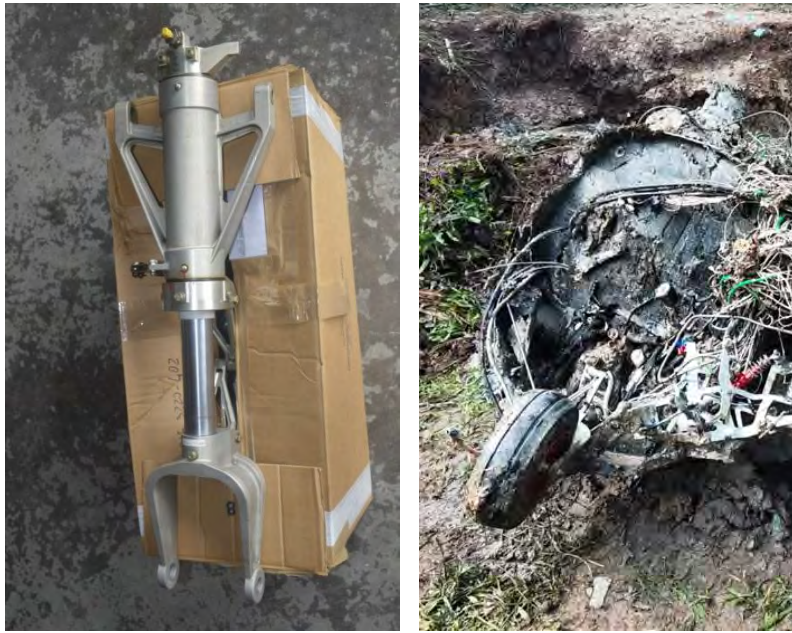
- **Nose Landing Gear (NLG) Replacement.** The aircraft's NLG was removed and replaced with a new unit by unauthorised personnel in February 2024. This replacement was completed, with assistance from the pilot, shortly before the accident flight on 13 February 2024, which was apparently intended as a test of the newly installed NLG.

Figure 13. Old NLG Found at AAFC Hangar (Left)  
and Newly Installed NLG on Wreckage (Right)

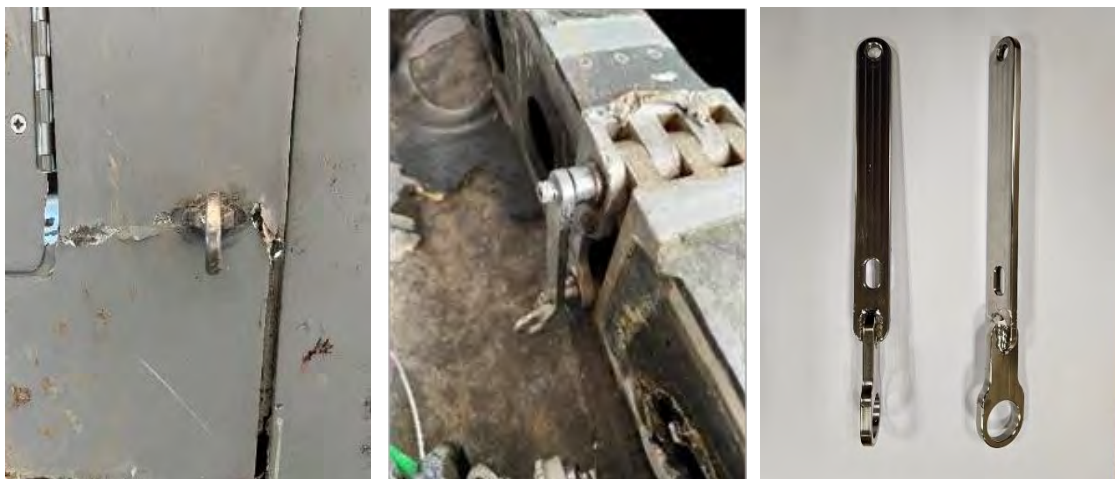
- **Installation of Non-Certified Tie-Down Rings.** Non-certified 'tie-down ring' parts were installed on the underside of each wing, near the main landing gear wheel well. These were bolted through the composite wing skin onto the joint of the wing fitting with the main spar. Witness testimony indicates these parts were installed by the pilot on 23 November 2023.

Figure 14. Tie-Down Ring on the Underside of the RH Wing Near Wheel Well (Left);  
Tie-Down Ring Bolted to the LH Wing Joint (Centre);  
Two New Similar Parts Found at the Pilot's Locker at AAFC (Right)

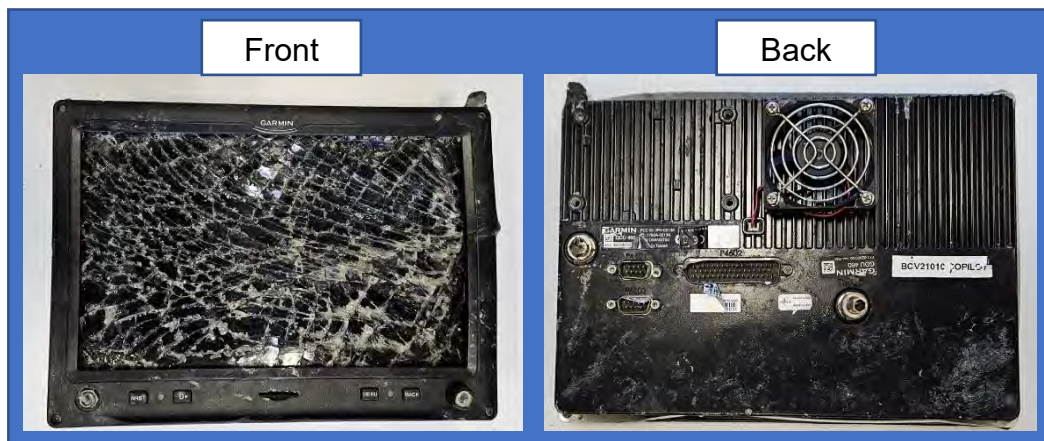
Figure 16. Damaged Garmin G3X GDU 460

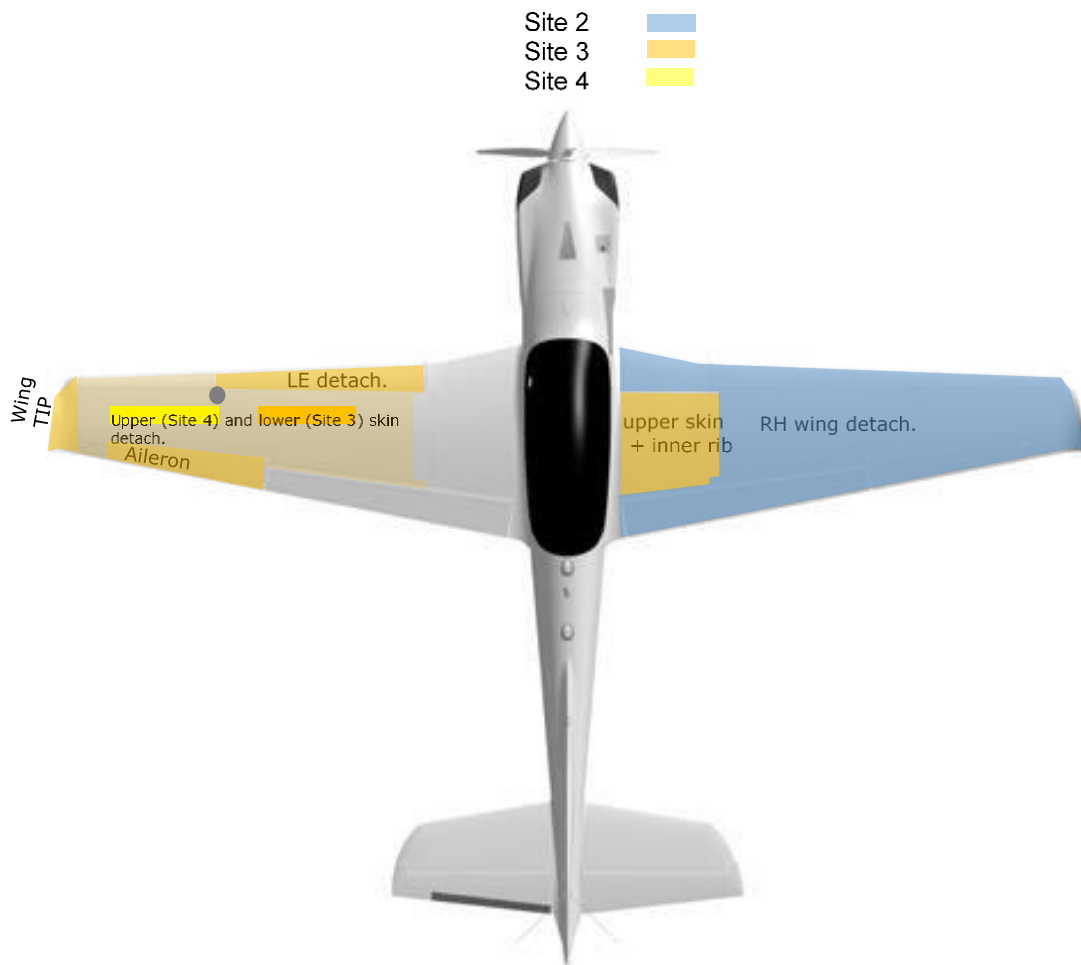
Figure 17 below displays the major separated structural parts found after the accident. Smaller debris, such as canopy fragments at Site 3, are not included in the illustration. Notable damage includes the left (LH) aileron, which detached from its hinges, and the aileron connecting rod, which separated from the bellcrank. The right (RH) wing, which detached at both the front and rear spars, was found at Site 2. The RH wing's inner upper skin, detached along with the inner rib, was found at Site 3. The LH wing's upper skin was located at Site 4, while the lower skin was found at Site 3.

Figure 17. Structural Parts Recovered from Various Sites

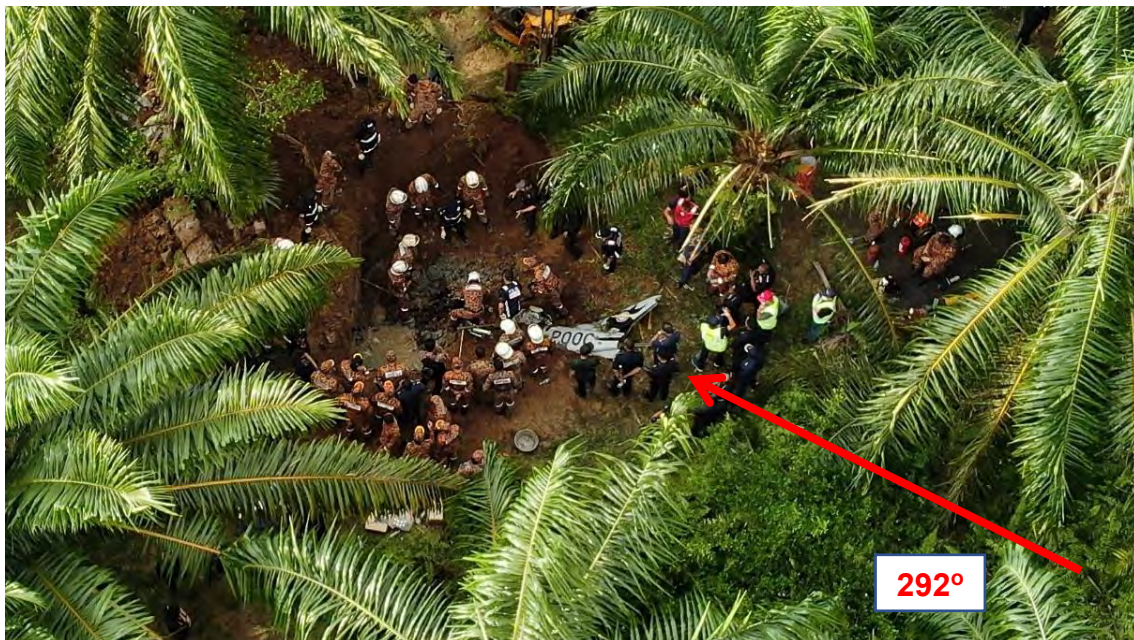
Numerous debris and aircraft parts were scattered around the impact site, within a radius of approximately 50 metres. No evidence of pre-crash or post-crash fire was found on the wreckage at or around the impact point.

Figure 19. Impact Point of Main Wreckage

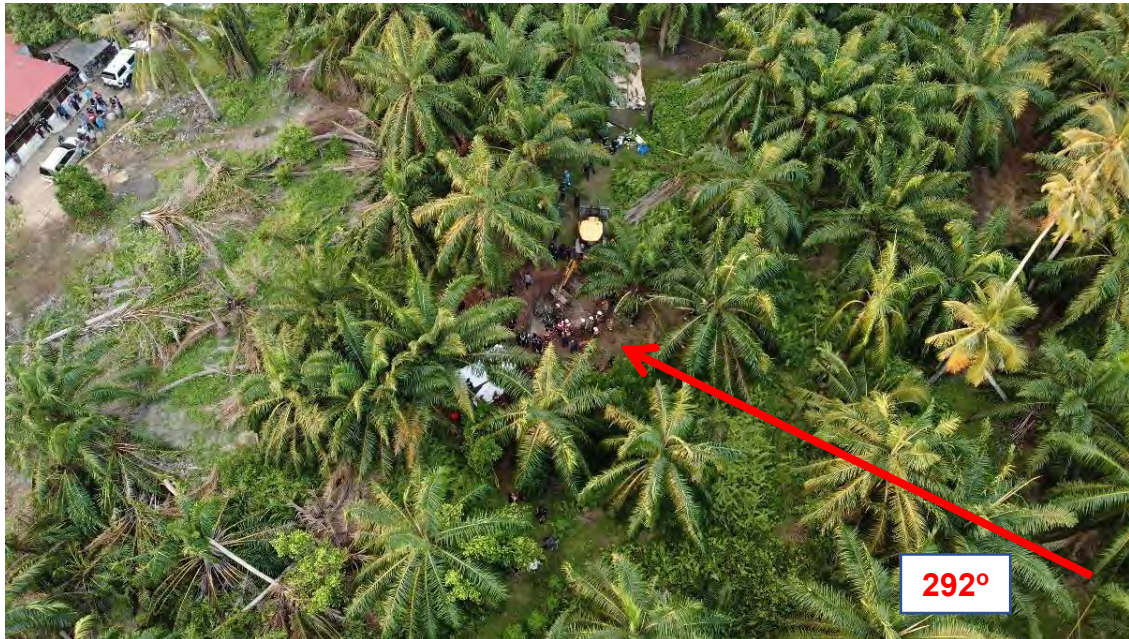
Based on the orientation of the partially buried fuselage, ground markings near the wreckage, and freshly broken branches at the top of an adjacent palm tree, the aircraft impacted the ground at an approximate heading of  $292^{\circ}$ . The vertical angle from the impact point on the ground to the top of the broken branches indicates that the aircraft struck the ground at an approximate  $45^{\circ}$  downward trajectory.

Figure 20. Impact Point of Main Wreckage  
and Travel Direction of Aircraft Impacting Ground

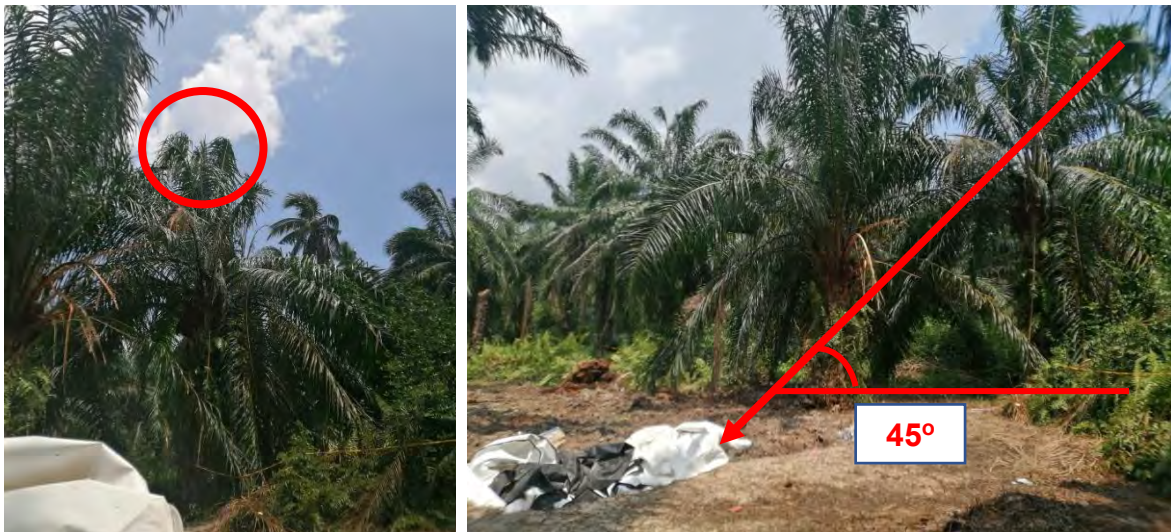
Figure 21. Broken Palm Branches (Left)  
and Aircraft Downwards Trajectory (Right)

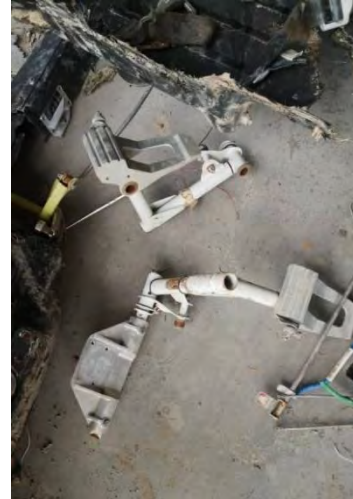
Figure 27. Pilot's Rudder  
Pedal Broken into Two Pieces

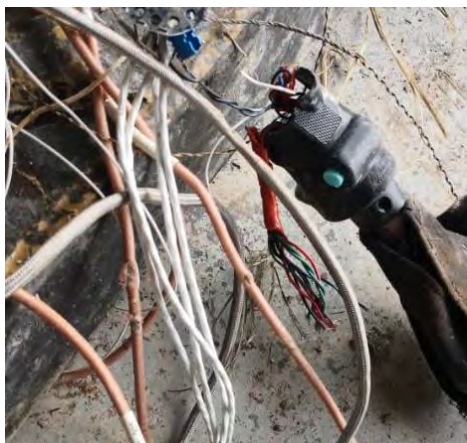
Figure 29. Rear Seat Control Column Broken into Half

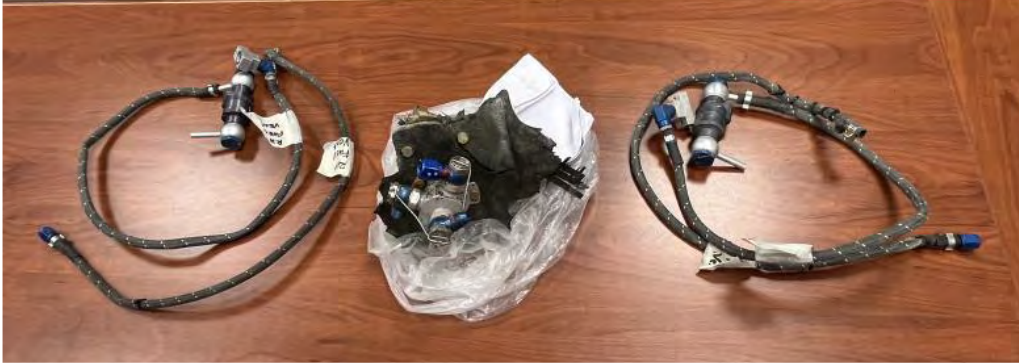
Figure 31. Fuel Components Tested by ANSV (Courtesy of ANSV)  
Fuel Valve (Centre); Inner and Outer Fuel Vent Lines (Left – LH; Right – RH)

- **Fuel Vent Lines Inspection.** The vent lines showed no structural damage aside from minor impact marks and were confirmed to be unobstructed, with stable pressure observed during all flight simulations, including inverted flight.

- **Fuel Valve Alignment and Functionality.** A minor misalignment in the fuel valve assembly—about 30 degrees of rotation and a 5 mm offset—was noted, likely due to accident impact, but was determined to have no significant effect on functionality. Flow through the valve was confirmed to be correct, with the selected tank identified as the LH tank.
- **Disassembly and Examination.** Internal examination showed that the valve moved freely with proper flow in each tank selection, and the electric motor operated normally, allowing unrestricted selector movement.
- **Conclusion.** The fuel valve and vent lines were found to be in good condition, without malfunctions or deviations from standards. These components remain in ANSV custody for any future needs by AAIB.

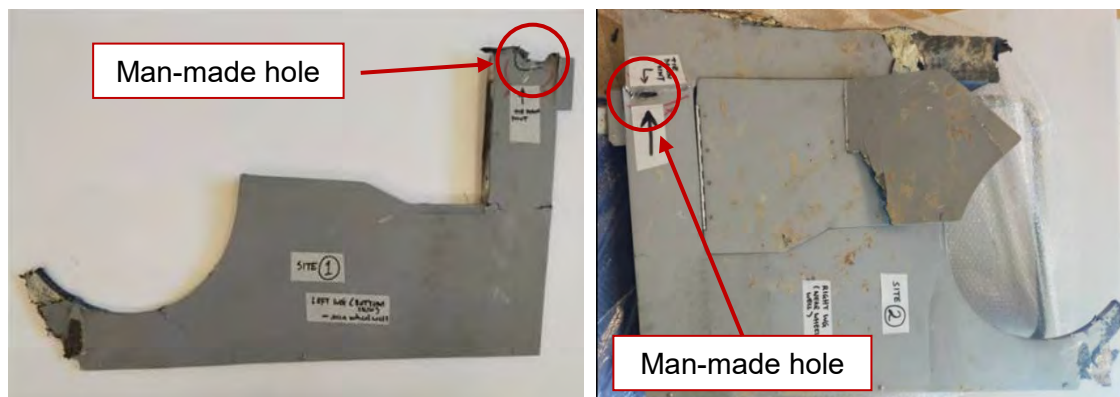
Most significantly, the installation of non-compliant 'tie-down rings' through man-made holes in the wings, combined with operational stresses, had serious implications for the aircraft's structural integrity and directly affected its airworthiness. The impact of these factors on the aircraft's airworthiness is further examined in Section 2.3.4.

Figure 36. Man-Made Holes on The Underside of The Aircraft Wings, Near the Wheel Wells (Left Picture: LH Wing; Right Picture: RH Wing)

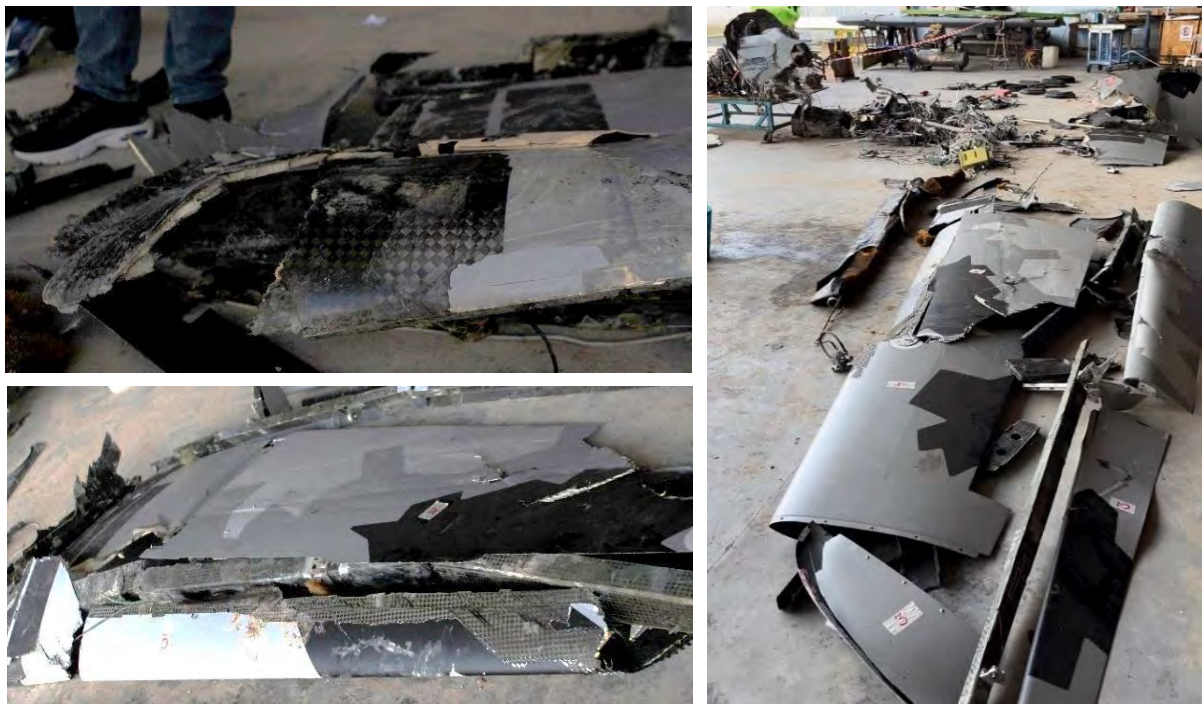
The LH wing main spar, aft spar and ribs were found at Site 1, the main wreckage area. The front and rear spar breaking points are compatible with high energy impact.

Figure 1. LH Wing

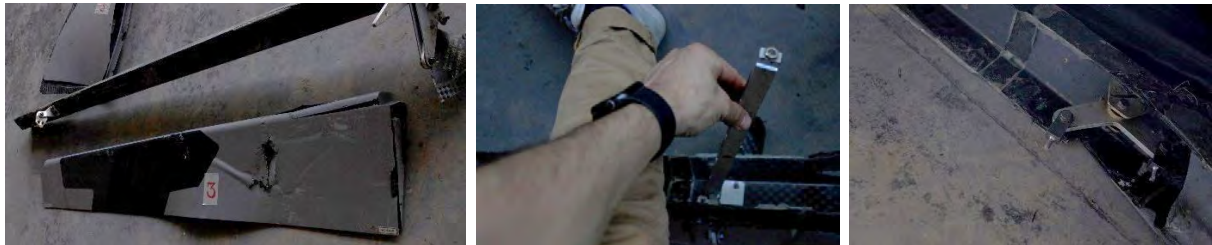
The LH aileron was found bent almost in the middle of its span. The aileron was detached from the hinges. The connecting rod was detached from the bellcrank.

Figure 2. LH Aileron Connecting Rod, and Bellcrank

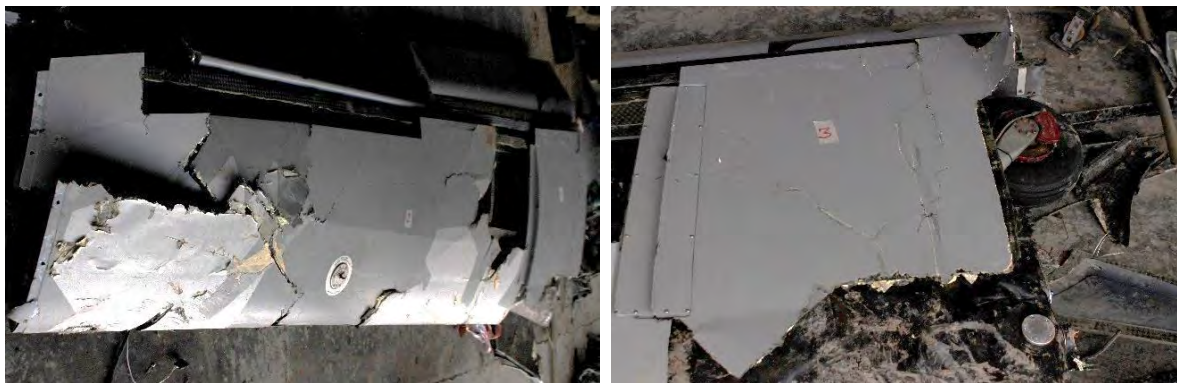
The whole RH wing (except for the inner upper skin) was found at Site 2, about 560 metres to the east of the main wreckage. The RH wing inner upper skin, together with the inner rib, was found at Site 3. Refer to paragraph 5 below for the failure mode of the upper skin. The failure mode of the inner rib is interlaminar failure. The RH flap and aileron were found connected to the wing.

Figure 3. RH Wing

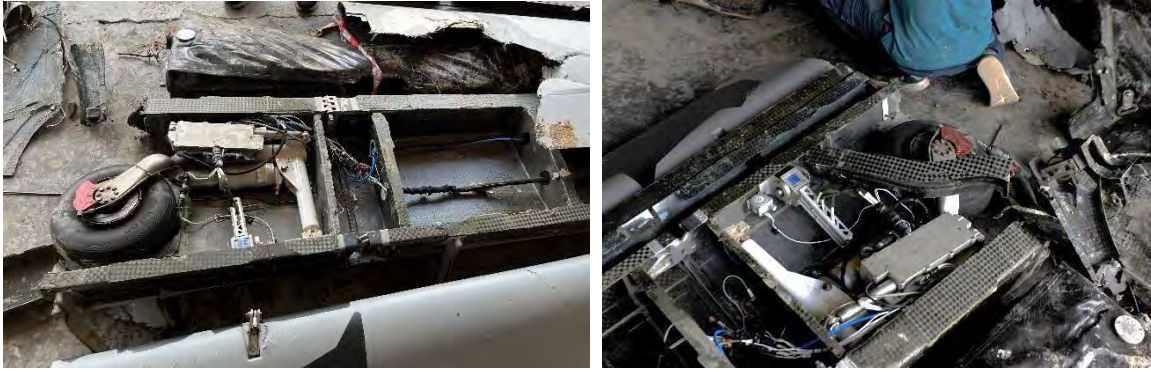
The MLG was found installed in the wing box in its retracted position. The forward (FWD) and rear (RWD) wing spars were totally cracked at the intersection with the fuselage monocoque, where the lower side fuselage spars are installed.

Figure 4. RH MLG

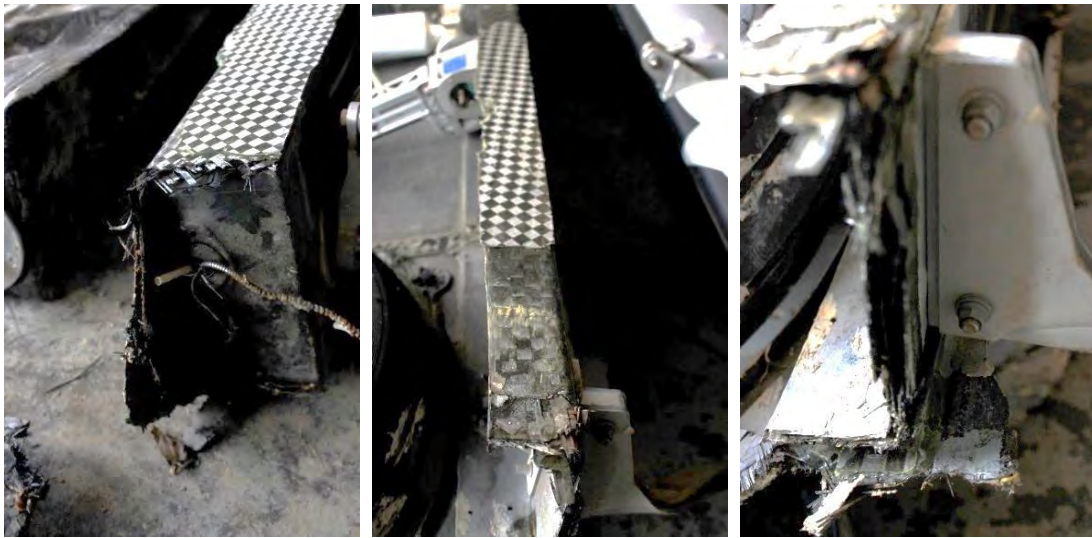
Figure 5. RH Wing Main and Rear Spar Crack

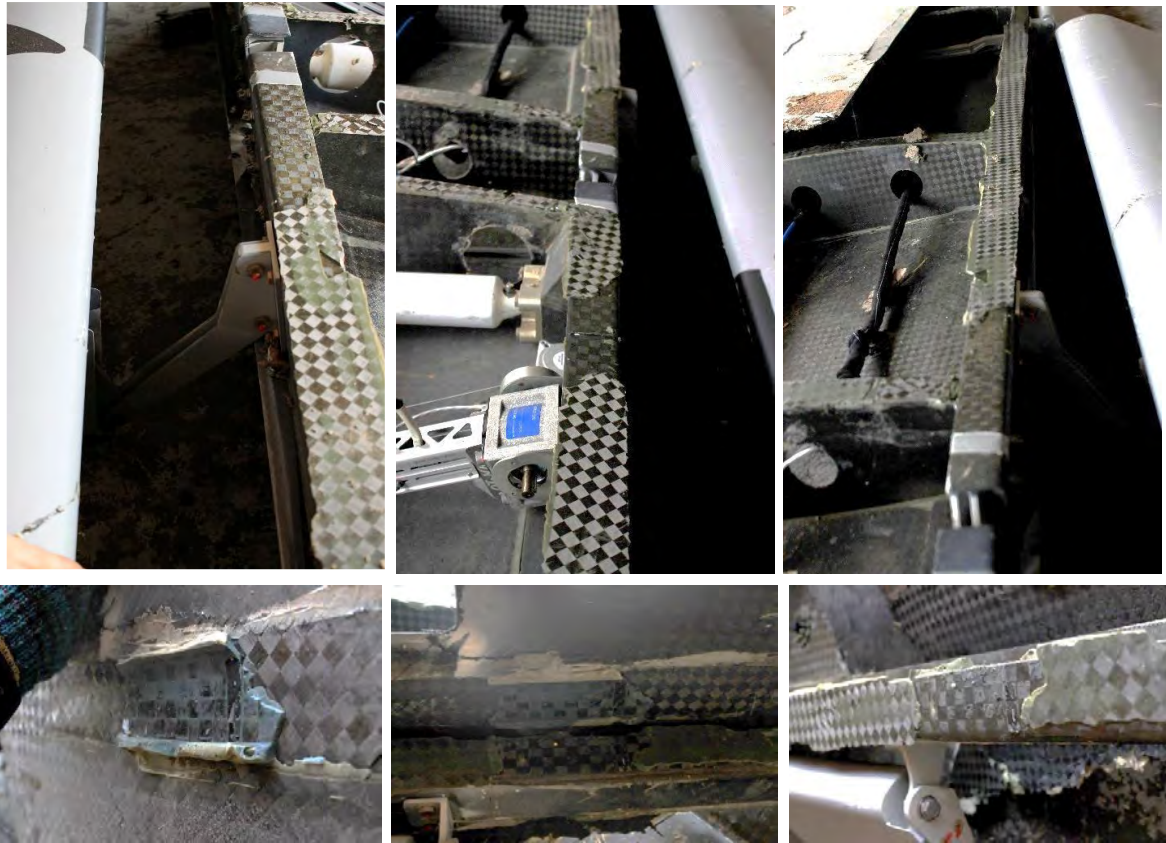
The failure of the skin/spar junction seems to be an interlaminar failure. The portion of laminate bonded to the wing spar remained attached to the spar cap revealing no failure of the bonding. The inner ribs of the wing box seem to have experienced the same failure mode.

Figure 6. Skin/Spar Failure Mode

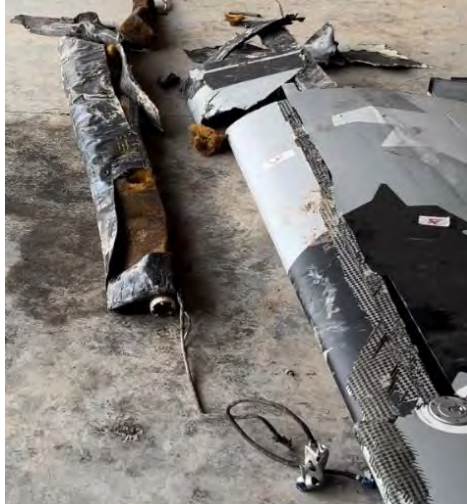
**7.1 LH Fuel Tank.** The bladder of the LH fuel tank appears to be torn apart in correspondence of the filler cap. The rest of the damage is probably due to the ground impact with the main wreckage.

Figure 8. LH Fuel Tank

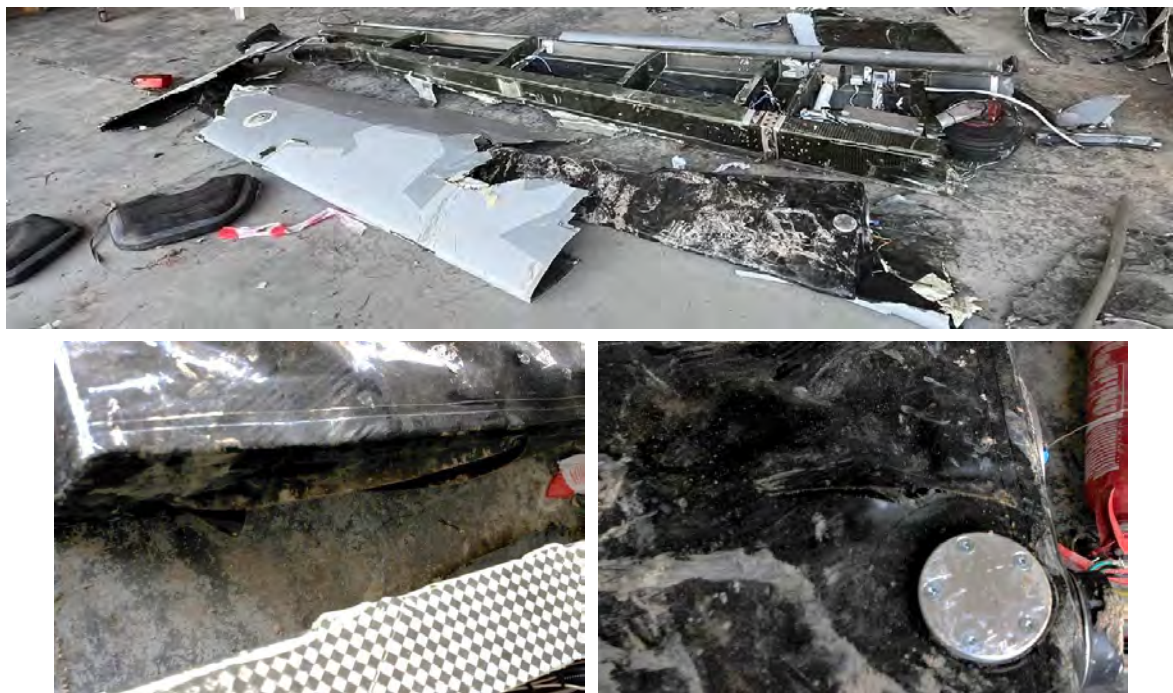
**7.2 RH Fuel Tank.** The RH fuel tank appears in good condition. There is no sign of collapse. Signs of rupture are found in the inner part of the tank.

Figure 9. RH Fuel Tank

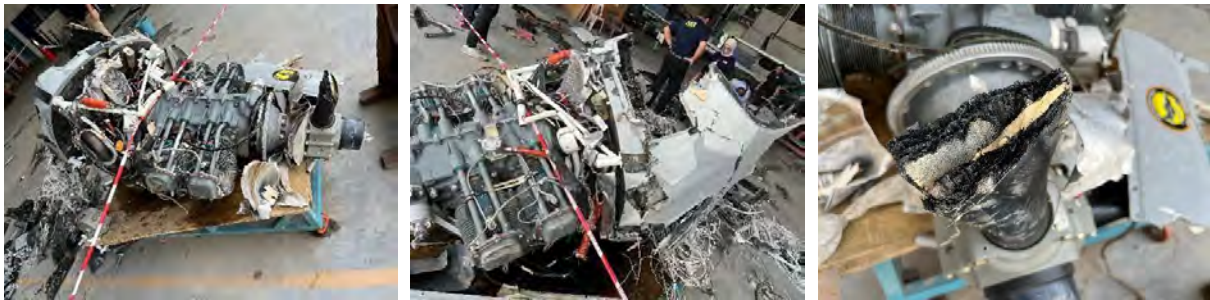
The engine compartment was found two metres under the ground. All damages appear to be caused by the high energy ground impact. Two blades were found cracked around the root. One blade is missing from the rotating shaft.

Figure 10. Engine Compartment and Propeller

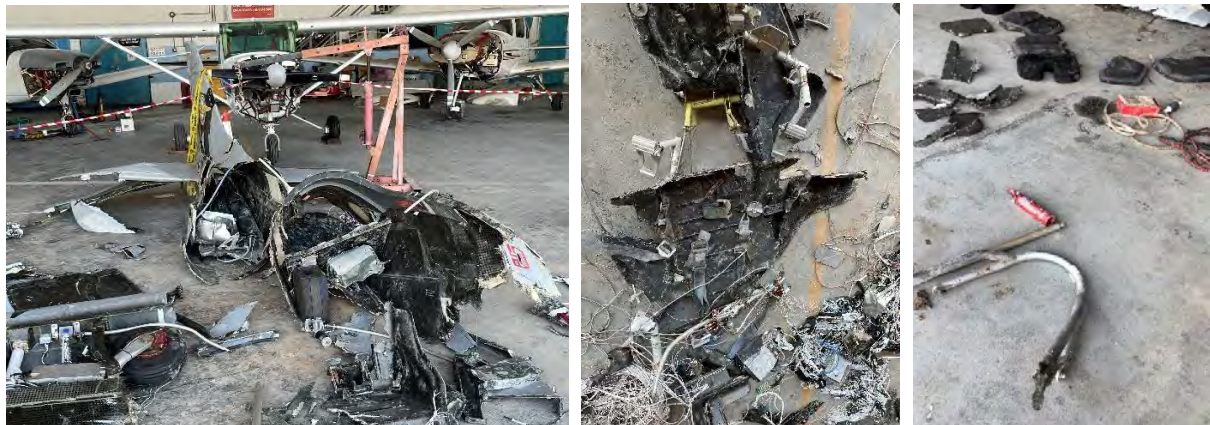
Both cockpits were found destroyed by the high energy ground impact. The roll bar and the seat cushions are retrieved as shown below.

Figure 11. Cockpit (Destroyed)

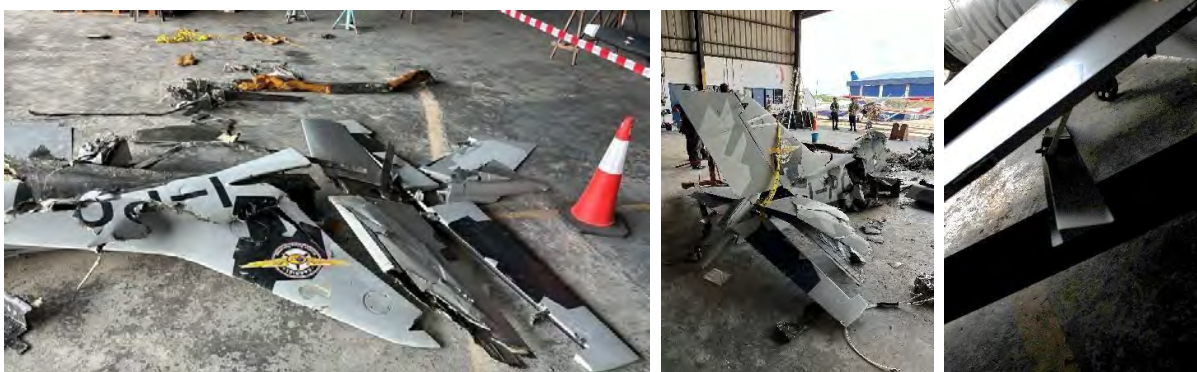
The rudder was found detached from the vertical stabiliser through the hinges. The horizontal stabiliser was found detached from the fuselage. The elevator was partially detached from the horizontal stabiliser through the hinges. The elevator trim was found detached from the elevator through the hinges. The lever to the trim motor was found in place.

Figure 19. Tail Destroyed (Left), Tail Reconstructed (Middle),  
Trim Tab (Right)

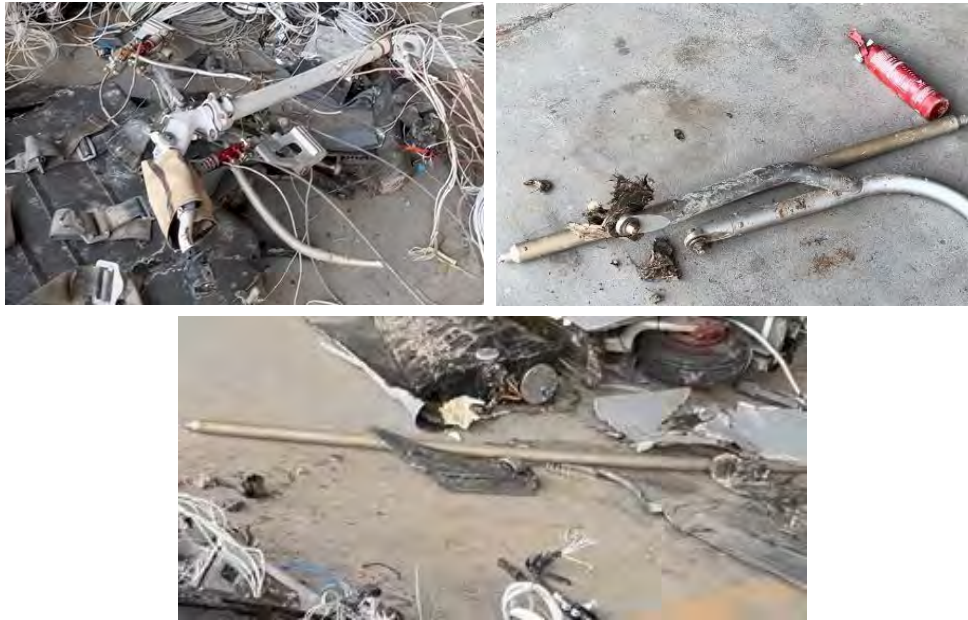
**12.1 Longitudinal.** All connecting rods are found disconnected from the forks (weakest elements).

Figure 20. Longitudinal Control: Control Column (Top Left), First Connecting Rod (Top Right), Last Connecting Rod (Bottom)

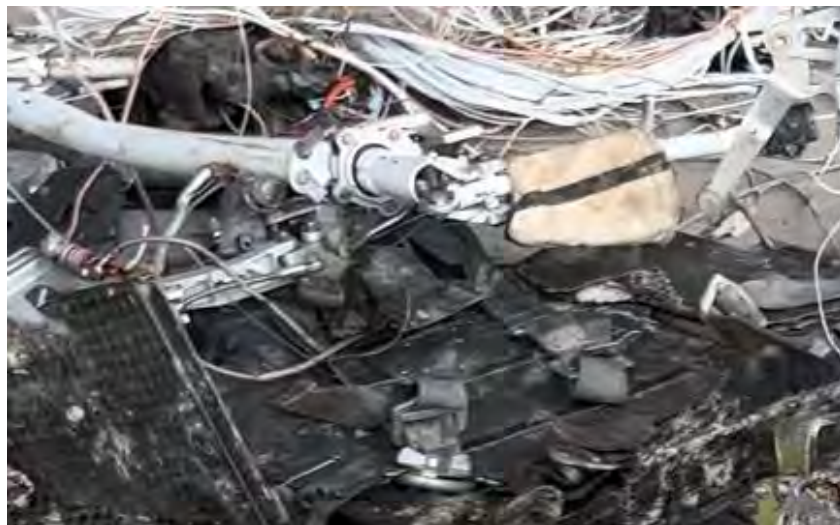
**12.2 Lateral.** The connecting forks to the control column are broken, probably due to high energy impact. The end connecting rod is detached from the bellcrank (refer to paragraph 3).

Figure 21. RH and LH Aileron Connecting Forks to The Control Column

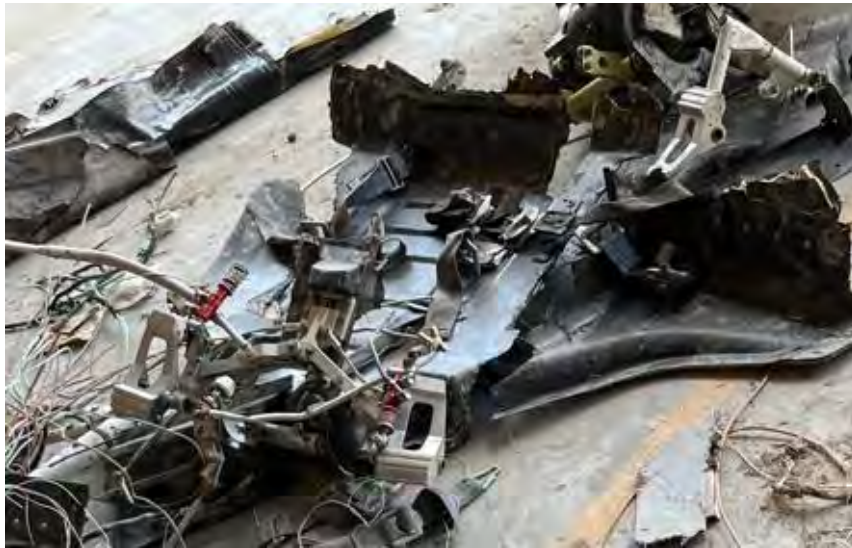
**12.3 Directional control.** The forward and aft pedal systems, and their connecting elements are found broken, compatible with the high energy impact,

Figure 22. Front and Rear Pedal Assembly

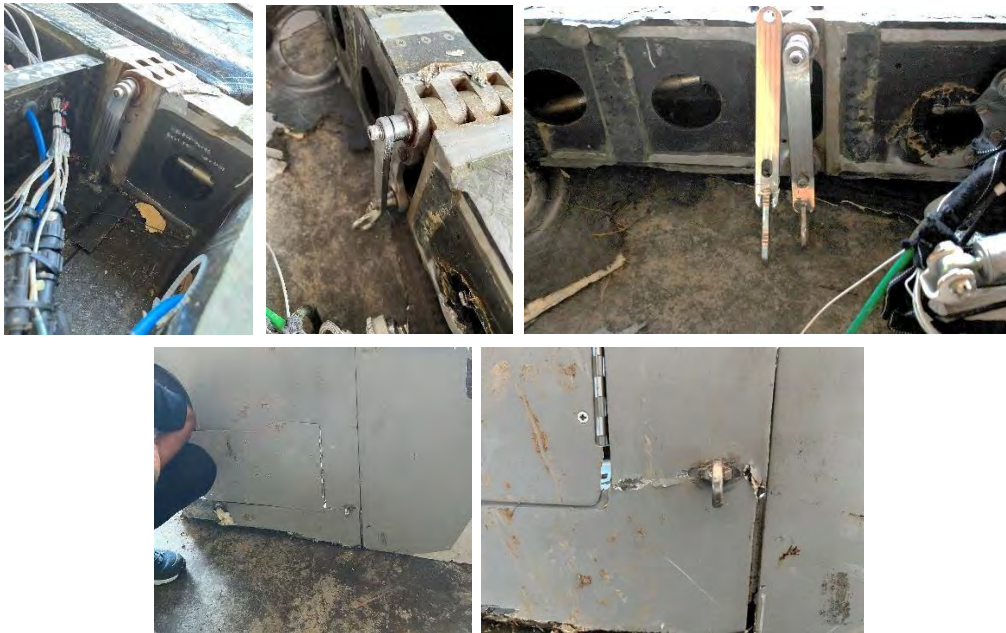
Figure 28. Non-Conforming Parts Installed on The LH And RH Wing Fitting

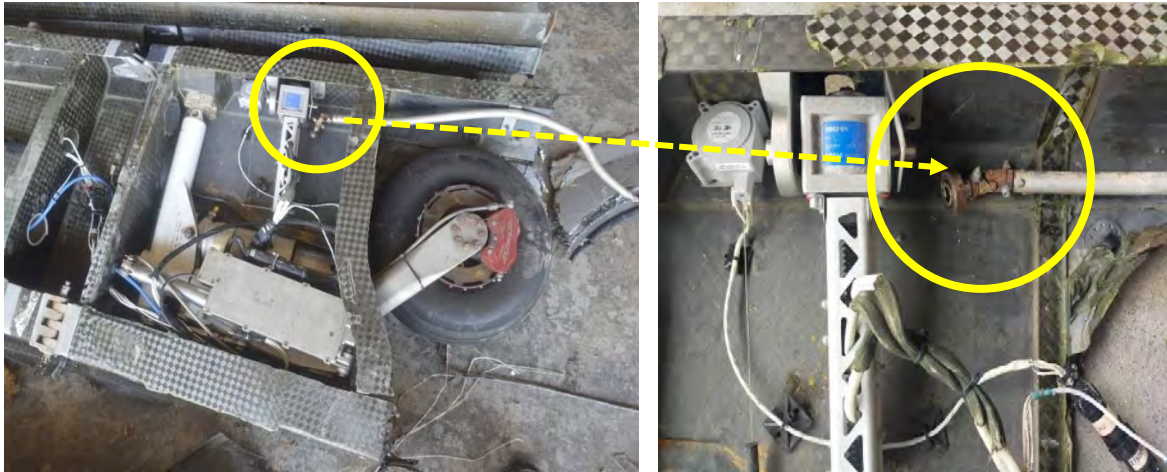
Figure 31. Physical condition of the connecting rod and shaft inside the RH wing  
(After recovery from the crash site – Site 2)

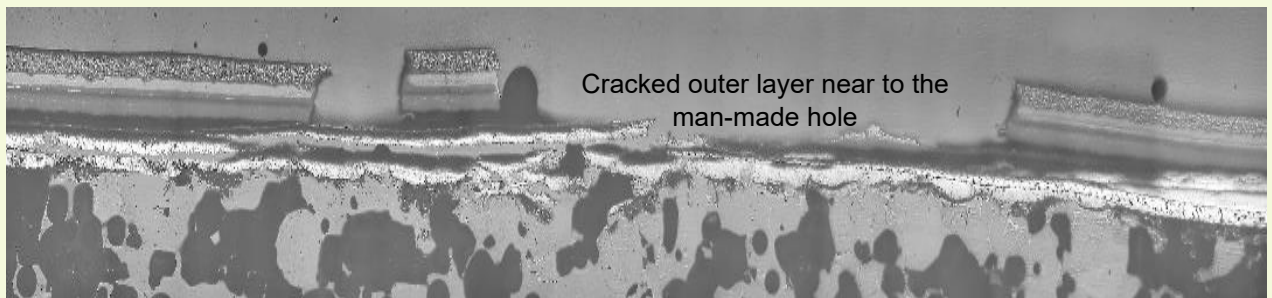
Cracked outer layer near to the  
man-made hole

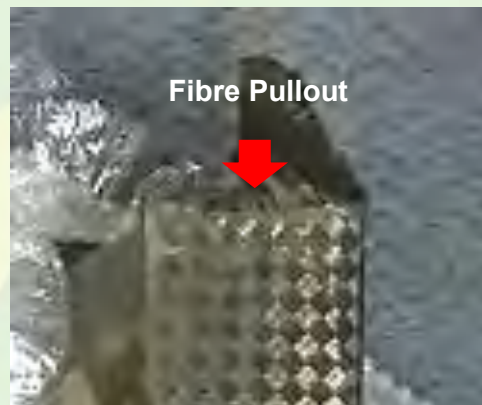
Figure 37. Fibre Pullout Found on ROI 1 of Component at Site 2; Sample ID: BSKU/IPOOC/004(S2) - Right wing - near to the wheel well
