AIRCRAFT SERIOUS INCIDENT

SI 05/24

**Fixed Wing Aircraft Diamond DA42NG Twin Star, Registration N566CB
at Sultan Abdul Aziz Shah Airport, Subang, Selangor
on 26 April 2024**

Issued on 16 January 2025
MOT(S).600-5/4/105

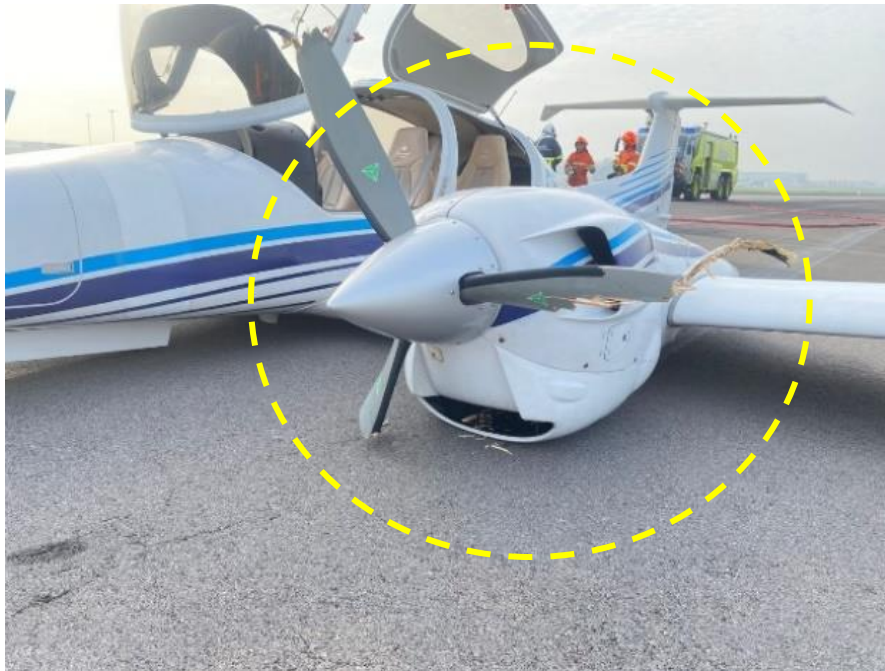
Preliminary analysis indicates significant damage to the left-hand (LH) and right-hand (RH) propellers, as shown in Figures 1 and 2. The damage to the LH propeller is notably more severe than that to the RH propeller. Additionally, noticeable scratch marks and damage were observed on both the bottom engine cowling and the tail boom area, as shown in Figure 3.

Figure 1: LH Propeller Damage

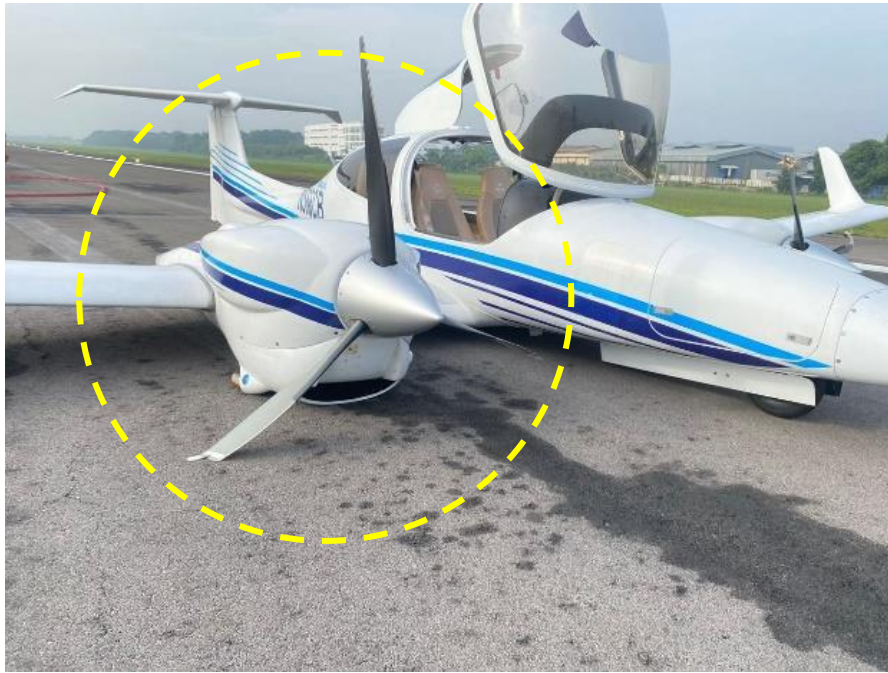
Figure 2: RH Propeller Damage.

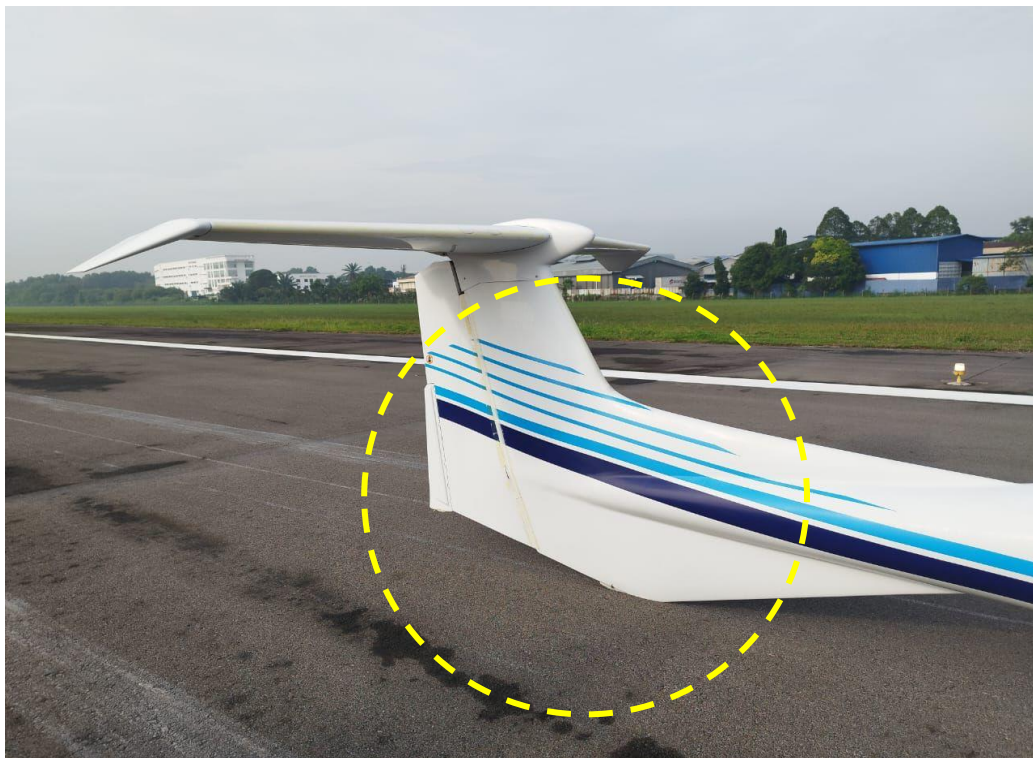
Figure 3: Tail Section Area

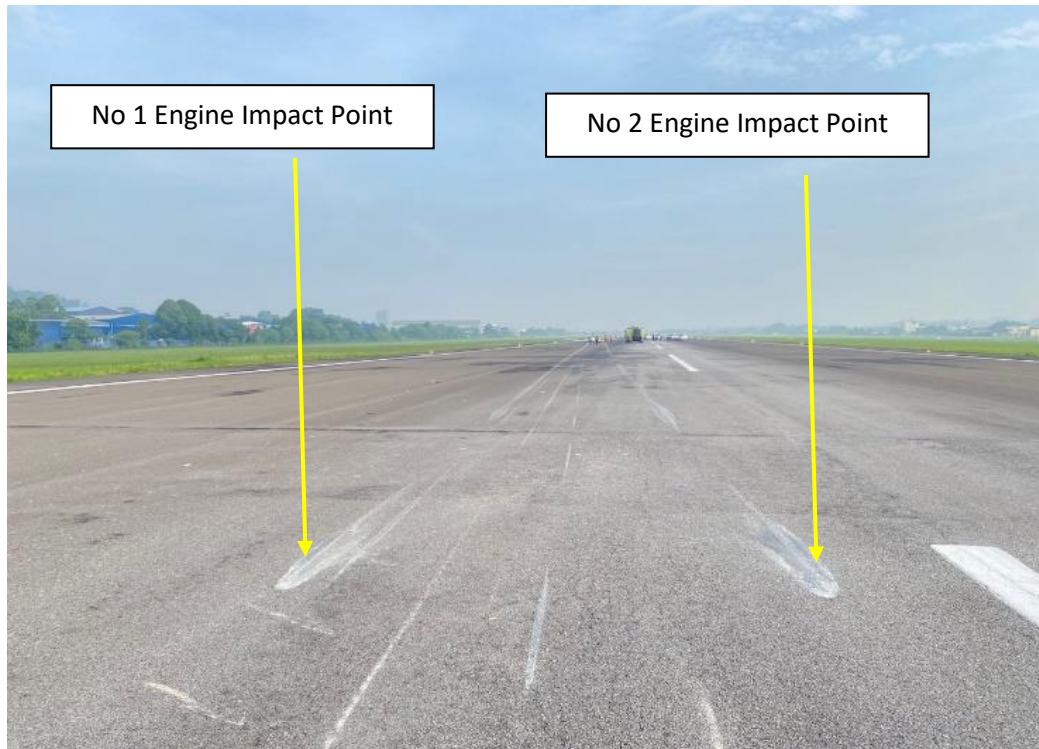
Initial assessment revealed that the aircraft skidded approximately 220 metres before coming to a stop, leaving visible scratch marks on the runway, as shown in Figure 4. The detailed damage assessment report is provided in Appendix B.

Figure 4: Initial Impact Point and Scratch Marks on Runway

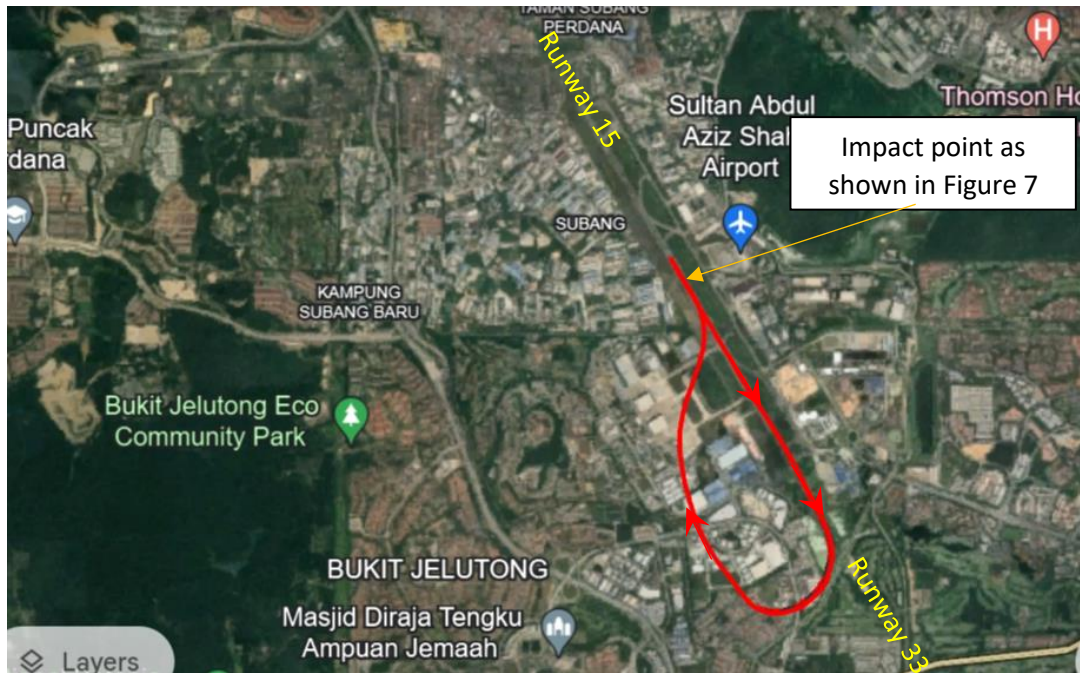
Figure 6: General description map of the incident

The red line in Figure 6 illustrates the flight path of the aircraft, which made a turn back after taking off from runway 15. Figure 7 highlights the impact point and visible scratch marks on the runway. The damage assessment is detailed in **Appendix B**.

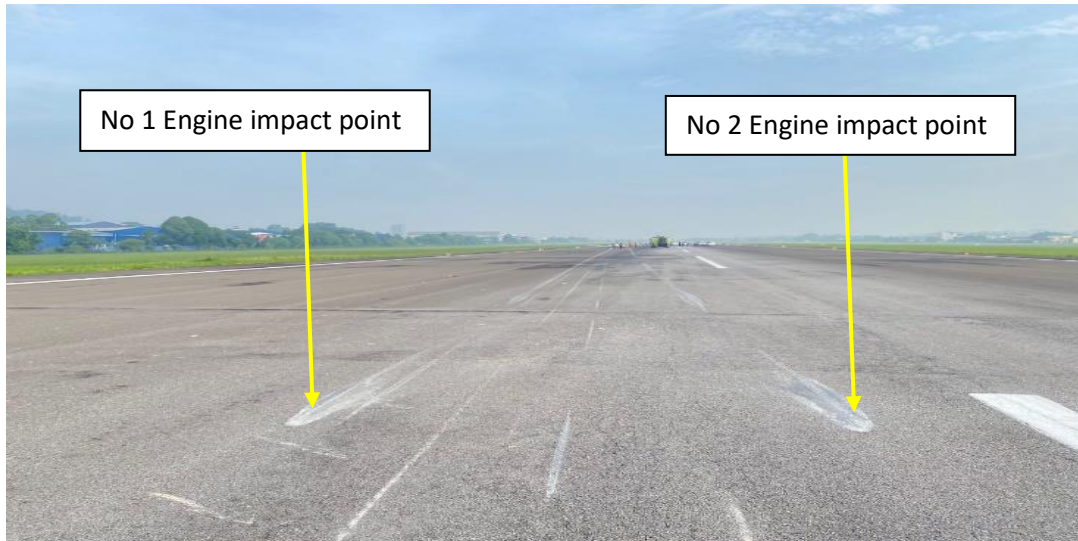
Figure 7: Initial impact point and Scratch Marks on Runway

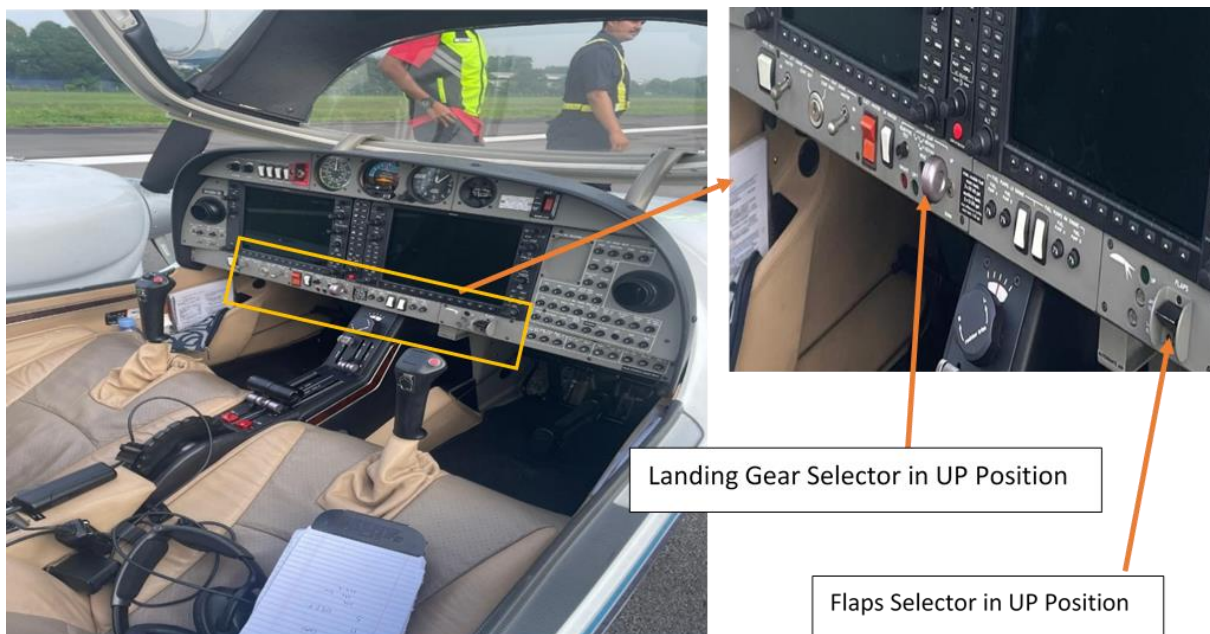
Figure 8: Cockpit Picture After the Incident

The pilot did not complete the pre-landing and landing checklist actions according to SOPs, as confirmed by both the pilot and passenger in interviews. Post-incident analysis revealed that the landing gear selector and flaps were in the up position at the time of impact (see Figure 8). This incident highlights the need to improve checklist accessibility, potentially by displaying it directly within the cockpit rather than relying solely on an iPad. SOPs are designed to safeguard operations by providing clear guidelines and consistent expectations. Non-compliance with SOPs undermines this safety framework, increasing the likelihood of errors, especially under high-stress or emergency conditions.

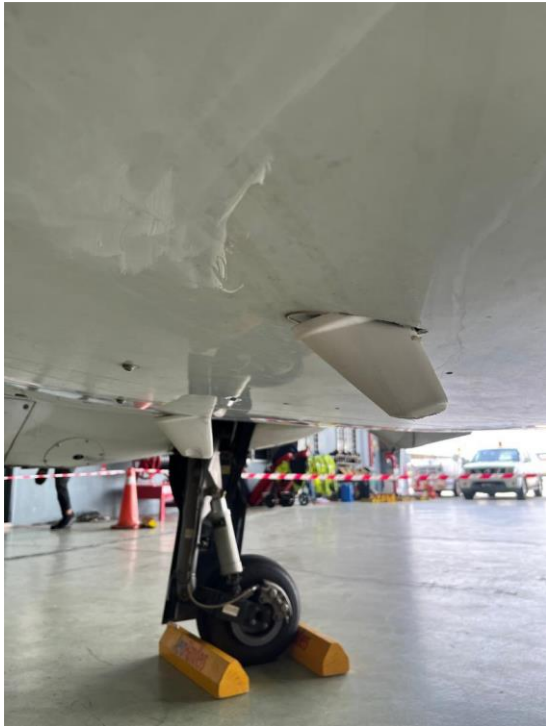
Damage to Antenna

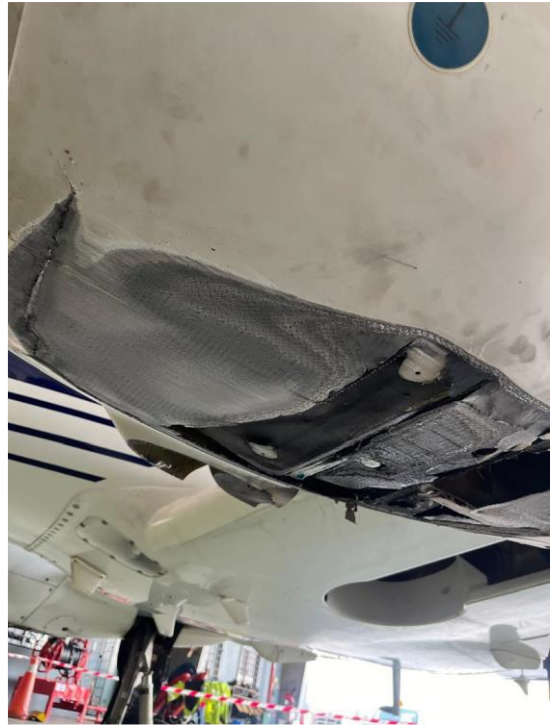
Damage to LH Engine Lower Cowling

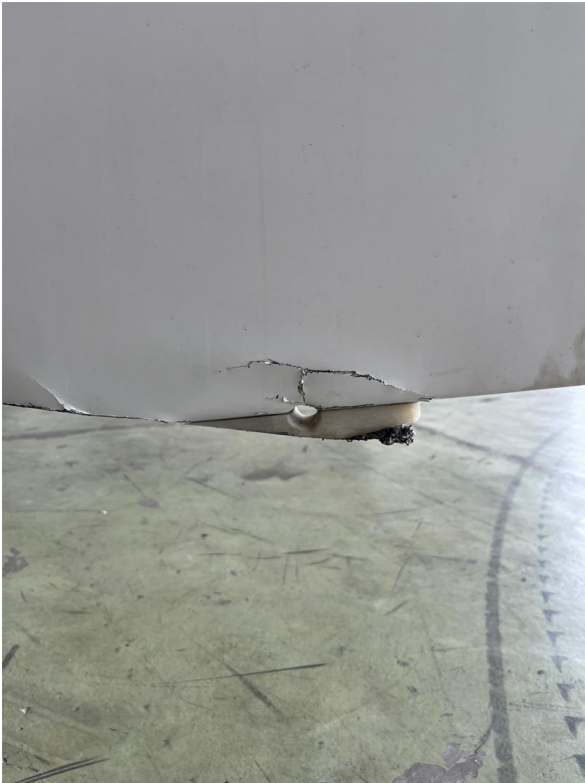
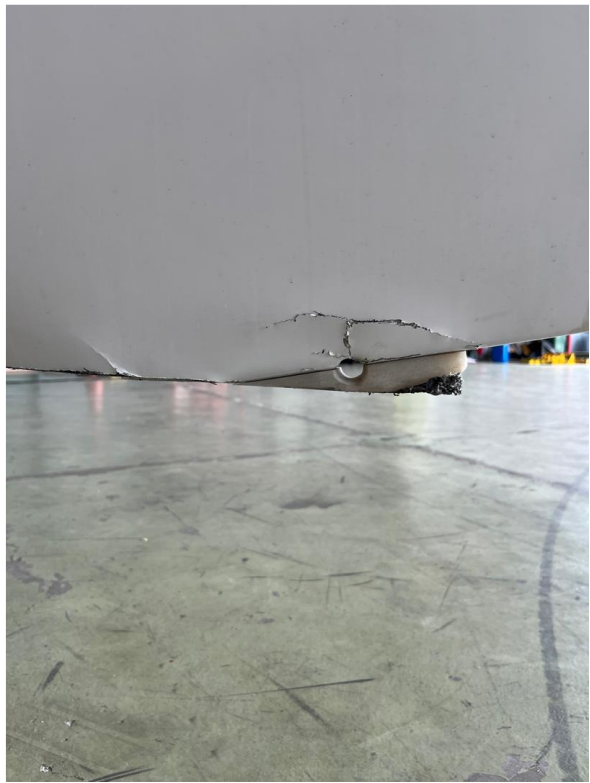
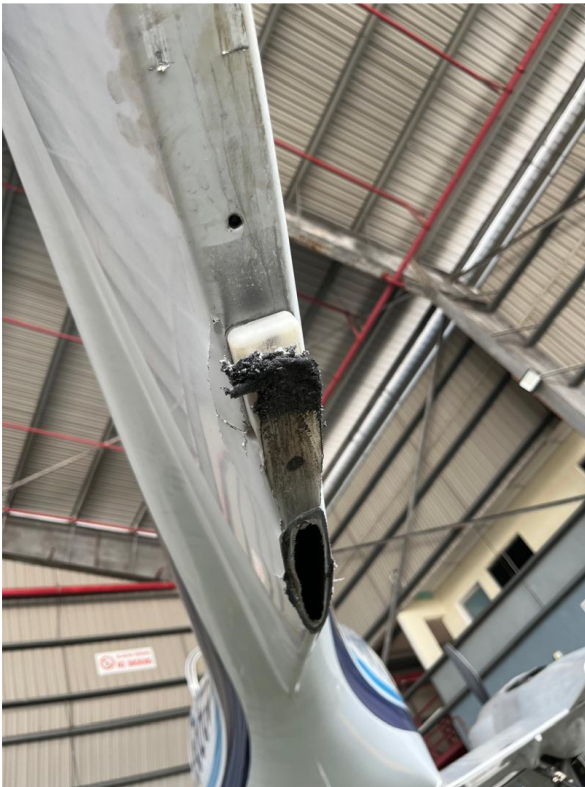
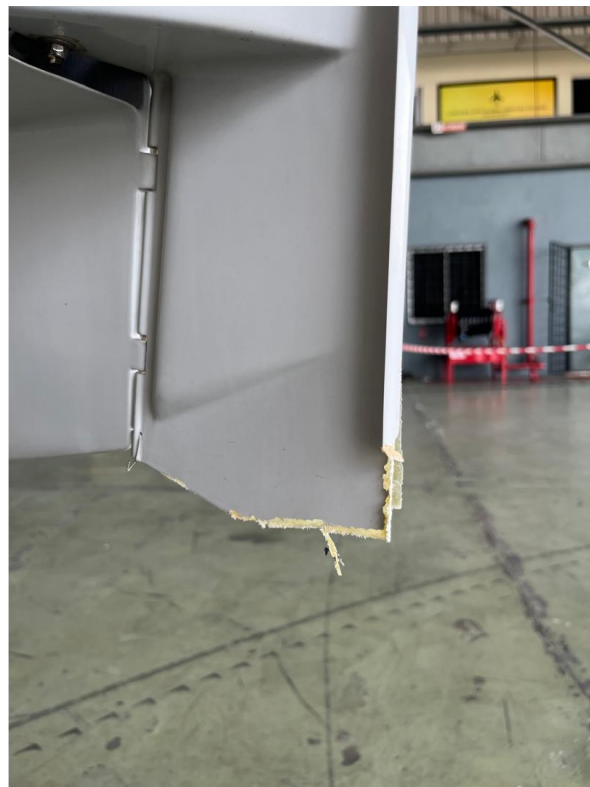
Damage to Tail Structure and Rudder Trim

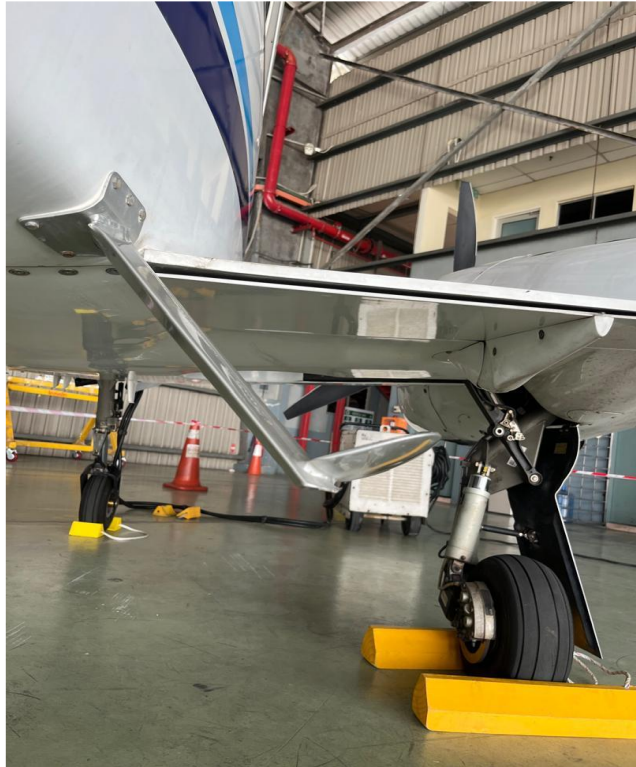
Damage on RH Step

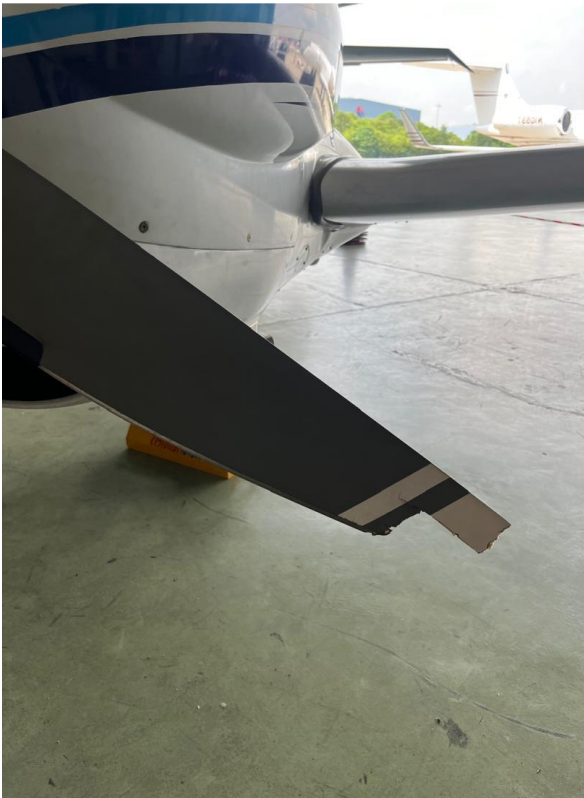
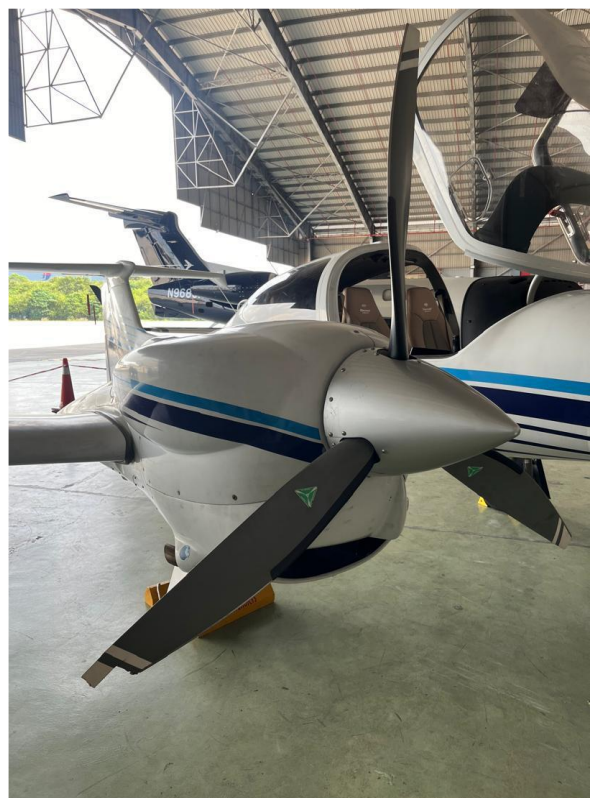
Damage / chip on RH Engine Propeller

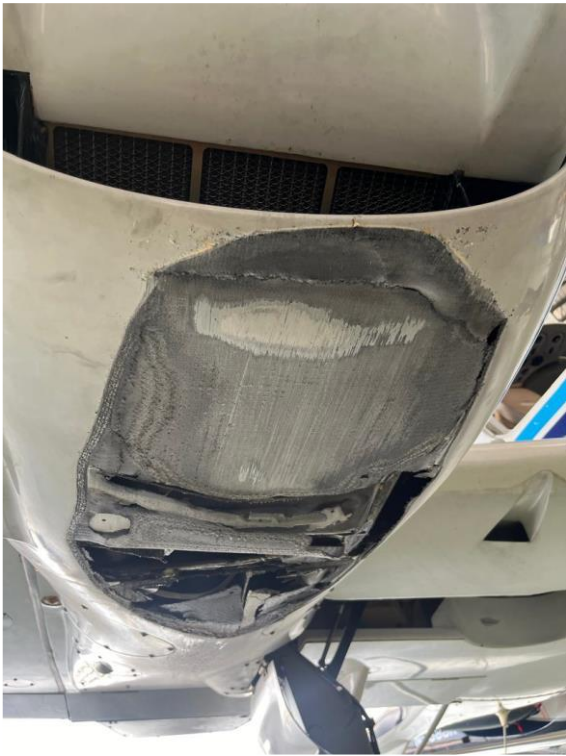
Damage to RH Engine Bottom

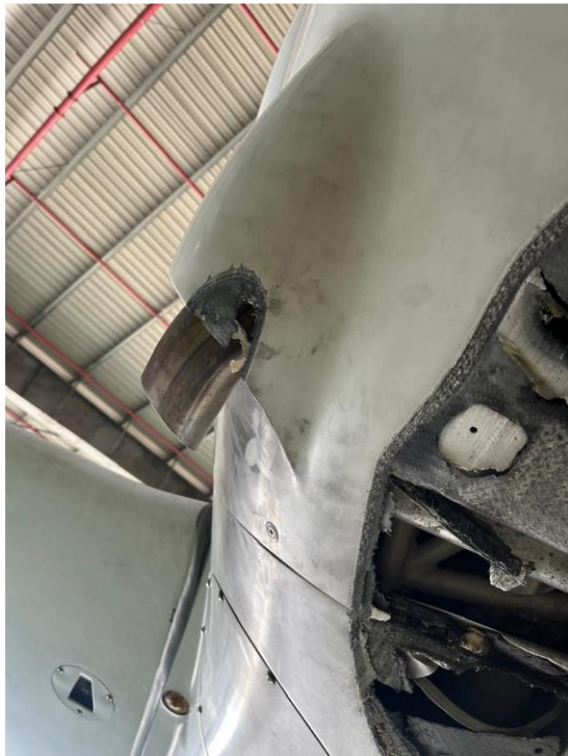
Damage on RH Engine Exhaust Nozzle

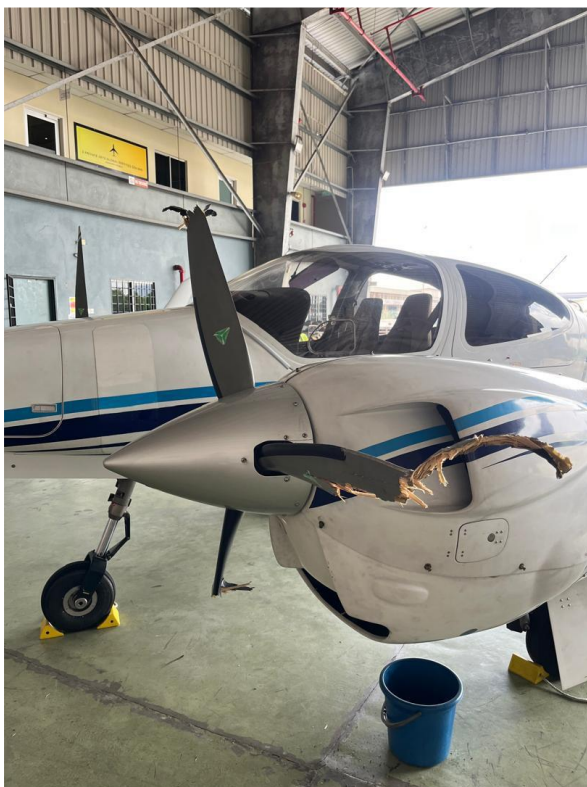
Damage to LH Engine Propeller

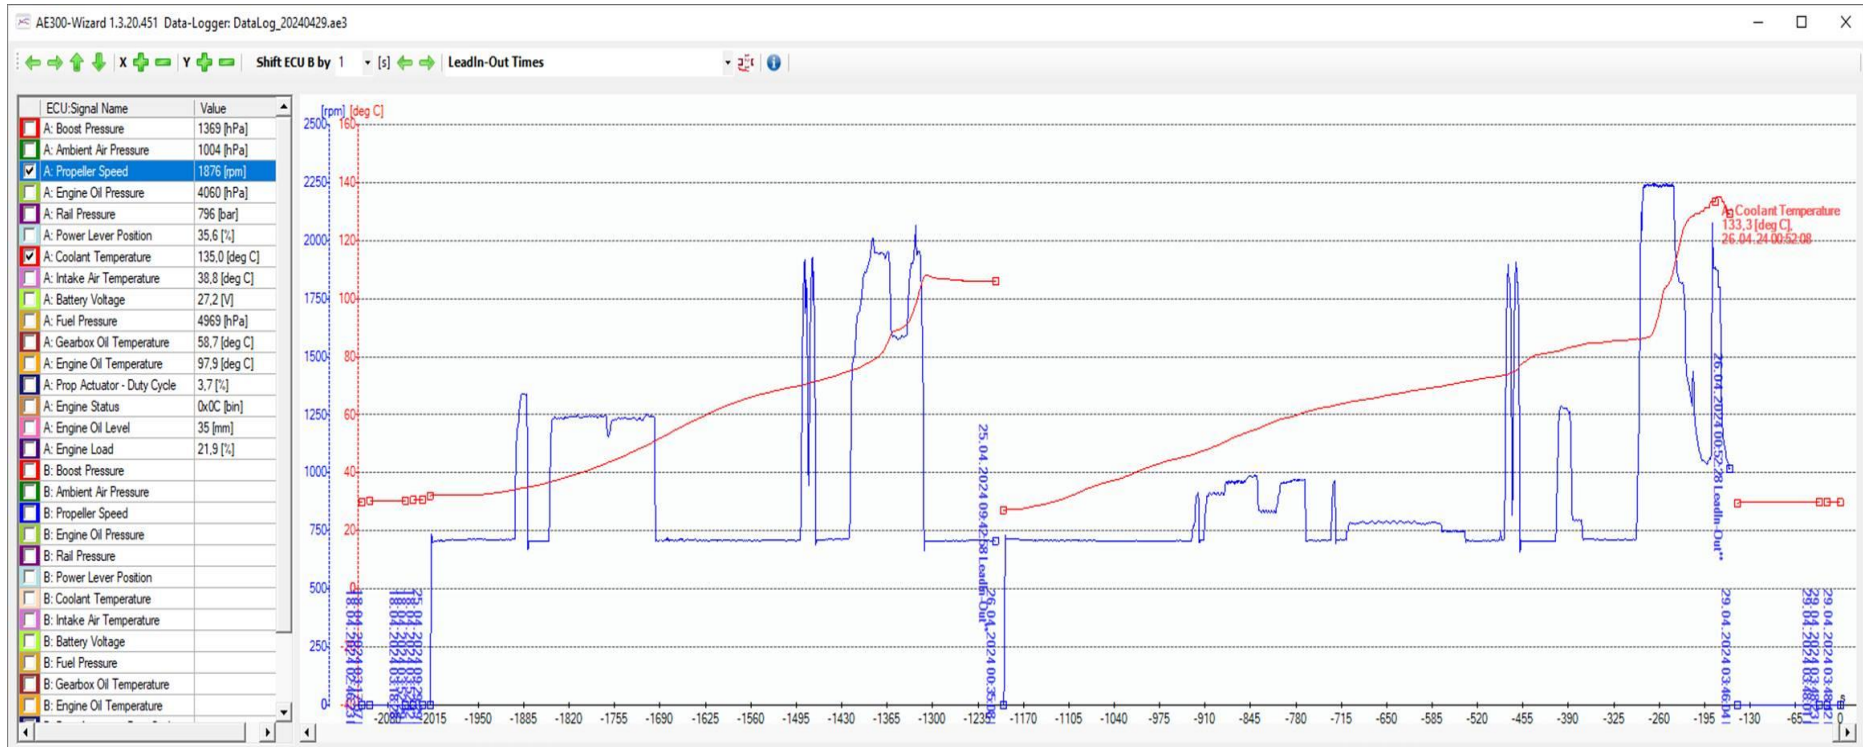
The data log shows problems with the coolant temperature on 25th and 26th of April:
