## **AIRCRAFT SERIOUS INCIDENT**

**SI 08/24**

**Air Accident Investigation Bureau (AAIB)**

**Fixed Wing Aircraft Boeing 737-800, Registration 9M-MXQ  
at Yangon International Airport, Myanmar  
on 19 July 2024**

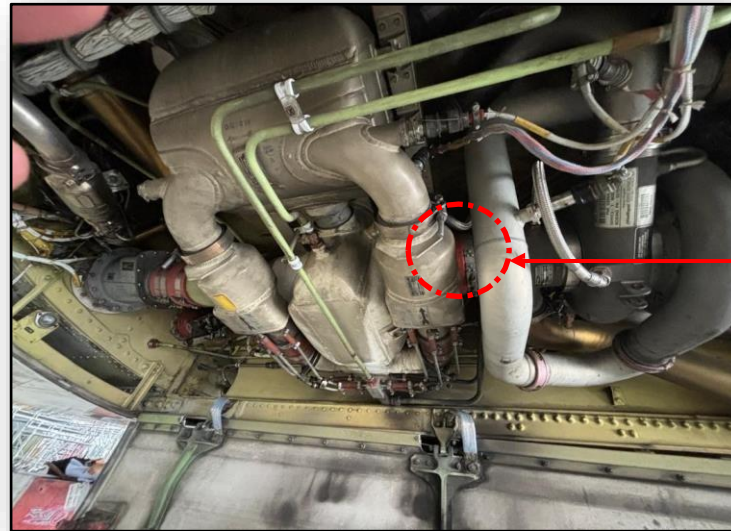
Location of  
Ruptured RH  
Flexible Pressure

Figure 6: RH Flexible Pressure Sleeve at Air Conditioning Compartment

The ruptured pressure sleeve was located between the Air Cycle Machine (ACM) and the High-Pressure Water Separator (HPWS). Because the pressure sleeve is situated upstream within the cooling system, its failure caused cooled air to leak from the right-hand (RH) cooling pack, resulting in the loss of positive air supply to the system. This confirmed the information provided by the cabin crew, who reported that the forward cabin area was hot

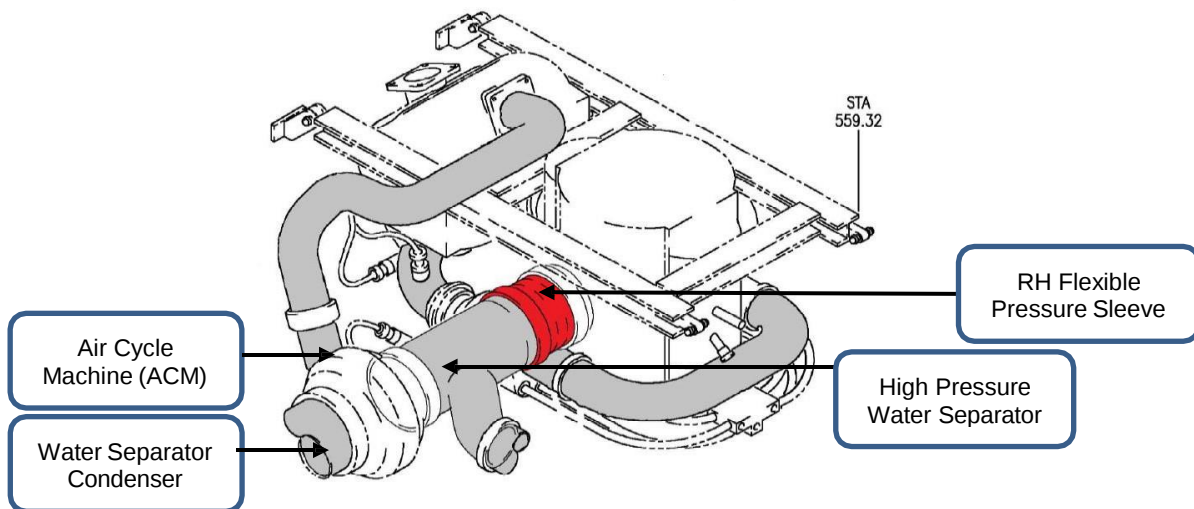
Figure 7: RH Flexible Pressure Location

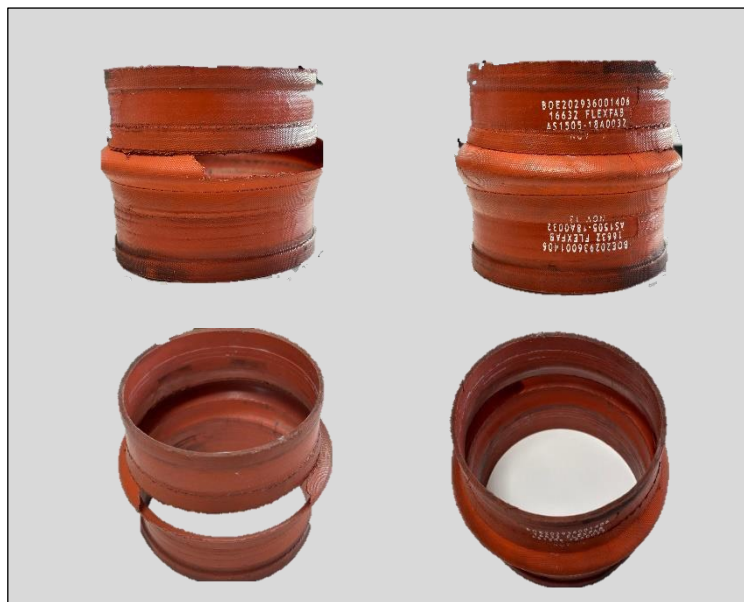
On 23 July 2024, the part that had been replaced (RH Cooling Pack) at RGN line station was obtained. The part received was found heavily ruptured. A picture and details of the defective part is shown below.

Figure 10: Condition of RH Flexible Pressure Sleeve Ruptured

The investigation determined that the rupture of the RH Flexible Pressure Sleeve was primarily caused by progressive thermal fatigue and material degradation over time.

The incident was caused by the rupture of the RH Flexible Pressure Sleeve, located downstream of the Air Cycle Machine (ACM) and High Pressure Water Separator (HPWS). This failure resulted in a significant loss of conditioned air from the right Environmental Control System (ECS) Pack, reducing the system's ability to cool and pressurize the cabin at high altitude. The compromised airflow contributed to inadequate cabin temperature control and degraded pressurisation during descent

Rectification involved replacing the ruptured part and conducting a ground functional test, which was found satisfactory by the technical team. The aircraft was subsequently released as fully serviceable, and its performance has been monitored by MAB's Technical Record – Record and Project Management with no abnormalities observed to date.

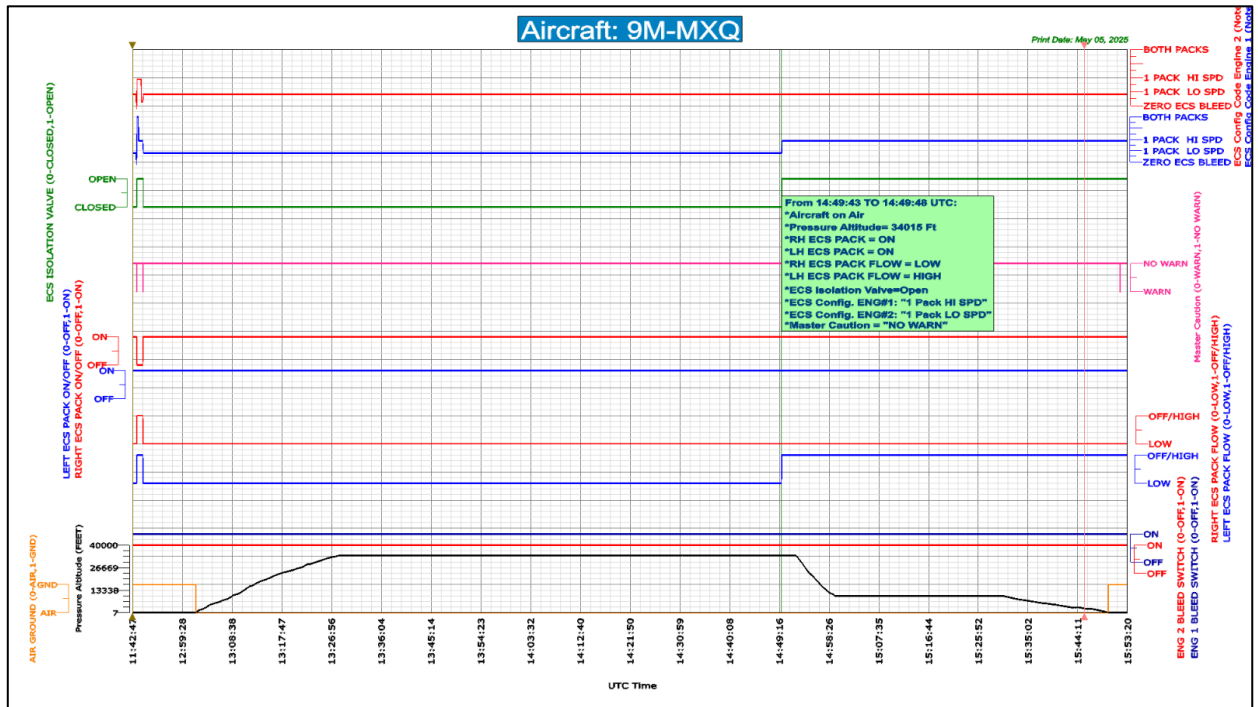
Figure 12: Excessive Cockpit Temperature Event

- At time **14:49:43** UTC, with pressure Altitude= 34014 ft:
  - 'LH ECS Pack' was **ON** and 'LH ECS Pack FLOW' set to **HIGH**, with 'RH ECS Pack' was **ON** and 'RH ECS Pack FLOW' was **LOW**.
- At time **14:49:44** UTC, with Pressure Altitude= 34015 ft:
  - 'ECS Isolation Valve' was **Open**.
- At time **14:49:48** UTC, with Pressure Altitude= 34012 ft:
  - 'ECS Config. **ENG #1**' changed from "1 Pack **LO** SPD" to "1 Pack **HI** SPD".
  - 'ECS Config. **ENG #2**' maintain at "1 Pack **LO** SPD".

balanced airflow from both packs. The reduced performance of the RH pack may have contributed to insufficient cooling in the cockpit, resulting in the excessive cockpit temperature reported by the flight crew.

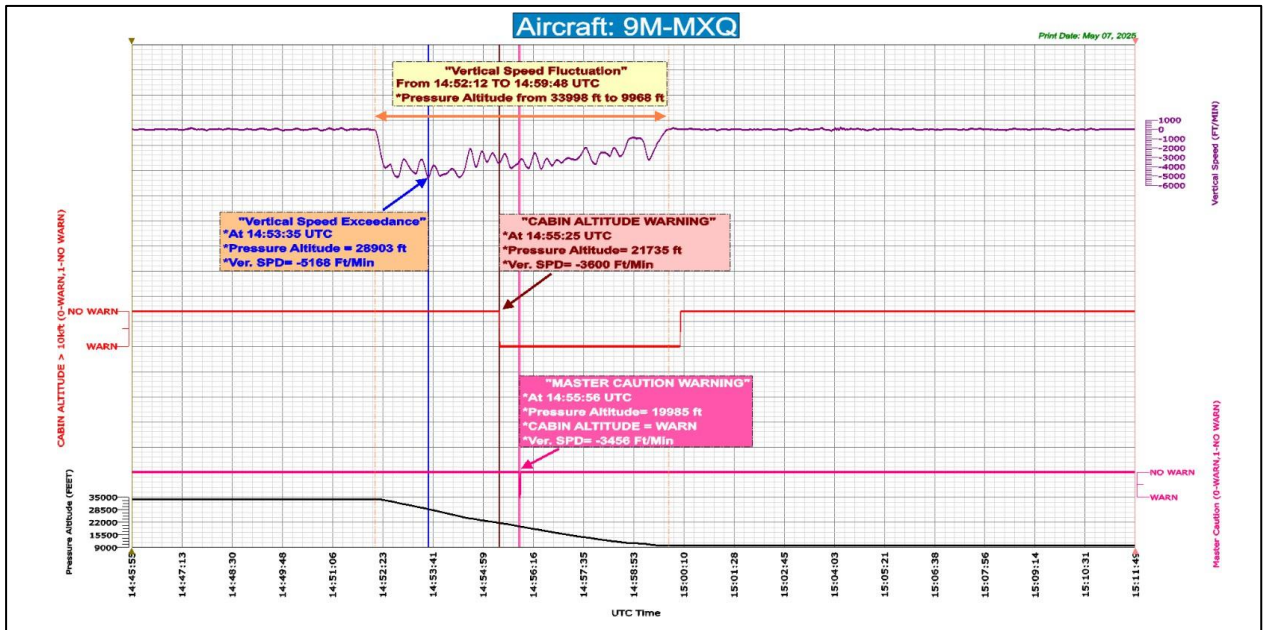
Figure 13: Cabin Altitude Warning Event

- During descent, Vertical **Speed Fluctuation** recorded from **14:52:12** to **14:59:48** UTC with Pressure Altitude from 33998 ft to 9968 ft, Vertical Speed Exceed the limits mentioned in **FCOM**.
- At **14:53:35** UTC vertical speed reached its **Max** value Ver. SPD= **-5168 Ft/Min** at pressure Altitude = 28903 ft.
- At **14:55:25** UTC & Pressure Altitude= 21735 ft with Ver. SPD= **-3600 Ft/Min**, **CABIN ALTITUDE WARNING** was triggered as indicated by the intermittent cabin altitude/configuration warning horn sounds indicated that CABIN ALTITUDE reached above 10,000ft.
- **CABIN ALTITUDE WARNING** was **ON** for (4Min & 40 Sec) till **15:00:05** UTC.
- At **14:55:56** UTC & Pressure Altitude= 19985 ft "**MASTER CAUTION WARNING**" was triggered with CABIN ALTITUDE = **WARN** at Ver. SPD= **-3456 Ft/Min**.

The activation of the cabin altitude and master caution warnings was likely attributed to a combination of factors that adversely affected the aircraft's pressurisation system. A significant reduction in conditioned airflow, most likely caused by the rupture of the right-hand flexible pressure sleeve—an essential component for directing pressurised air from the ECS Pack into the cabin.

The failure of this component would have degraded the right Pack's ability to contribute to cabin pressurisation. Collectively, these conditions led to the system's inability to maintain the cabin altitude within safe operating limits, thereby requiring the flight crew to take immediate corrective action.
