# **AIRCRAFT ACCIDENT PRELIMINARY REPORT**

**A 05/25**

**Air Accident Investigation Bureau (AAIB)  
Ministry of Transport, Malaysia**

**Accident Involving Airbus Helicopter AS355N,  
Registration 9M-PHG, at Sungai Pulai, Gelang Patah, Johor  
on 10 July 2025**

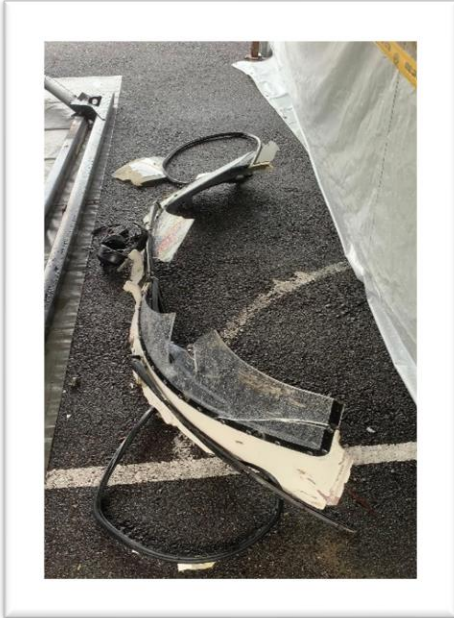
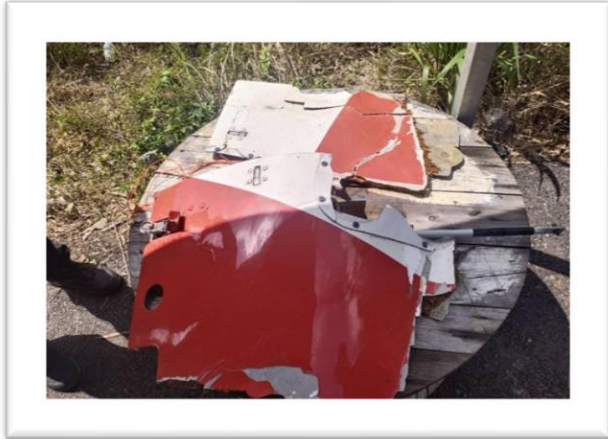
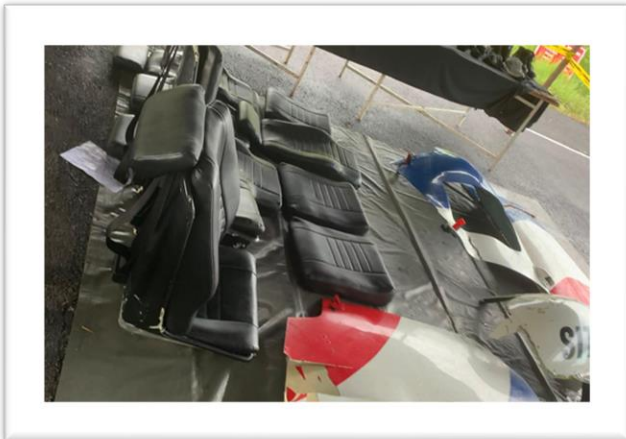
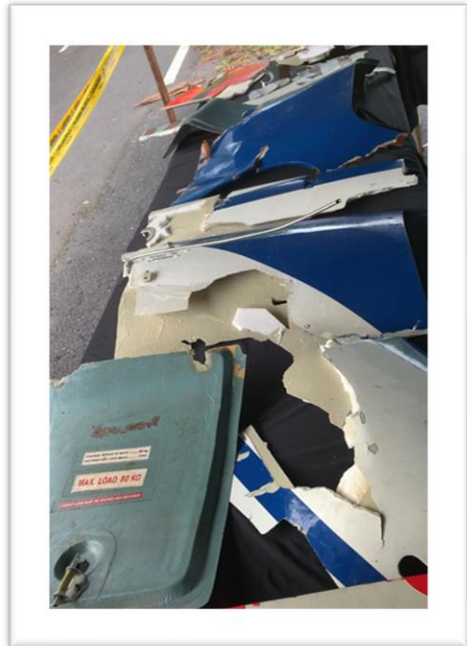
1. Several seats, fuselage panels and composite fairings were detached and recovered floating within a 30 to 40 metre radius of the primary impact point.
2. The main wreckage sank almost immediately after impact and came to rest fully submerged at an estimated depth of between 14 and 17 metres, depending on tidal conditions (low tide to high tide).
3. Recovered debris included seats, fuselage skin panels, access hatches and minor fairing components. The main airframe was recovered during salvage operations.

**DEBRIS (SEATS, FUSELAGE PANELS AND COMPOSITE FAIRINGS)  
DETACHED AND RECOVERED FLOATING WITHIN  
30 TO 40 METRE RADIUS OF THE PRIMARY IMPACT POINT**

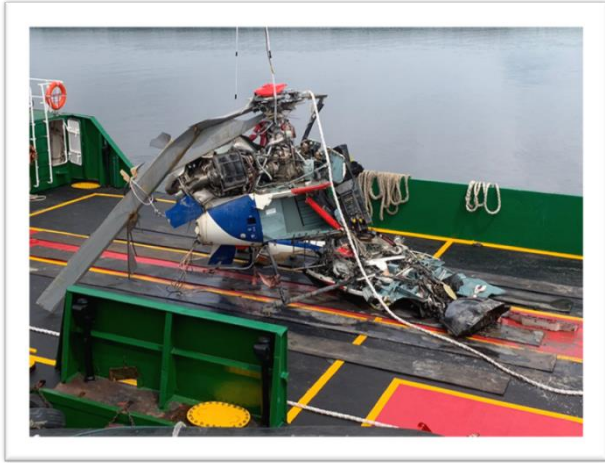
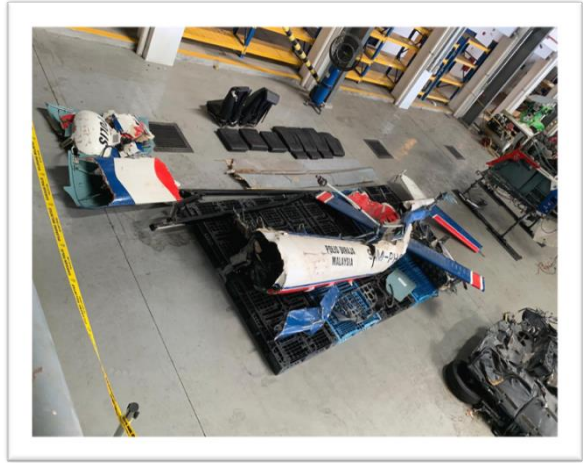
A general visual inspection was carried out to assess and identify the damage to the aircraft after the salvage operations. The helicopter was destroyed due to impact on water and can be seen in **Appendix A**.

**WRECKAGE SALVAGED FROM SUNGAI PULAI  
ON 17 JULY 2025**

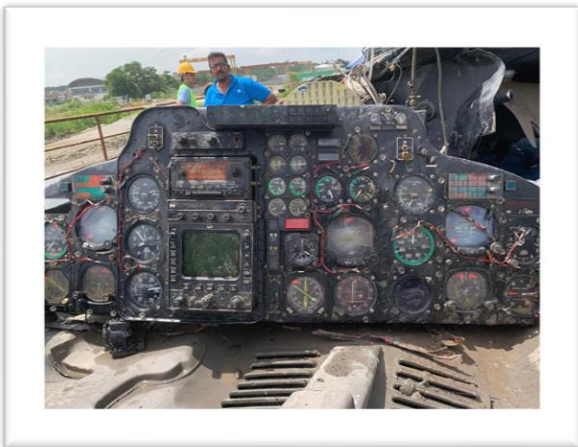
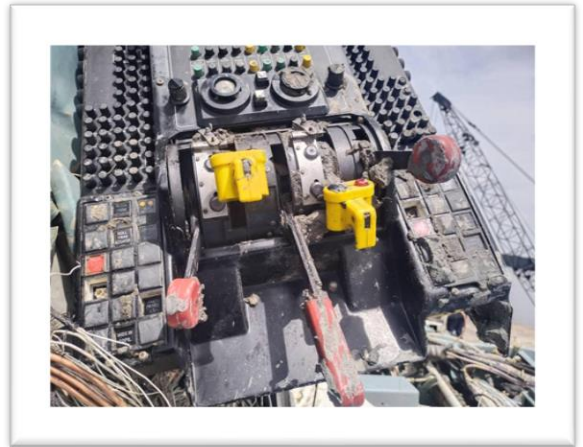
**FLIGHT INSTRUMENT PANEL RECOVERED FROM  
SUNGAI PULAI ON 17 JULY 2025**
