AIRCRAFT ACCIDENT

FINAL REPORT

A 01/25

Rotary Wing Helicopter Bell 206L4, Registration PK-ZUV

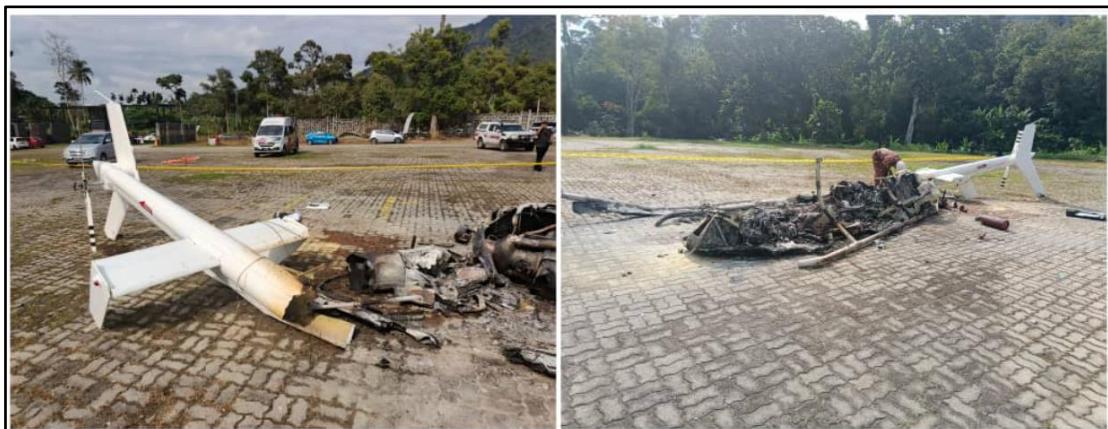
The tail boom section of the helicopter remained intact; however, the rest of the helicopter was destroyed by post-impact fire (Refer to Figure 2).

Figure 2: Pictures of the destroyed helicopter

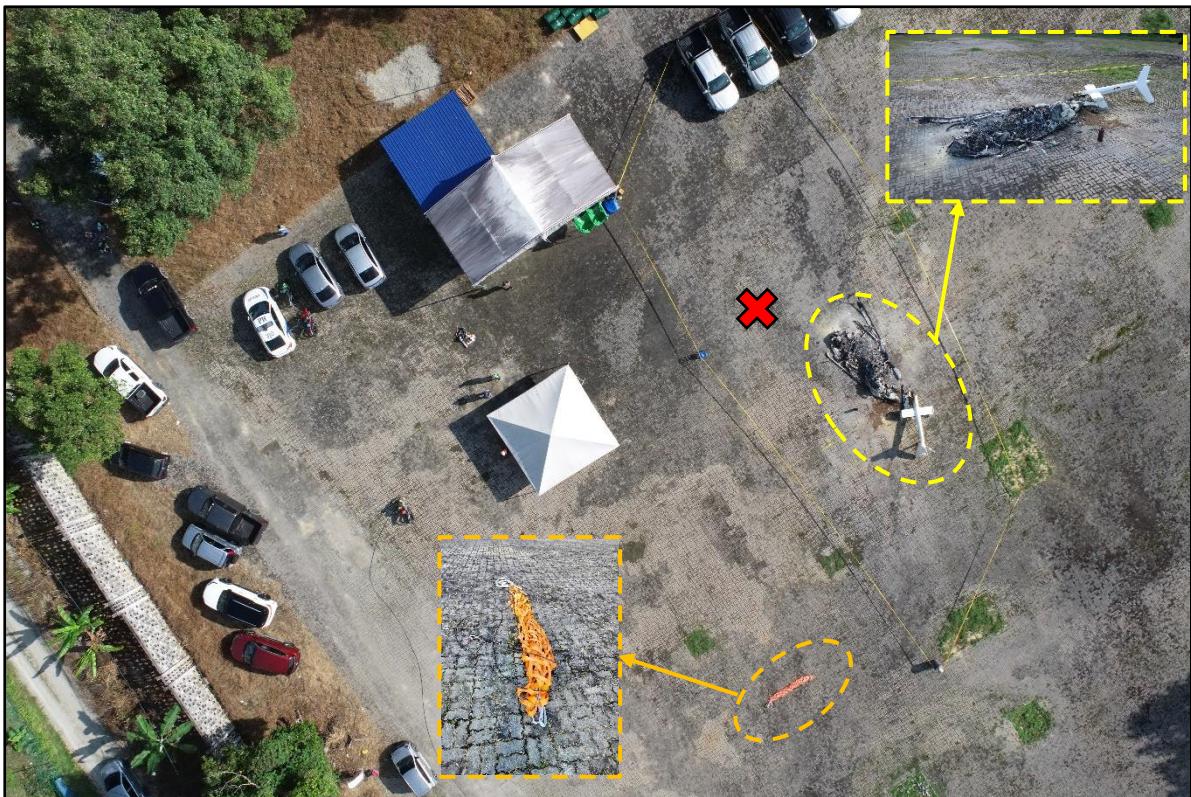
Figure 5 below provides a general description of the site, the helicopter wreckage location, the last location of the victim, and the location of the underslung cargo net. The 'broken yellow line circle' indicates the helicopter wreckage location, the 'red X' is the last location of the victim (deceased), and the 'broken orange line circle' illustrates the location of the underslung cargo net, which was released on the ground earlier on prior to refuelling.

Figure 5: PK-ZUV general description map of the accident site and wreckage location

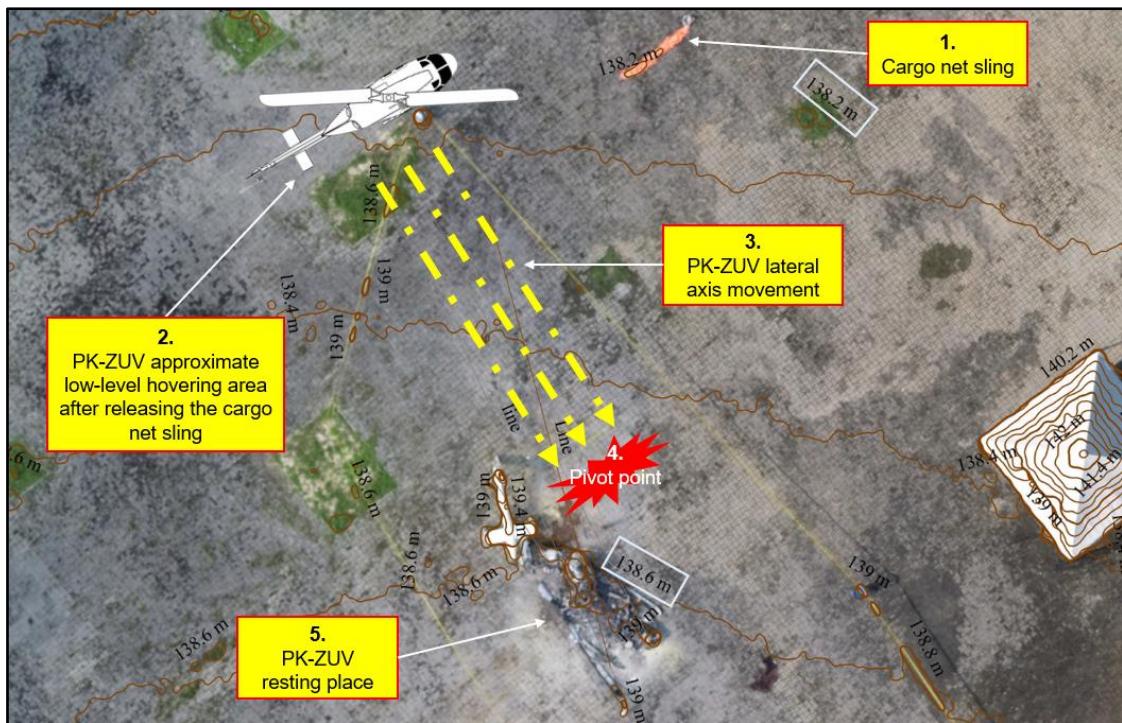
Figure 6: Chronology of events in relation to the ground features and surface conditions of the HLS 2 area

Prior to landing, PK-ZUV released the cargo net sling and entered a low-level hover over ground contour 138.2 meters. Upon realising the distance from the intended reference point (drum barrel located at ground contour 138.6 meters), the pilot initiated a low-level lateral manoeuvre to the right in an attempt to reposition the helicopter closer. During this manoeuvre, excessive control input caused the helicopter's right skid to strike the ground, resulting in a loss of control. The helicopter subsequently toppled and caught fire.

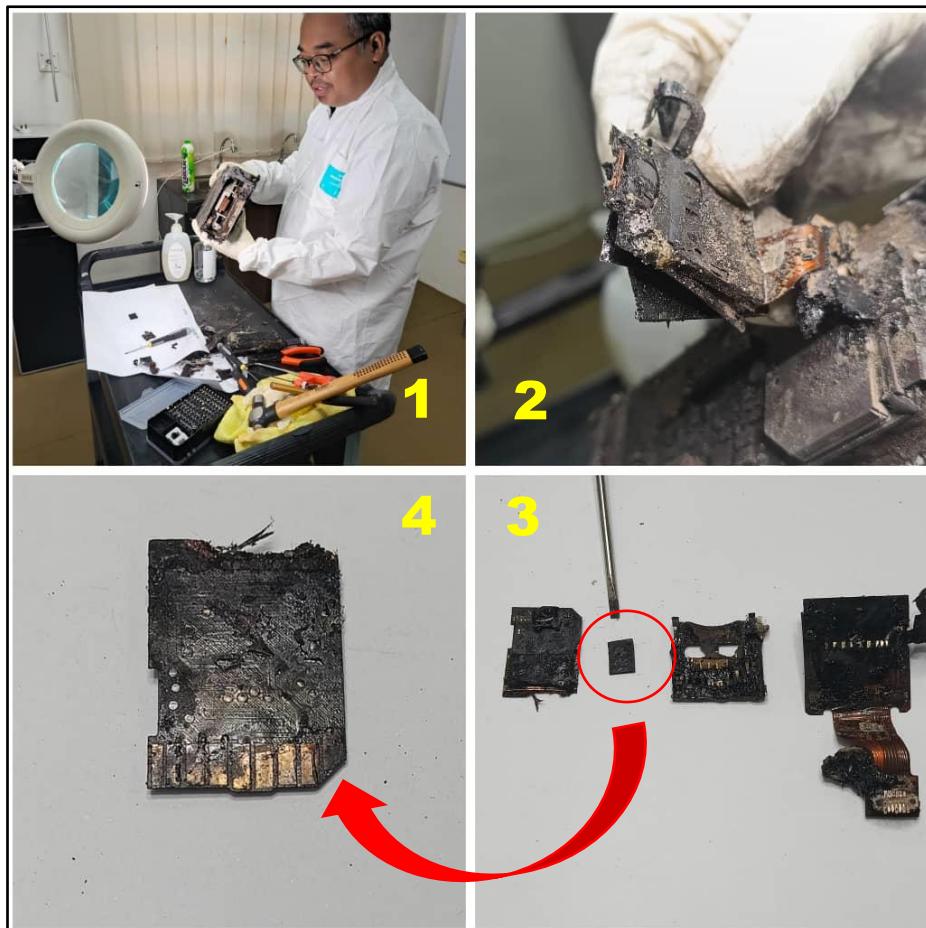
The unit was dismantled to access the internal components and retrieve the memory card. Once the casing was opened, the circuit board was fully removed, allowing for the extraction of the memory card. However, upon inspection, the memory card showed visible signs of burning and damage, rendering data extraction impossible (refer to Figure 7).

Figure 7: Retrieval of the Garmin GTN 6xx series unit memory card accessible

Picture 4: The memory card shows signs of burning and damage, making data extraction impossible.

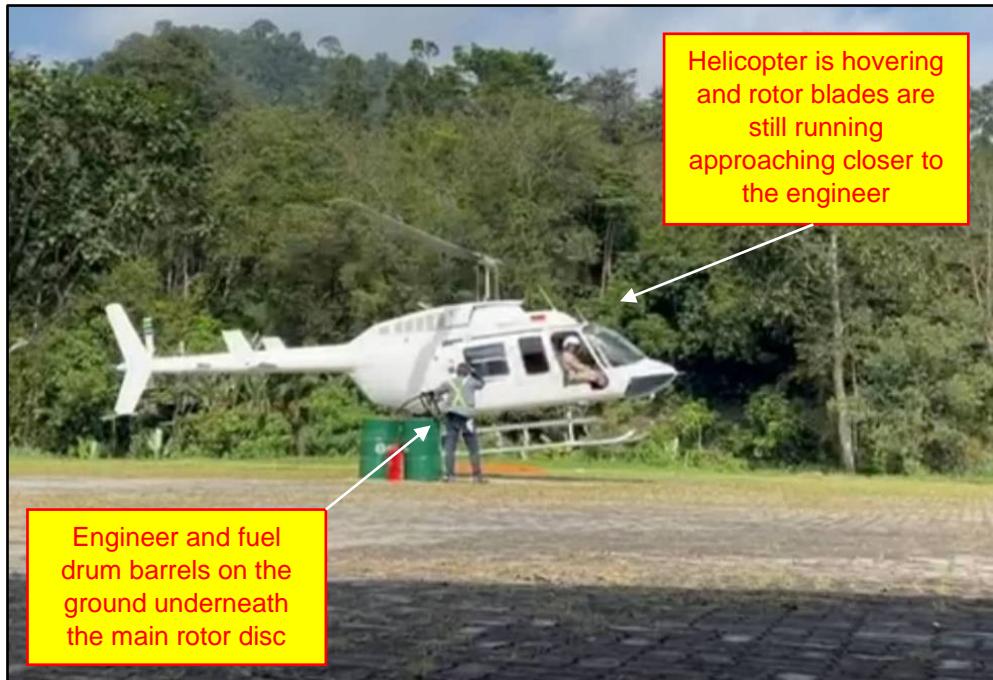
Based on video footage of PK-ZUV conducting hot refuelling a day before the accident (refer to Figure 9), it was observed that the crew from the Lessor did not adhere to the

prescribed SWP for hot refuelling. Such non-compliance poses a potential risk and could lead to unsafe conditions.

Figure 9: PK-ZUV hot refuelling a day before

Figure 8, Paragraph 1.4.1 (c), (e), and (f) clearly define the SWP for conducting hot refuelling. However, as observed in Figure 9, the aircraft operator or the Lessor failed to adhere to these procedures.

Additionally, Paragraph 1.4.1 (e) states that the refuelling crew should only approach the helicopter after receiving a clear instruction (thumbs-up) from the pilot. However, as shown in Figure 9, the crew is already positioned beneath the helicopter while it is still hovering and approaching for landing, indicating a clear violation of this procedure.

The footage shows the ground engineer and fuel drums positioned directly beneath the active main rotor disc while the helicopter was still in a hover and attempting to land. This behaviour constitutes a direct violation of the SWP's requirement for crews to remain at a safe distance and approach only after receiving explicit pilot instruction. These unsafe actions introduced potential hazards into the operational environment, effectively bypassing the defensive layers intended to prevent rotor strikes.

4.2.2.1 To review and update its operational documentation to ensure that safety distances and ground crew positioning requirements during landing and refuelling are clearly defined and consistent with specific site hazards.
