**AIRCRAFT SERIOUS INCIDENT  
FINAL REPORT  
SI 02/25  
Air Accident Investigation Bureau (AAIB)  
Ministry of Transport Malaysia**

**Fixed-Wing Aircraft Airbus A321-211,  
Registration PK-TLG, at Sultan Abdul Aziz Shah Airport, Subang, Selangor  
on 14 February 2025**

**REPORT NO: SI 02/25**

**OPERATOR** : PT. TRANSNUSA AVIATION MANDIRI  
**AIRCRAFT TYPE** : AIRBUS A321-211  
**NATIONALITY** : INDONESIA  
**REGISTRATION** : PK-TLG  
**PLACE OF OCCURRENCE** : SULTAN ABDUL AZIZ SHAH AIRPORT,  
SUBANG, SELANGOR  
**DATE AND TIME** : 14 FEBRUARY 2025 AT 1944 LT (1144 UTC)

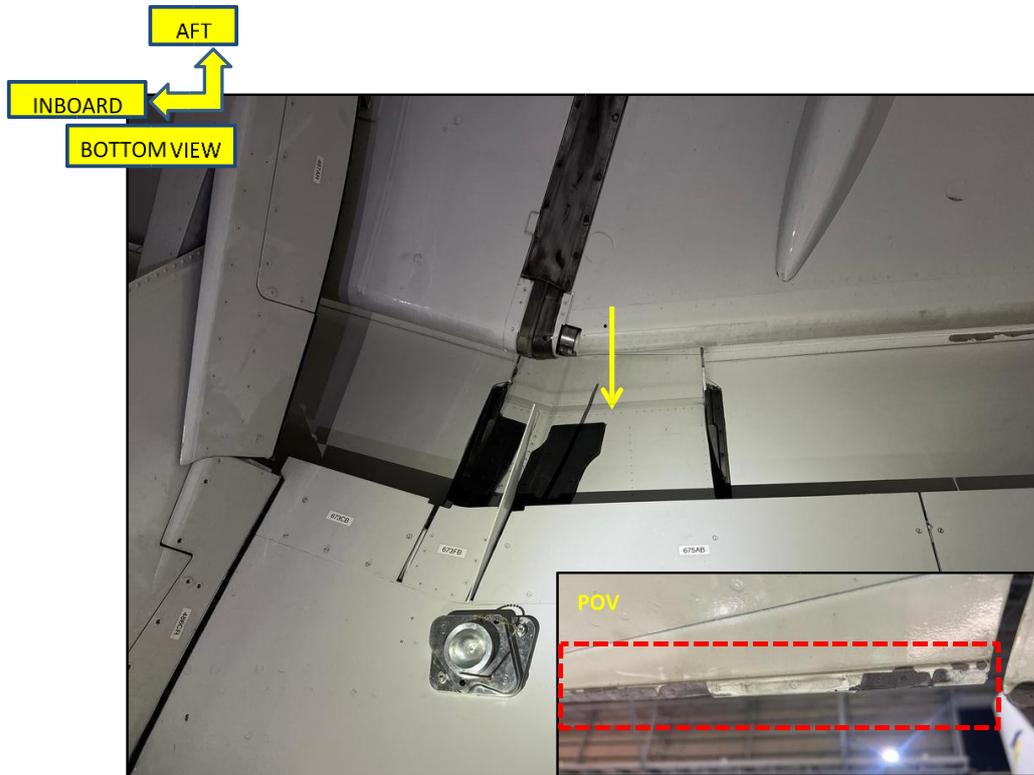
Figure 1: RH Strip Rubbing Trailing Edge Falsework between Spoiler 1 & 2 Chaffing

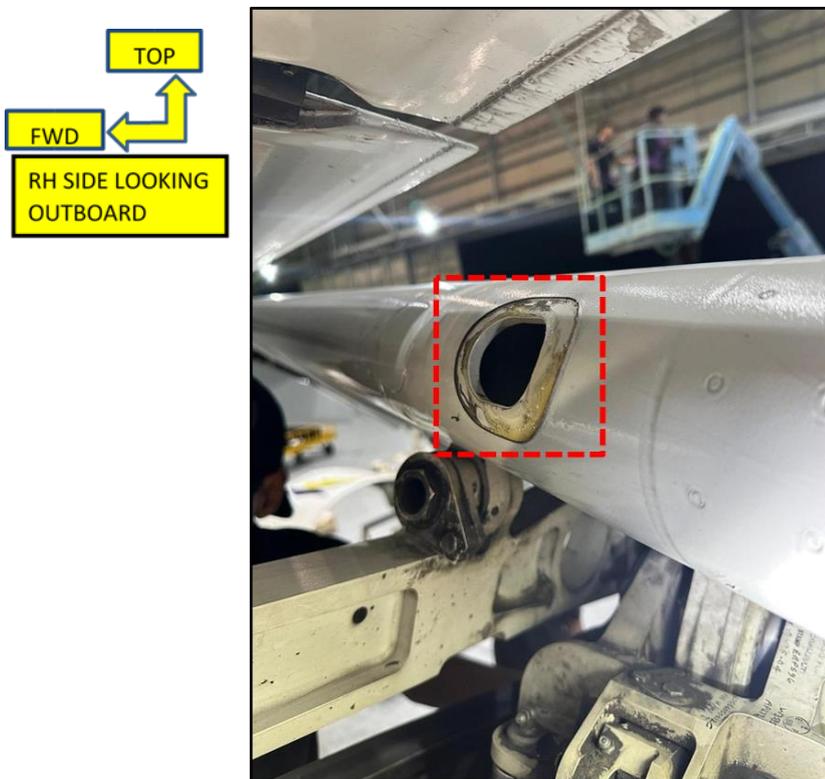
Figure 2 : RH Flap Trap Fairing No. 3 Hoist Patch Missing

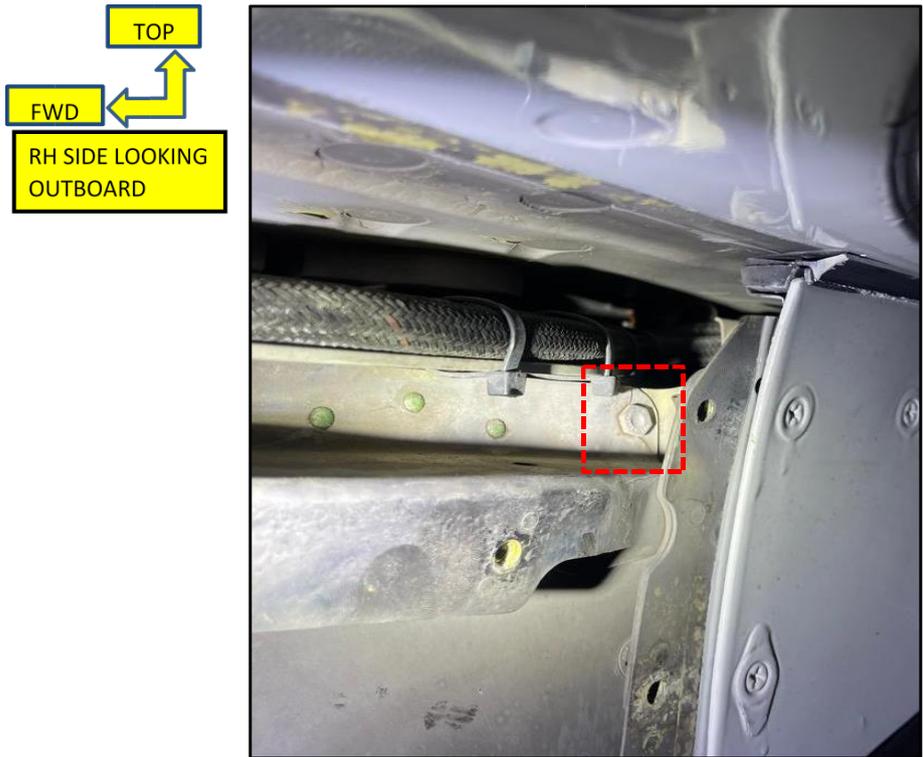
Figure 3: Crack found at Pylon Bracket inboard Engine No. 2

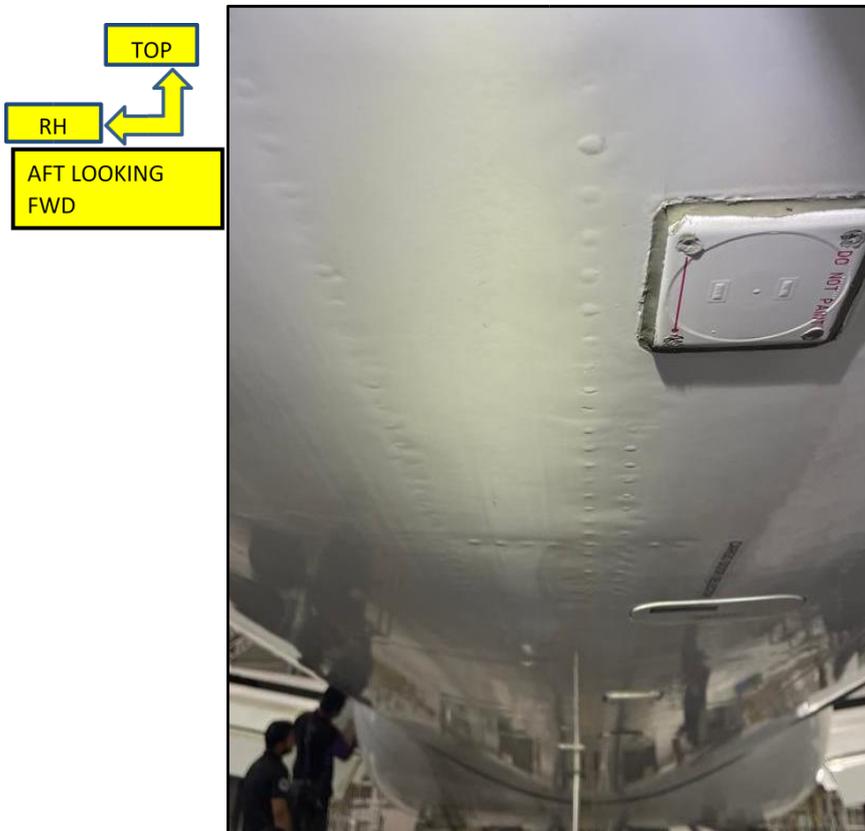
Figure 4: Suspected Skin Buckling at FR50-65

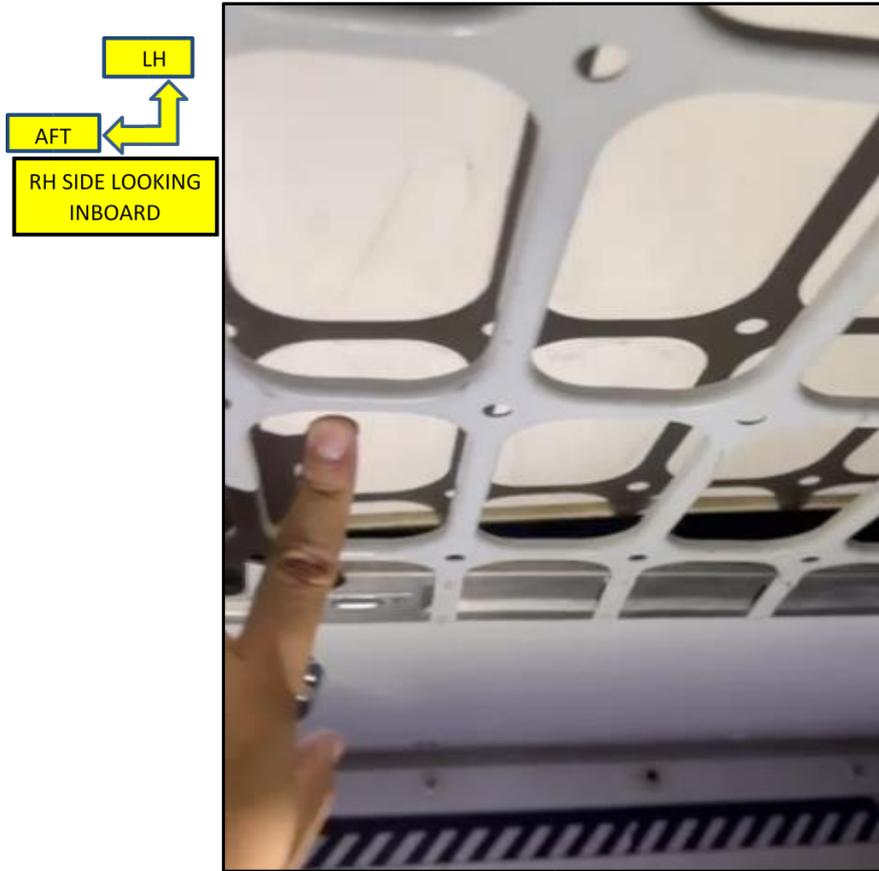
Figure 5: Aft Cargo Decompression Panel Unlatched

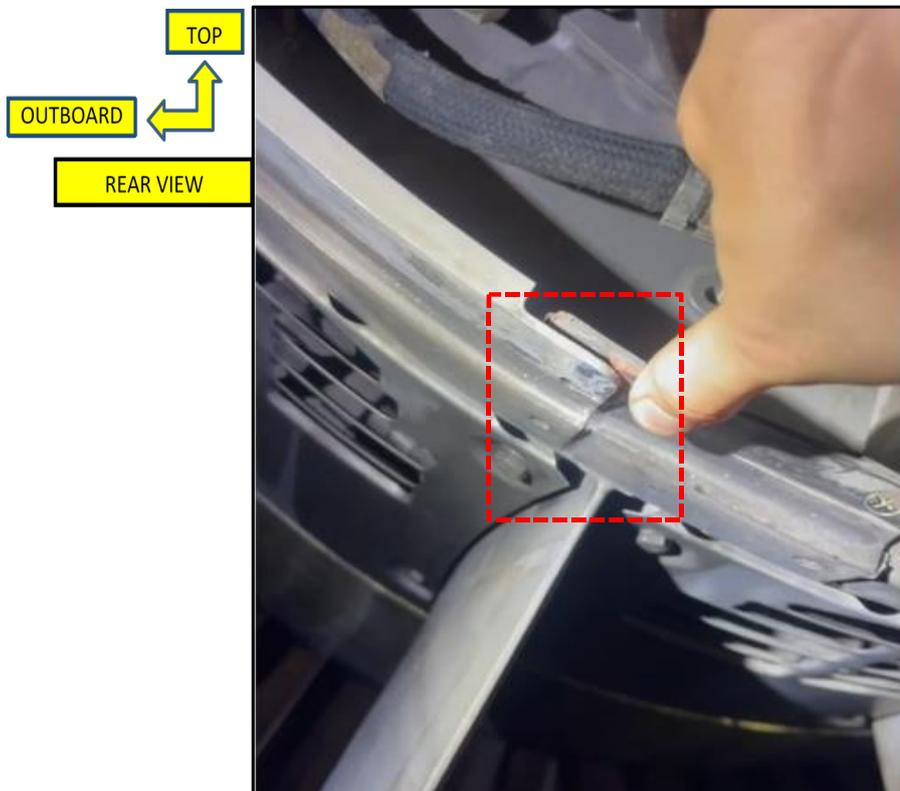
Figure 6: Engine No. 1 Flange Aft of VBV Rivet Pop-Out

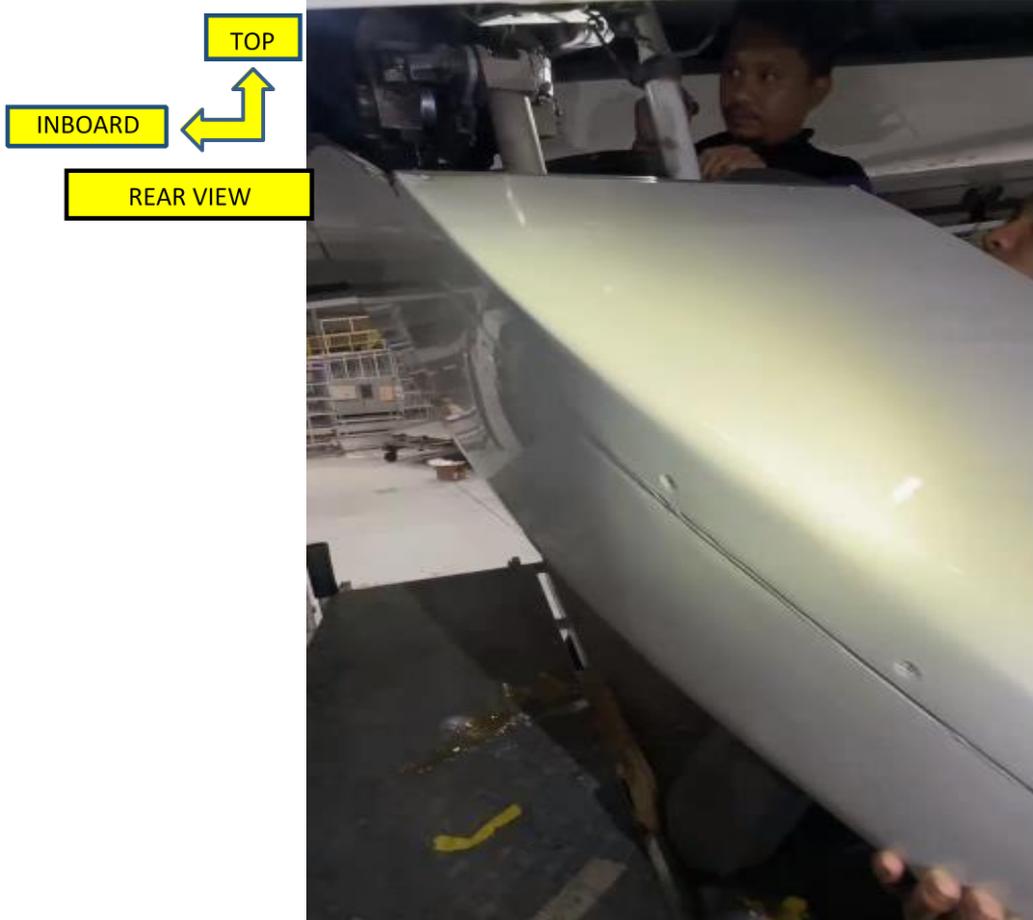
Figure 7: All Flap Fairing High Free-Play

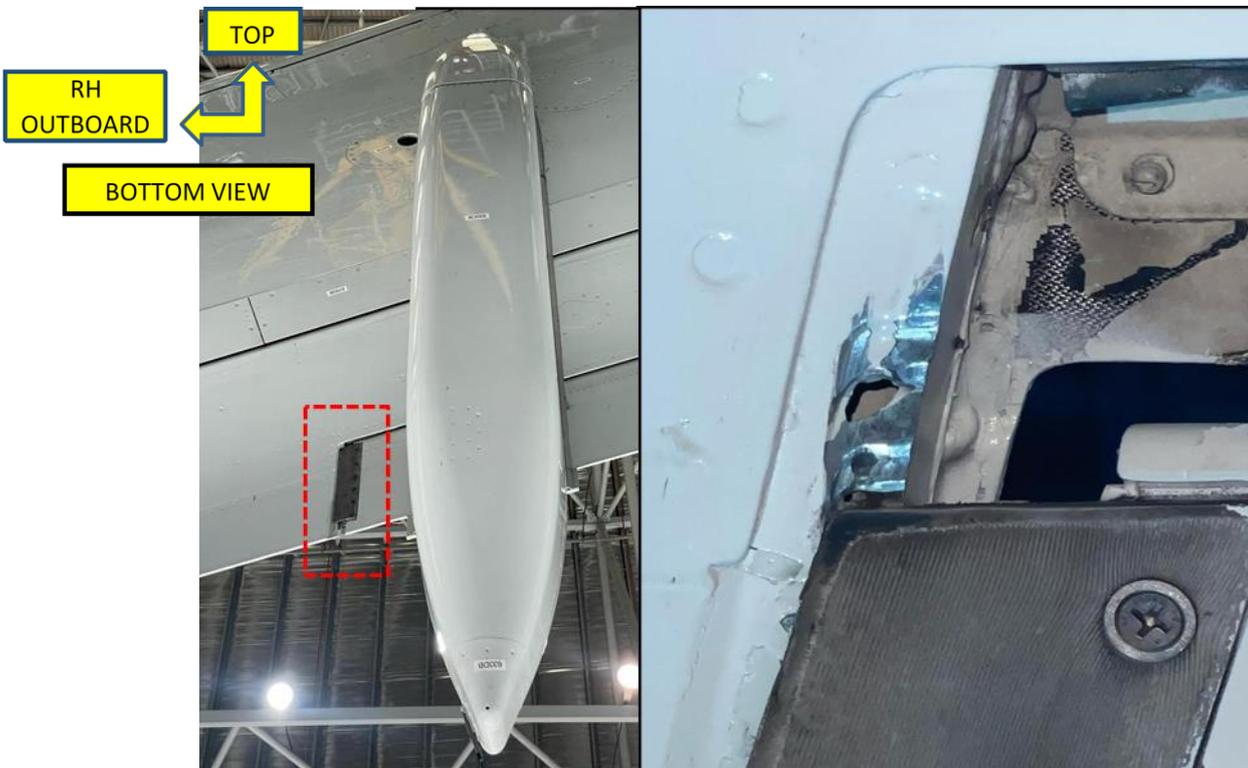
Figure 8: RH Outboard Flap Punctured

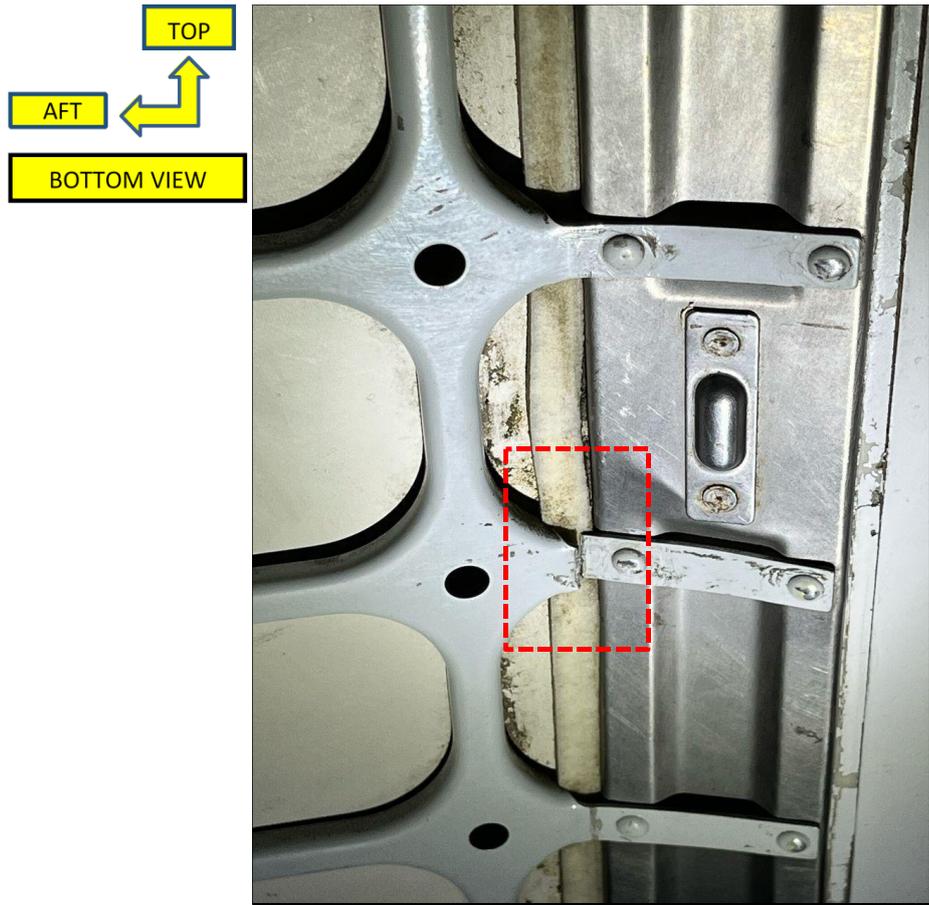
Figure 9: Forward Cargo Decompression Panel Broken

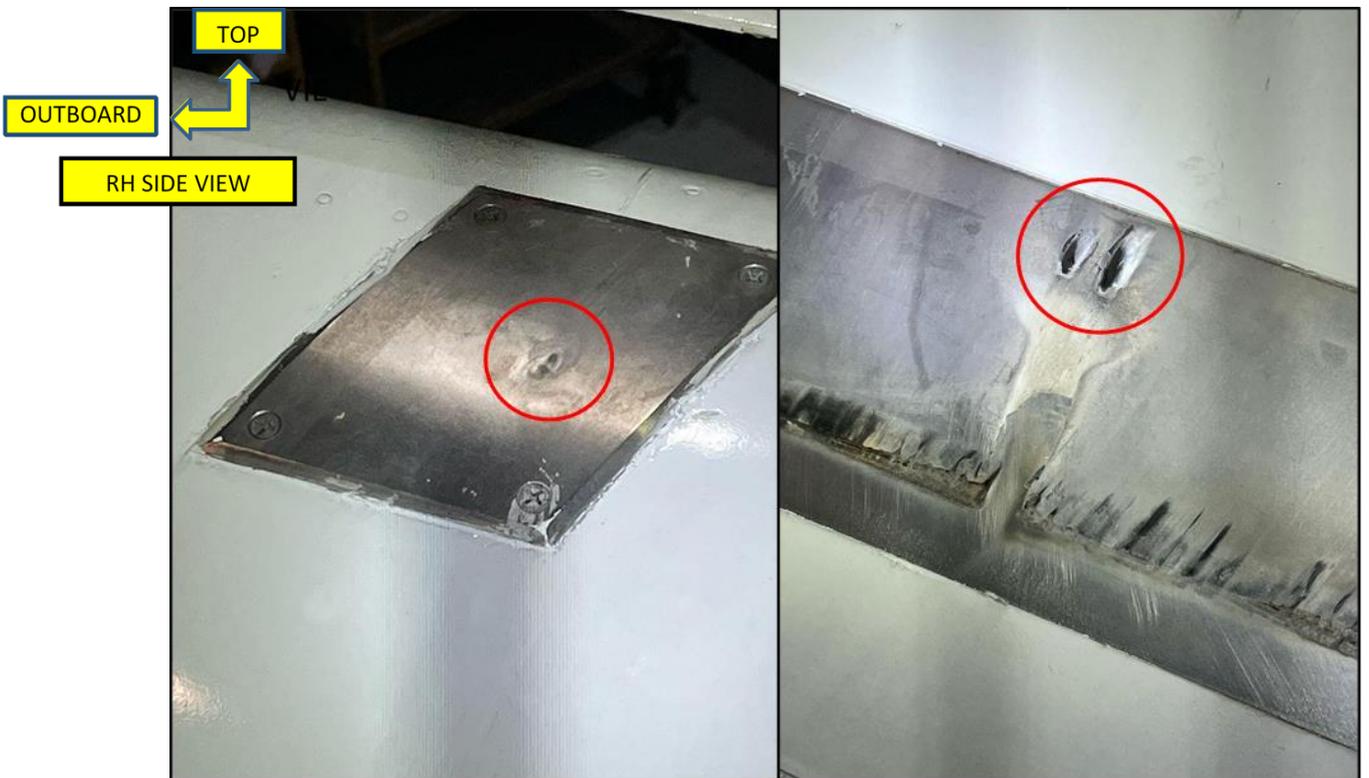
Figure 10: Gouge on LH Flap Rubber Strip

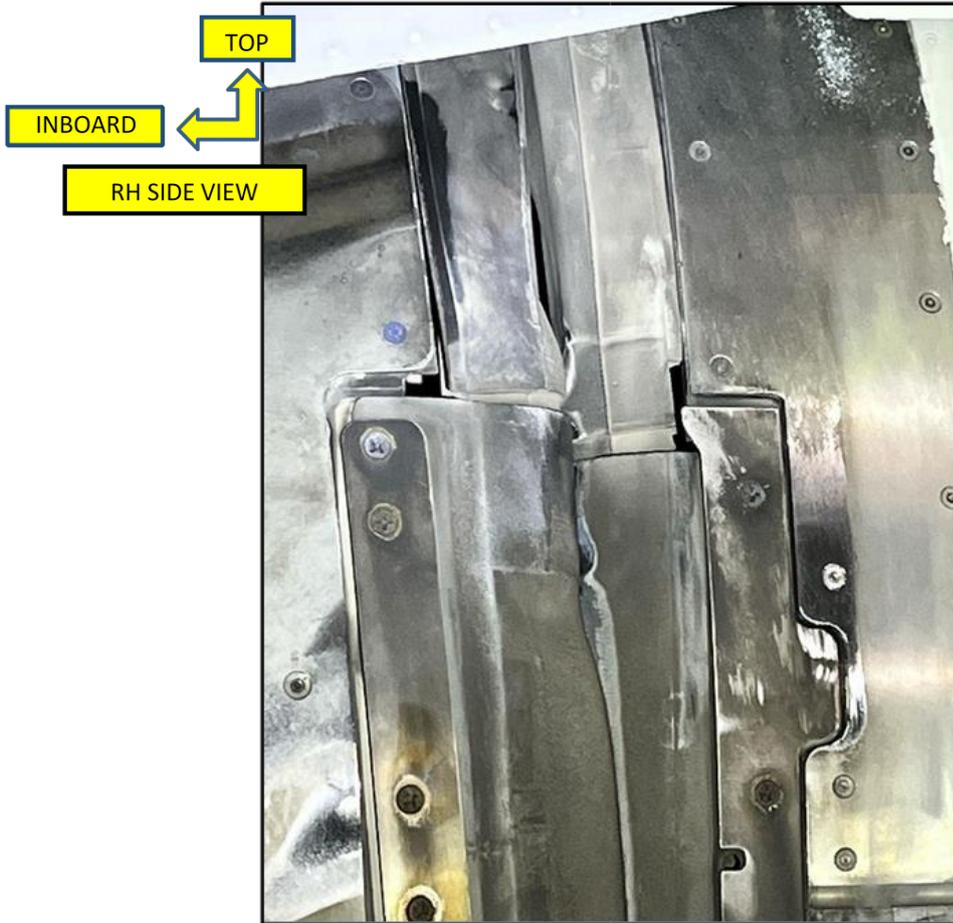
Figure 11: Sign on Seal Distortion on RH Flap

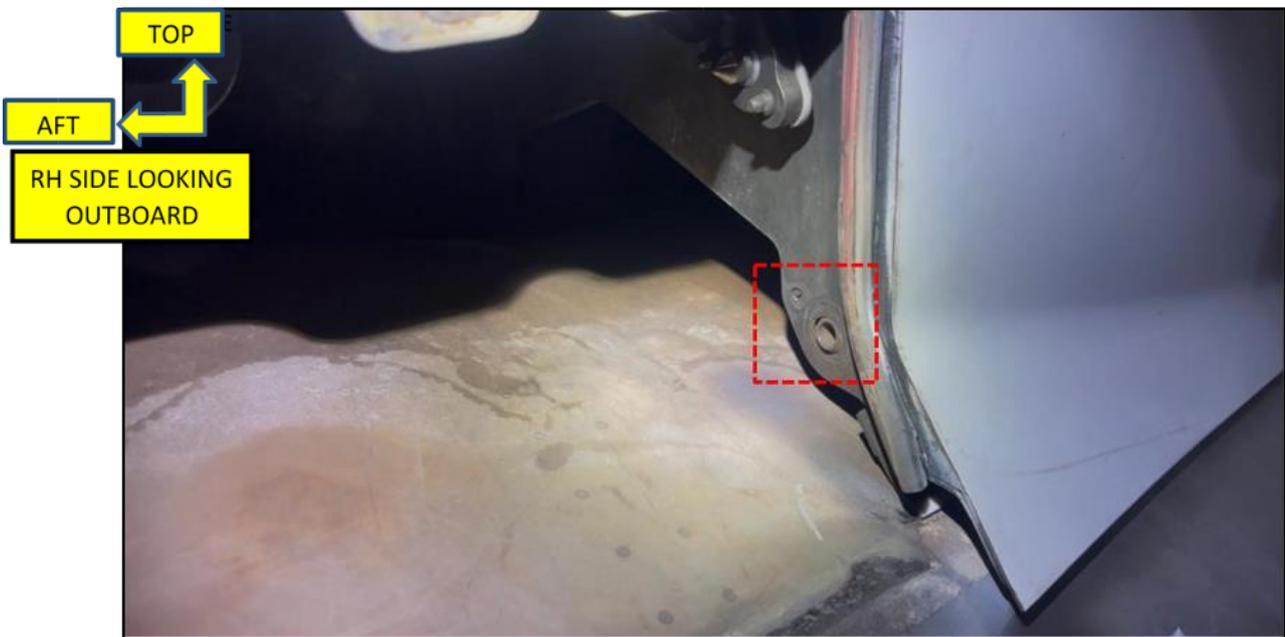
Figure 12: Loose Bearing on Engine No. 1 Pylon Inboard Panel

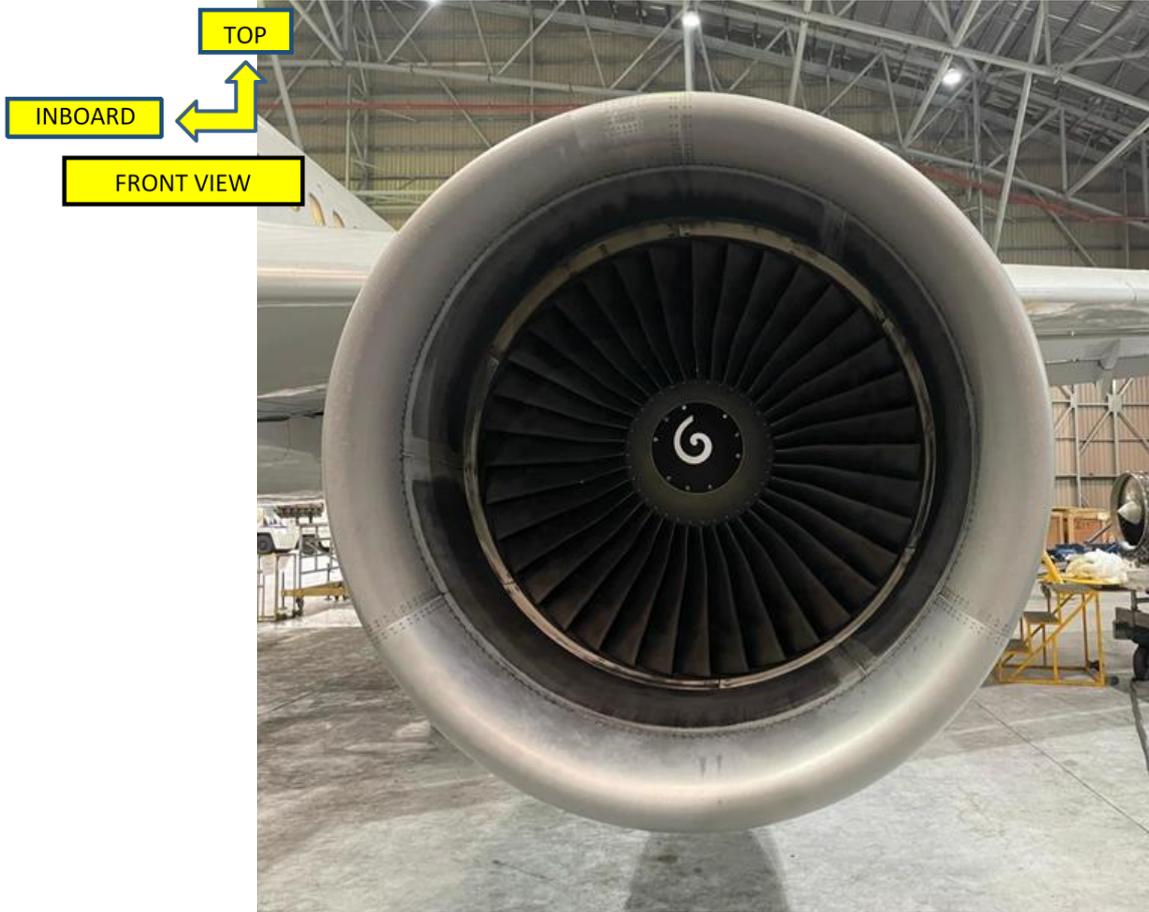
Figure 13: Engine No. 1 Fan Rotor Unsmooth Rotation
