AIRCRAFT SERIOUS INCIDENT PRELIMINARY REPORT

SI 02/25

**Fixed-Wing Aircraft Airbus A321-211,
Registration PK-TLG, at Sultan Abdul Aziz Shah Airport, Subang, Selangor
on 14 February 2025**

INITIAL DAMAGE ASSESSMENT

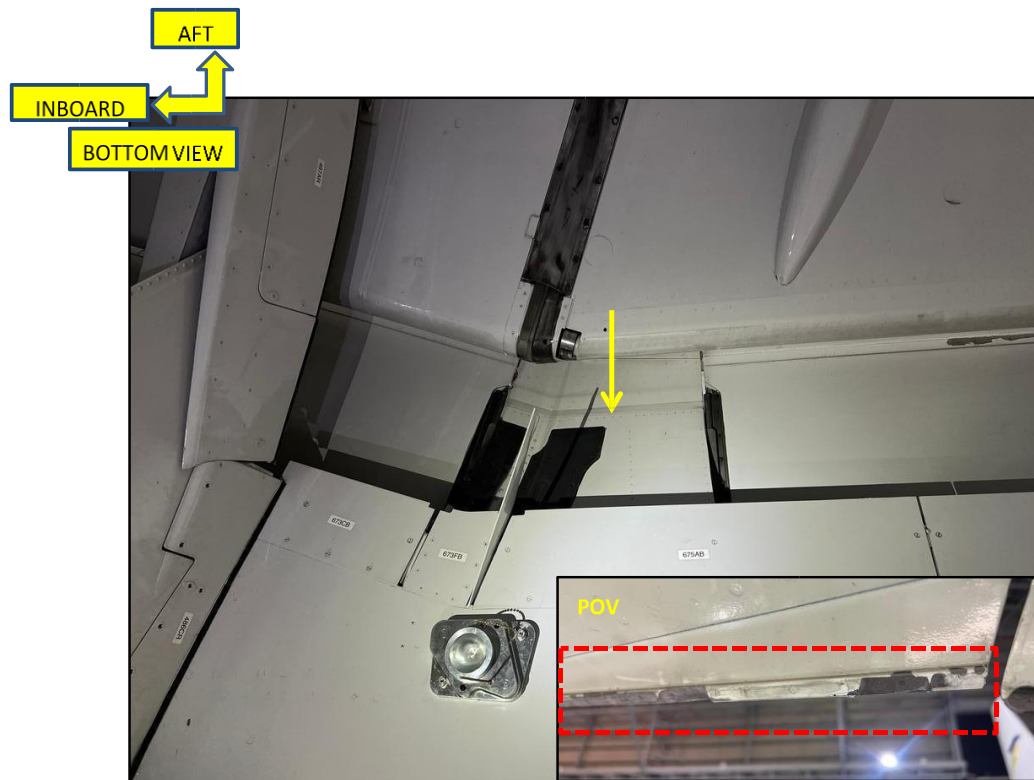
Figure 1: RH Strip Rubbing Trailing Edge Falsework between Spoiler 1 & 2

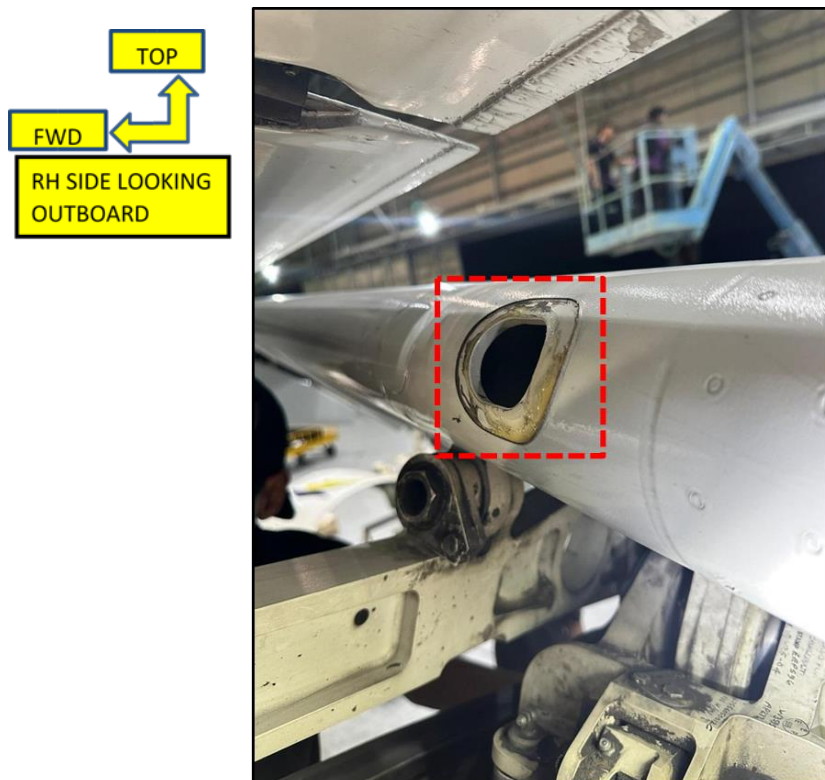
Figure 2: RH Flap Trap Fairing No. 3 Hoist Patch Missing

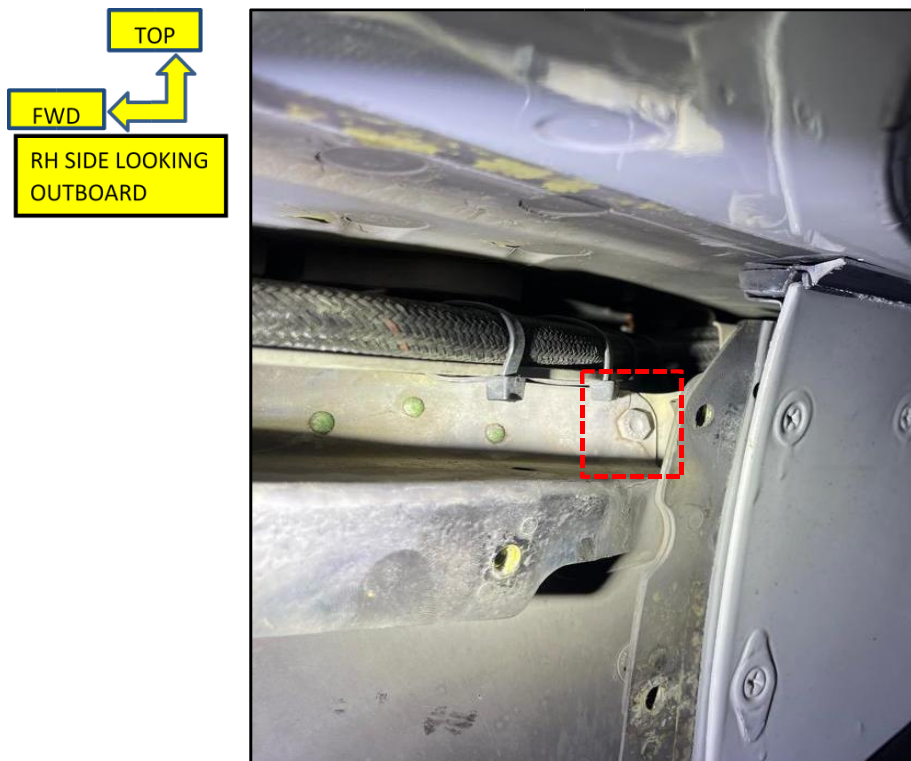
Figure 3: Crack found at Pylon Bracket inboard Engine No. 2

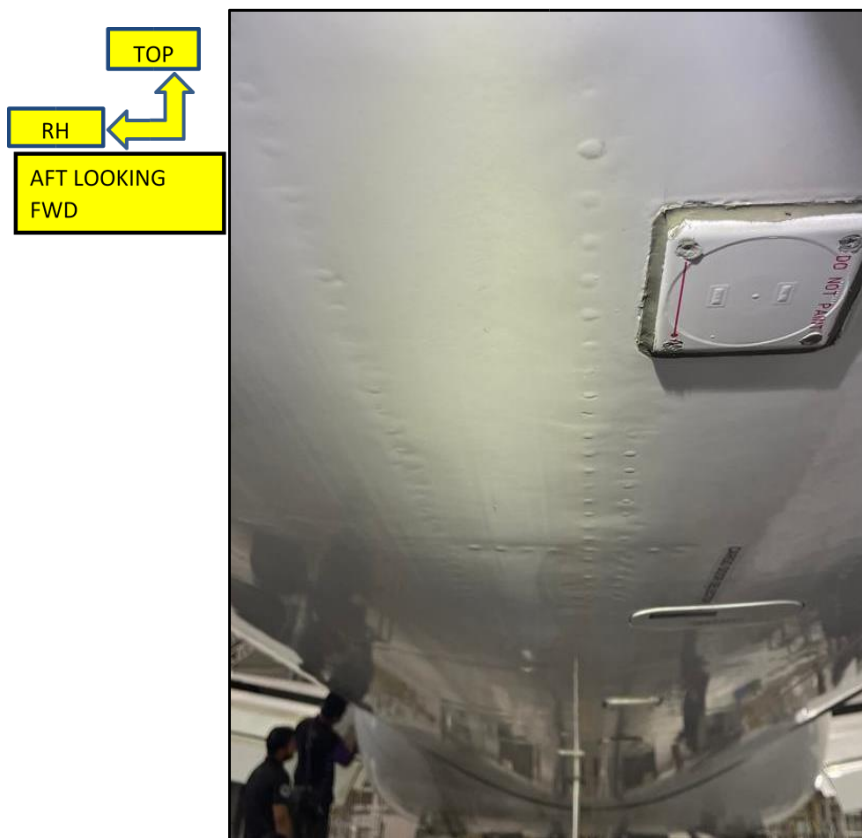
Figure 4: Suspected Skin Buckling at FR50-65

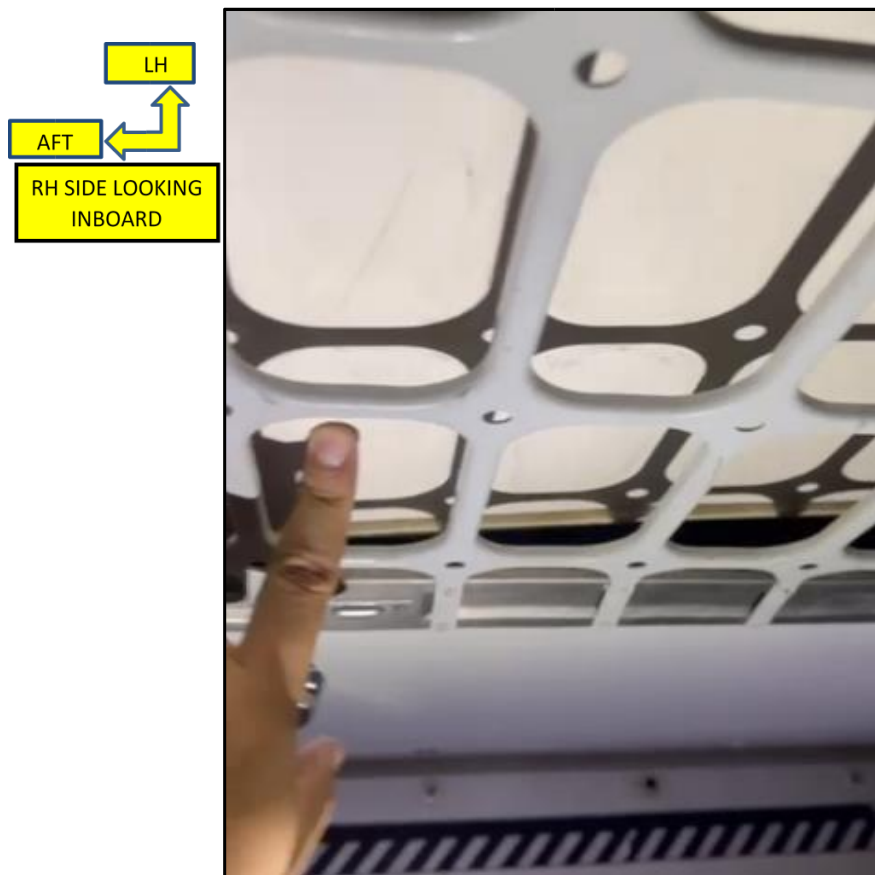
Figure 5: Aft Cargo Decompression Panel Unlatched

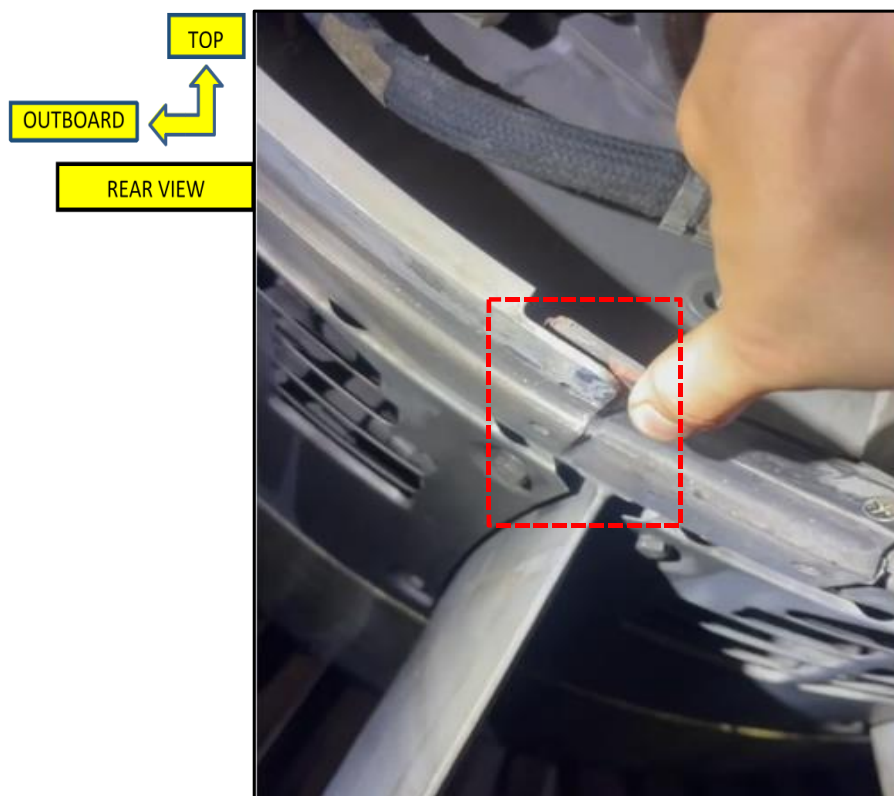
Figure 6: Engine No. 1 Flange Aft of VBV Rivet Pop-Out

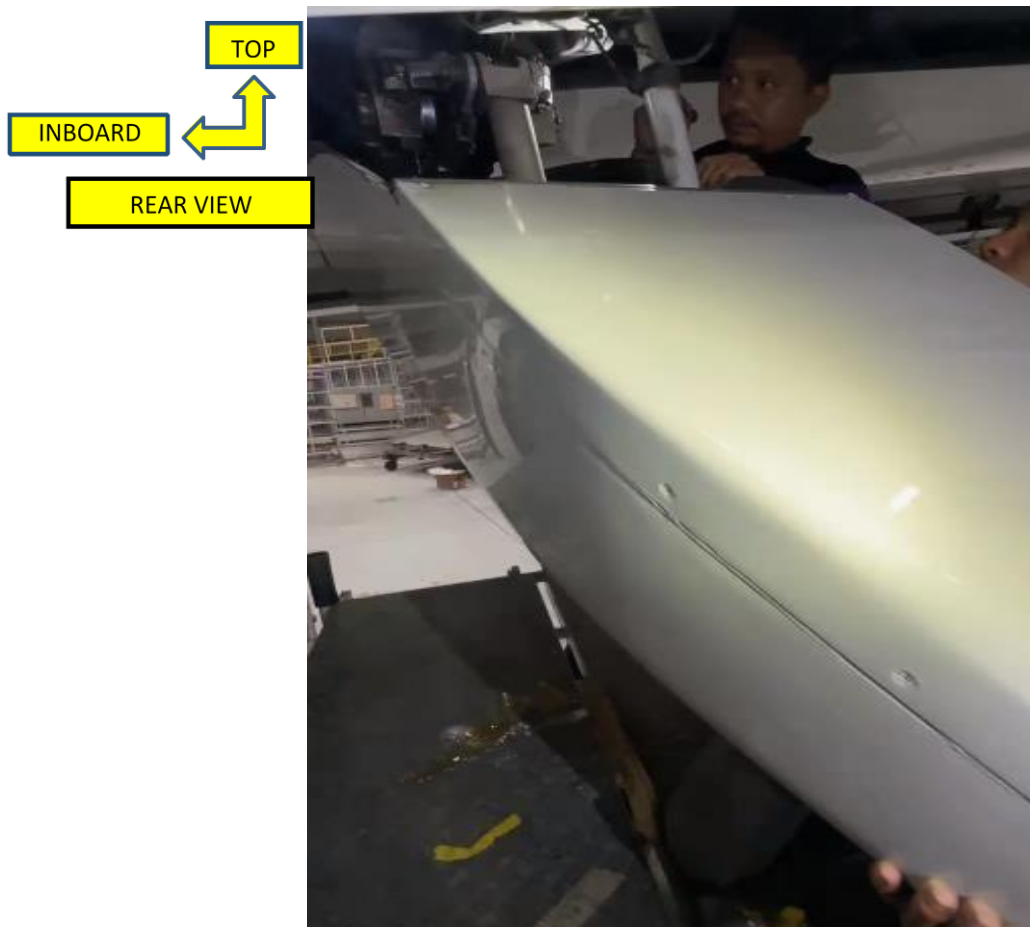
Figure 7: All Flap Fairing High Free-Play

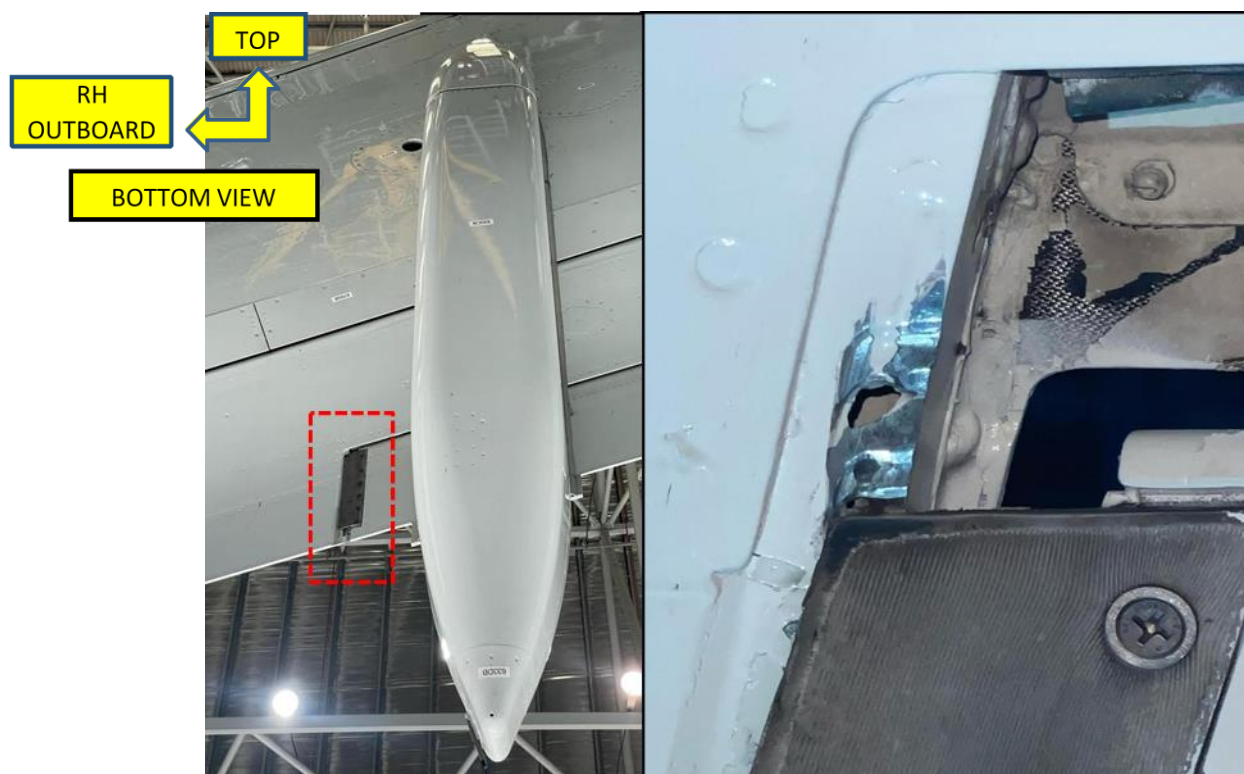
Figure 8: RH Outboard Flap Punctured

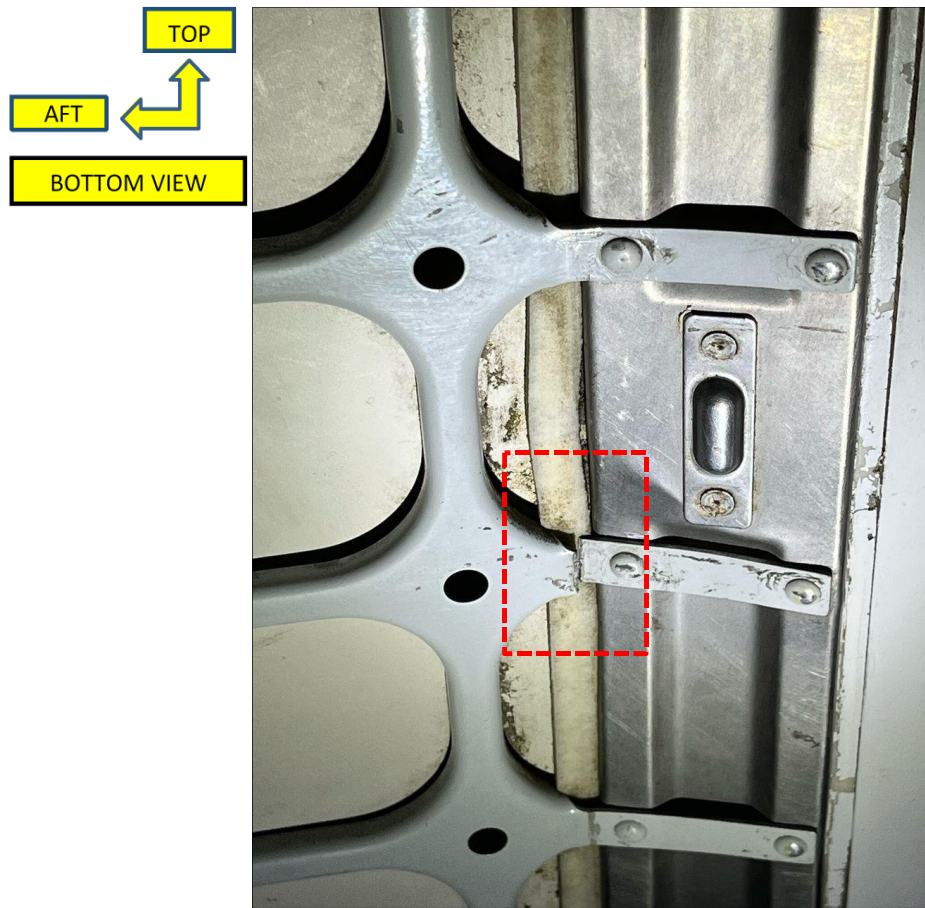
Figure 9: Forward Cargo Decompression Panel Broken

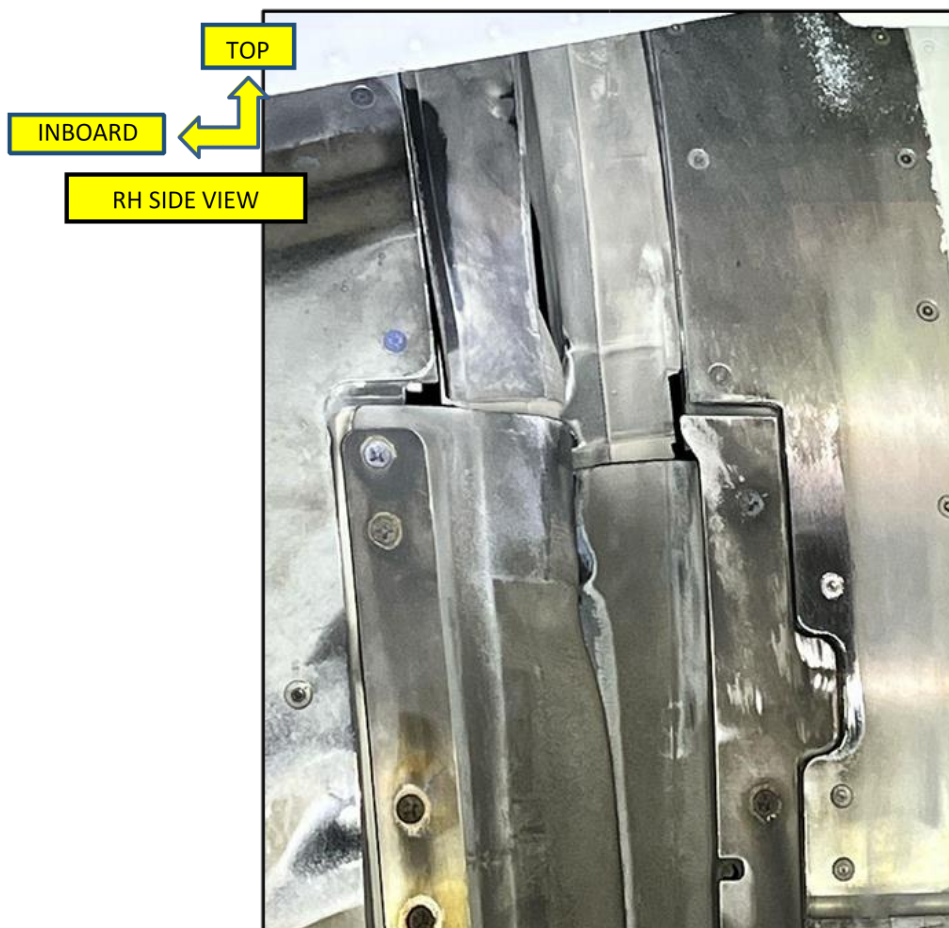
Figure 11: Sign on Seal Distortion on RH Flap

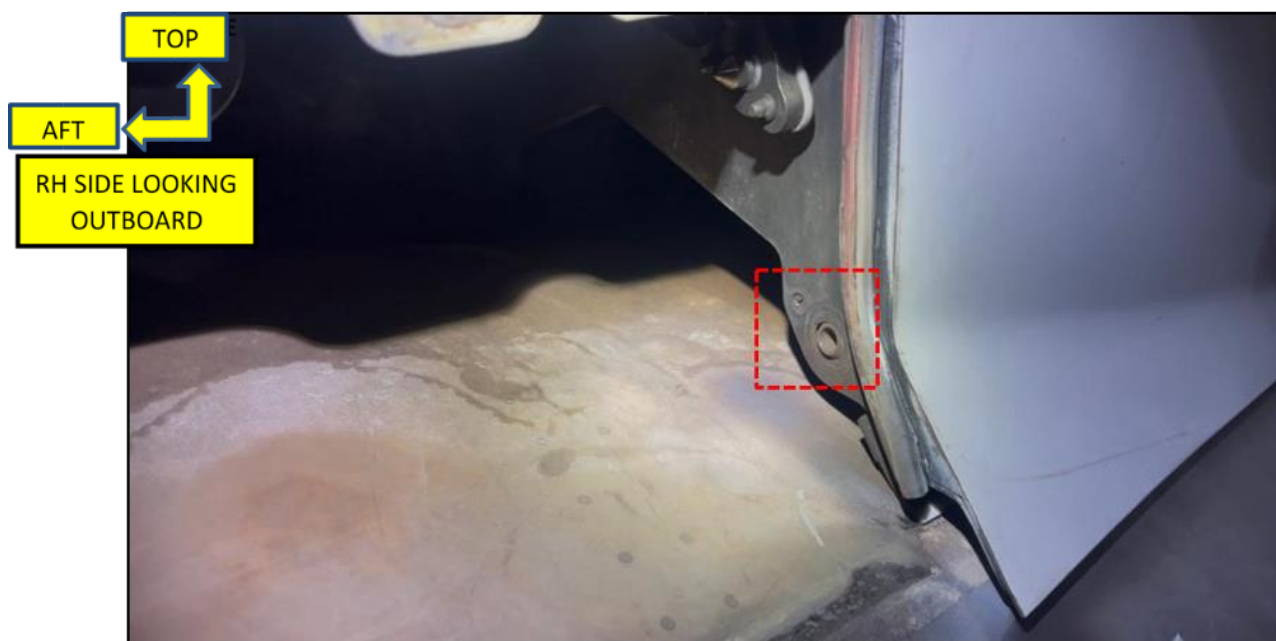
Figure 12: Loose Bearing on Engine No. 1 Pylon Inboard Panel

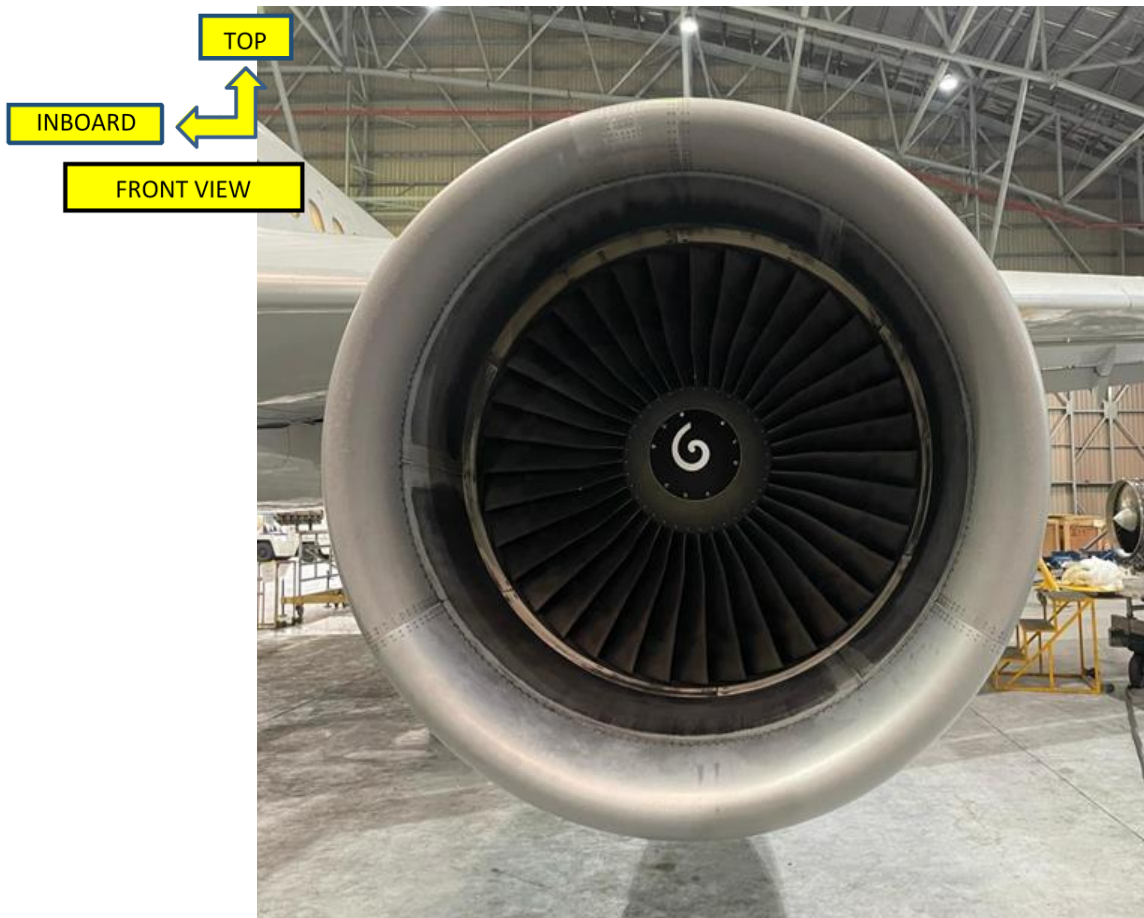
Figure 13: Engine No. 1 Ran Rotor Unsmooth Rotation
