AIRCRAFT ACCIDENT

PRELIMINARY REPORT

A 10/25

Fixed Wing Aircraft PIPER PA28-181 Archer III, Registration 9M-SKR

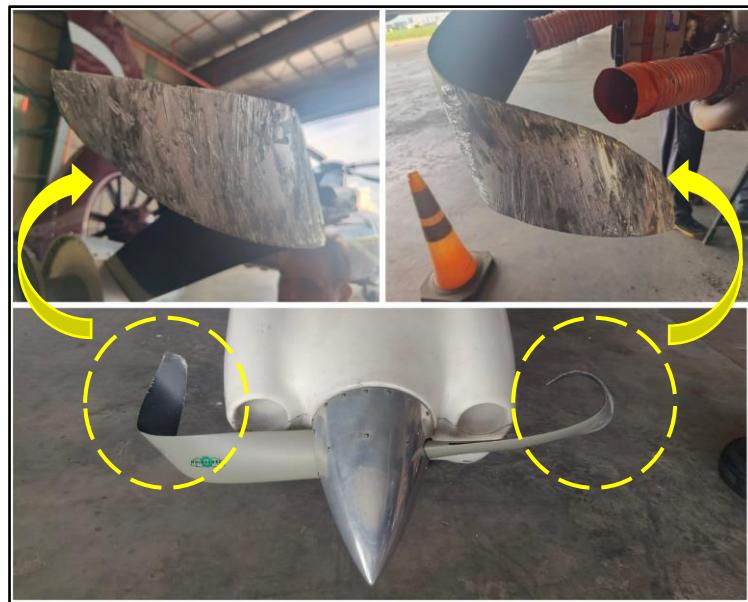
Preliminary examination identified substantial damage to the propeller blades, as shown in Figure 1. Deformation and abrasion marks were observed on the lower fuselage area of the aircraft, as depicted in Figure 2. A complete damage assessment will be documented in the Final Report.

Figure 1: Condition of the aircraft propeller blades

- iv) The aircraft was not equipped with an FDR or a CVR.
- v) The aircraft sustained substantial damage to the propeller blades, and deformation and abrasion marks were observed on the lower fuselage area of the aircraft.

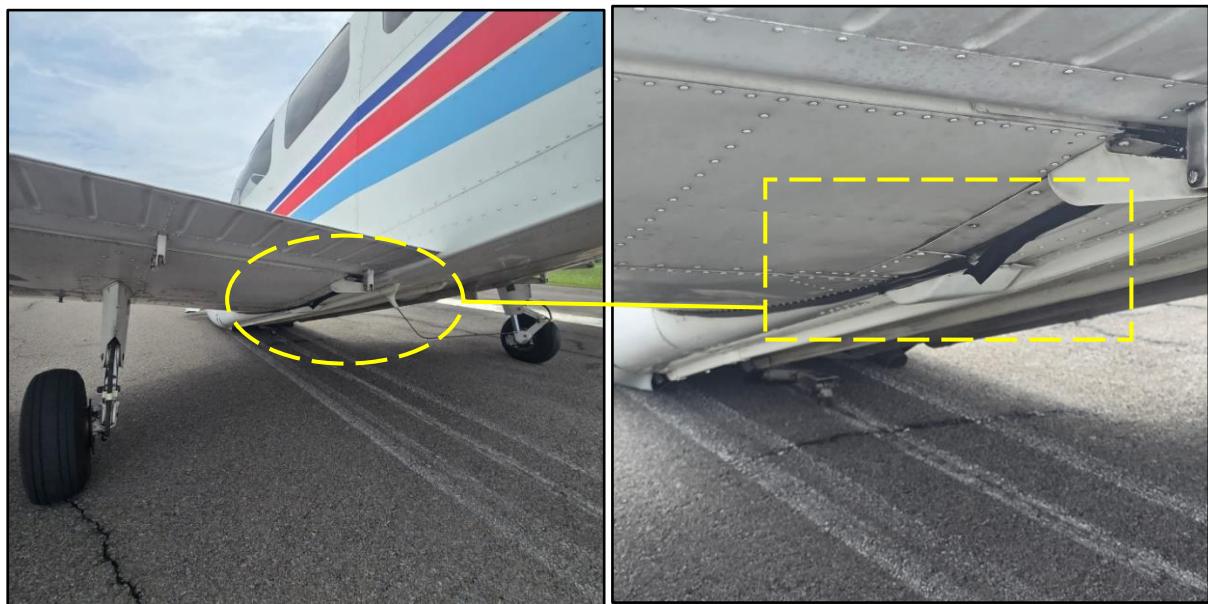
Figure 2: Deformation and abrasion marks on the lower fuselage area of the aircraft

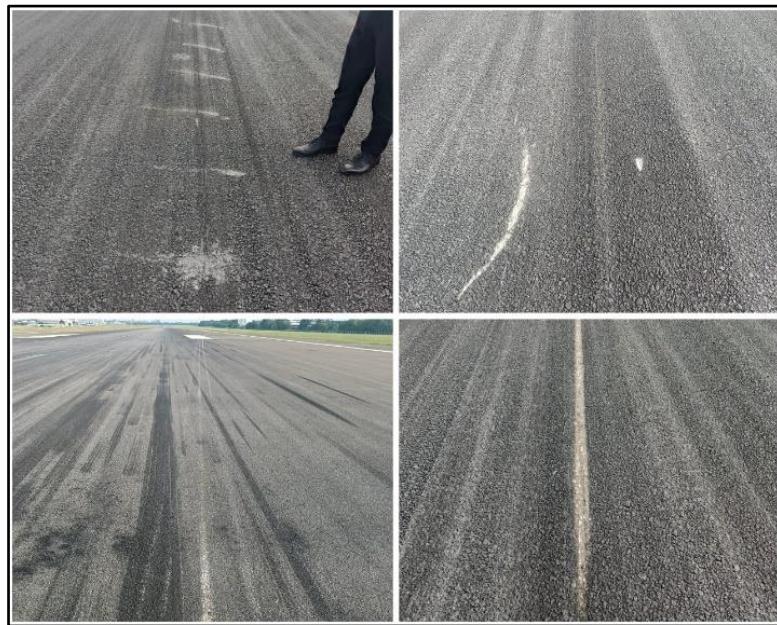
During the site investigation, scrape marks consistent with propeller blade contact were observed on the runway surface, as shown in Figure 3. Additionally, shallow potholes caused by the broken oleo from the nose landing gear were identified along the skid path.

Figure 3: Scrape marks on the Runway

- i) The runway sustained scrape marks from propeller blade contact and shallow potholes caused by the broken oleo from the nose landing gear.

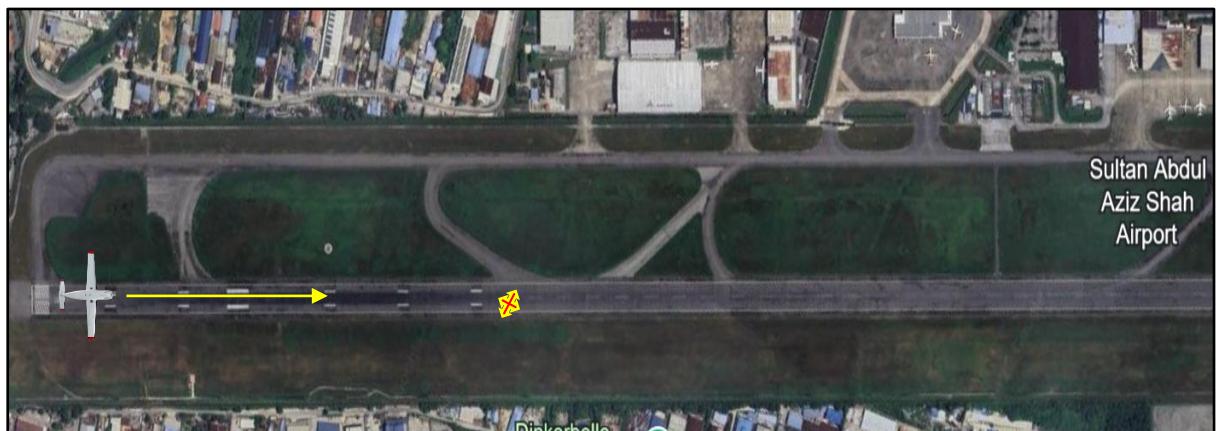
Figure 5: 9M-SKR wreckage and impact information (WMSA)

Figure 5 depicts the wreckage and impact information of aircraft 9M-SKR at WMSA on the day of the occurrence. The yellow line represents the aircraft's inbound track toward Rwy15, while the red cross indicates the aircraft's final resting position.
