## AIRCRAFT SERIOUS INCIDENT

### PRELIMINARY REPORT

SI 11/25

**Fixed-Wing Aircraft Boeing 737-800,  
Registration 9M-MXU, at Sultan Ahmad Shah Airport, Kuantan, Pahang  
on 27 November 2025**

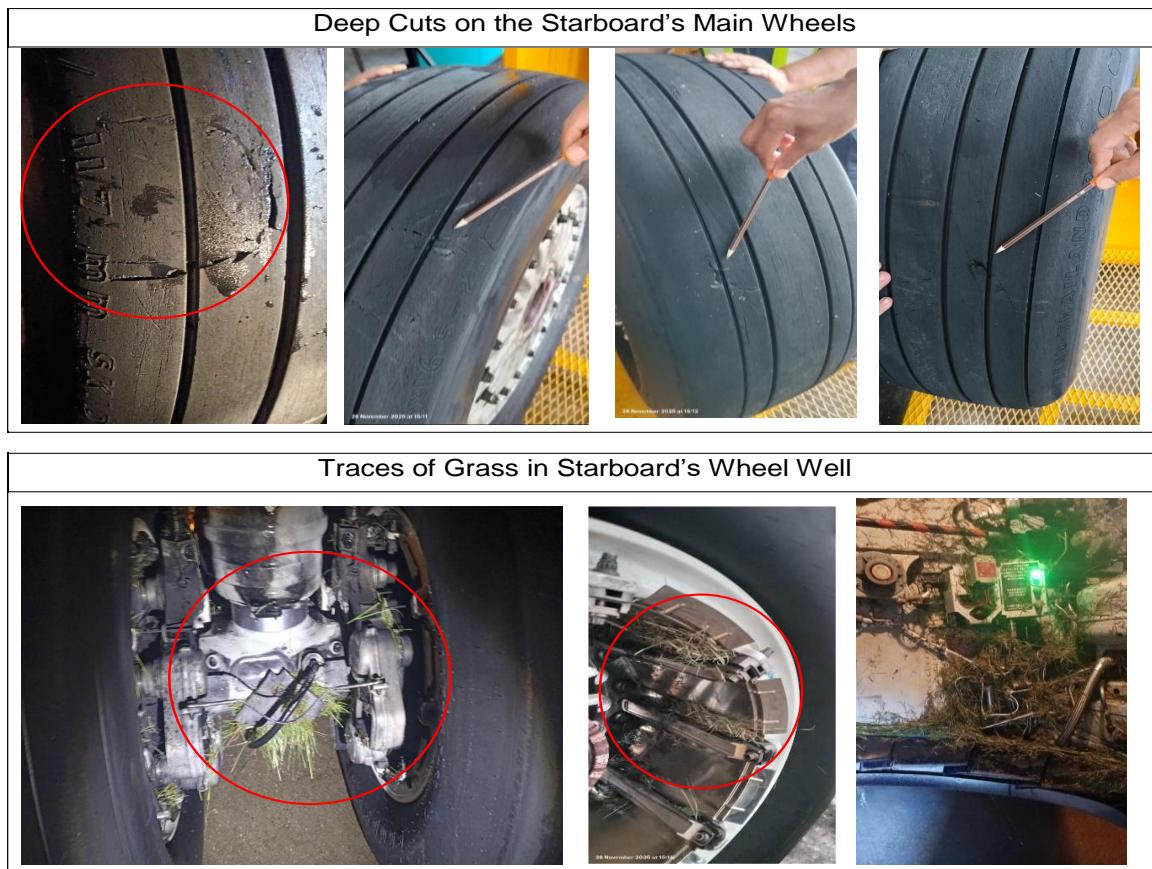
A post-occurrence inspection of the aircraft was conducted to determine the presence and extent on any damage. No damage was observed to the aircraft structure. However, several deep cuts were identified on the starboard main landing gear wheels, and traces of grass were found within the starboard wheel well and inboard flap area as shown in Figure 1 and Figure 2.

Figure 1 : Condition at Starboard's Main Landing Gear Wheels and Wheel Well

3.1.2.3 The aircraft's starboard main landing gear wheels exhibited several deep cuts.

In response to the PIC’s report, ground maintenance personnel conducted a physical inspection for a hard landing in accordance with the Aircraft Maintenance Manual (AMM), and reviewed the aircraft on-line maintenance data from the operator’s headquarters; neither the physical inspection nor the on-line data indicated that a hard landing had occurred. The post-flight inspection identified several deep cuts on the starboard main landing gear wheels, with traces of grass observed within the starboard main landing gear wheel well and the inboard flap area. The condition was assessed as a normal defect rather than damage associated with a runway excursion, and the affected tyres were replaced prior to the occurrence being reported to the AAIB.

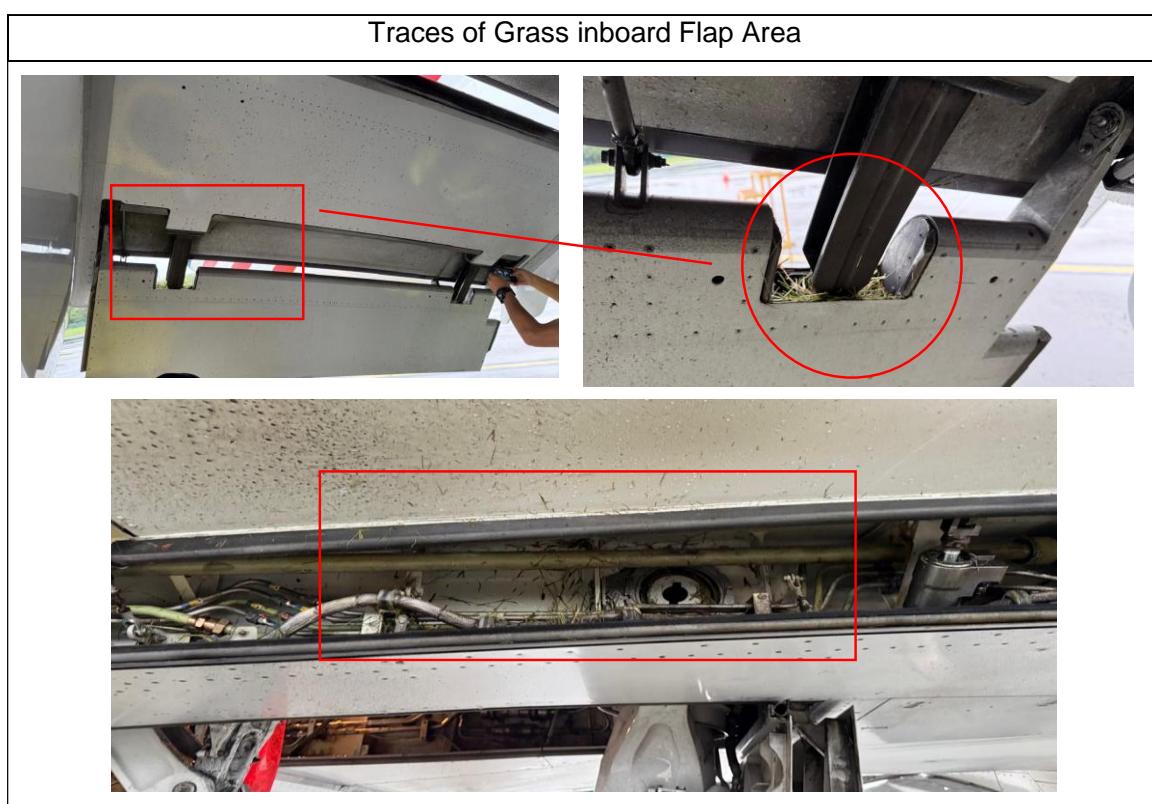
Figure 2: Condition at Inbord Starboard Flap Area

3.1.2.4 Inspection revealed traces of grass within the aircraft's starboard wheel well and inboard flap area.

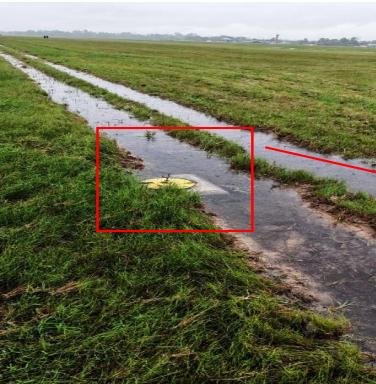
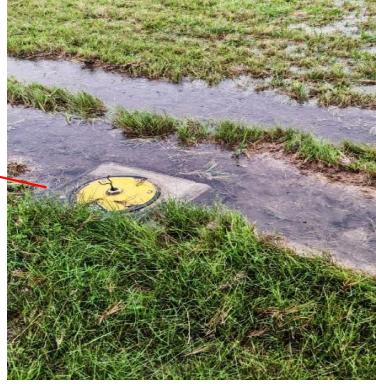
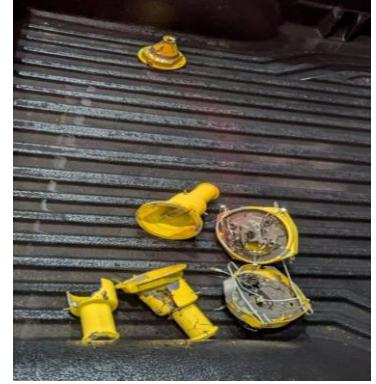
A general visual inspection of the runway was conducted following the occurrence to assess and identify any damage. The inspection revealed that three (3) runway edge lights on the eastern side of the runway were damaged. In addition, tyre marks were observed on the grass strip adjacent to the eastern side of the runway.

Location one of damaged Runway Edge Light	Location of damaged Runway Edge Light (Close-up)	Damaged Runway Edge Lights

Figure 3 : Condition of the Runway Edge Lights

3.1.3.1 Three Runway Edge Light on the eastern side of the runway were found damaged.

4.2.1 The damaged Runway Edge Lights should be promptly repaired or replaced. Until repairs are completed, the affected lights should be clearly marked as unserviceable and flight operations should be conducted with caution with NOTAMs issued to alert pilots.

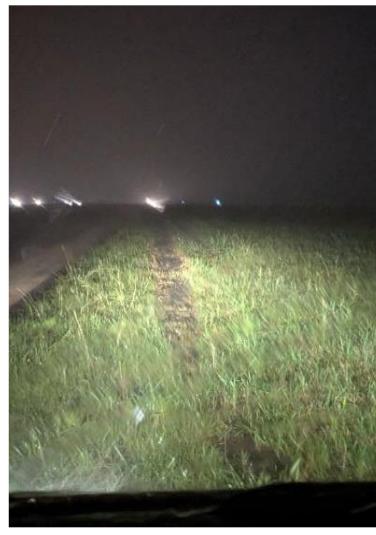
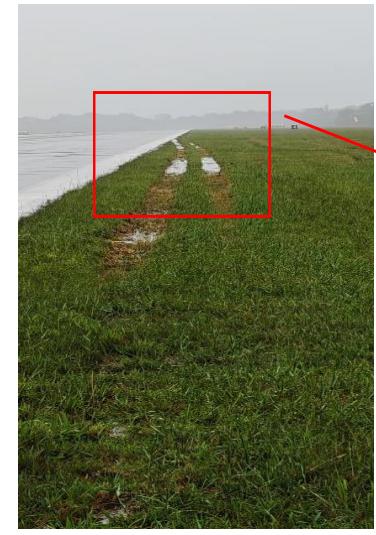
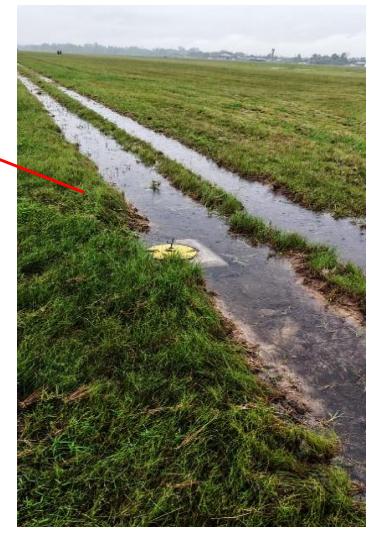
Tyre marks on the grass strip (following the incident)	Tyre marks on the grass strip (At daylight after the incident)	The tyre marks on the grass strip (Close-up)

Figure 4: Tyre Marks on Grass Strip of the runway

3.1.3.2 Tyre marks were observed on the grass strip adjacent to the eastern side of the runway

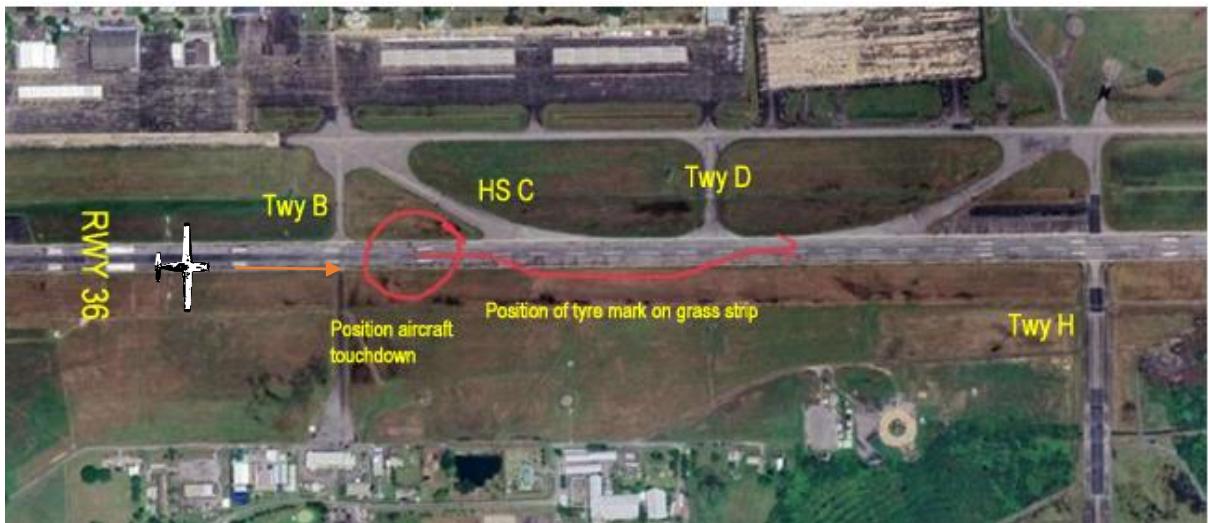
Figure 6: 9M-MXU wreckage and impact information (WMKD)

Figure 6 illustrates the wreckage and impact information of aircraft 9M-MXU at WMKD on the day of occurrence. The red circle denotes the approximate position of aircraft first touchdown from inbound track runway 36 observed by the ATC from the control tower and the red line represent the aircraft steered on ground onto the adjacent grass area before the aircraft returned to the runway.
