## **AIRCRAFT ACCIDENT REPORT A 02/18**

**Air Accident Investigation Bureau  
Ministry of Transport, Malaysia**

**Final Report on the Accident Involving  
Fixed Wing Aircraft M-18A Dromader Registration VH-FOS  
In Keratong, Pahang, Malaysia  
On The 25<sup>th</sup> February 2018**

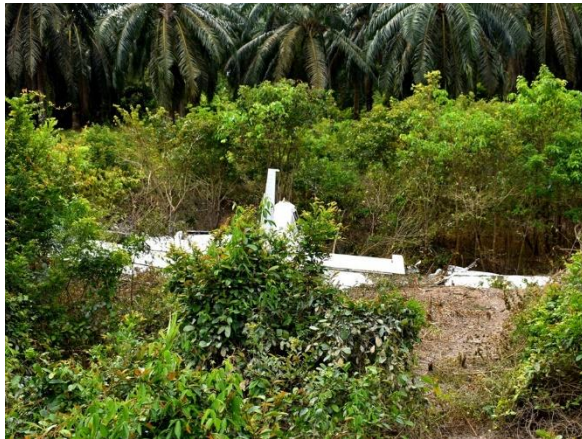
**Picture 1**

Aircraft impacted with the ground cushioned by the shrub. However the aircraft considered destroyed with the engine separated from the airframe upon impact. Port wing tip separated from the wing and the right wing badly damaged.

Aircraft final resting place

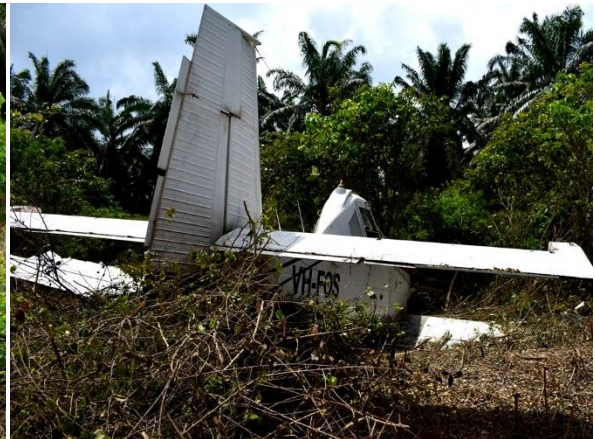
**Picture 2**

Impact cushioned by the shrub

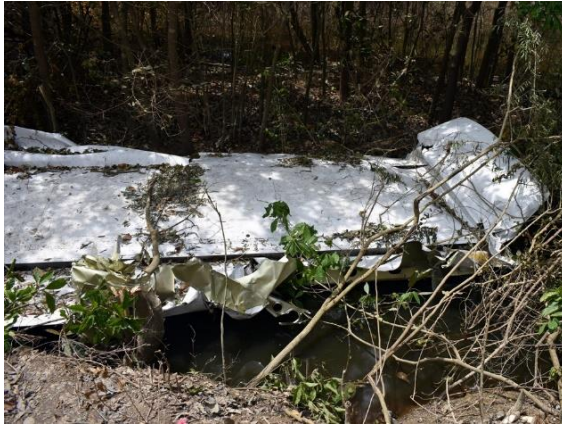
Port and starboard wing badly damaged

**Picture 3**  
Starboard wing

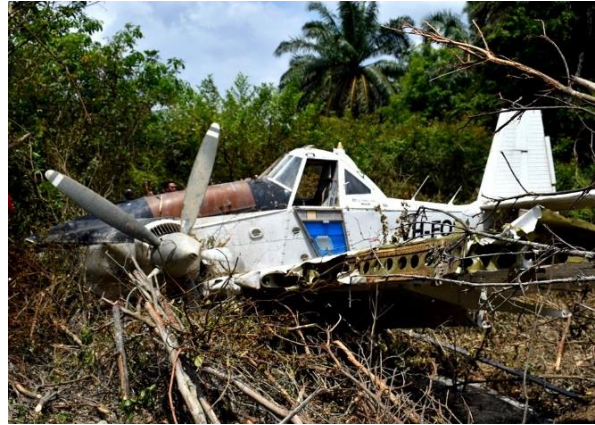
**Picture 4**  
Port wing

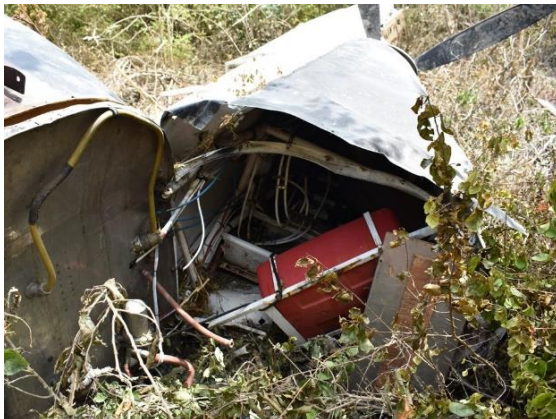
Engine separated from the airframe, bend and twisted to the left

**Picture 5**  
Engine separated from airframe

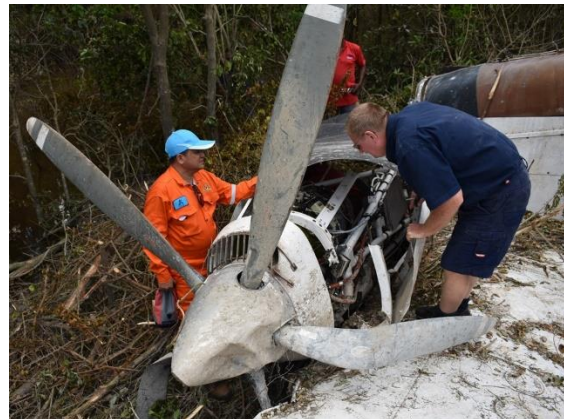
**Picture 6**  
Engine bend to the left

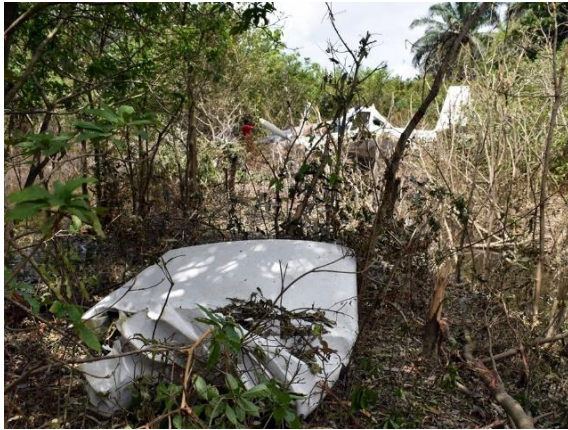
**Picture 7**

Port wing tip separated from the wing

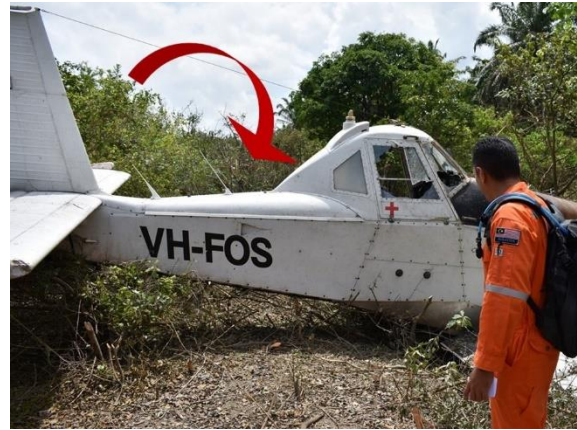
**Picture 8**

Aircraft final path as per the arrow

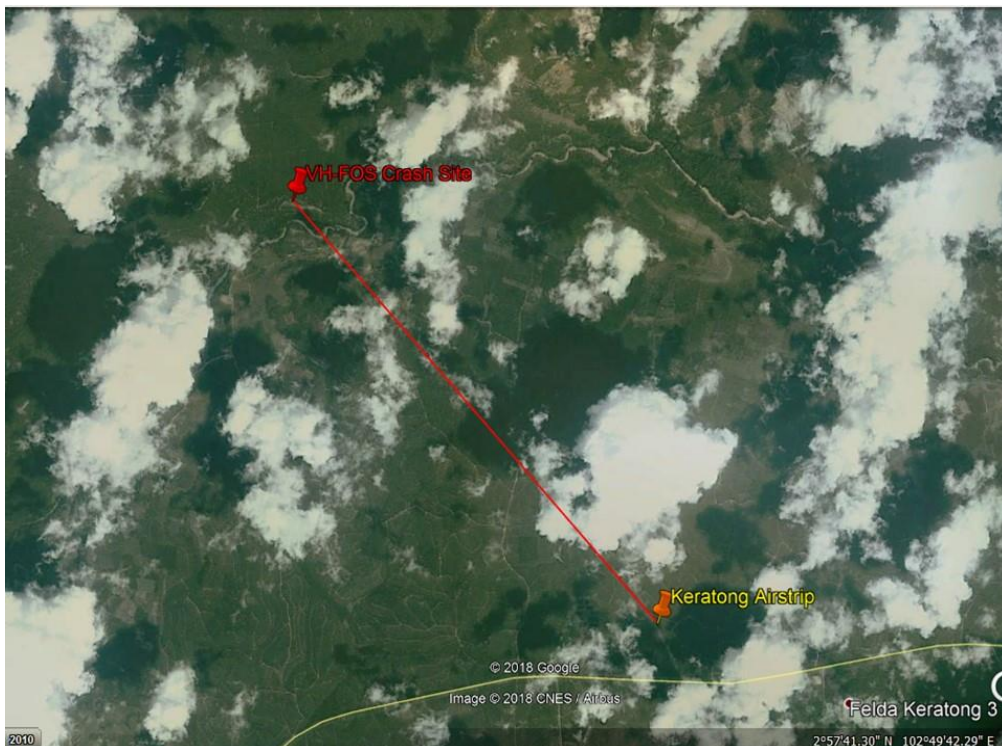
**Picture 9**

Even though the impact with ground has been minimised, the aircraft considered **destroyed** with both wings badly damage, and the engine torn off from the airframe and bend sideway.

Crash Site – approximately 3 nm to the North West of Keratong Airstrip

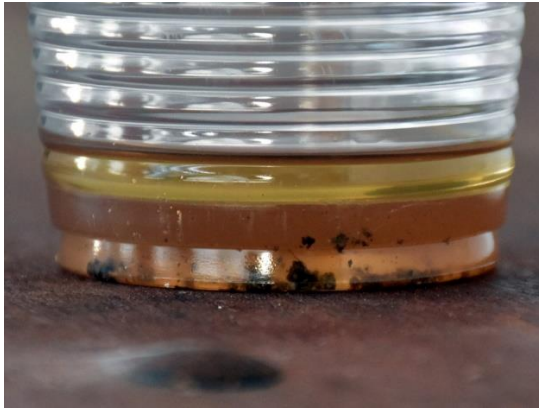
**Picture 12**

Fuel (avtur) sample was taken from the **airframe filter** at the crash site and visually a contamination can be seen. When the sample later tested with water detector capsule, it is confirmed that water have been contaminating the fuel.

Visual indication of contamination

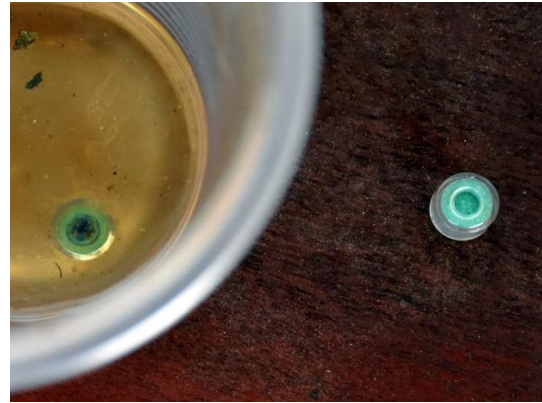
**Picture 13**

Change of colour of the capsule indicating water exist in the fuel sample

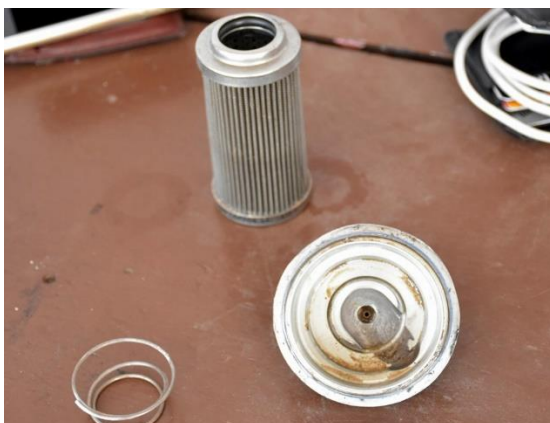
**Picture 14**

After the wreckage safely secured at the storage hangar in Subang, fuel sample from the **FCU filter** were taken and tested for contamination. The water detector tablet used and the colour of the capsule changed to indicate water exist in the FCU filter.

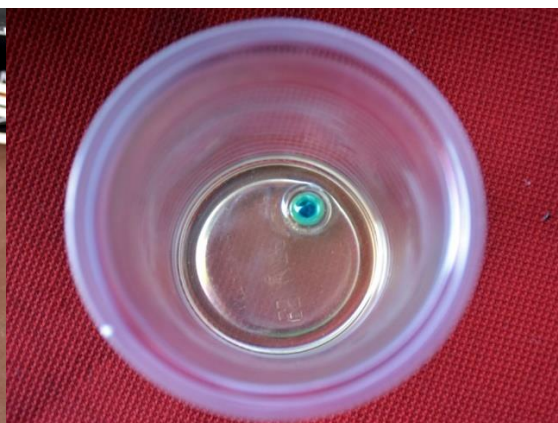
**Picture 15**

Fuel sample from FCU filter. The colour of the tablet changed

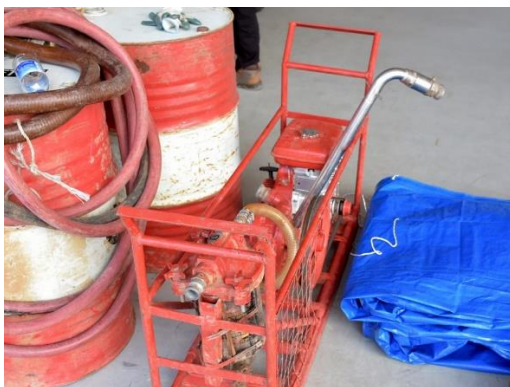
**Picture 16**

The hose is made up of a few hoses joint together using the hose clamp. This hose found to be dry with no sign of water during the inspection.

The investigation team was unable to trace the actual source of the water contaminating the fuel. However, it is strongly believed that the heavy rain over Keratong the whole day before the accident contributed to the contamination. The fuel drums, motorised fuel pump and fuel pump's hose were inspected 11 days after the accident. Due to hot weather of Malaysia, no trace of water from those items during inspection which by then would have been dried out. The source of water could be from any of the three items which are the fuel drums, the motorised fuel pump or the fuel pump's hose.

- 4.1 Operator to develop Standard Operating Procedure on a proper management of fuel at work side including the proper ways of testing the fuel (not just dipping the capsule), storing of fuel drum after being unloaded and proper storage of fuel hose when not in use.
- 4.2 Operator is to emphasise on the Quality Assurance in order to ensure the usage of expired water detector capsules will not happen again when checking for fuel contamination.
- 4.3 Operator is to provide course and/or training including refresher training for ground handler on managing fuel.
- 4.4 Operator is to conduct a quality control on a fuel management and usage of fuel from drum storage.

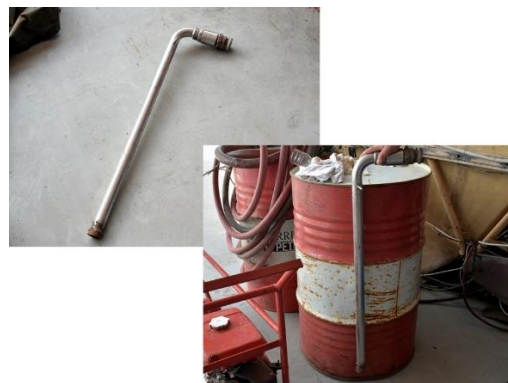
**Picture 17**

The stainless pipe used (dipped into the fuel drum) has been modified with a stopper bars on the side as to ensure the pipe did not goes all the way to the bottom of the drum. This is the procedure use by the ground handler as to ensure some of the fuel at the bottom will be left in the drum as a precautionary to ensure if there is a water contamination, it will remain in the drum.

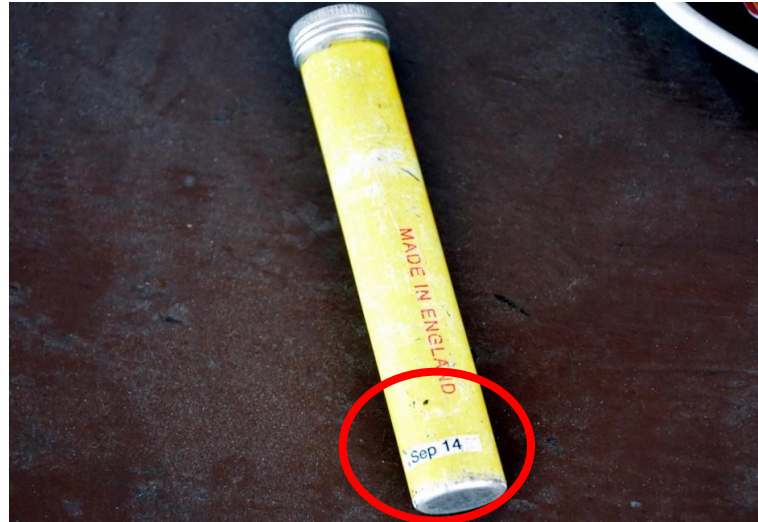
**Picture 20**

The storage life for unused Shell Water Detector capsule is nine months from the time of manufacture. Capsules used by the ground handler was manufactured in the year of 2014 (**Picture 20**)

Month and year of manufacture

Expired water detector capsules and incorrect methodology employ will reduce or perhaps hinder detection of water in fuels
