Engine failure involving Airbus A330, 9M-XXE

Near Carnarvon, Western Australia, on 25 June 2017

ATSB Transport Safety Report
Aviation Occurrence Investigation
AO-2017-066
Final – 30 June 2020

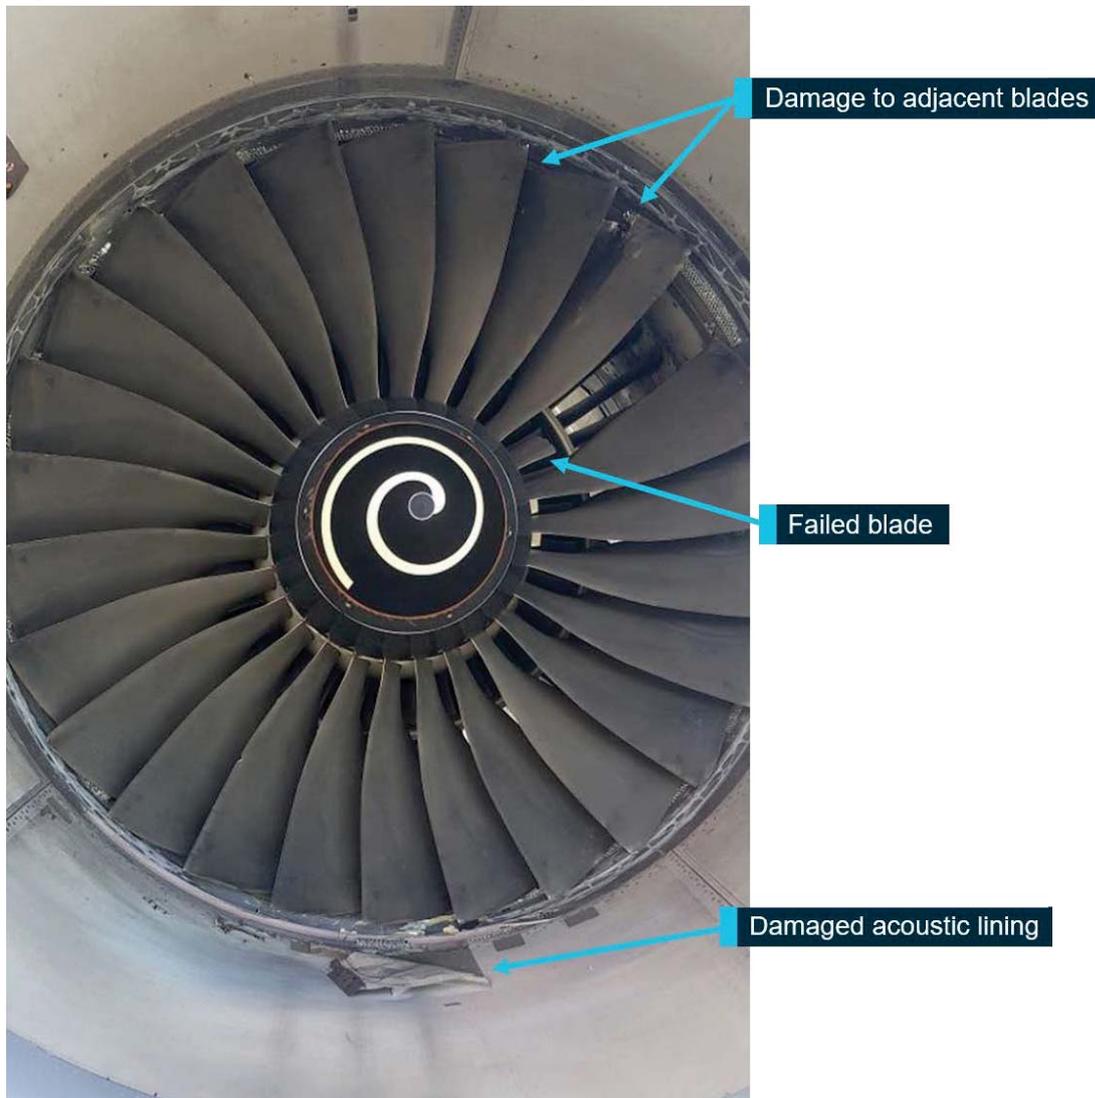
The aircraft landed at Perth at 0957. A post-flight inspection revealed that approximately three quarters of one fan blade (serial number RGF35538) aerofoil was missing on the left engine (Figure 2). No damage to the airframe was identified.

Figure 2: Left engine failed fan blade, with adjacent damaged blades

The engine strip inspection identified that the blade failure was contained within the engine. There was no evidence of internal or external fire, nor of pre-existing foreign object damage. Secondary damage was observed on the remaining fan blades as a result of impact damage and heavy tip rub. The engine inlet cowling suffered damage due to secondary debris impacting the inner barrel. The low pressure (LP) compressor (fan) shaft was bent by about 0.5 inches (13 mm) along its length and exhibited frictional heating damage between the shaft and the intermediate pressure (IP) front stub shaft. The IP compressor module front bearing house assembly was distorted and damaged by the contact of the LP compressor shaft/bearing housing assembly on to the front face.

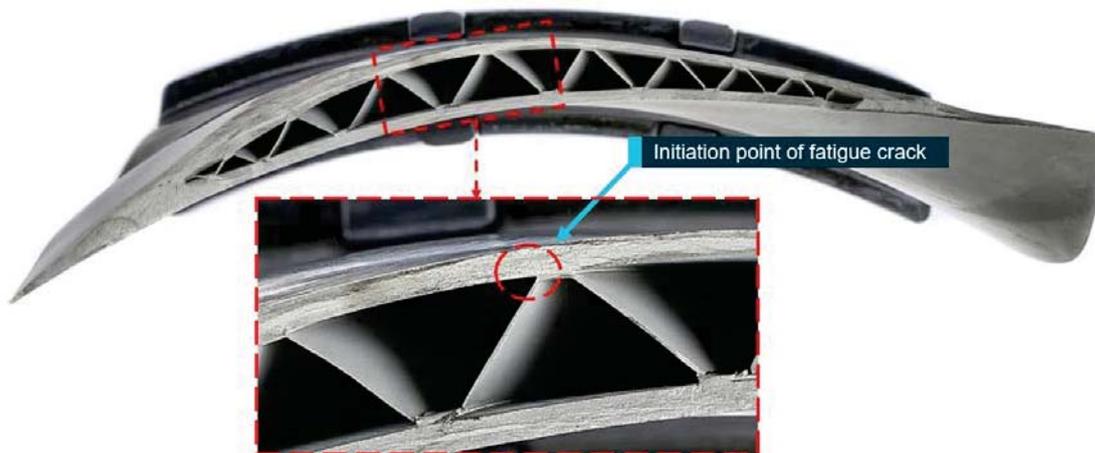
Optical and electron microscope inspection identified a region of fatigue cracking on the inner surface of the convex panel of the fan blade, about mid-chord from the blade leading edge. The fatigue appeared to have initiated on the inner surface of the panel at the acute corner of a membrane-to-panel bond (Figure 4).

Figure 4: Overview of fracture surface showing the initiation point of the fatigue crack on the inner surface of the convex panel

Photograph of the remaining section of the failed blade identifies the initiation point of the stress crack that led to the blade failure. Source: Rolls-Royce and ATSB.

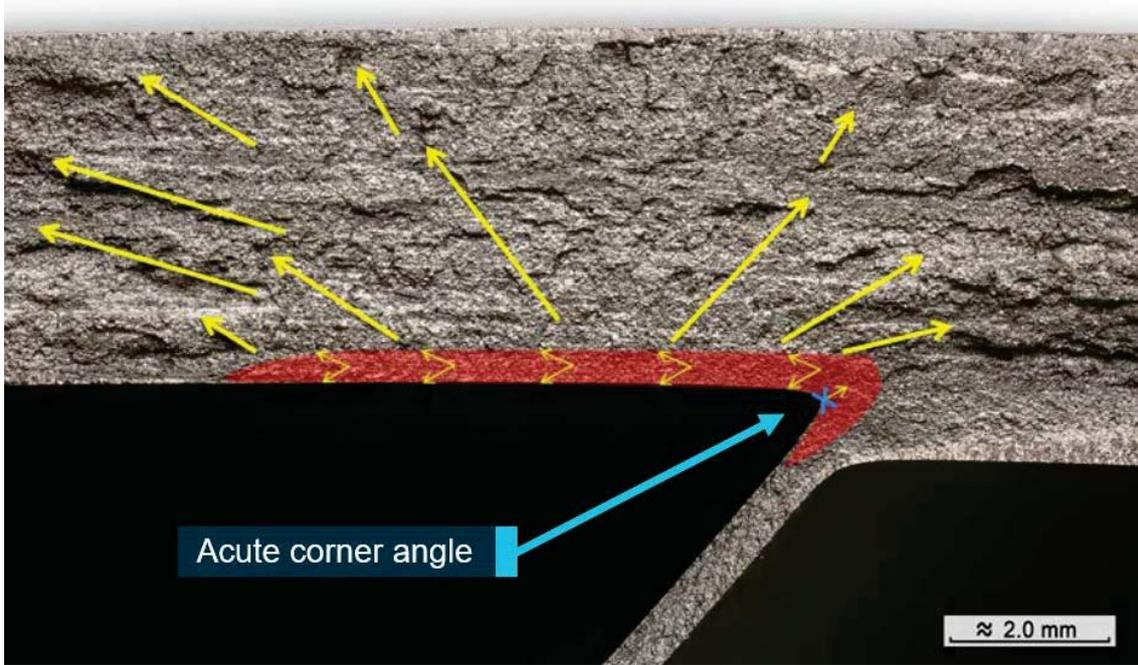
Initial crack propagation was in a chordwise direction,¹⁶ before propagating towards the outer aerofoil surface (Figure 5). The remaining fracture surface was comparatively duller and angled; consistent with a ductile overstress failure.

Figure 5: Magnified view of the fracture near the initiation point showing propagation of the fatigue crack from the inner surface of the convex panel

The blue cross indicates the crack initiation point, the red region is the initial chordwise propagation area, and the yellow arrows show the general propagation directions.
Source: Rolls-Royce.
