Birdstrike and engine failure involving Airbus A330, 9M-XXT

Gold Coast Airport, Queensland, 3 July 2017

ATSB Transport Safety Report
Aviation Occurrence Investigation
AO-2017-070
Final – 2 May 2018

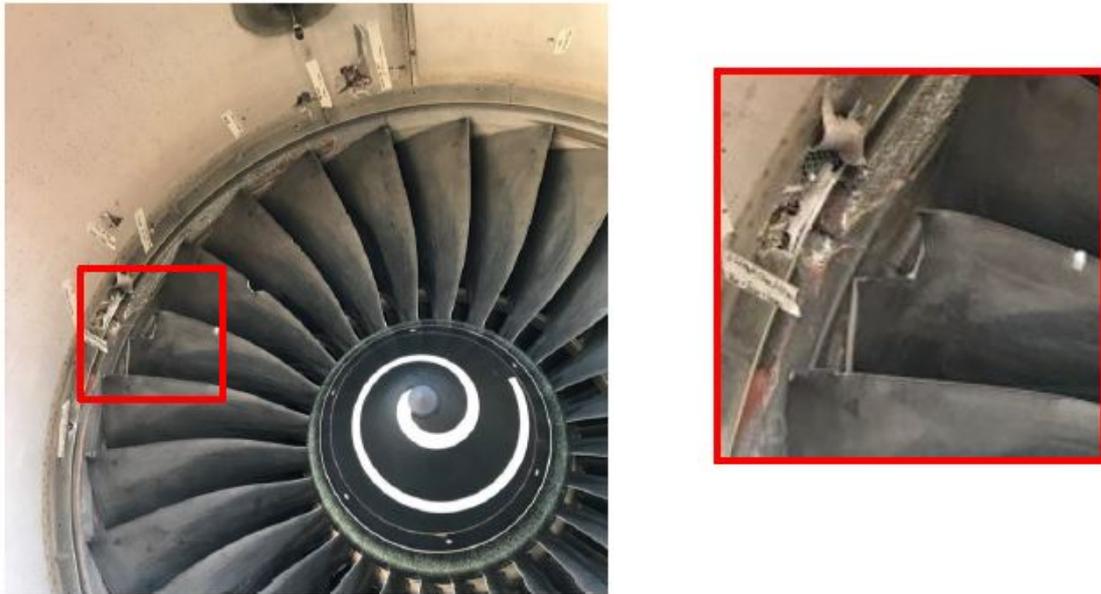
Figure 1: Damage to Rolls Royce Trent 700 engine fan blades

After the occurrence, an engineering examination at Brisbane Airport found a single fan blade-tip section, approximately 140 mm x 125 mm, had fractured from one fan blade and the fan rear seal

was found broken into pieces and scattered throughout the bypass areas of the engine (Figure 1). There was also evidence of fire within the engine.

- Blade 1 exhibited cupping damage consistent with soft body impact close to the point of material release. The radial height of the fracture on the blade was in a leading edge impact cup at approximately 84 per cent blade-height (Figure 1 and Figure 2).

- There was blade damage on a blade adjacent to blade 1 (see to the right of the red square in Figure 1). This damage to the adjacent blade was consistent with impact from a hard body, and laboratory analysis did not identify that any foreign object had impacted that blade.

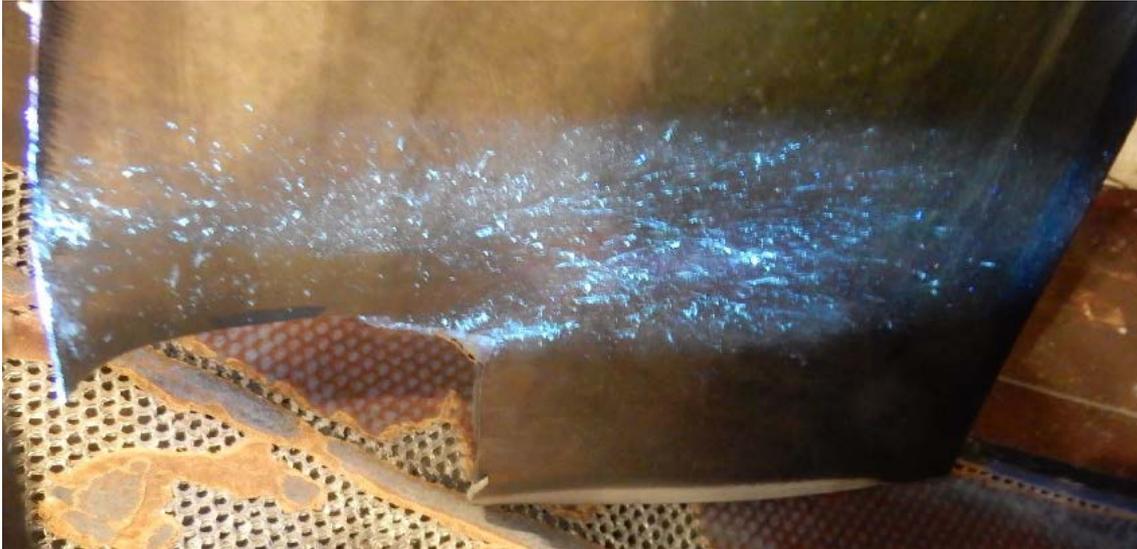
Figure 2: Ultraviolet light showing bird remains on damaged fan blade

- UV light inspection identified that blade 1 (the blade with the released tip) had organic debris in the area near the blade-tip release (Figure 2), and there was also organic debris on the blade-tip that was recovered at Brisbane Airport. DNA analysis confirmed the debris from the blade and the blade-tip was from a masked lapwing.

- Laboratory analysis of the fracture surface of blade 1 confirmed the fracture mode as overload. There was no evidence of fatigue or pre-existing material deficiencies that could have contributed to the release of the blade-tip.
