**AIRCRAFT SERIOUS INCIDENT  
FINAL REPORT  
SI 02/17**

**Air Accident Investigation Bureau  
Ministry of Transport, Malaysia**

**Final Report on the Serious Incident involving  
Fixed wing aircraft Airbus A330 Registration 9M-XXS  
En-route from Taipei to Kuala Lumpur  
on the 03<sup>rd</sup> May 2017**

**ACCIDENT REPORT NO. : SI 02/17**

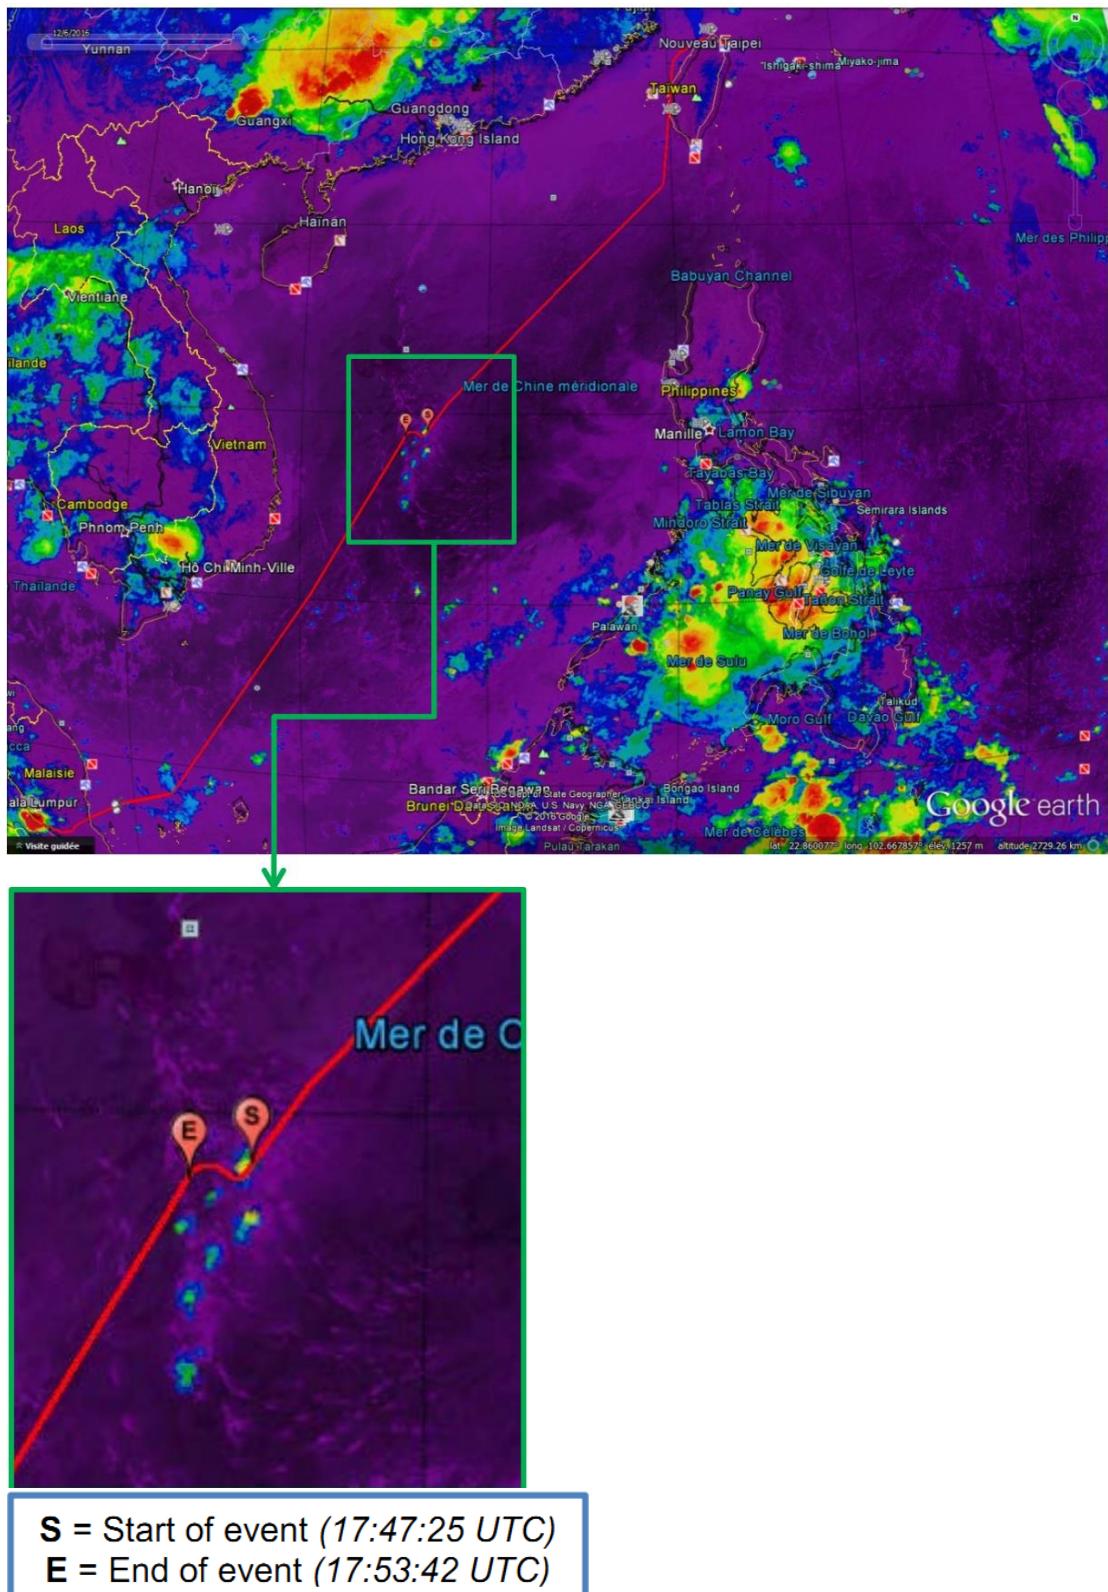
### Appendix 1: Weather Information

No significant weather was reported on the forecast en-route weather, but the satellite IR image supplied by Airbus (dated 03-MAY-2017, 17:50 UTC) showed a very local air column / build-up close to the turbulence encounter. Such meteorological phenomena may generate high vertical air velocities.

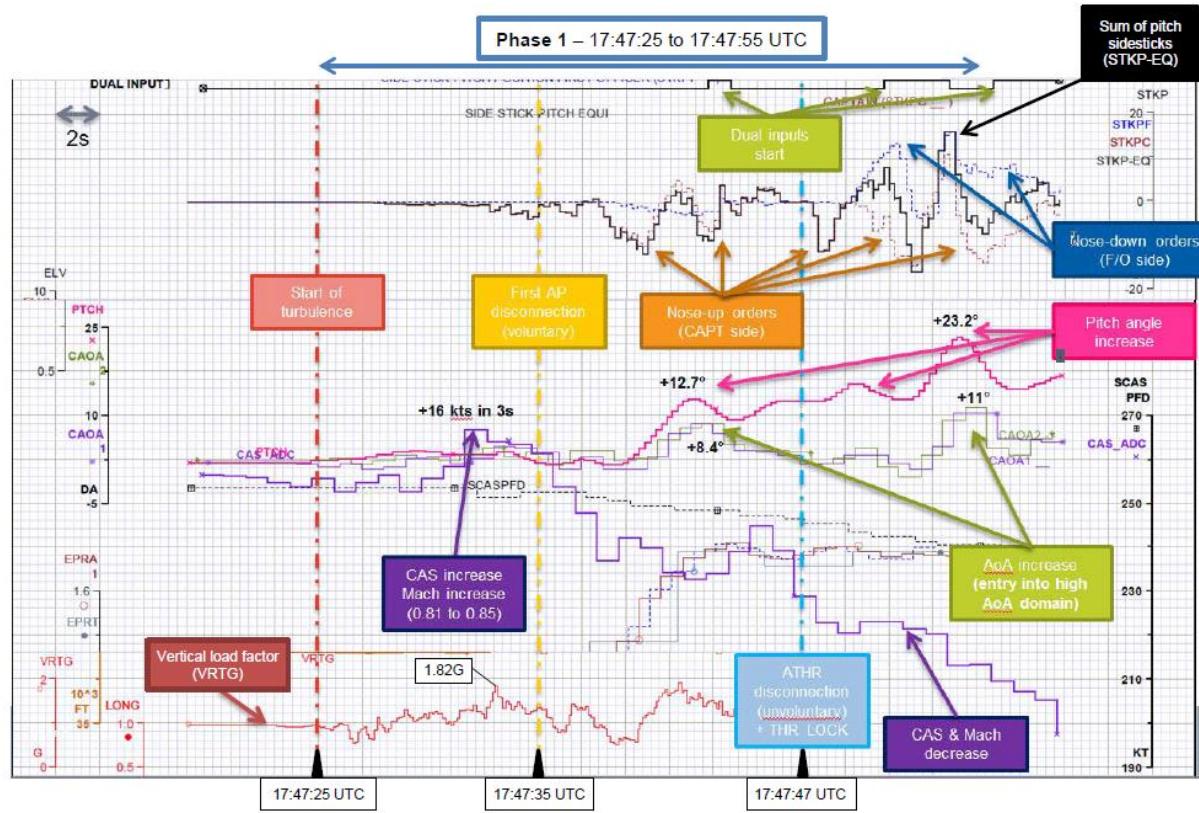
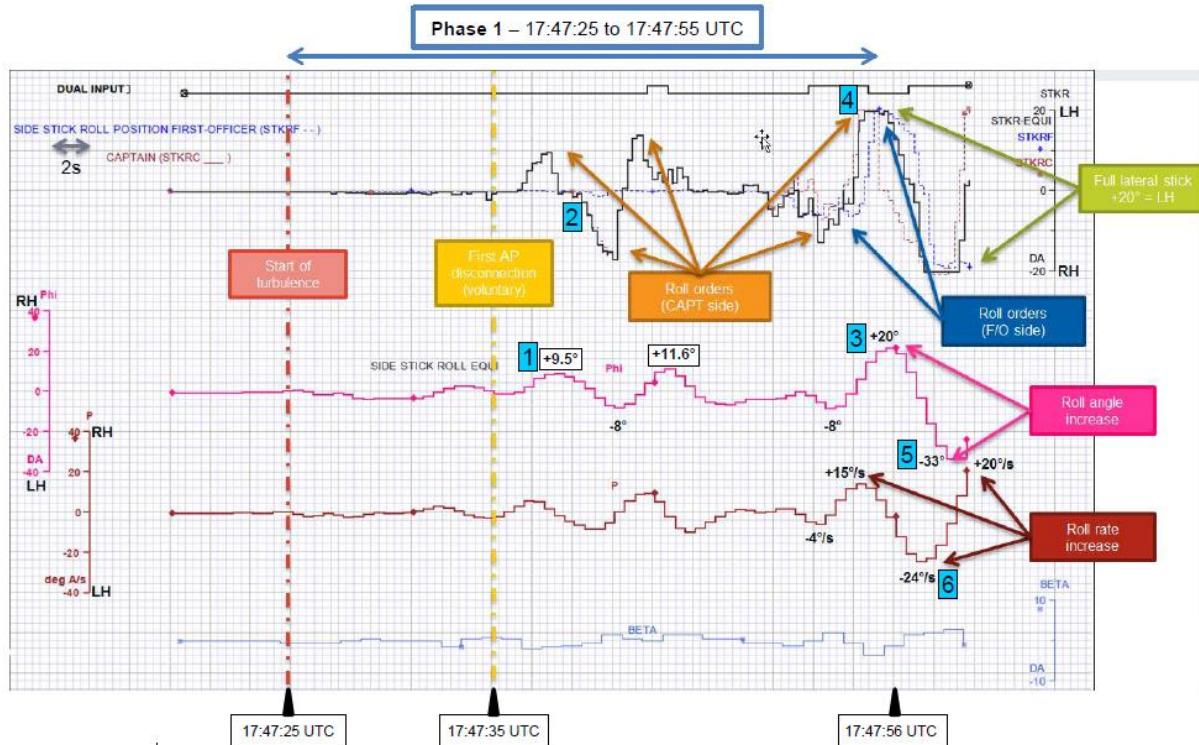
## Appendix 2: Phase 1 Longitudinal and Lateral Axis

### 2.1.3 Phase 1: start of turbulence, AP disconnection and nose-up orders (17:47:25 to 17:47:55 UTC) (Refer Appendix 2: Phase 1 Longitudinal and Lateral Axis)

- The turbulence started – it is considered as moderate to severe (maximum vertical load factor (VRTG) of 1.82G, lateral load factor (LATG) of -0.15G).

- CAS and Mach first increased quickly from 252 Kts/0.81 to 266 Kts/0.85, before decreasing towards 200 Kts/0.70.
- The AP was voluntary disconnected (using the sidestick P/B). Master warning triggered accordingly during 3s.

- The Captain began applying significant nose-up stick inputs (STKPC) and took the priority (STKFINOP=1) during 1s (using the sidestick P/B).
- Dual inputs started in pitch: The F/O applied mostly moderate nose-down stick inputs (STKPF). Dual input boolean (DUAL INPUT) was consistently recorded at 1 during most of this time period.

- Pitch angle (PTCH) and AoA (CAOA1&2) started to increase. Vertical speed (VSPD) reached +7100ft/min. Altitude (ALT) started to increase
- A/THR was involuntary disconnected, resulting in a Thrust Lock condition, at the climb thrust (THRLKD=1).
