**AIRCRAFT SERIOUS INCIDENT  
FINAL REPORT  
SI 05/19  
Air Accident Investigation Bureau (AAIB)  
Ministry of Transport Malaysia**

**Serious Incident involving Diamond DA 40  
Registration 9M - ITG  
at Malacca International Airport (WMKM) Malaysia  
on the 6 July 2019**

**FINAL REPORT SI 05/19**

**AIRCRAFT TYPE : DIAMOND DA 40**

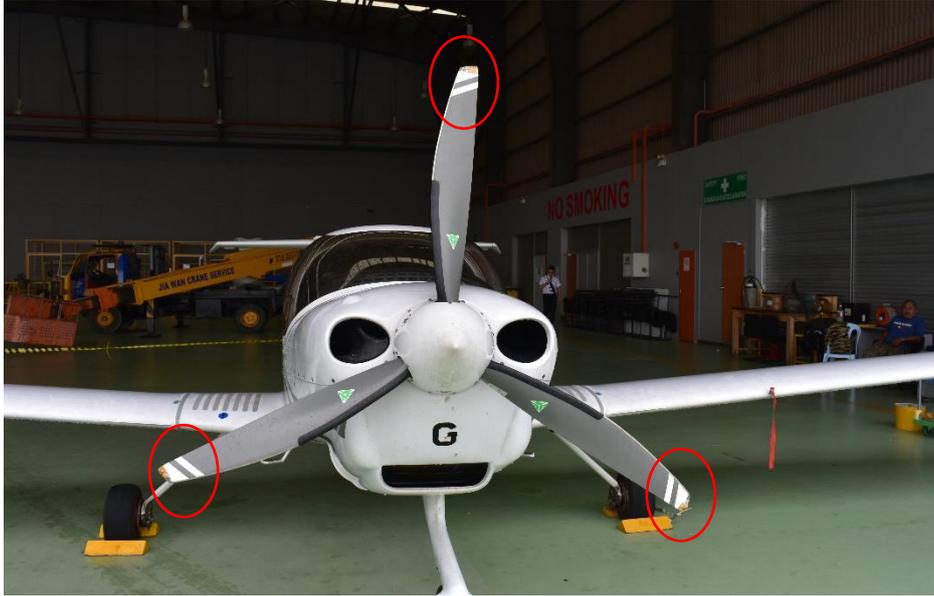
Damage was noticed by ground staff after the aircraft engine was shut down and subsequently reported to the student pilot's instructor and the student. There were no reported injuries to the student pilot. All the tip of the aircraft's propeller blades were chipped off.

Photo 1: Chipped Off Propeller Blades Tip

Evidence from the three strike marks indicated most probably the control column was pushed forward during the multiple bounce sequence which resulted the nose attitude moving down significantly. This nose down attitude movement inadvertently caused the propeller blade tips to strike the runway surface.

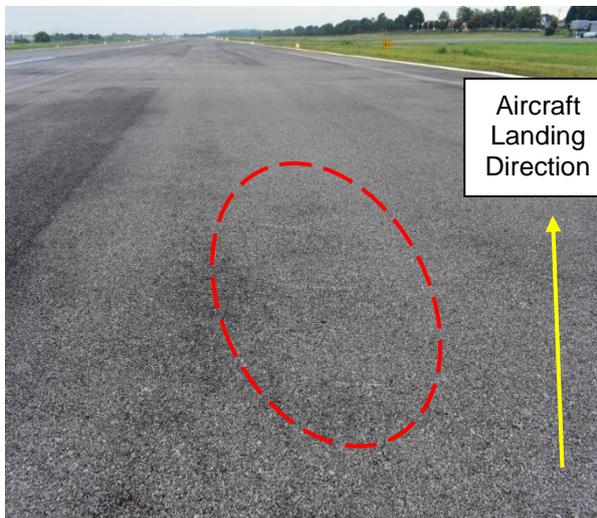
Photo 2: Aircraft Propeller Strike Marks on Runway 03 Surface

Immediate runway inspection carried out by MASB staff after the incident found three significant strike marks, some debris made of wood and plastic like material on the runway which matched the material of the aircraft propeller thus confirming that the aircraft propeller had struck the runway surface.

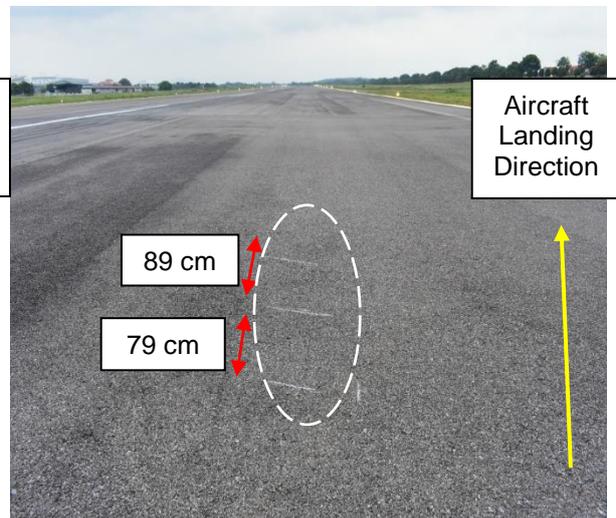
Photo 3: Distance Between Propeller Strike Marks (strike marks highlighted)

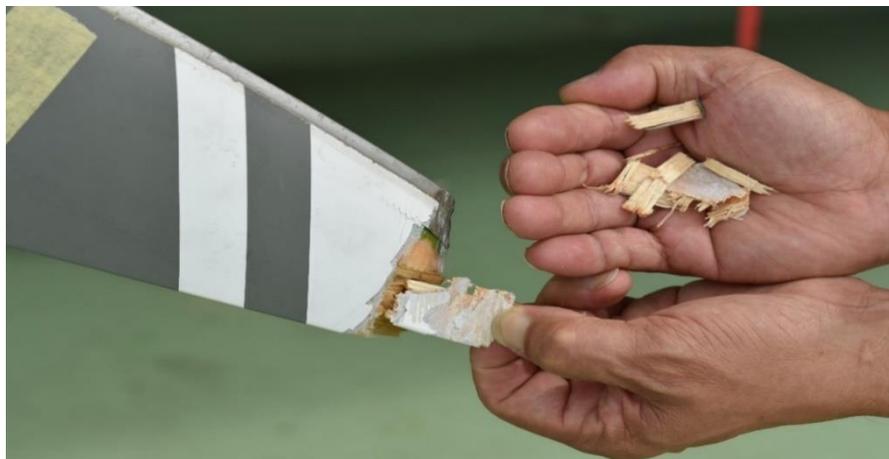
Photo 4: Debris made of wood and plastic found on runway

a. During the runway inspection, he found strike marks and a few pieces of wooden and plastic like material scattered on the runway near the strike marks. All these debris were later handed over to AAIB investigation team.

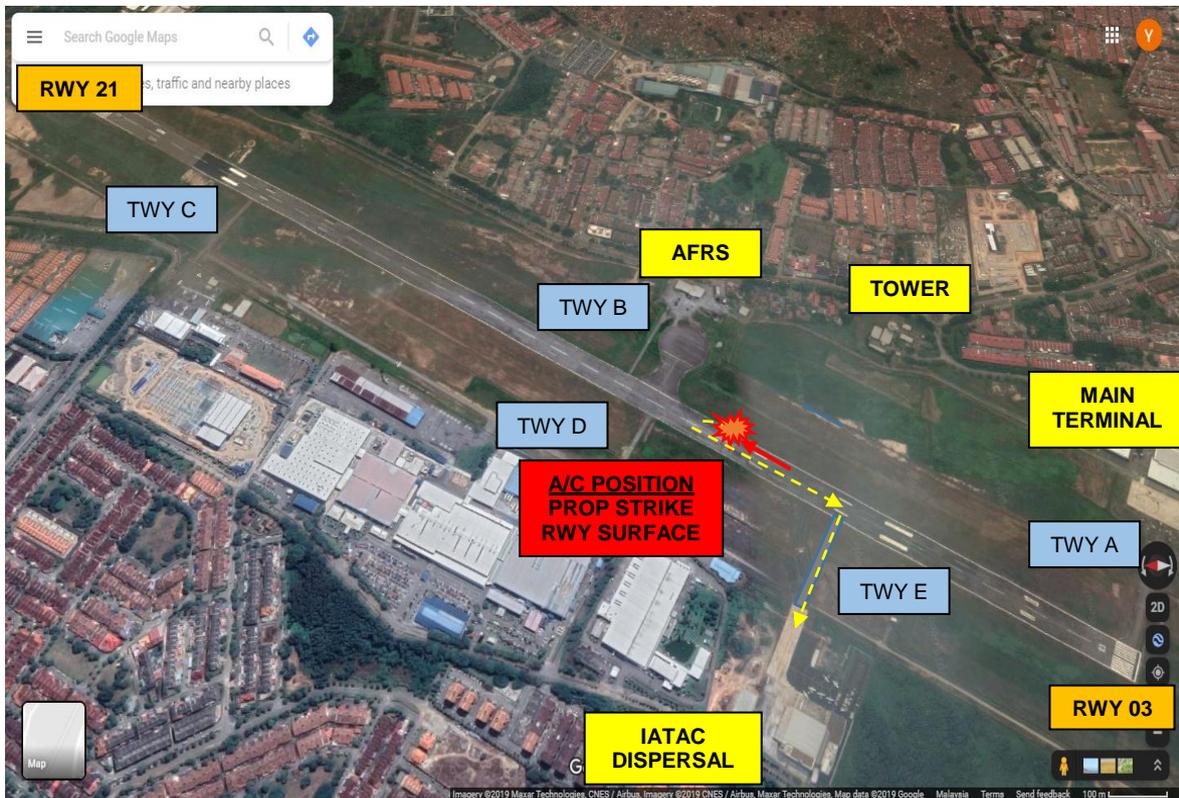
Aircraft was intact and able to taxi to IATAC dispersal after the propeller blades strike the runway surface. Below is the aerial view of the runway where the approximate aircraft position was when the aircraft propeller blades struck runway the surface:

Photo 5: Aerial View of Aircraft Position when Propeller Strike the Runway Surface at Malacca Aerodrome (Not according to scale)
