**SERIOUS INCIDENT REPORT NUMBER SI 01/2017
(FINAL REPORT)**

**SERIOUS INCIDENT INVOLVING MALAYSIA AIRLINES MH2718
BOEING B737-800 REGISTRATION 9M-MXX
AT SIBU AIRPORT, SARAWAK
8 APRIL 2017**

**BIRO SIASATAN KEMALANGAN UDARA
MINISTRY OF TRANSPORT
MALAYSIA**

SERIOUS INCIDENT REPORT NO.: SI 01/2017

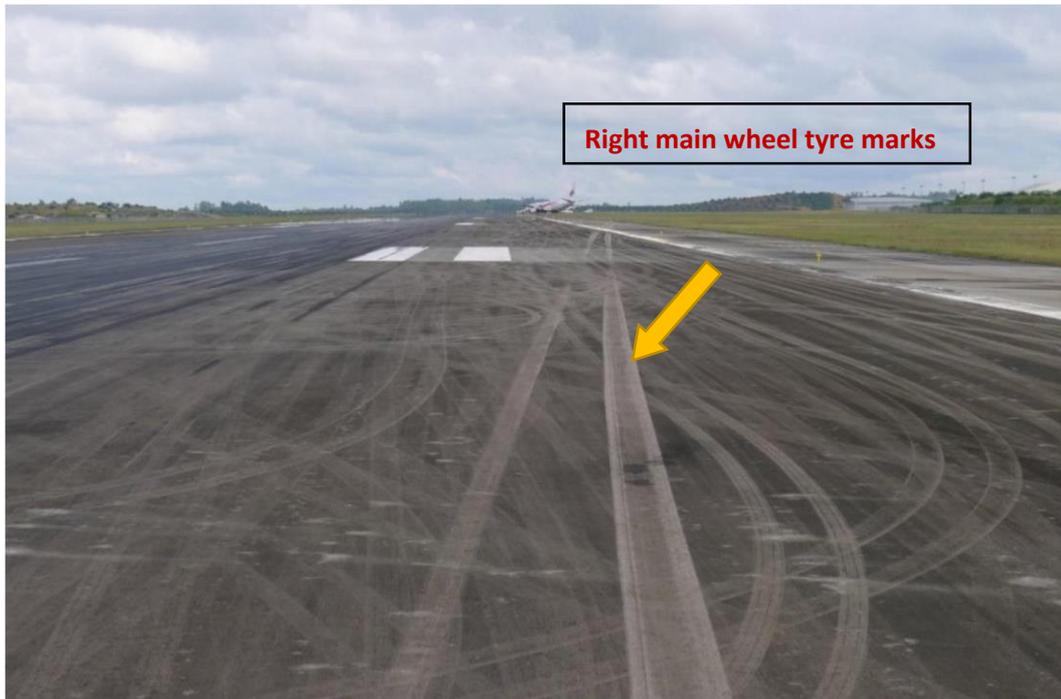
Figure 4: Right Wheel tyre marking on runway
(Shown as “Image 2 in the airport layout in Figure 3)

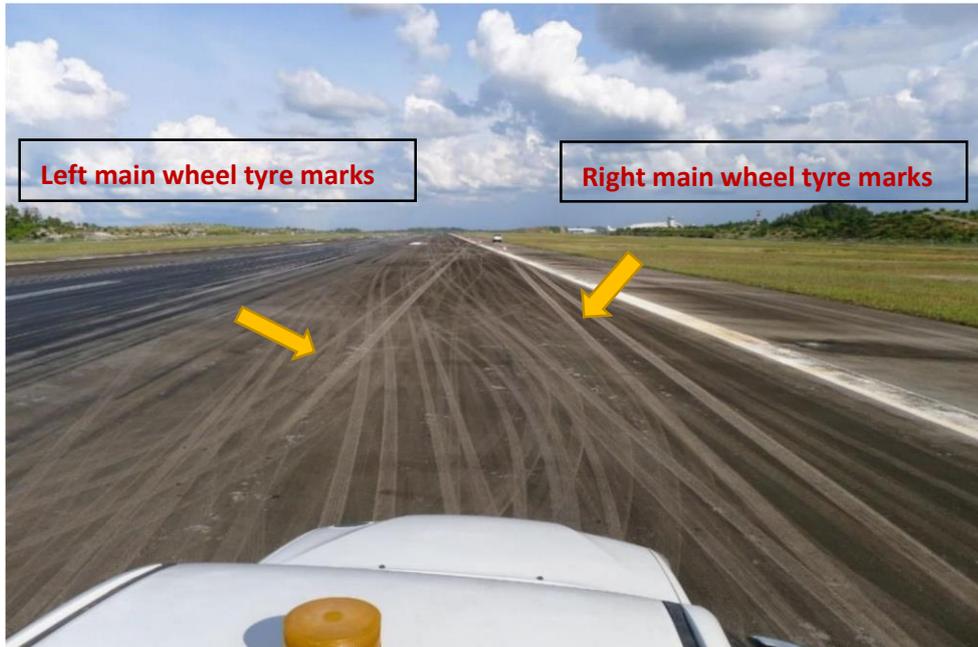
Figure 5: Both main wheel marks show aircraft veering to the right. Left main wheel contacted runway at 620 m from Threshold Runway 13 (shown as “Image 3” in the airport layout in Figure 3)

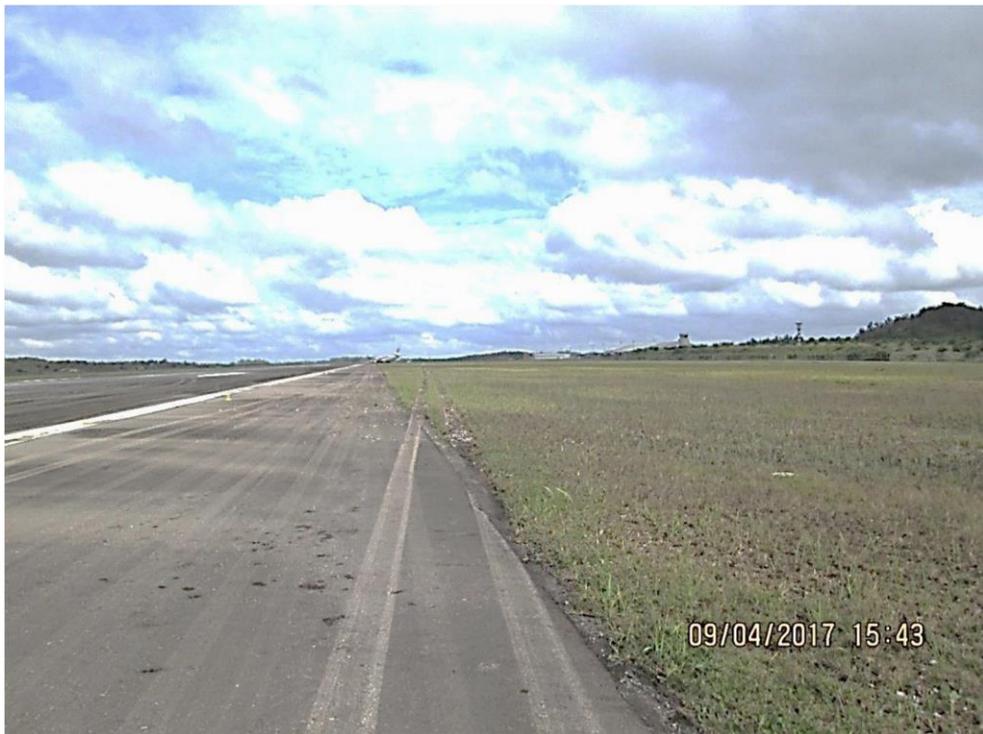
Figure 6: Right main wheel leaving the paved runway surface at approximately 720 m from Threshold Runway 13 (Shown as “Image 4” in the airport layout in Figure 3)

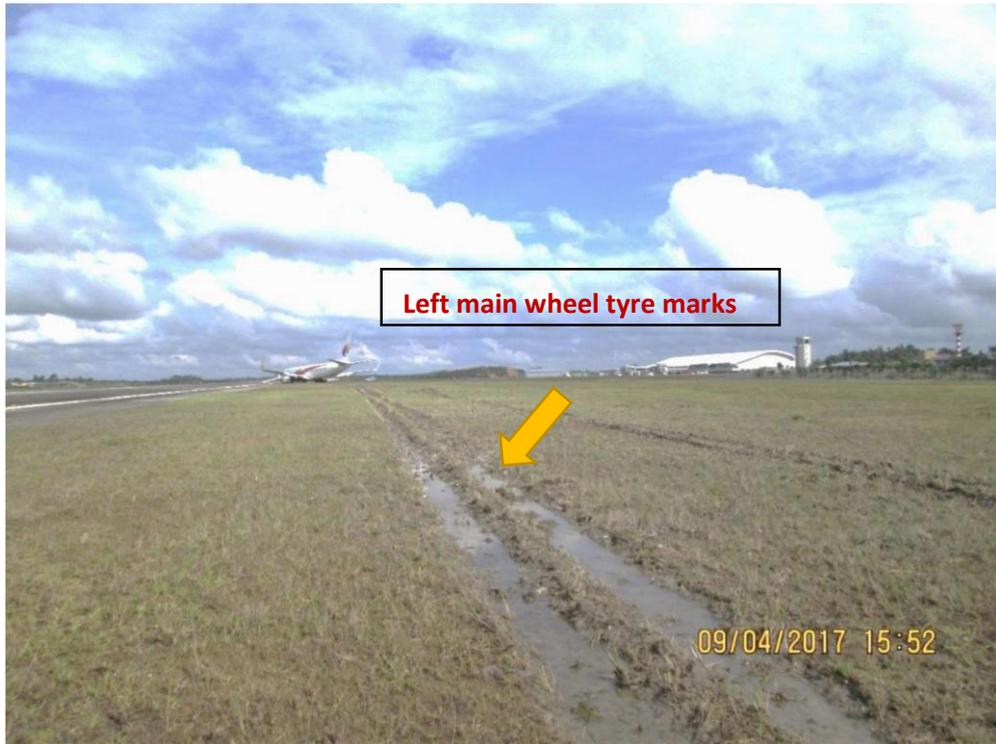
Figure 7: Wheel track on the soft ground approximately 20 m parallel with the runway (Shown as “Image 5” in the airport layout in Figure 3)

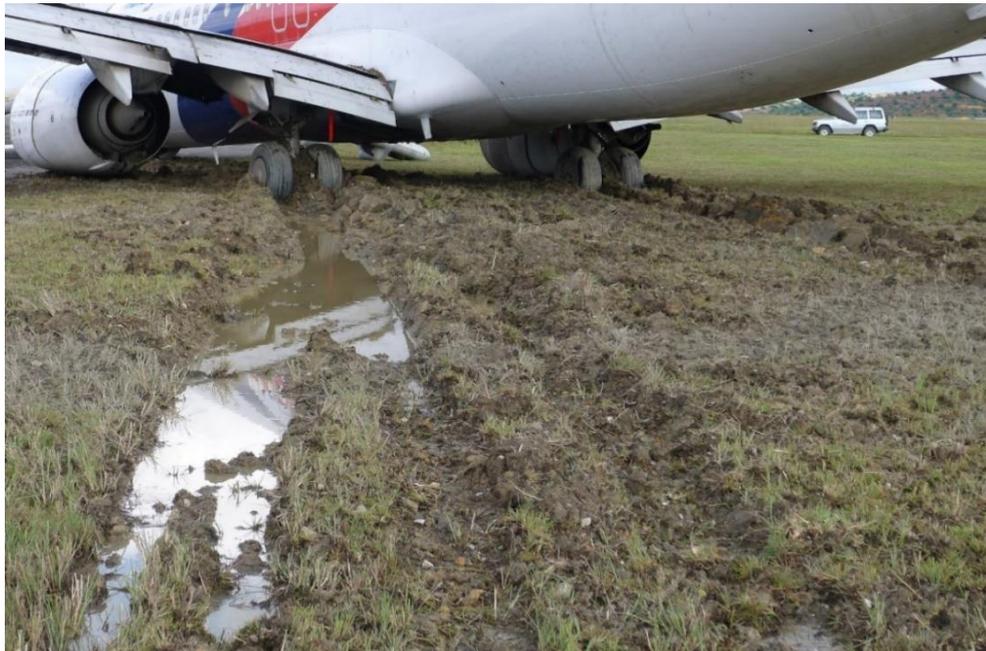
Figure 8: Approximate location of nose gear collapse (Shown as “Image 6” in the airport layout in Figure 3)

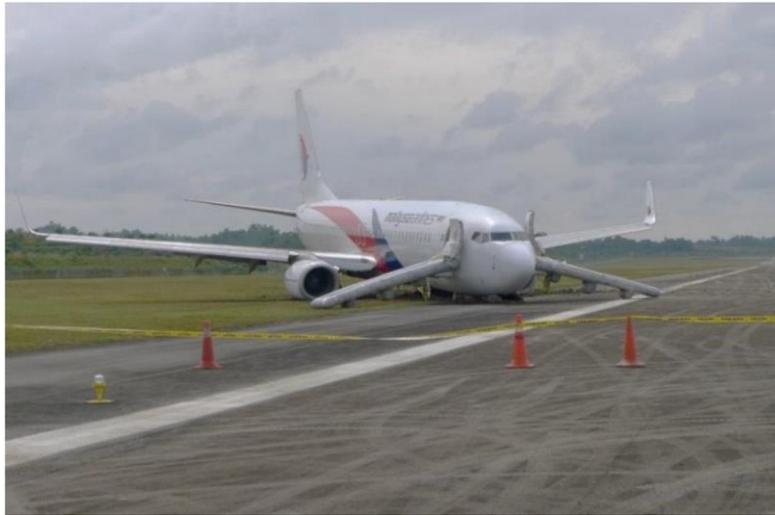
Figure 9: Final aircraft location – 1,260 m from Threshold Runway 13 (Shown as “Image 7” in the airport layout in Figure 3)

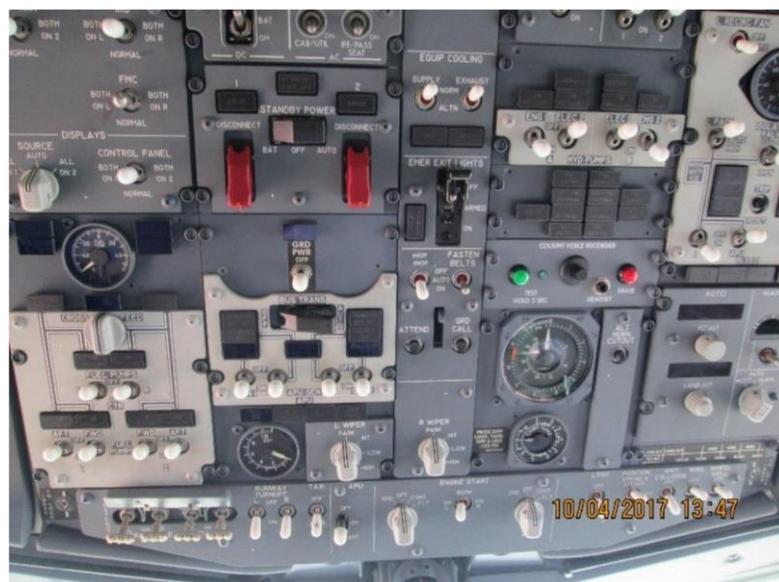
Figure 10: Photograph of Overhead Cockpit P5 Panel

1.13.1 Overhead Cockpit P5 Panel. The positions of the following switches are noted (as shown in Figure 10):

- 1.13.1.1 Electric Hydraulic Pumps – OFF.
- 1.13.1.2 APU – ON.
- a. 1.13.1.3 Fuel Pump – OFF.
- b. 1.13.1.4 Pack – OFF.

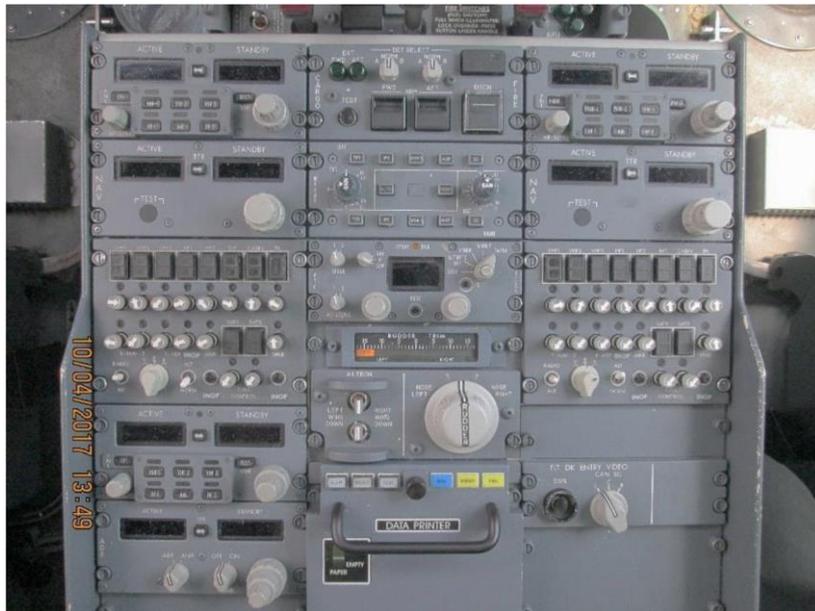
Figure 11: Photograph of Center pedestal

1.13.2 Center Pedestal. With the complete power down, the position (Left or Right) and the units of rudder trim could not be established, as shown in Figure 11.

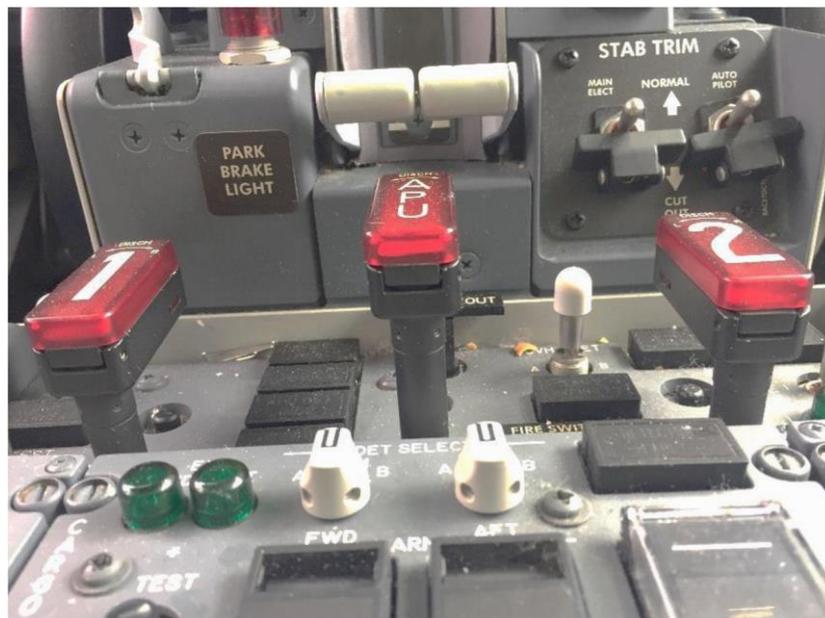
Figure 12: Photograph of Engine and APU Fire Panel

1.13.3 **Engine and APU Fire Panel.** The APU Fire handle was pulled whereas the Engine 1 and 2 Fire handles were in normal position (not pulled) as shown in Figure 12.

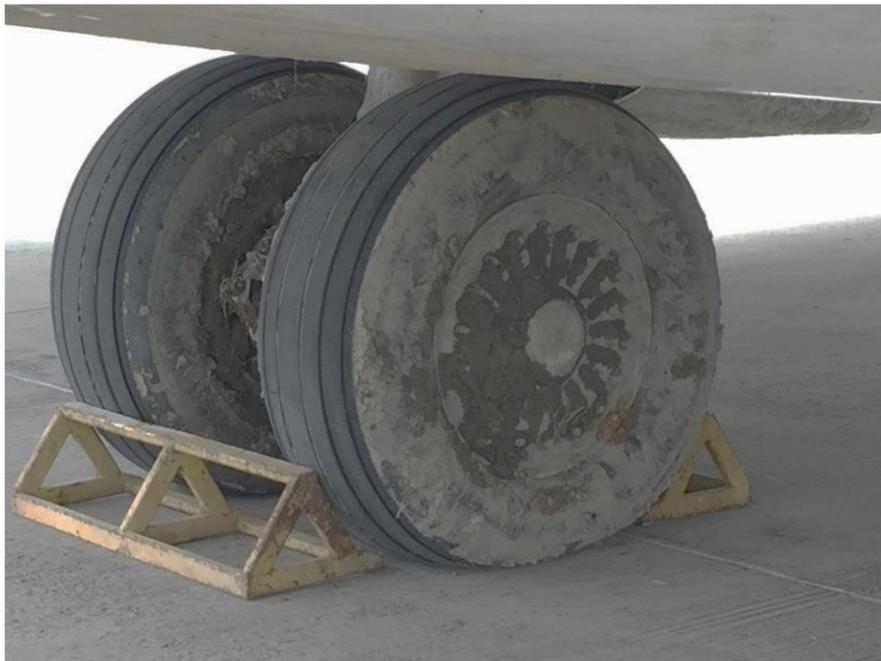
Figure 13: Photograph of Left Main Wheel

1.13.4.1 **Left Main Gear Wheels.** The left wheel tyres and other components appeared to be covered in mud following the excursion. There were minor damages evident on various components and flight control surfaces. However, the conditions of the tyres were inspected and they appeared to be in compliance with manufacturer's recommendation.

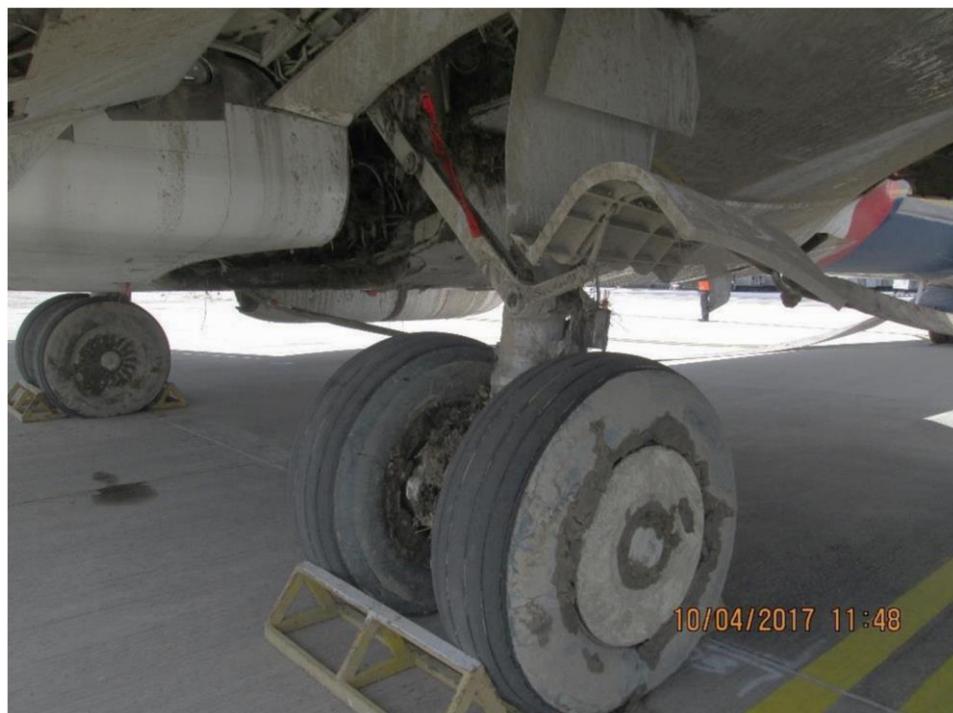
Figure 14: Photograph of Right Main Wheel

1.13.4.2 **Right Main Gear Wheels.** Similar to the left wheels, the right wheels and the other landing gear components were also covered in mud following the excursion. Tyres condition were examined and found to be in compliance with manufacturer's recommendation as shown in Figure 14.

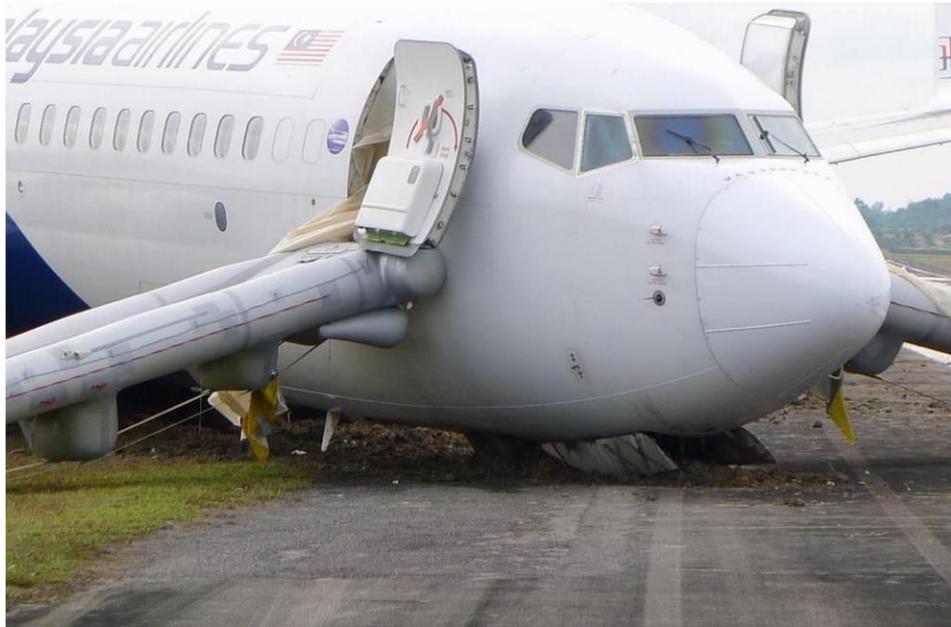
Figure 15: Photograph of Nose Wheel (Collapsed)

1.13.4.3 **Nose wheel (collapsed).** The nose wheel and the nose landing gear components sustained significant damages following the collapse while travelling over the soft ground as shown in Figure 15.

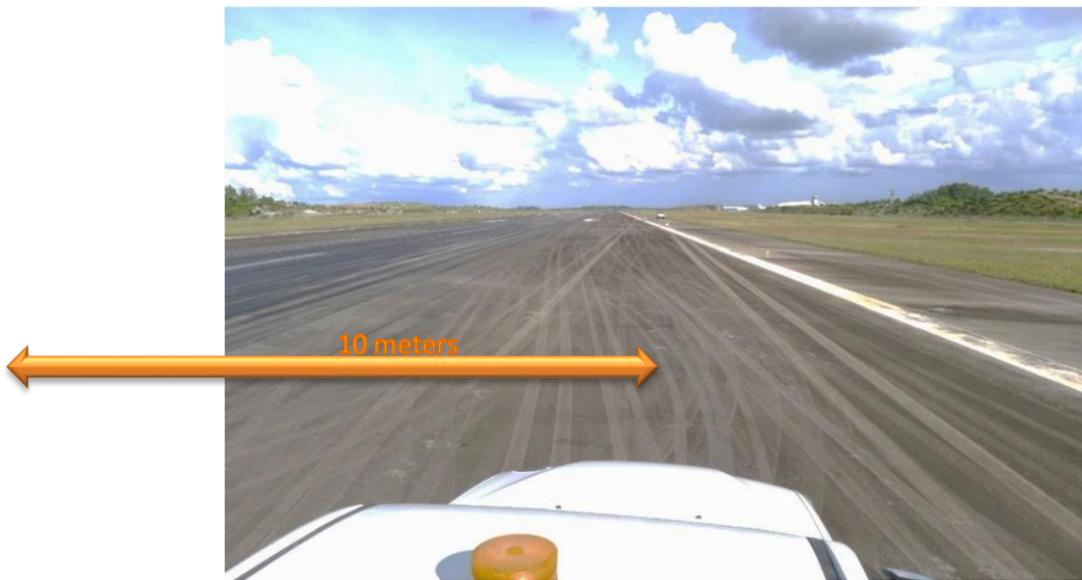
- a. The right wheel contacted the runway first at a distance of 540 m from Threshold Runway 13. This was followed by left wheel touchdown at distance of 620 m from Threshold Runway 13. The FDR data confirmed 1 second lapse between the right and left wheel touchdown.
- b. Lateral displacement of right wheel touchdown position from runway centerline was measured to be approximately 13 m to right of centerline. Given the wheel base of B737-800 of 5.7 m, the lateral displacement of the aircraft from normal touchdown position was approximately 10 m to the right (Refer to Figure 16 below).

Figure 16: Photograph showing aircraft touchdown position relative to runway centerline.

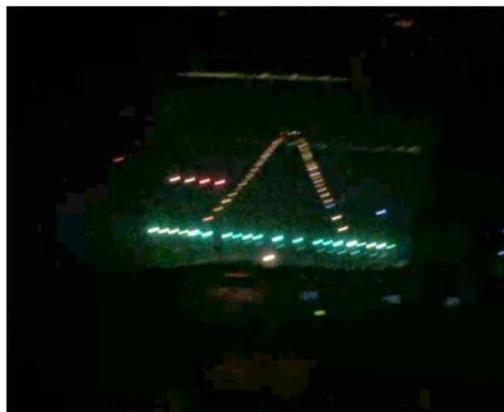
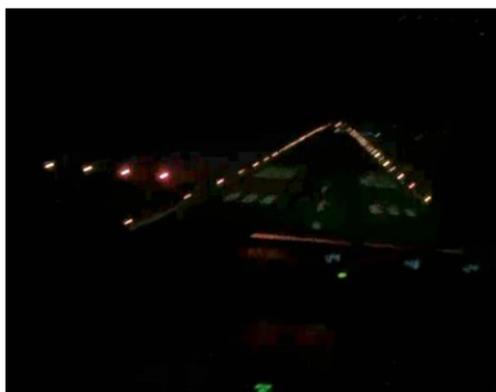
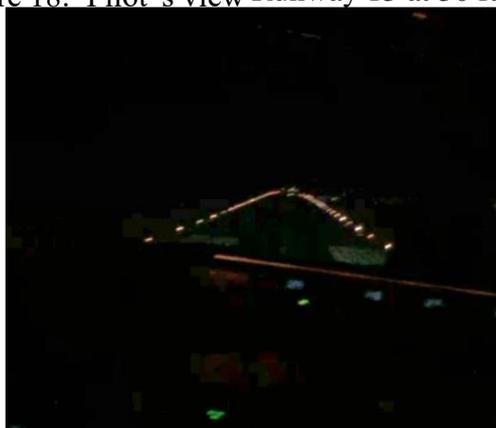
- h. Analysis of the photographs shows that the pilots would have noticed the PAPI and runway edge lights until 20 ft RA, below which only the runway edge lights would have been discernable.

- i. Based on the above images, the investigators collectively agreed that the flight crew had limited visual reference available while descending below 20 ft RA in heavy rain. Below this height, the PF would be looking entirely outside of the aircraft to execute flare and landing maneuvers. With only the runway edge lights available as visual reference, it would be difficult for the PF to accurately judge or detect deviation from the runway centerline, including if there was any inadvertent or deliberate bank angle induced.

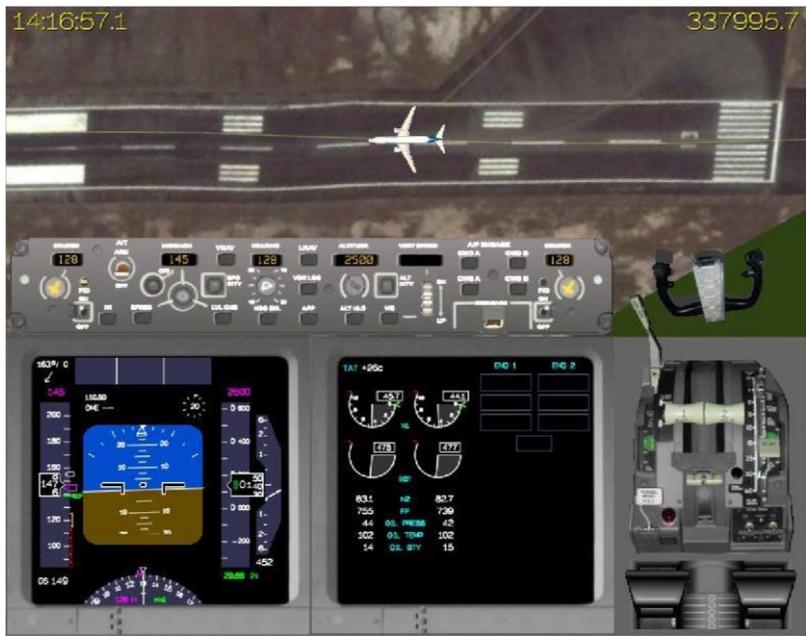
Photograph 3: Aircraft began to drift from centerline below 20ft RA. A slight bank is visible at this point. Heading was 130°.

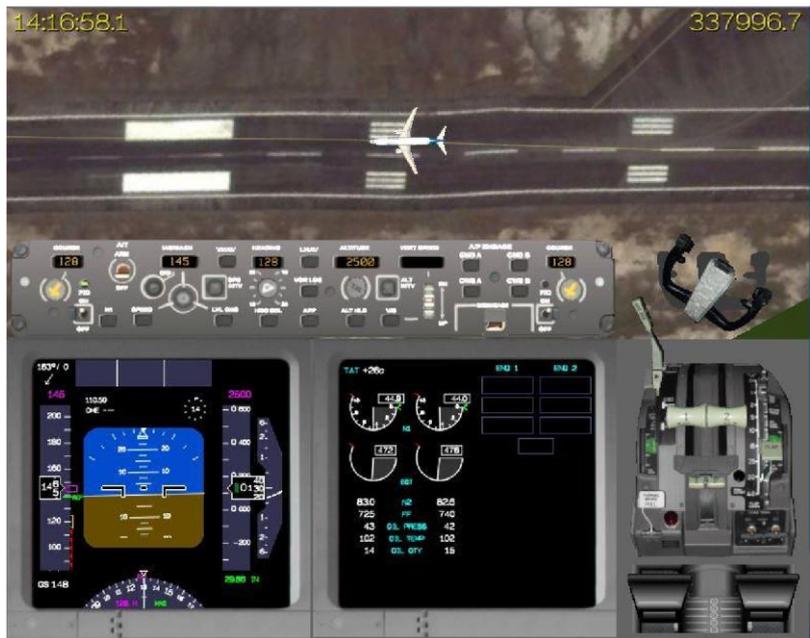
Photograph 4: More bank was induced by the PF. Heading was increasing to 131°.

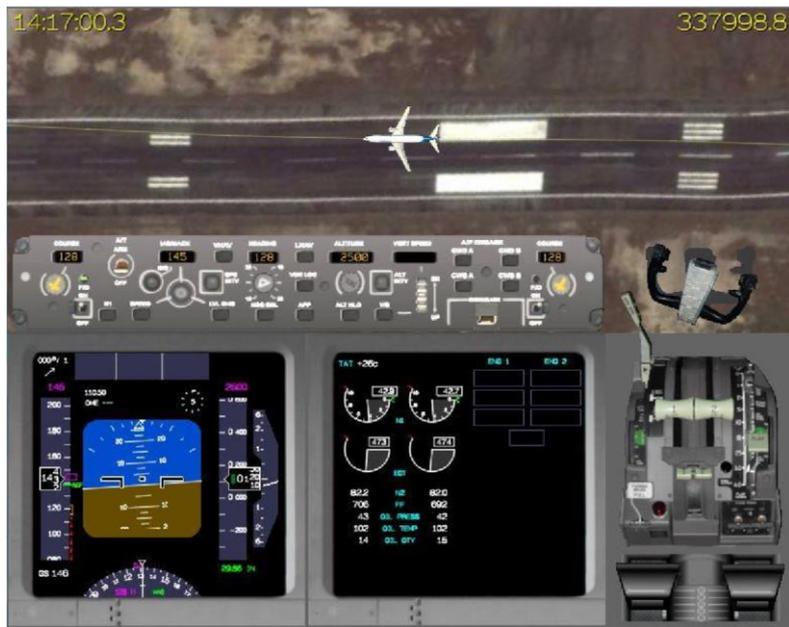
Photograph 5: Bank angle was increasing with aircraft turning towards the right. Heading now is at 132°.

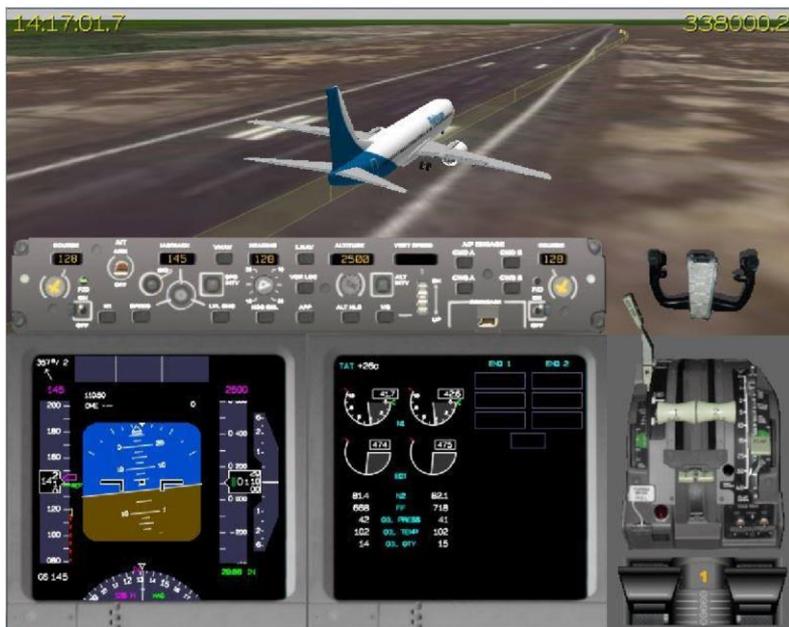
Photograph 6: Aircraft was about to touch down on Runway 13. Bank angle was increasing to 4°.

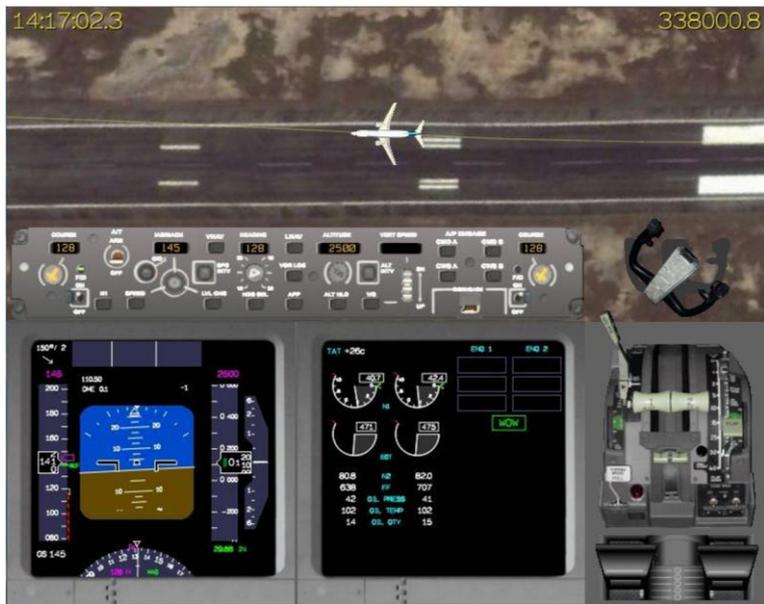
Photograph 7: First point of touchdown (on Right main wheel) at 540 m from Threshold Runway 13.
 Aircraft heading was 132°.
 Bank angle was approximately 4° with heading 133°.

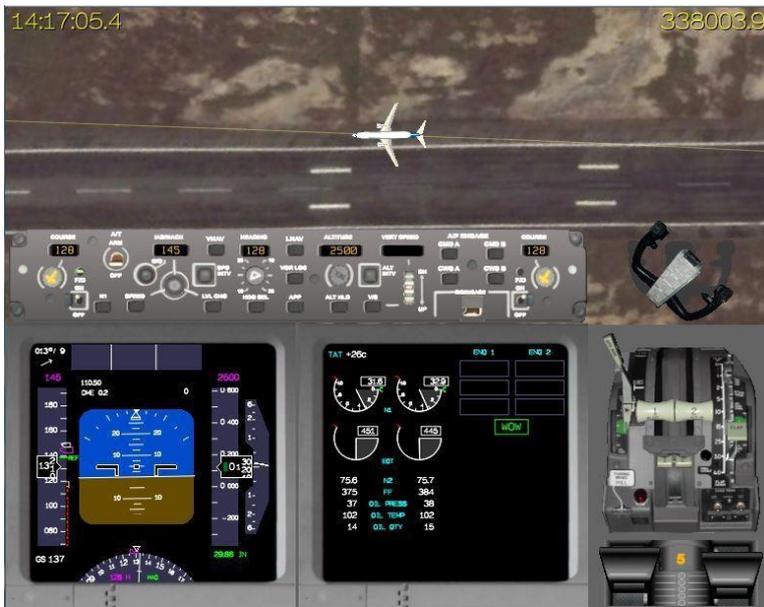
Photograph 8: Aircraft vacated the runway surface at approximately 780 m from Threshold Runway 13.

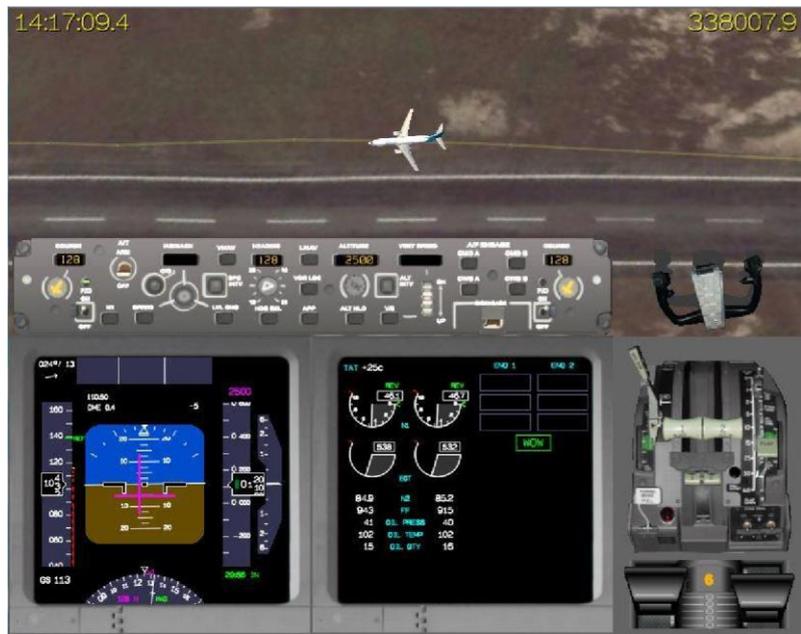
Photograph 9: Aircraft was on soft grounds, parallel to the runway.

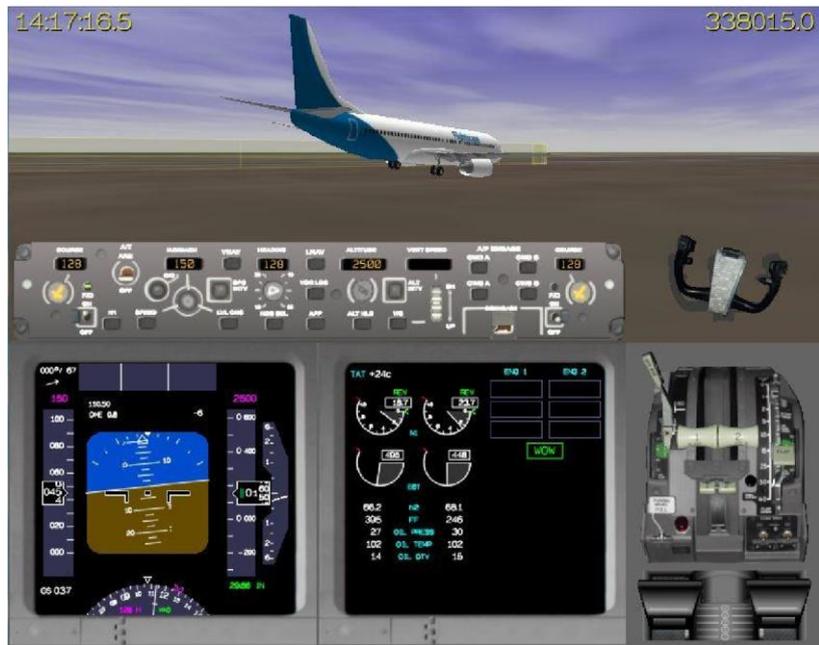
Photograph 11: Nose gear collapsed at this point (14 seconds after touchdown).

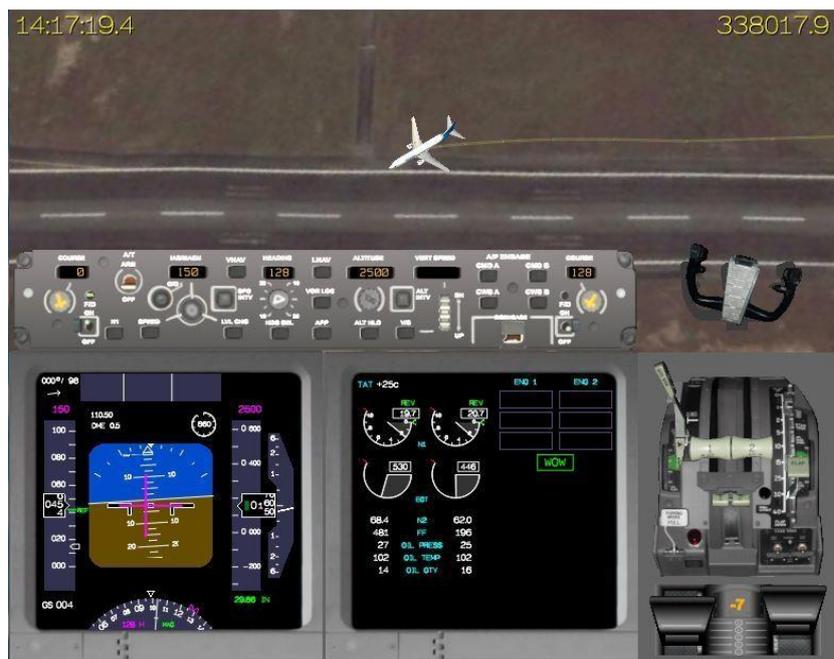
Photograph 12: Aircraft's final stop, approximately 1,260 m from Threshold Runway 13.

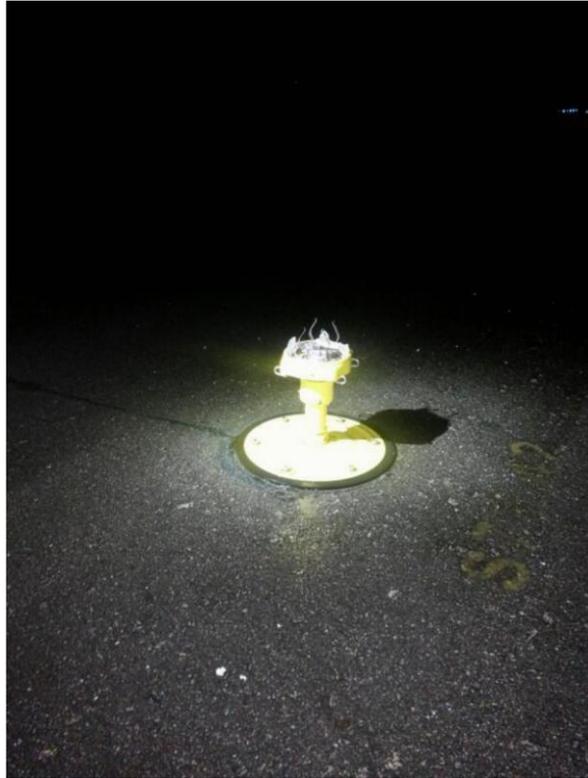
(12th edge light is approximately 720 m from Threshold Runway 13)

1.4 Other Damages. One of the runway edge light cover on the right-hand side of the runway located approximately 720 m from Threshold Runway 13 was damaged by the aircraft. There were minor damages to the runway surface around the areas where the aircraft came to a stop.

Runway 12th Edge Light that was damaged
