Accident Investigation Coordinating Committee

Report 2018/01

Final Report on the Serious Incident to
Airbus, A330-300 (9M-XXC), A350-900 (A7-ALL)
Velana International Airport, Maldives
7 July 2018

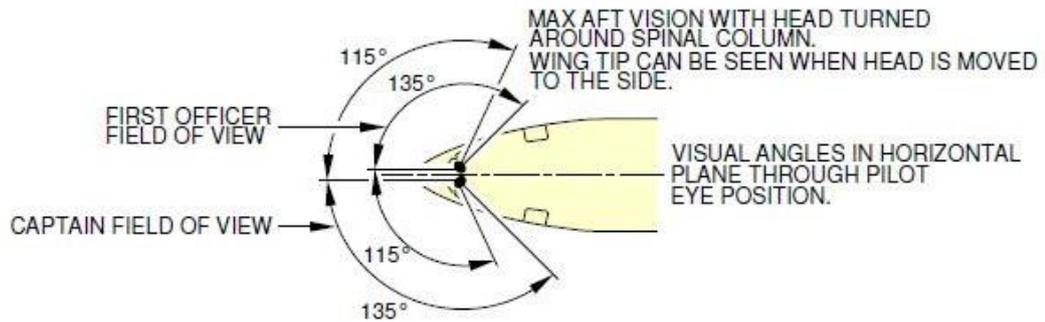
Figure 1 – A330-300 visibility from cockpit in static position

On the A330-300 aircraft, the visual angle in the horizontal plane through the co-pilot's normal eye position and looking towards the wingtip is 115°. If the pilot moves his head to the side, the visual angle in the horizontal plane increases to 135°, and the wing tip becomes visible, as summarised in Figure 1.

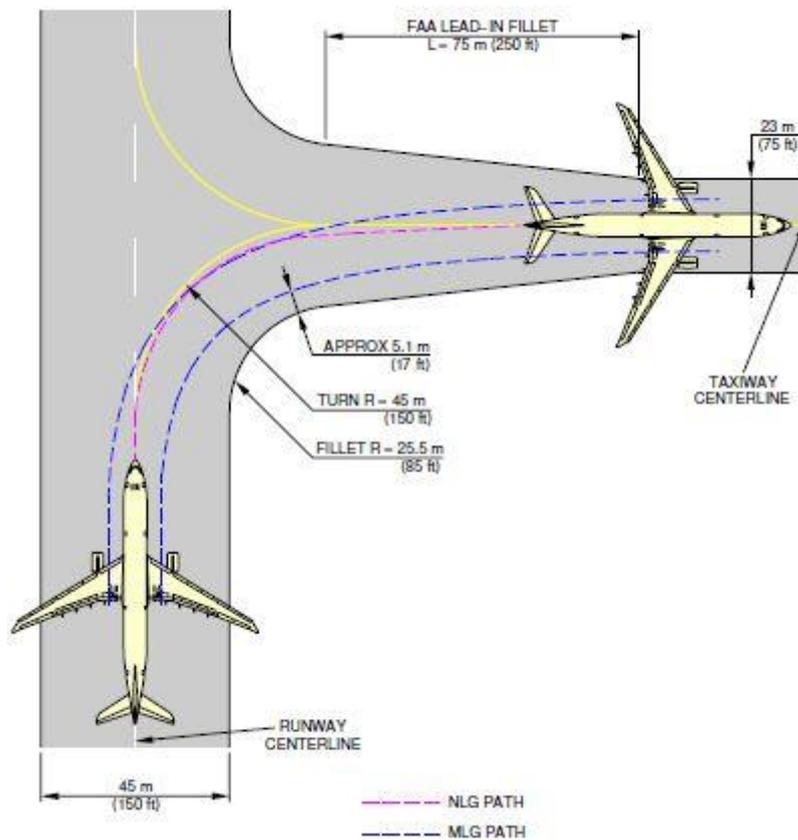
Figure 2 – 90 degree turn: runway to Taxi-way

The clearances required for a 90 degree turn on the A330-300 are given in the figure below. This example is on a 90 degree turn from runway to Taxi-way using “Cockpit Over Centreline Method”.

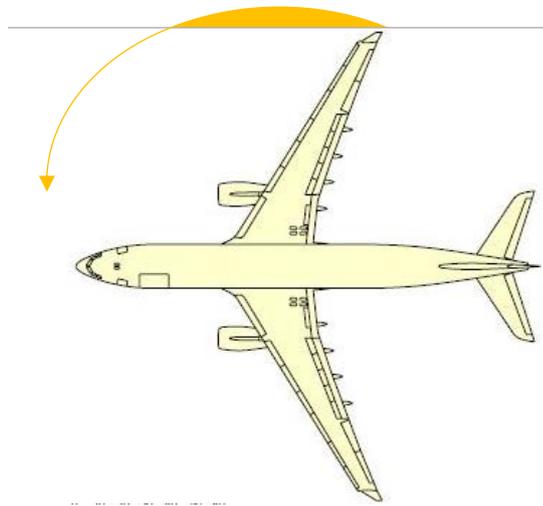
Figure 3 – Swept wing growth

The A330 aircraft, like most modern large transport aircraft have swept wings that are subject to a phenomenon known as ‘swept wing growth’ or ‘wing creep’. This occurs during a turn when the wing tip describes an arc greater than the normal wingspan due to the geometry of the aircraft and the arrangement of the landing gear¹.

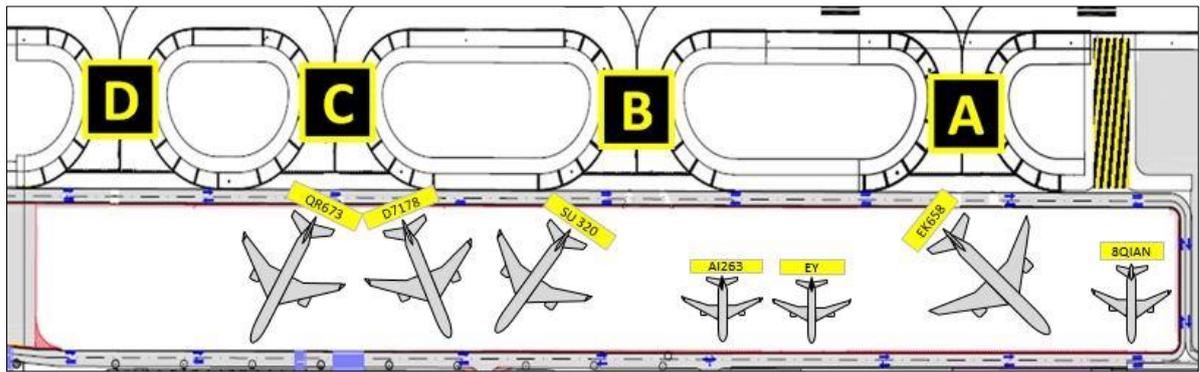
Figure 5 – Parking allocation for 9M-XXC

"Plan-4" was generated for the arrival of 9M-XXC (flight number D7178), among other aircraft. In this plan 9M-XXC was to be parked near Taxi-way C between A7-ALL (flight number QR673) and another A330 (flight number SU 320).

The Duty In-charge is responsible to brief the marshaller on where and how the aircraft should be parked based on this allocation scheme. At the same time, the SOP states ‘parking is carried out solely based on the experience of the marshaller’ as the apron is not marked.

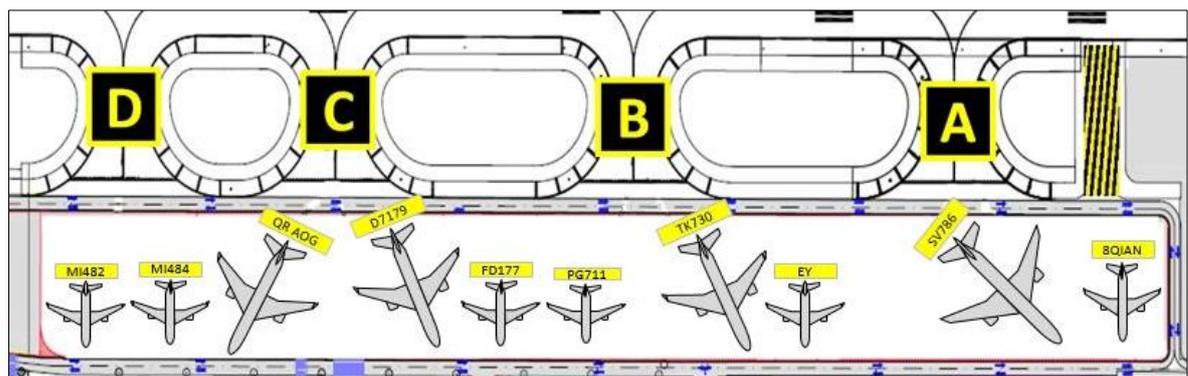
Figure 6 – Parking Allocation with the most aircraft

Given that the parking bays are not marked, the allocation (i.e. number, type and orientation) of aircraft varies depending on the traffic. For example, the parking allocation with the most number of aircraft, for the day, was “Plan-6” shown in figure 6. In this arrangement 10 aircraft are parked.

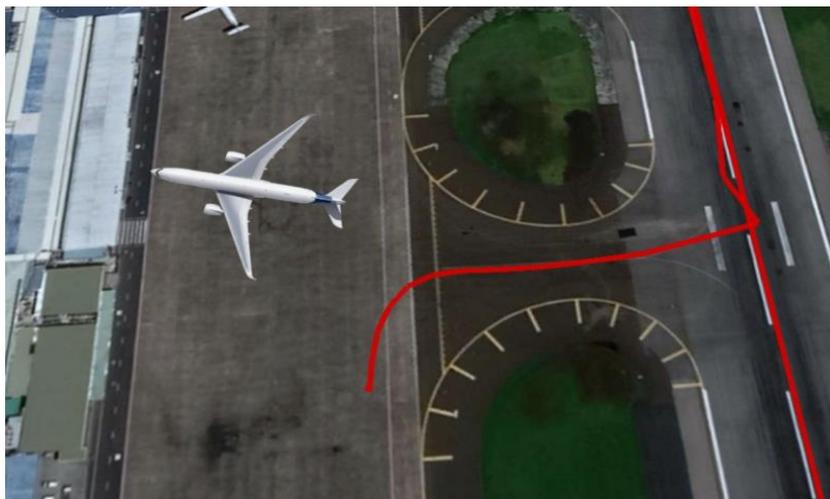
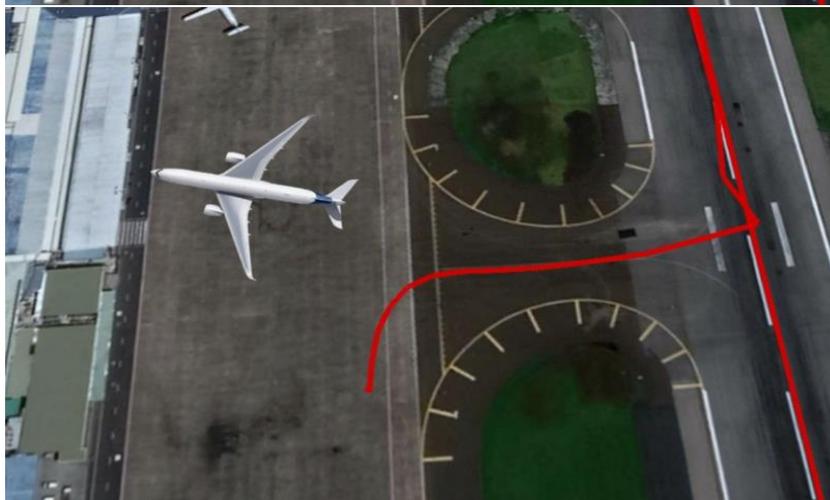
Figure 7 – The path (red line) taken Air Asia aircraft

The AirAsia aircraft is fitted with a flight data system that, among other parameters, records the GPS position of the aircraft. This data was provided by AirAsia X. The mapping of this data together with the position of Qatar Airways aircraft (measured on ground) is shown below. Scale drawing of the aircraft is superimposed on this data to reconstruct the movement of Air Asia aircraft.

The red line in the above figures represent the movement of the aircraft from the Flight data System. It is evident from the mapping above, the starboard (right hand) wing of the Air Asia aircraft could not have cleared the Qatar Airways aircraft horizontal stabilizer.
