# **AIRCRAFT ACCIDENT REPORT NUMBER 15/15**

**AIR ACCIDENT INVESTIGATION BUREAU  
MINISTRY OF TRANSPORT  
MALAYSIA**

**ENGINE FAILURE IN-FLIGHT INVOLVING, N9297N, PA-28-181  
AT SENAI AIRPORT GOLF COURSE, JOHOR, MALAYSIA  
15 NOVEMBER 2015**

**ACCIDENT REPORT NO.: 15/15**

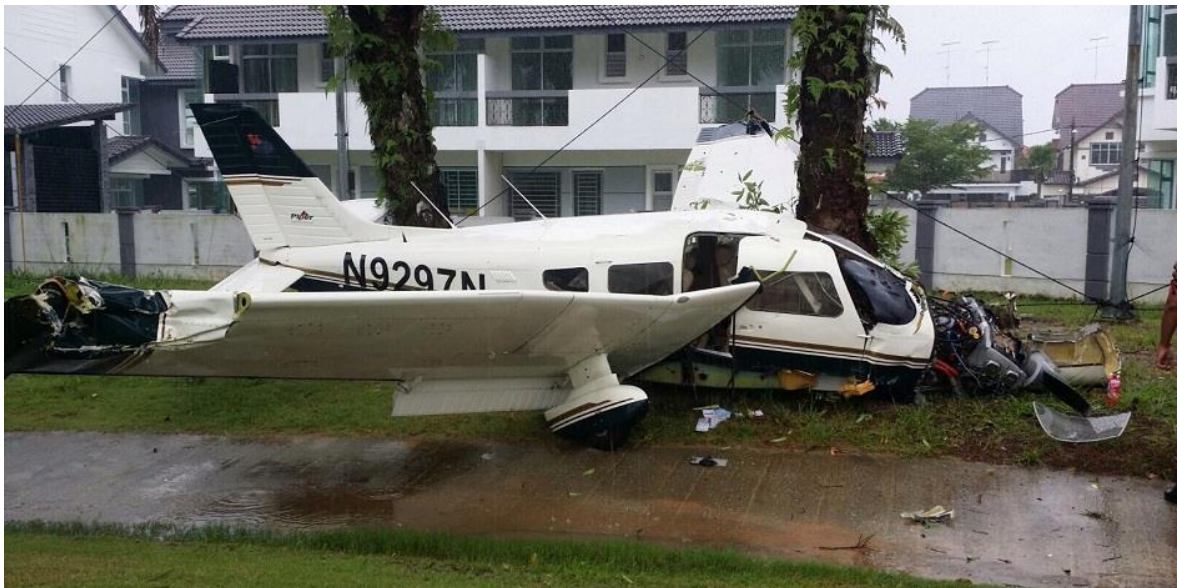
N8287N was totally damaged during the final collision with the tree, ie. N9297N aircraft suffered total lost.

Figure 1: Damaged N9297N Aircraft

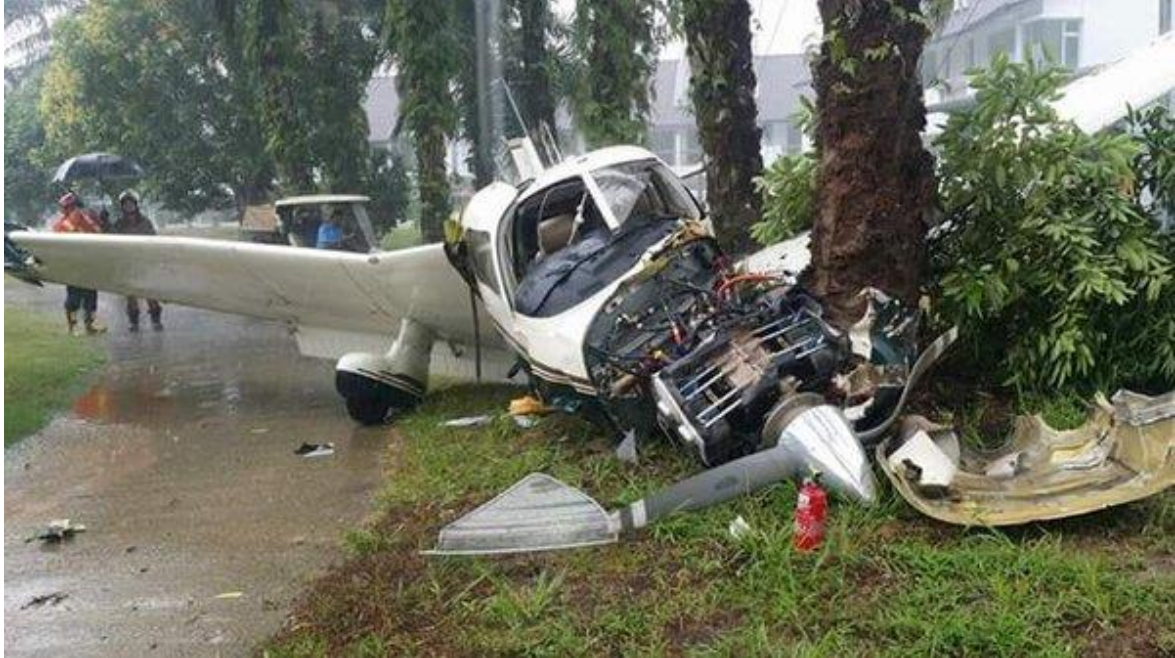
1.1.6 Captain of N9297N aircraft forced landed the aircraft safely at Senai International Airport Golf Course. Nevertheless, just before N9297N aircraft came to a complete stop, it hit a tree which is located very near to a golf course green.

Figure 2: N9297N hit a Tree during the Forced Landing

1.1.6 Owing to the severe hit against the tree, N9297N aircraft was severely damaged. In fact, the damage of N9297N aircraft was considered a total lost.

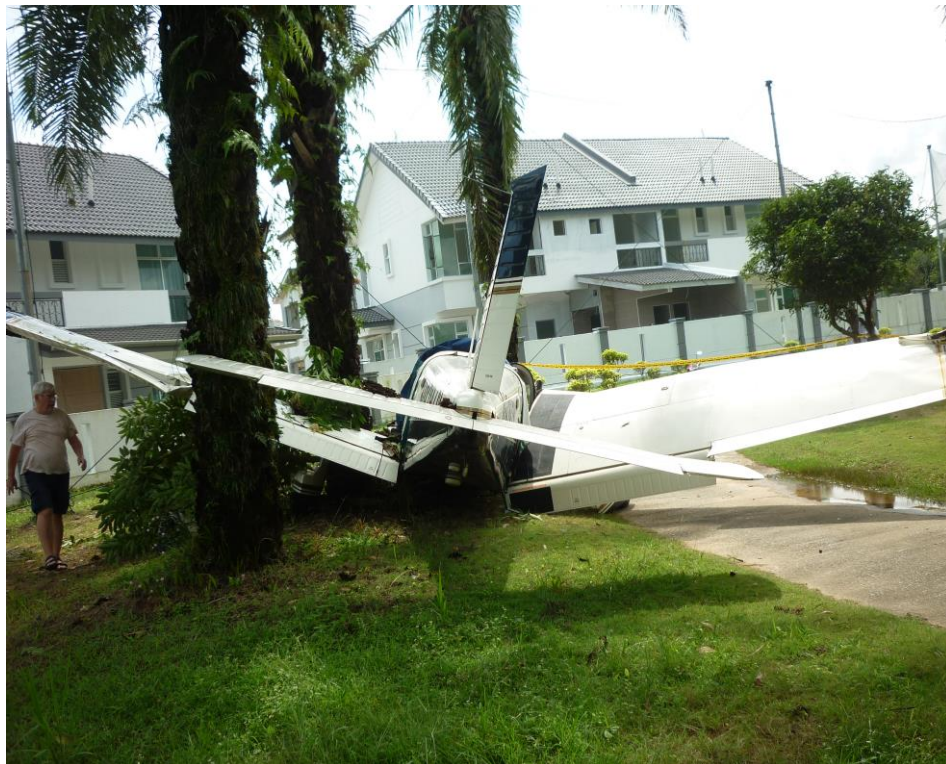
1.4.1 N9297N aircraft was severely damaged during the forced landing. However, the Captain only sustained minor injury.

Figure 3: Real View of Damaged N9297N Aircraft

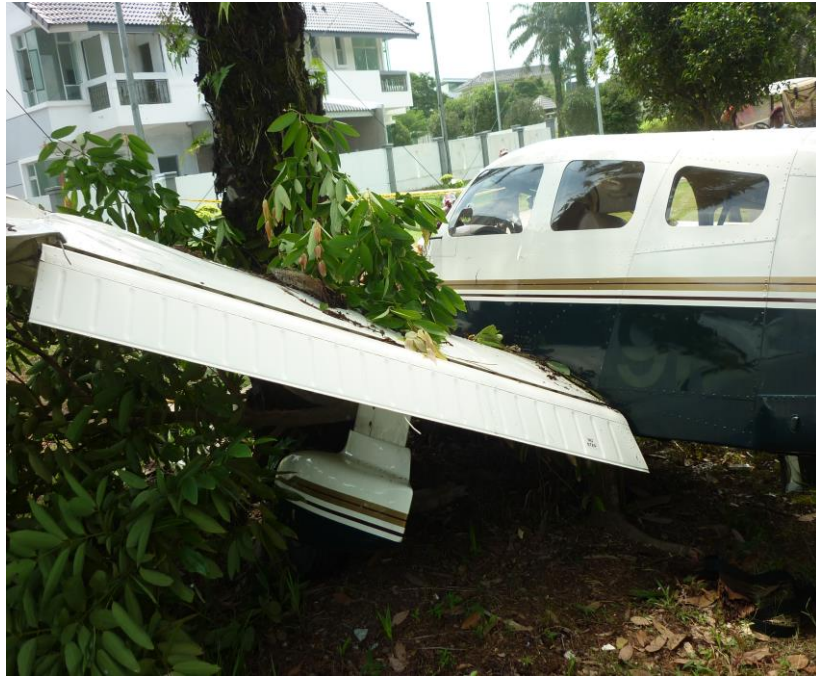
Figure 4: N9297N Aircraft Collided with A Tree

2.5 In the process of the forced landing on the Senai International Airport Golf Course, N9297N aircraft collided with a tree at the end of the forced landing, ie. during its final stop. The collision with the tree caused the severe damage to N9297N aircraft.

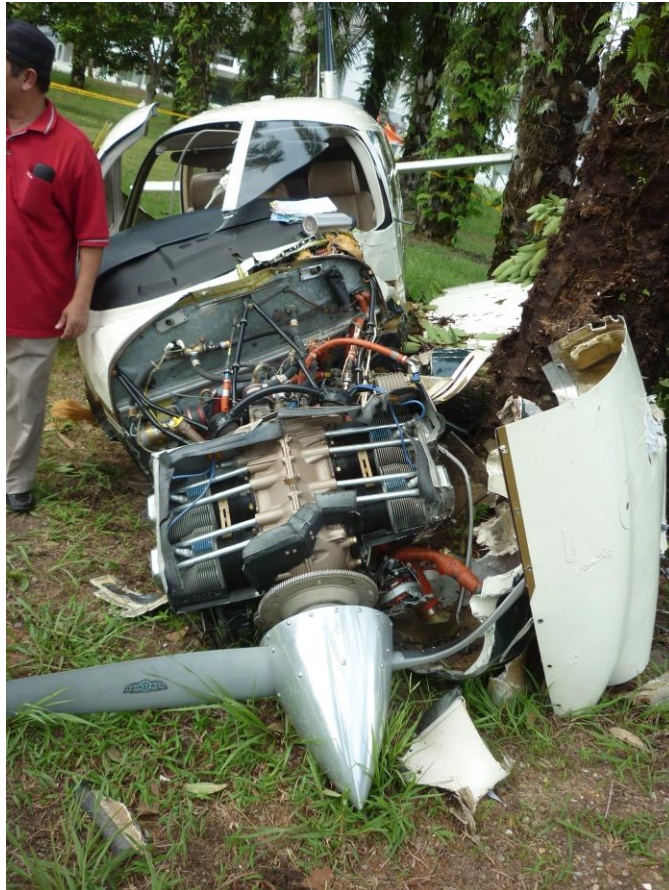
Figure 5: Engine of Damaged N9297N Aircraft

2.6 Owing to collision with the tree, the engine of N9297N aircraft was so severely damaged. Because of this fact, the engine could not be used properly to confirm the cause of the engine power loss.

3.2.1 The probable cause of the engine failure or engine power loss while holding to the West of Senai International Airport at 1,000 ft was owing to presence of fuel sentiments in the fuel tank.

4.1.2 Water contamination presence in the fuel tank or fuel system was due to absent of proper fuel check during the preflight by the engineering personnel or Captain prior to taking the aircraft for flying. Future pre flight check has to include fuel sample check for contamination.

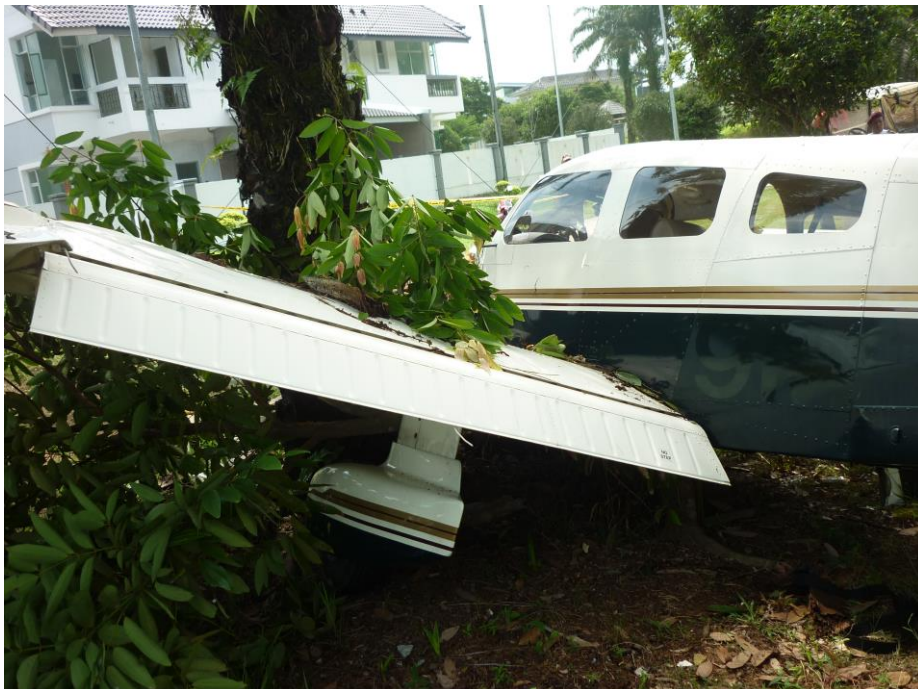
1.13.1 The Captain did the forced landing on the Senai International Airport Golf Course. The forced landing was good on the Senai International Airport Golf Course. Just before N9297N aircraft came to a stop, it hit at tree just next to a green. The collision with the tree caused the aircraft to be severely damaged.

1.13.2 Although the forced landing on the golf course was successful, the collision of N9297N aircraft with a tree caused the aircraft to suffer a Write-Off category, the Captain only suffered slight injury.
