Australian Government
Australian Transport Safety Bureau

Data entry and navigational issues involving Airbus A330-343X 9M-XXM

Sydney Airport, New South Wales | 10 March 2015

ATSB Transport Safety Report
Aviation Occurrence Investigation
AO-2015-029
Final – 7 September 2016

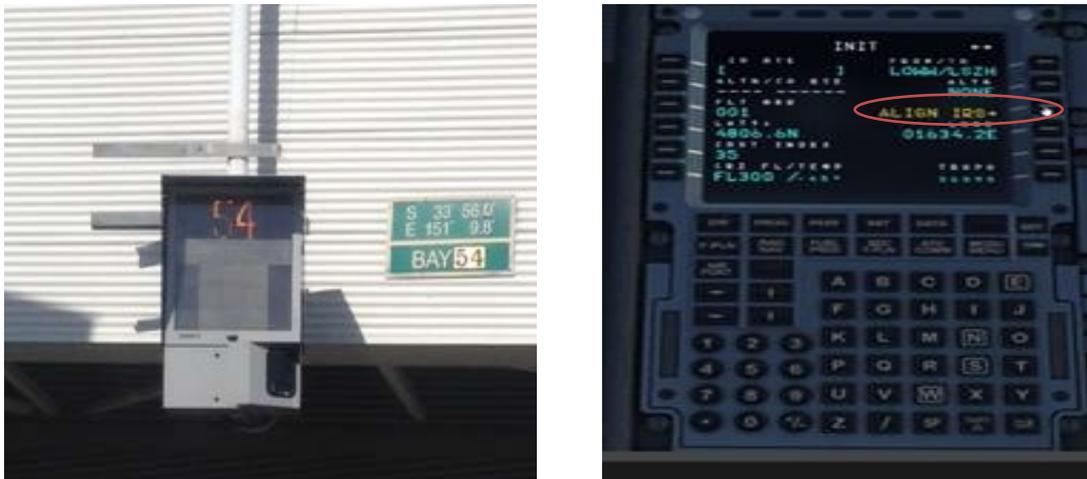
Figure 1: At left, Gate 54 showing the coordinates sign and, at right, the MCDU used during the ADIRS initialisation with the ALIGN IRS prompt highlighted in red (Note: the MCDU does not depict the gate 54 coordinates)

- When manually entering the coordinates of the aircraft's position using a data entry technique that was not recommended by the aircraft manufacturer, the longitude was incorrectly entered as 01519.8 east (15° 19.8' east) instead of 15109.8 east (151° 9.8' east). This resulted in a positional error in excess of 11,000 km, which adversely affected the aircraft's navigation systems and some alerting systems.

Airbus recommended that the aircraft's position should be entered into the MCDU via that equipment's slew keys. That method of data entry inherently limited the possibility of large errors, as the incremental nature of the slew keys required significant time to effect large changes in latitude and longitude. By contrast, the entry of latitude and longitude using the multipurpose and control display unit (MCDU) scratchpad involved the input of a sequence of 16 characters consisting of 12 numerical characters, two letters and two separate decimal points. This number of characters generally increases the likelihood for error when copying such a sequence from the gate sign to the scratchpad. On this occasion the use of the scratchpad directly facilitated the large positional error.

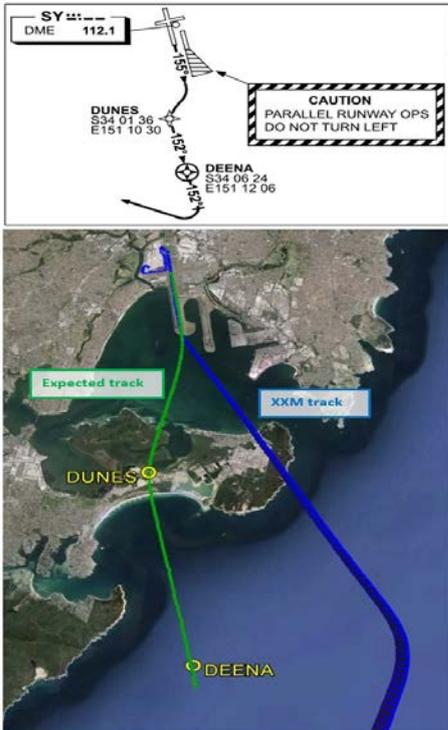
A few seconds later, ATC observed the aircraft turning left, contrary to the SID, and tracking towards the flight path for the active parallel runway, runway 16L. In response, ATC contacted the crew and requested confirmation that they were tracking via the SID and would be maintaining a heading of 155° before turning right. At the same time ATC held another aircraft in the line-up position for departure from runway 16L (Figure 2).

Figure 2: During departure 9M-XXM initially turned left, instead of right, and crossed the departure flight path of the parallel runway 16L (displayed here in blue). Note the standard instrument departure chart caution against turning left. The DEENA 5 SID is depicted in green

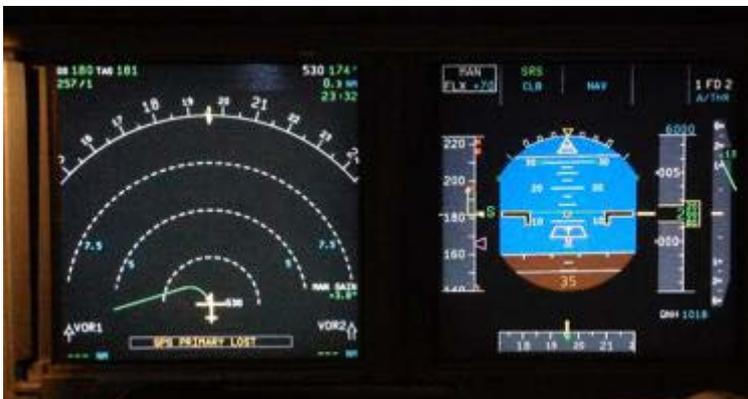
ATC audio recordings indicated an initial hesitation in the captain’s reply to ATC, first confirming the heading and then asking ATC to standby as they had lost their primary instruments. During interviews the crew stated that once the EGPWS alert was assessed as spurious, and the decision not to carry out an EGPWS escape manoeuvre made, the crew noticed that all of the expected navigation waypoints and tracking information were not displayed on the ND. Instead, an amber GPS PRIMARY LOST message appeared on the NDs together with an unusual tracking line without an associated waypoint (Figure 3).

Figure 3: Photograph of an exemplar ND and the primary flight display during a simulated recreation of the flight scenario. Note the GPS PRIMARY LOST message (in yellow) at the bottom-left of the photograph and the green tracking line emanating from the white aircraft depiction at the centre of that representation

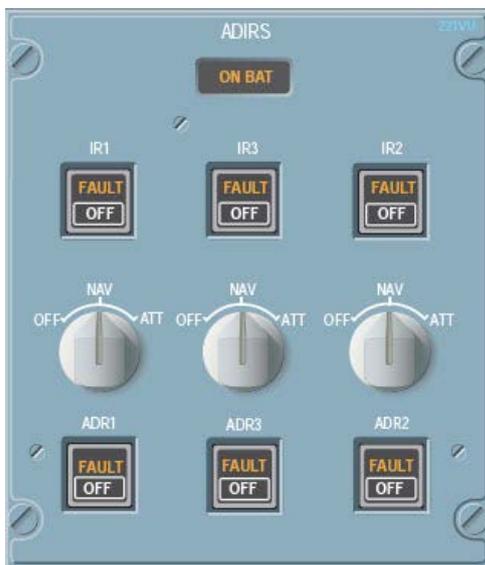
The FO informed the captain that, in order to attempt to reset the system, it was intended to cycle the three air data and inertial reference unit (ADIRU) rotary switches on the overhead panel from NAV to OFF (Figure 4), and that this would likely cause the autopilot to drop out. The ADIRU rotary switches influence both the ADR and inertial reference parts of the respective ADIRU, and have a greater combined effect on aircraft systems compared with the individual ADR and/or inertial reference push-buttons available on the same overhead panel (Figure 4) (see the section titled *Context*).

During interview the captain and FO stated that the captain's response was simply 'Yes'. The FO recalled initially holding their hand in the vicinity of the rotary switches awaiting confirmation from the captain to cycle them to OFF. Both crew recalled that ATC instructions then disrupted the normal process of confirmation before actioning critical flight deck switches. Once the ATC instruction was acknowledged and complied with, the FO turned ADIRU 1 and 3 OFF without clarifying the captain's confirmation for the action. In response, several flight guidance and navigation systems degraded and the autopilot disengaged. The captain instructed the FO to stop actioning the switches, with ADIRU 2 remaining in the NAV position.

Figure 4: ADIRU rotary switches and individual inertial reference and ADR fault lights and OFF push-buttons on the A330 flight deck overhead panel

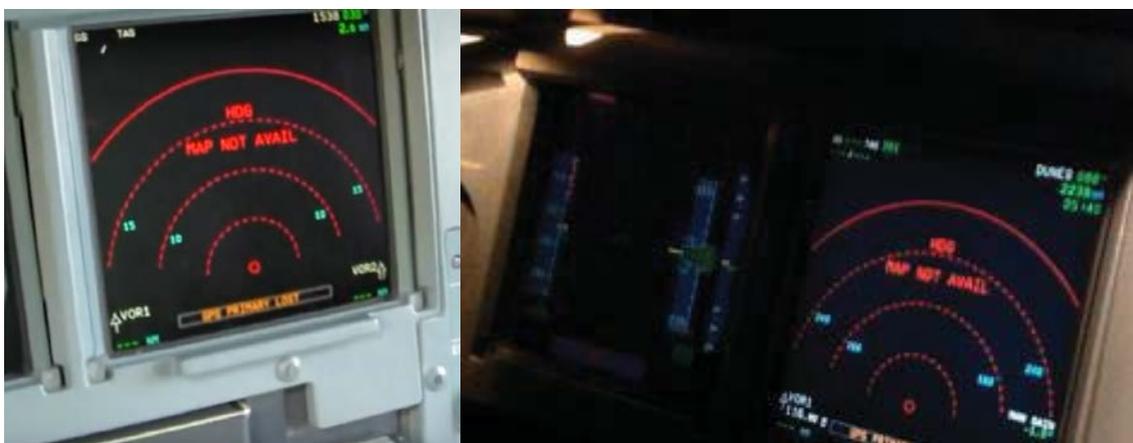
Once ADIRUs 1 and 3 were selected OFF, the captain's primary flight display (PFD) lost all information except accurate airspeed and vertical speed, and the captain's ND displayed the GPS PRIMARY LOST, HDG and MAP NOT AVAILABLE warning flags (Figure 5). In addition to the information remaining on the captain's PFD, the FO's PFD continued to display accurate airspeed, vertical speed and attitude information, but the displayed heading information was incorrect. The FO's ND also displayed incorrect heading information and there was no usable map, waypoint or tracking information. The autopilot and autothrust systems were also unavailable, and the aircraft had reverted from 'normal law' to 'alternate law'. This affected some of the aircraft's handling characteristics and flight envelope protections (see the section titled *Flight control laws and Alternate law*). The integrated standby instrument system, located on the forward instrument panel, continued to provide aircraft attitude from its own internal accelerometer and gyrometer, and uncorrected airspeed from the standby pitot and standby static probes. The standby compass provided heading information, but this was affected by any slight aircraft acceleration (Figure 5).

Figure 5: Simulator recreation of the captain's PFD and ND after the ADIRU 1 and 3 switches were selected off. Note the GPS PRIMARY LOST message (in amber) at the base of the photographs and the HDG and MAP NOT AVAIL message (in red) at the centre-upper of the photographs

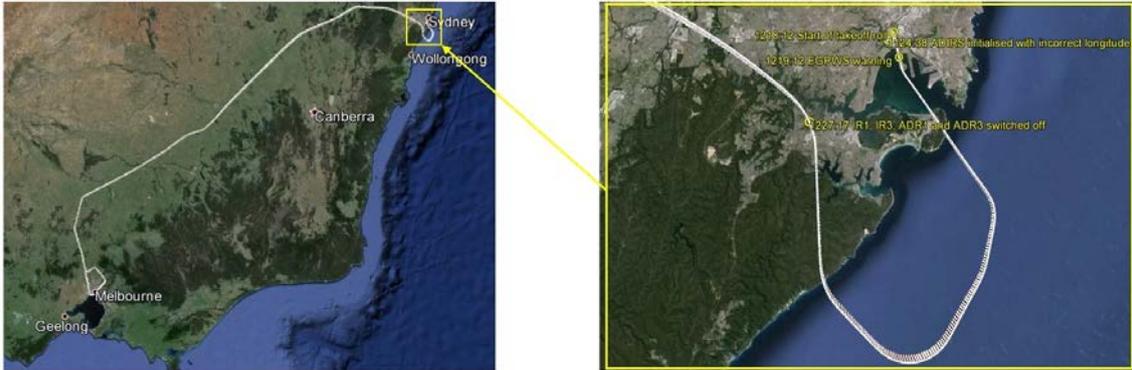
Figure 6: Visual depiction of the flight from Sydney to Melbourne, including an inset of the departure from Sydney (right of the two graphics)

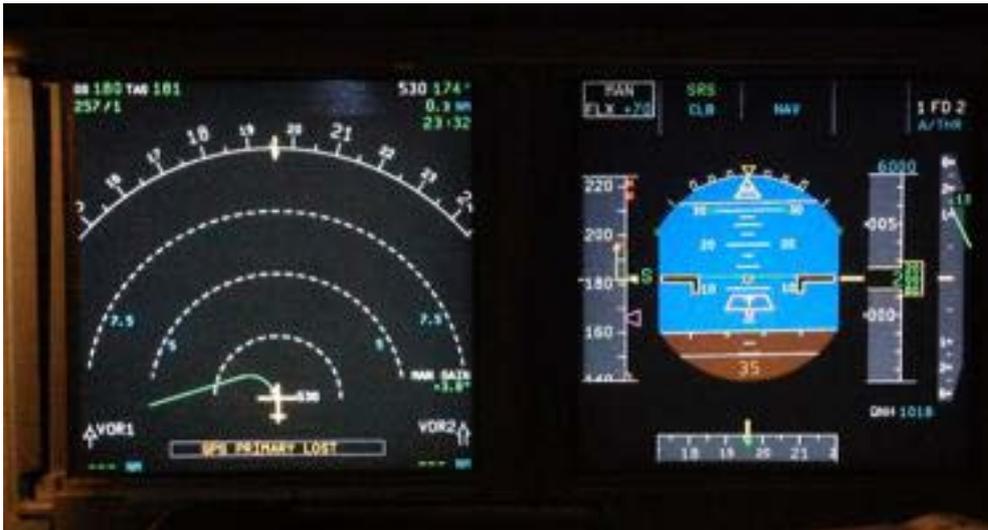
Figure 14: GPS PRIMARY LOST displayed (in amber) at the bottom-left of an exemplar ND

The GPS PRIMARY message is typically displayed when the GPS is capable of passing the integrity and accuracy checks by receiving an adequate number of satellites in the correct positions relative to the aircraft and horizon. When this message is active, the two GPSs interface with the respective inertial reference system (IRS) and output a combined position to the FMC. If GPS PRIMARY is active for more than 10 minutes, and the GPS integrity or accuracy check then fail because of an anomaly with the satellite array, the GPS signal is invalidated. The IRS output then reverts to a mixed IRS only position (IRMIX) and eventually GPS PRIMARY LOST is displayed on the ND. There can be a delay of a few minutes between the invalidation of the GPS signal and display of GPS PRIMARY LOST.

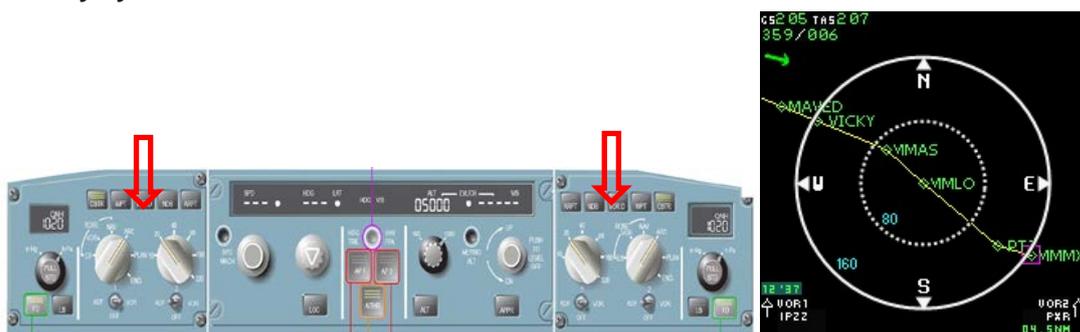
The recorded data also indicated that the FO selected plan mode and every available ND range during the line-up/take-off roll. This may indicate that the FO was attempting to interpret an unusual display on the ND associated with the positional error.

Figure 13: ND controls and an example of a PLAN mode display (right picture). Note that the track (in yellow) and waypoints (in green) are displayed but there is no aircraft or runway symbol
