FINAL REPORT

**SERIOUS INCIDENT TO AIRBUS A320-216, REGISTRATION 9M-AQA,
RUNWAY EXCURSION**

7 JULY 2014

**[AAIB BRUNEI 001/2014]
Air Accident Investigation Team
Brunei Darussalam
Ministry of Communication
21 May 2015**

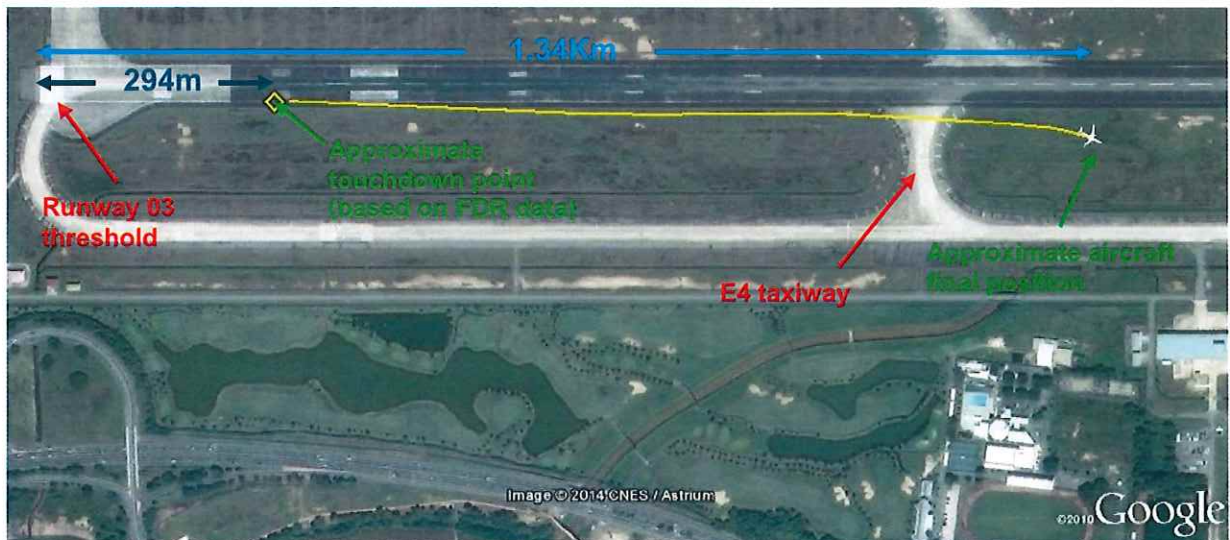
- 1.1.8 According to the aerodrome controller, at around 15:32 when the aircraft was approximately 1 Nautical Mile from the runway, the shower intensified and extended up to the area around the E4 taxiway (See Figure 1)

- 1.1.14 At 15:32:36, both main gears of the aircraft touched down on the runway pavement, close to the right edge of the runway. (About three seconds later, ambient noises corresponding to the aircraft veering off the runway was recorded on the Cockpit Voice Recorder (CVR))
- 1.1.15 The PIC applied left rudder input (as recorded in FDR, rudder position 7° increased reaching 22.5° in less than one second), however, he was unable to bring the aircraft back to the runway.
- 1.1.16 After the nose gear touched down on the grass patch at 15:32:47, the aircraft travelled across taxiway E4 onto another grass patch before coming to a stop (See Figure 1). Subsequently, the PIC requested for all the cabin crew members to be at their assigned stations.

Figure 1: Yellow line shows path of aircraft
