SAFETY INVESTIGATION REPORT

**Malaysia Airlines Boeing B777-200ER (9M-MRO)
08 March 2014**

The Malaysian ICAO Annex 13 Safety Investigation Team for MH370

Issued on 02 July 2018
MH370/01/2018

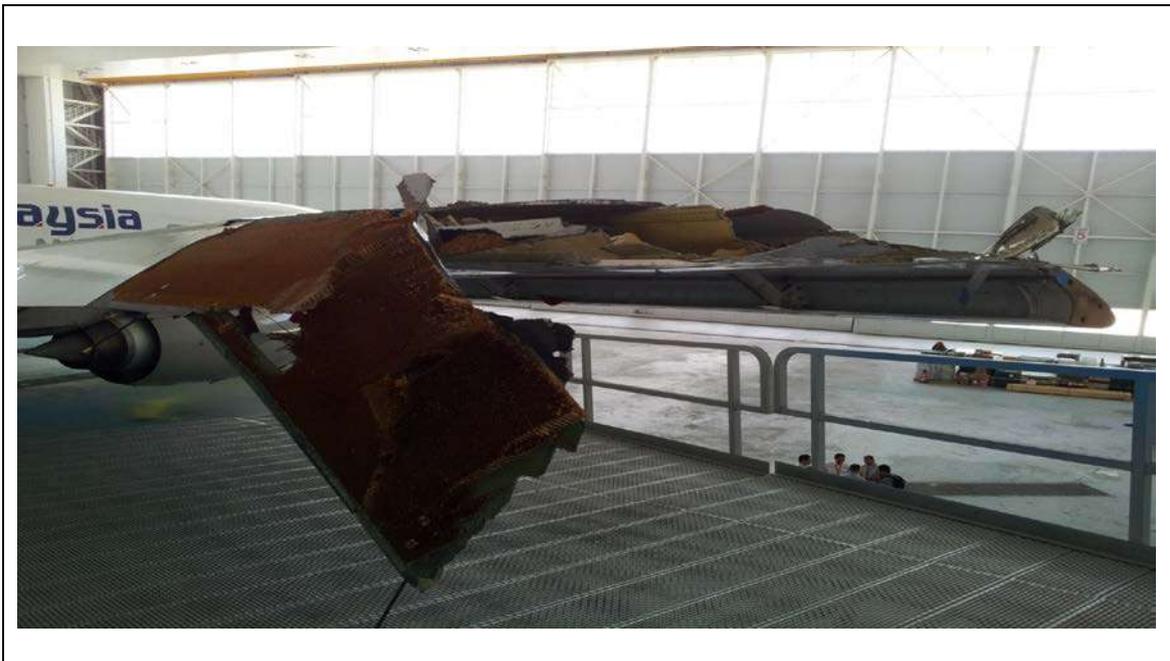
Figure 1.6A - Right Wing Tip Damage

There was an entry in the Aircraft Log Book on 09 August 2012 that the aircraft right wing tip was damaged during taxiing at Pudong, Shanghai Airport. The aircraft collided with a China Eastern Airlines A340-600, registered B-6050. The right wing tip of 9M-MRO ran into the left horizontal stabilizer of B-6050. Part of the aircraft wing tip was ruptured and stuck at the left elevator of the B-6050. *Figures 1.6A and 1.6B (below) show the wing tip damages.*

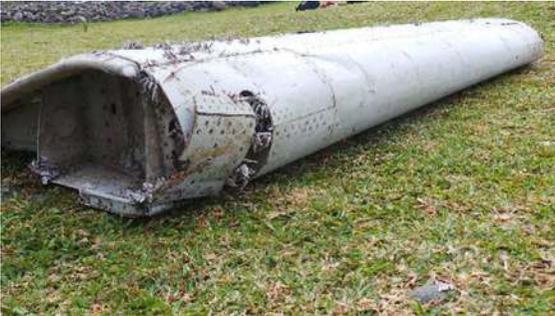
<p data-bbox="792 663 999 699">Right Flaperon</p>

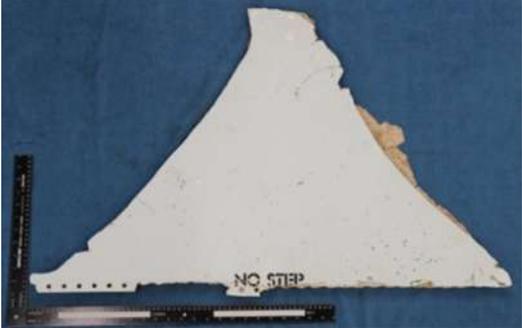
<p data-bbox="667 719 1128 751">Right Horizontal Stabiliser Panel</p>

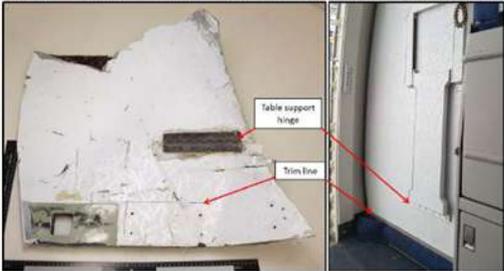
<p>Source: Malaysian MOT / ATSD</p> <p>Door R1 Stowage Closet</p>

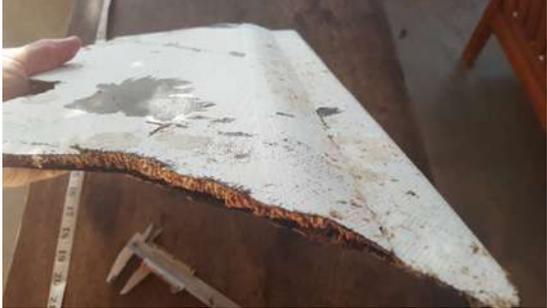
<p data-bbox="748 727 1048 762">Wing to Body Fairing</p>

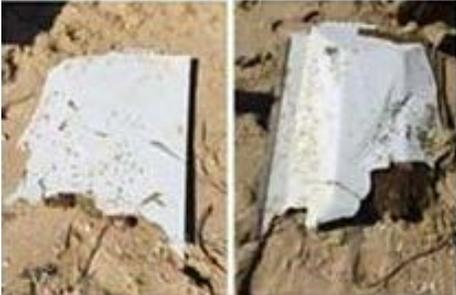
<p data-bbox="629 719 1059 751">Left Wing Trailing Edge Panel</p>

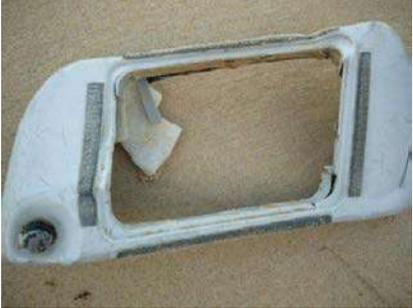
<p data-bbox="741 727 1055 799">Seat Back Trim Panel encasing IFE Monitor</p>

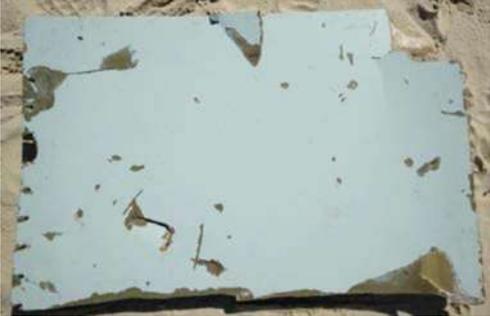
<p data-bbox="674 730 1124 767">Right Wing Trailing Edge Panel</p>

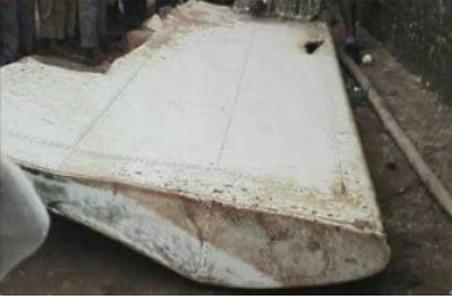
<p data-bbox="757 722 1043 754">Right Outboard Flap</p>

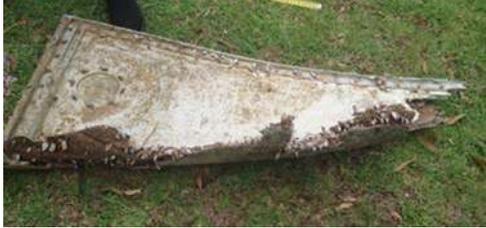
Right Wing No. 7 Flap Support Fairing
