## **DEBRIS EXAMINATION REPORT**

### **SAFETY INVESTIGATION FOR MH370**

**Malaysia Airlines MH370 Boeing B777-200ER (9M-MRO)  
08 March 2014**

**Identification of Debris (Item 23 in the “Summary of Possible MH370 Debris Recovered”) recovered from Riake Beach, Nosy Bohara Island, Madagascar in October 2016**

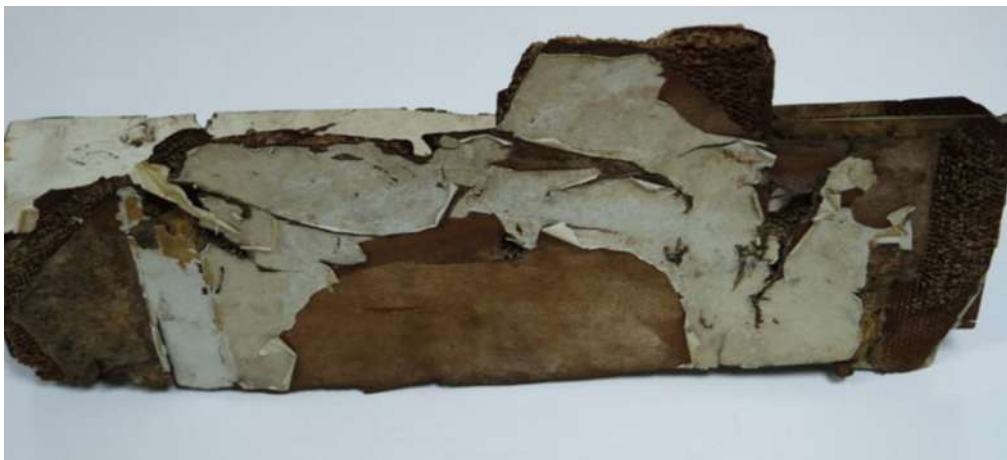
This item was recovered from Riake Beach, Nosy Bohara Island, Madagascar in October 2016. The item is identified as Item No 23 of the items recovered; refer to the "***Summary of Possible MH370 Debris Recovered***".

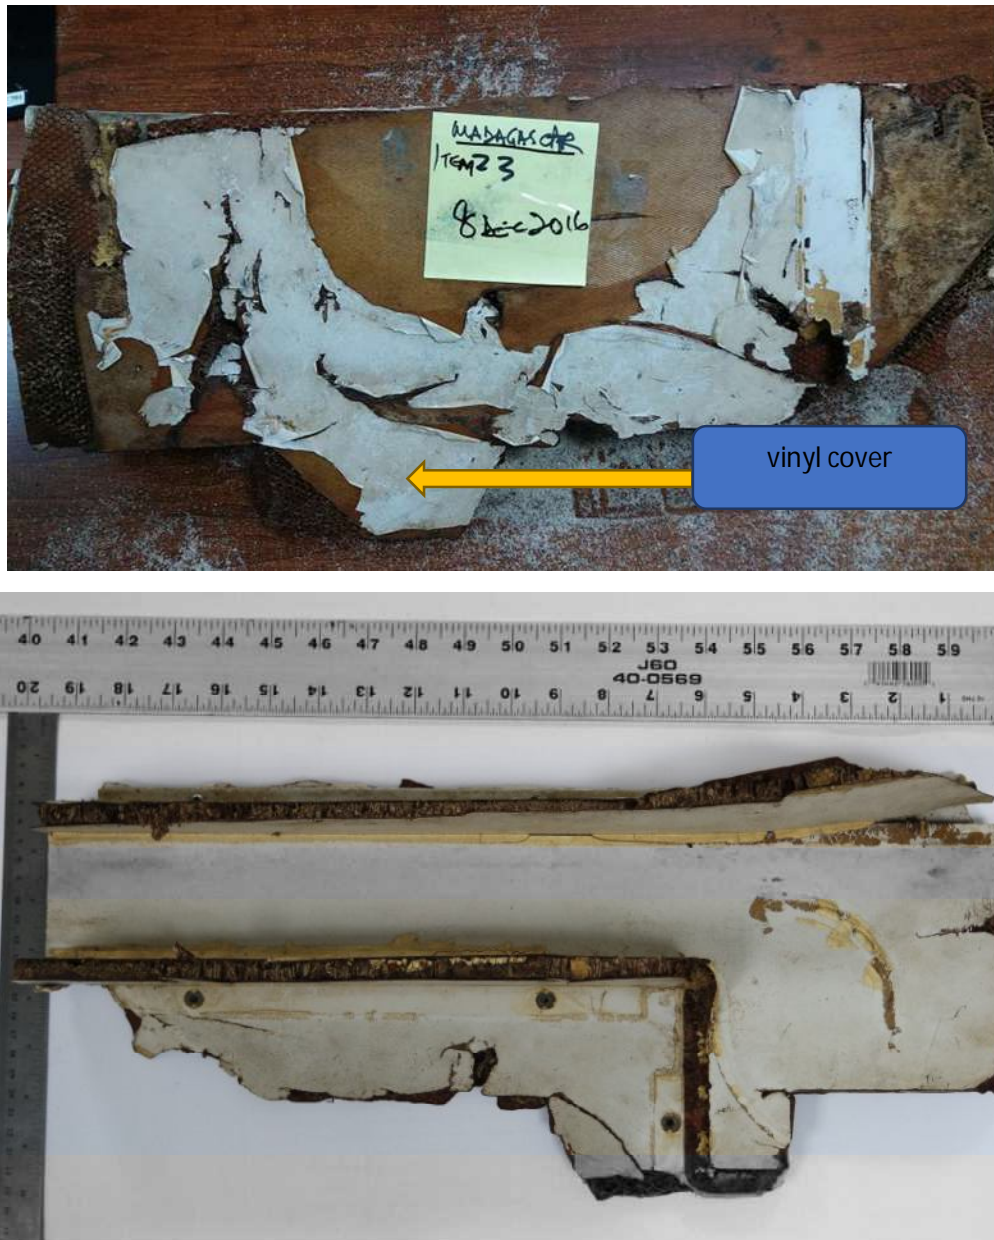
It was a basic composite part with non-metallic honeycomb core. The laminate was obviously not made of carbon fiber since it was brown in colour. The part was measured to be approximately 20 inches in length and weighed 0.545 Kg.

The part was taken to a B777-200ER, formerly operated by Malaysia Airlines (MAS), undergoing a maintenance check at Subang, Malaysia, for identification purposes. The part structure construction characteristics showed that it was not part of the aircraft structure. It appeared more likely to be from the aircraft interior based on the vinyl and edge sealant which was on the part. The vinyl and sealant colour on the part matched that of the parts generally used in aircraft galleys.

The fractured fibres on the item indicated the fibres were pulled out which could indicate tension failure on its structure.

Although it appeared to be part of an aircraft interior there is no conclusive evidence to indicate whether the part could have actually originated from an aircraft.
