DEBRIS EXAMINATION REPORT

SAFETY INVESTIGATION FOR MH370

**Malaysia Airlines MH370 Boeing B777-200ER (9M-MRO)
08 March 2014**

Identification of Debris (Item 27 in the “Summary of Possible MH370 Debris Recovered”) recovered from Mpame Beach, South Africa on 27 January 2017

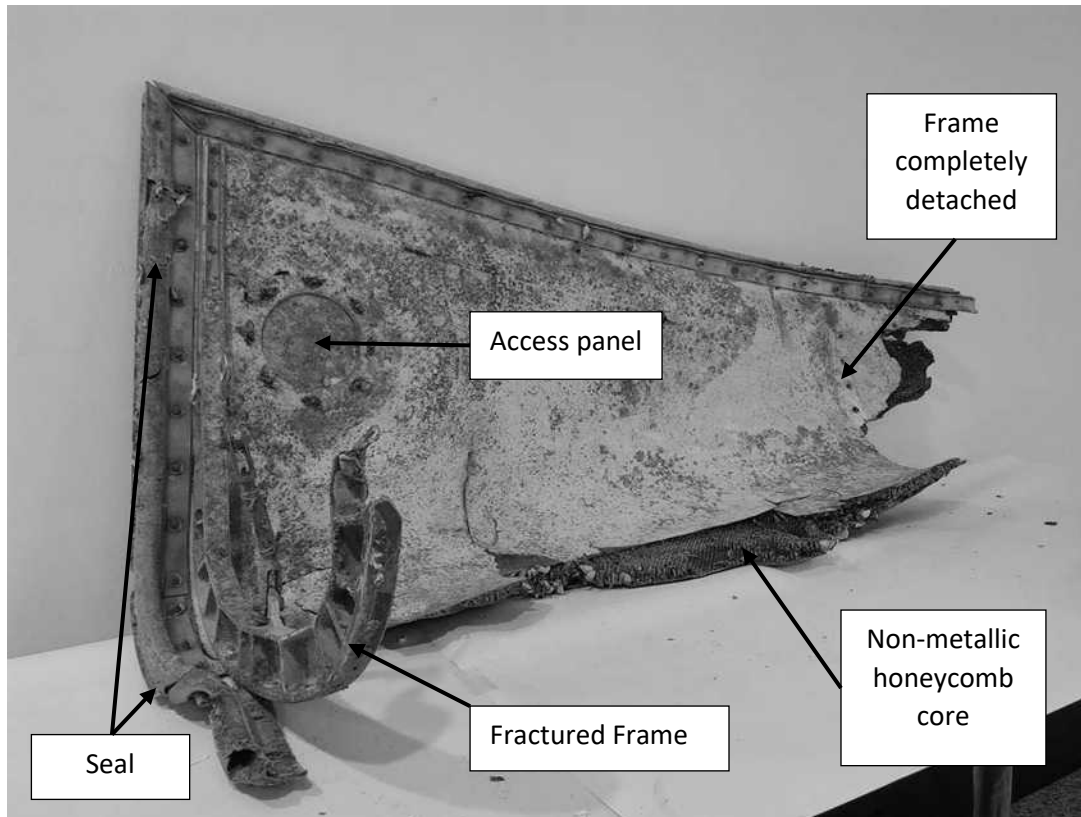
This part was made of composite Carbon Fibre Reinforced Plastic (CFRP) with non-metallic honeycomb core. A fractured metallic frame was still attached to the assembly. Seals were still intact around the part. An access panel was also still intact and completely attached in its position. There was evidence of another metallic frame installed on the part shown by its visible fastener holes; however this was completely detached from the part assembly. Refer to the picture below.

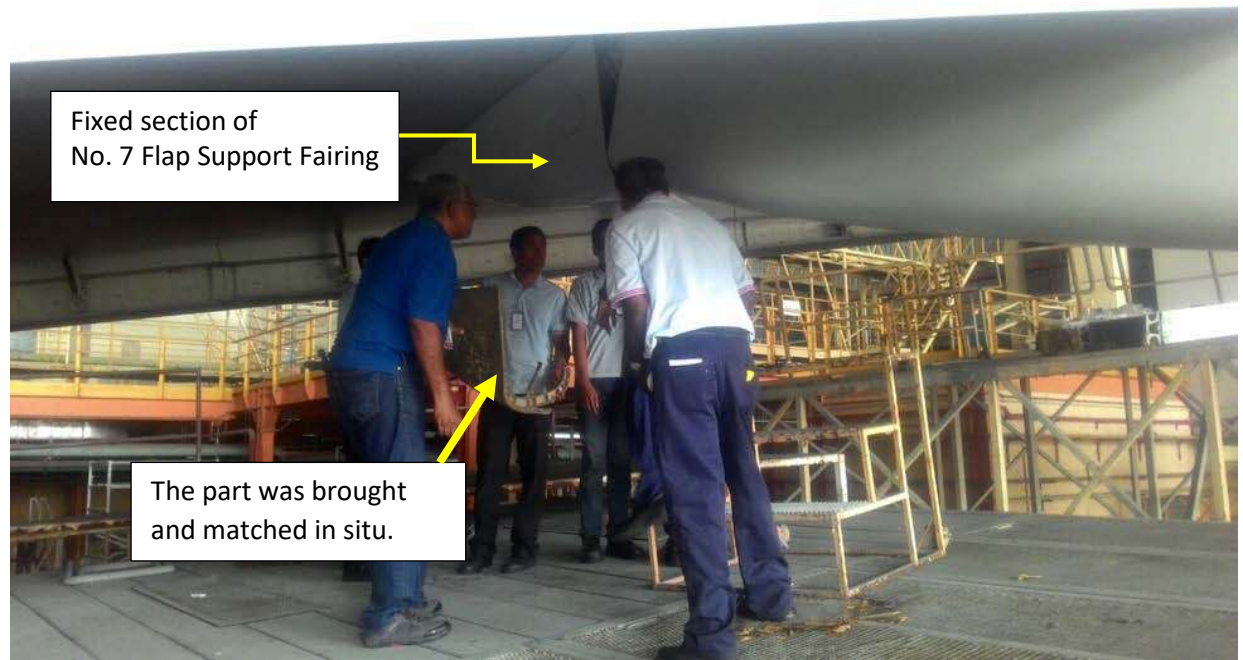
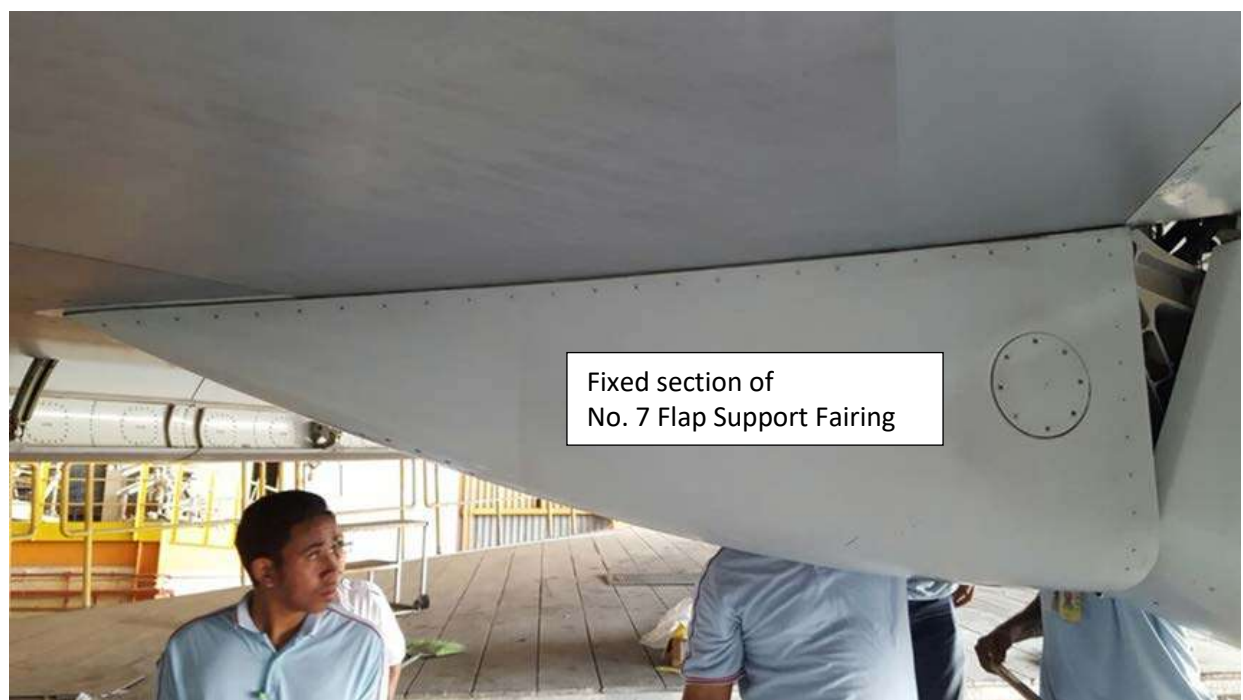
It was easily matched to the fixed, forward section of the No. 7 flap support fairing, as shown in the pictures below. Item No. 2, found on 27 December 2015 at Daghatane Beach, Mozambique, is also part of the same fairing; however it is part of the rear, moveable section.

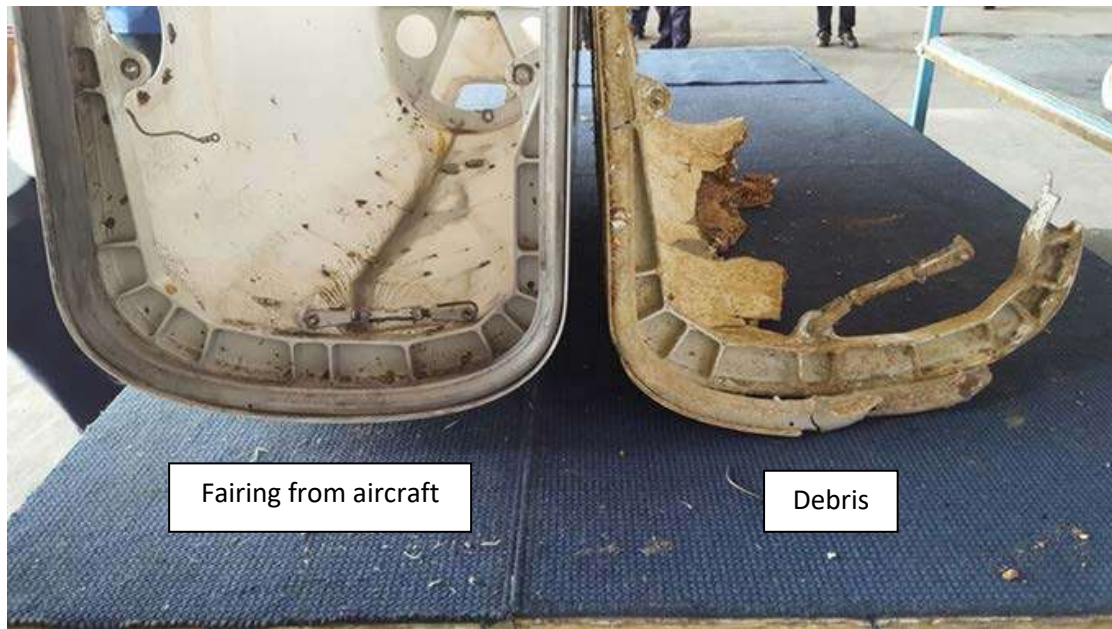
The fairing from the aircraft was removed and matched side by side with the debris as shown below. The features were found to be identical.

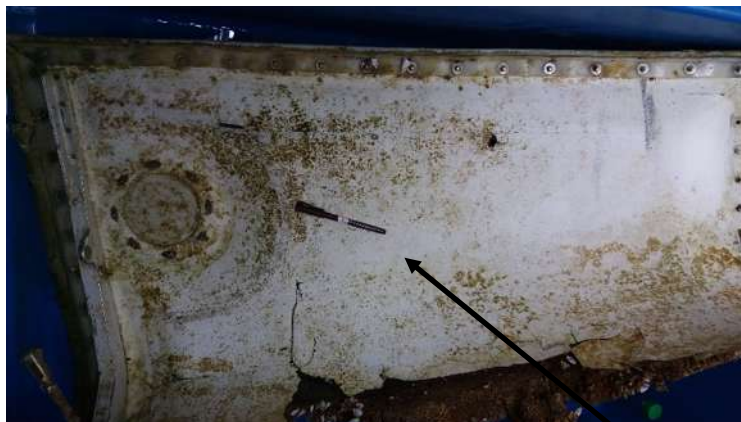
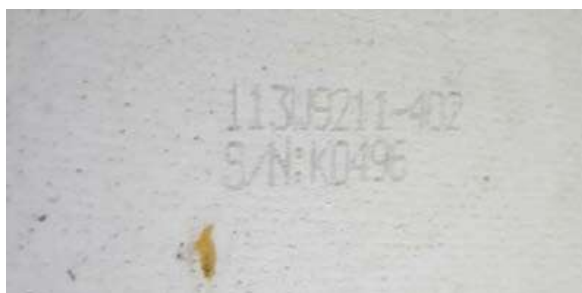
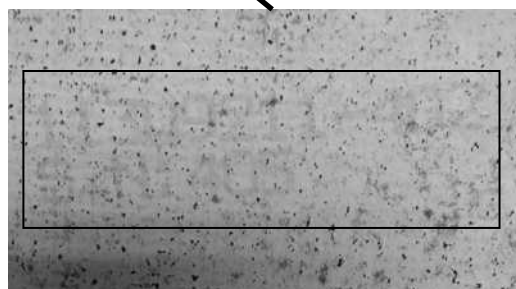
The numbers on the debris were 113W9211-402, S/N: 406. The part number was identical to the one found on the fairing removed from the aircraft, which was 113W9211-402 indicating that the debris was indeed a part of the No. 7 flap support fairing of a B777 aircraft. Refer to the pictures below. The serial number could not be used to link it to any particular aircraft as there were no records available to confirm this.

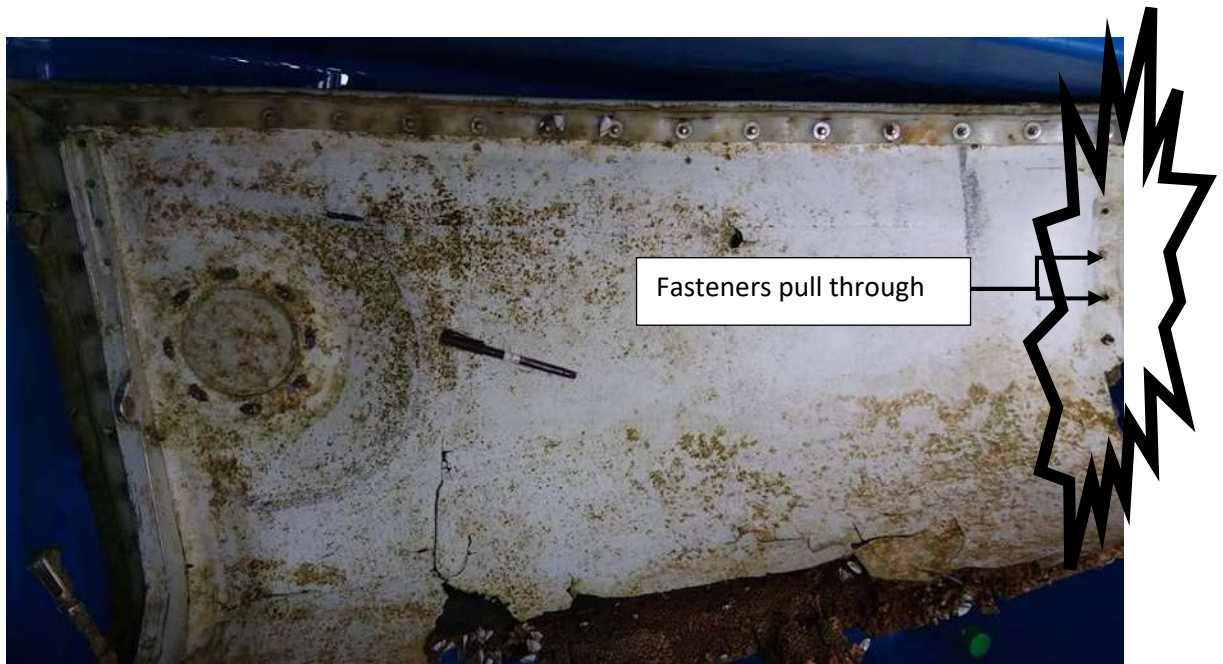
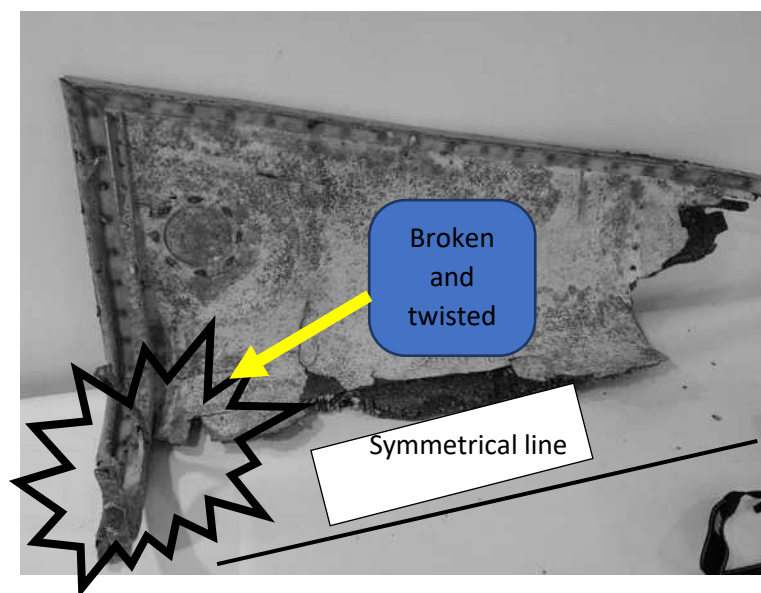
The part was fractured almost through its symmetry axis. One of the frames was completely detached from the skin. It may be due to fasteners pull through as the fasteners' holes appeared to be torn off with diameters larger than the fasteners. The bracket had broken off with some sign of twist which is evidently shown by the bent push rod.
